Subject: Repair/Replacement of Missing or Altered Storefronts

Anne Grimmer, Technical Preservation Services, National Park Service

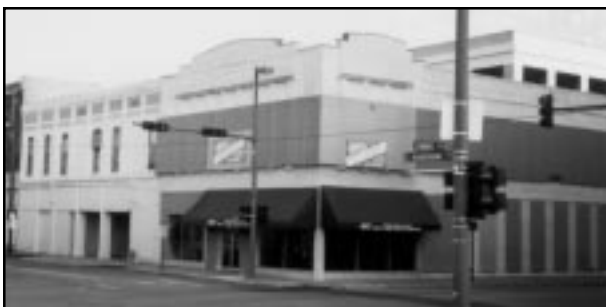
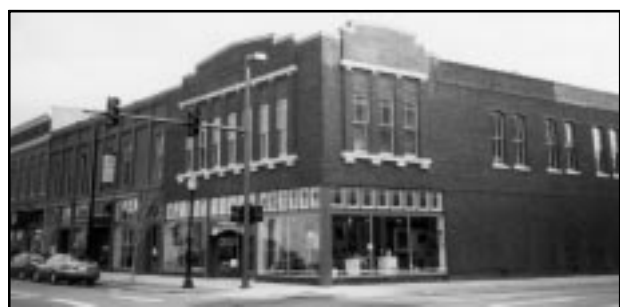
Before rehabilitation (left), the storefronts and the second floor windows were covered by plywood and metal panels. Removal of the panels revealed that the historic storefronts and windows were still intact and could be preserved (right).

**Application 1 (Compatible treatment):** This two-story, brick structure was constructed c. 1876 for commercial use on the first floor and a hotel upstairs. In 1916, the corner portion of the building was "updated" and remodeled in the Craftsman style. Over the next eighty years many more changes, most of them unsympathetic, were inflicted on the building. Transoms above the storefronts, the second floor windows and the first floor windows around the corner were covered with metal cladding. Two of the original 1870s storefront bays on the left side of the building were removed to allow vehicular access into the building when it was used as a parking garage, and the other storefront bays and second story windows were blocked down with plywood. In addition, much of the exterior brick was painted.

When the plywood and metal panels were removed at the start of the rehabilitation, the historic storefront and the second floor

windows with their distinctive Craftsman-style details and muntin configuration were revealed to be intact, needing only minor repairs. On the left side of the building, the 1870s windows on the second floor were also intact and repairable. Although portions of the original storefronts had been removed to create garage door openings, the historic cast-iron frame itself remained, and only the missing display windows had to be replaced to re-establish these historic storefronts.

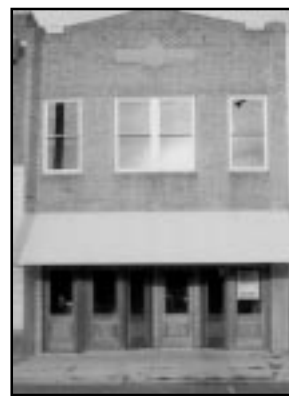
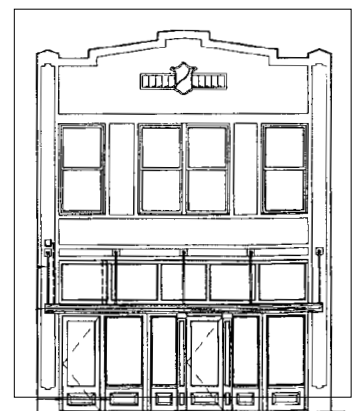
**Application 3** (*Incompatible treatment later modified to meet the Standards*): This small, two-story brick building, originally constructed in 1889 as a newspaper office, had been “modernized” with an aluminum storefront installed in the 1950s. Although no historic photographs were found to show the building's original appearance, the storefront still had two entrances, one on the left leading to the upstairs, and another leading to the newspaper offices on the first floor. As part of a recent project to rehabilitate the building as a sports bar with apartments upstairs, a new, varnished wood storefront had been installed along with a very large awning that concealed the still extant, historic transom above the storefront. This new storefront was incompatible in scale, proportion, color and finish with the character of the historic building.

The storefront of this 1889 building was altered in the 1950s (left). The replacement storefront and awning were incompatible in scale, proportion, color and finish with the historic building (center). Remedial work to make the new storefront compatible will include re-installing a horizontal metal awning, painting the wood, and increasing the glass to wood ratio of the storefront (right).

Remedial work was proposed to bring the storefront into compliance with the Standards. The proportions of the storefront were corrected by lowering the height of the bulkhead panels and lengthening the glass in the display windows and the entrance doors. A traditional metal horizontal awning suspended from the facade would be installed which would once again reveal the transom. And, the new varnished wood of the storefront—the varnish already deteriorating rapidly on this west exposure, would be given a traditional painted finish, more appropriate to the character of the historic building and more protective of the wood.
