Subject: Corridors in Historic Highrise Apartment Buildings and Hotels

- Applicable Standards:**
- 2. Retention of Historic Character
 - 5. Preservation of Distinctive Features, Finishes and Craftsmanship

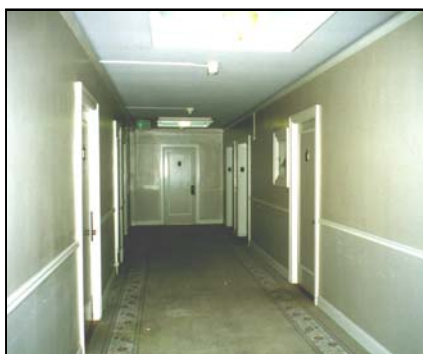
Application 1 (*Incompatible treatment*): Completed in 1926, this ten-story brick and terra cotta building was originally an apartment hotel (“bachelor” apartments without kitchenettes on the first floor and efficiency apartments on the remaining floors). Eventually, it was converted to hotel use only. The building is distinguished by virtually intact historic fabric and floor plans, including a T-shaped, double-loaded corridor system on floors two through ten. The rehabilitation proposal calls for gutting of these floors, which are in excellent condition, and construction of new corridors and hotel rooms. While the new corridor system would essentially reproduce the shape of the historic corridor system, the proposal to completely eliminate intact, character-defining features, finishes and spaces, including the apartment layouts, does not meet the Standards.

LEFT: Pre-rehabilitation photograph of typical corridor showing historic detailing, including wood trim and plaster finishes.

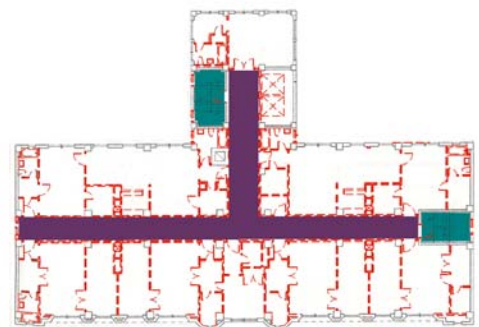
TOP RIGHT: Proposed demolition plan for each of the upper floors. Red, dotted lines indicate removal of original corridor and room partitions with the historic trim and detailing.

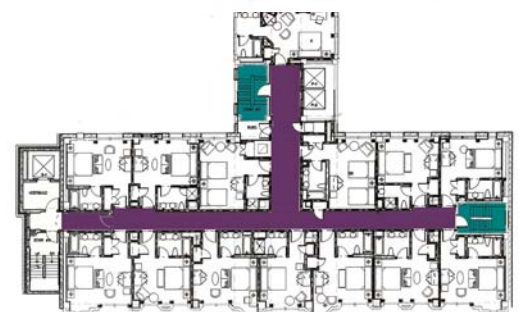
BOTTOM RIGHT: Proposed plan for the upper floors. The longer section of the new corridor is narrower than its historic counterpart. All finishes, detailing and trim would be imitations of the original.

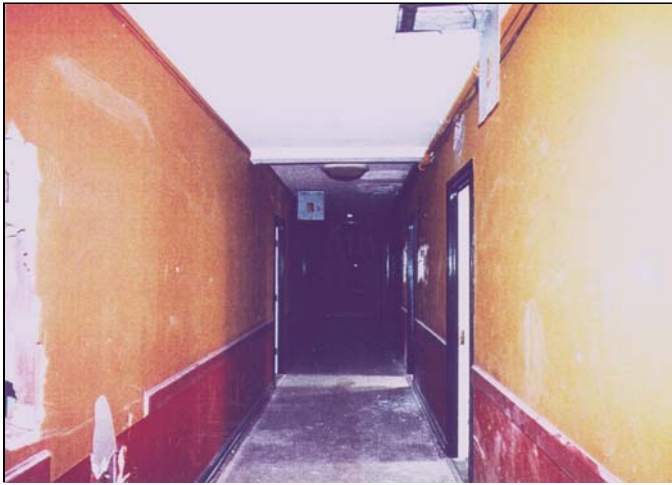
LEFT: Pre-rehabilitation view of typical corridor showing historic trim and deteriorated flat plaster.

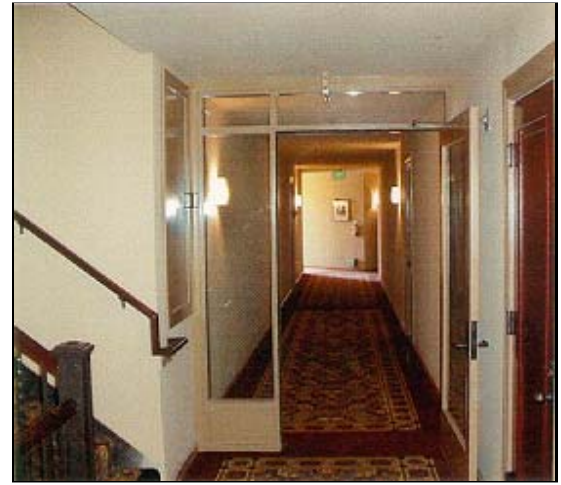
RIGHT: Post-rehabilitation view of typical corridor showing retention of historic trim, drywall finishes that match the appearance of the original flat plaster, and a slightly lower ceiling that conceals new systems. Also shown are a compatible, largely glazed fire door and a portion of the preserved open stair (lower left of image).

Application 2 (Compatible treatment): Opened in 1927 to serve as an apartment hotel (originally, 85 apartment suites and 32 hotel rooms), this building is a fifteen-story, reinforced-concrete tower. Over the years, virtually all of the building became a hotel. Then, as part of the recent rehabilitation, the building shifted back to apartment building use. Above lobby level, the floors are served by double-loaded corridors that follow the footprint of the wide central section of the building and its diagonal end wings. The rehabilitation retained the elevator lobbies, corridors, and the associated historic fabric, with a few minor modifications (the basic room configuration was also retained, with some grouping of rooms to create apartments). Two small corridor “access ways” for fire escapes were converted to private space for adjacent apartments (as the fire escapes themselves were eliminated); drywall was laminated to the deteriorated plaster walls (historic trim and detailing were retained); and a drywall ceiling was dropped slightly below the historic flat plaster ceiling to accommodate the new mechanical, electrical and plumbing systems. This work preserves the historic character of the corridors and, thus, meets the Standards.

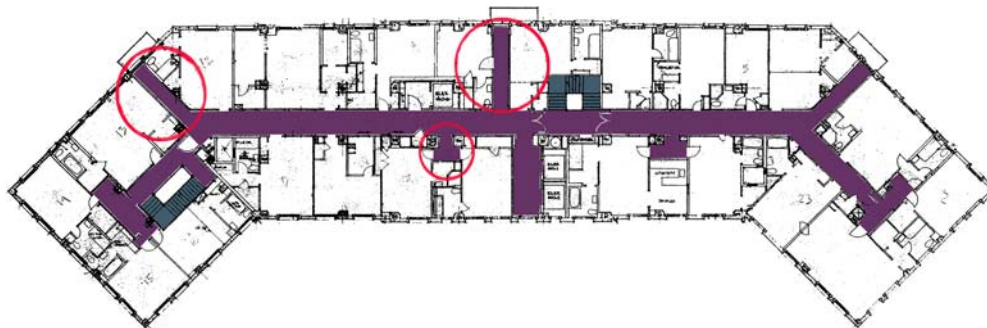
Pre-rehabilitation plan of typical upper floor. Circled areas indicate the only major changes to the corridor plan to take place during rehabilitation.

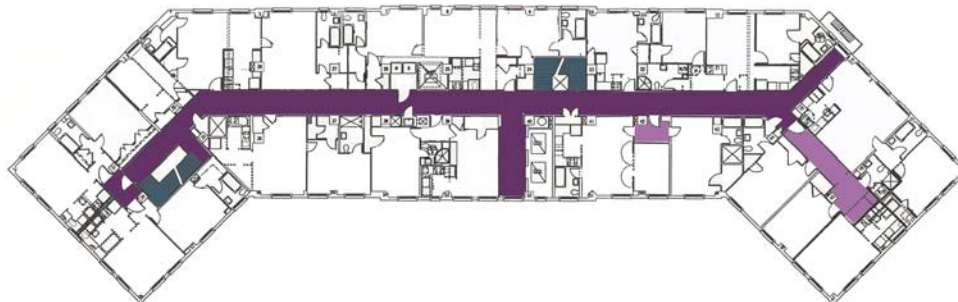
Post-rehabilitation plan of typical upper floor. Corridors and staircases have survived intact. Former fire escape “accessways” have been absorbed into two apartments and a vestibule is absorbed into one apartment on each floor. Shown in lavender are intact, previously public areas (a small vestibule and the end leg of the corridor) that have been incorporated into two of the apartments on each floor.
