Death in the line of duty...

A summary of a NIOSH fire fighter fatality investigation

September 23, 2005

One Part-time Fire Fighter Dies and Another Is Seriously Injured When Two Fire Engines Collide at an Intersection While Responding to a Fire - Illinois

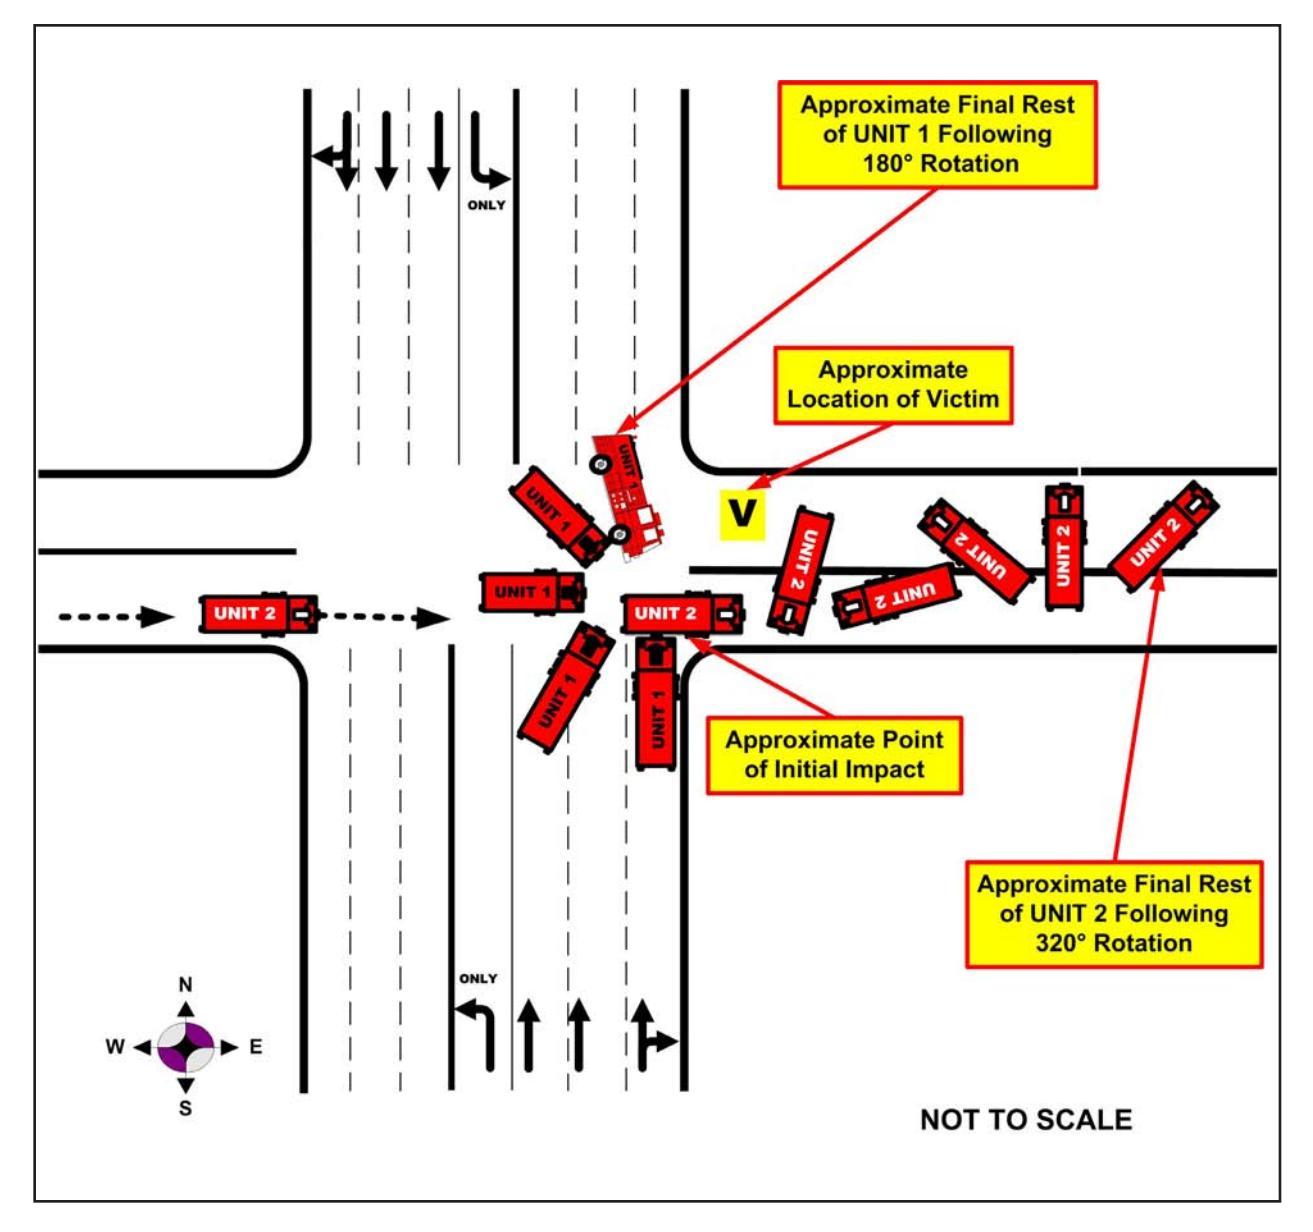
Weather/road: The incident occurred at the intersection of two concrete roadways bordered on both sides by raised concrete curbs. The east-west roadway (R1) has two lanes; the northsouth roadway (R2) has three northbound and three southbound lanes. (Diagram). R2 has dedicated left-turn-only lanes on both the northand southbound sides. Traffic at the time of the crash was reported as being of medium density. The crash occurred during daylight hours; the weather was clear and the roads were dry.

Diagram. Aerial view of intersection where crash occurred

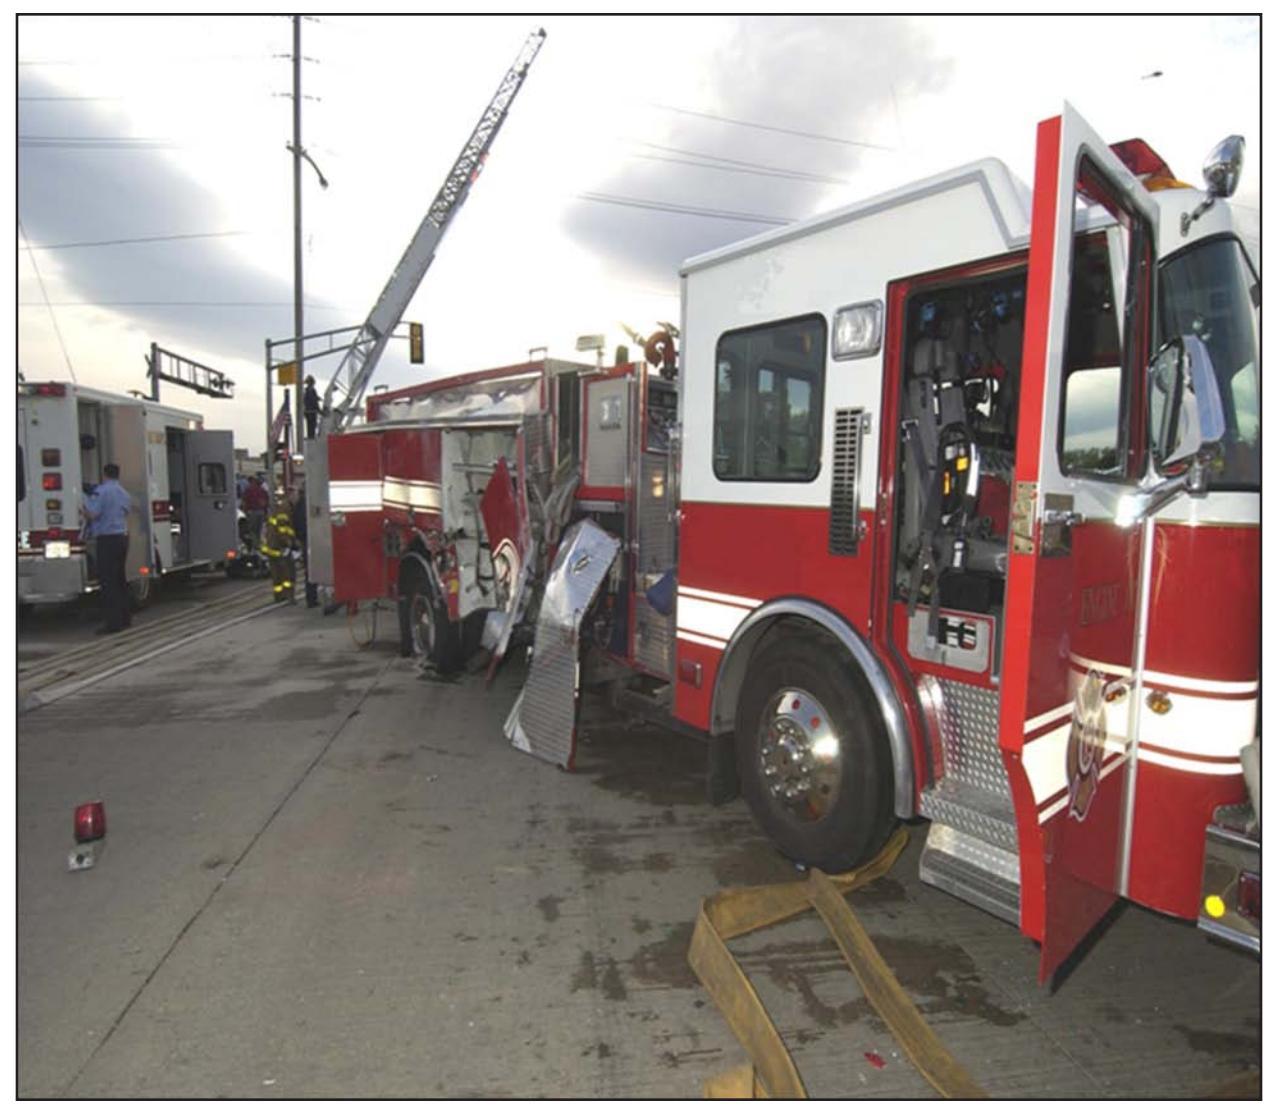
Photo 1. View of Unit 2 which was struck on the passenger side

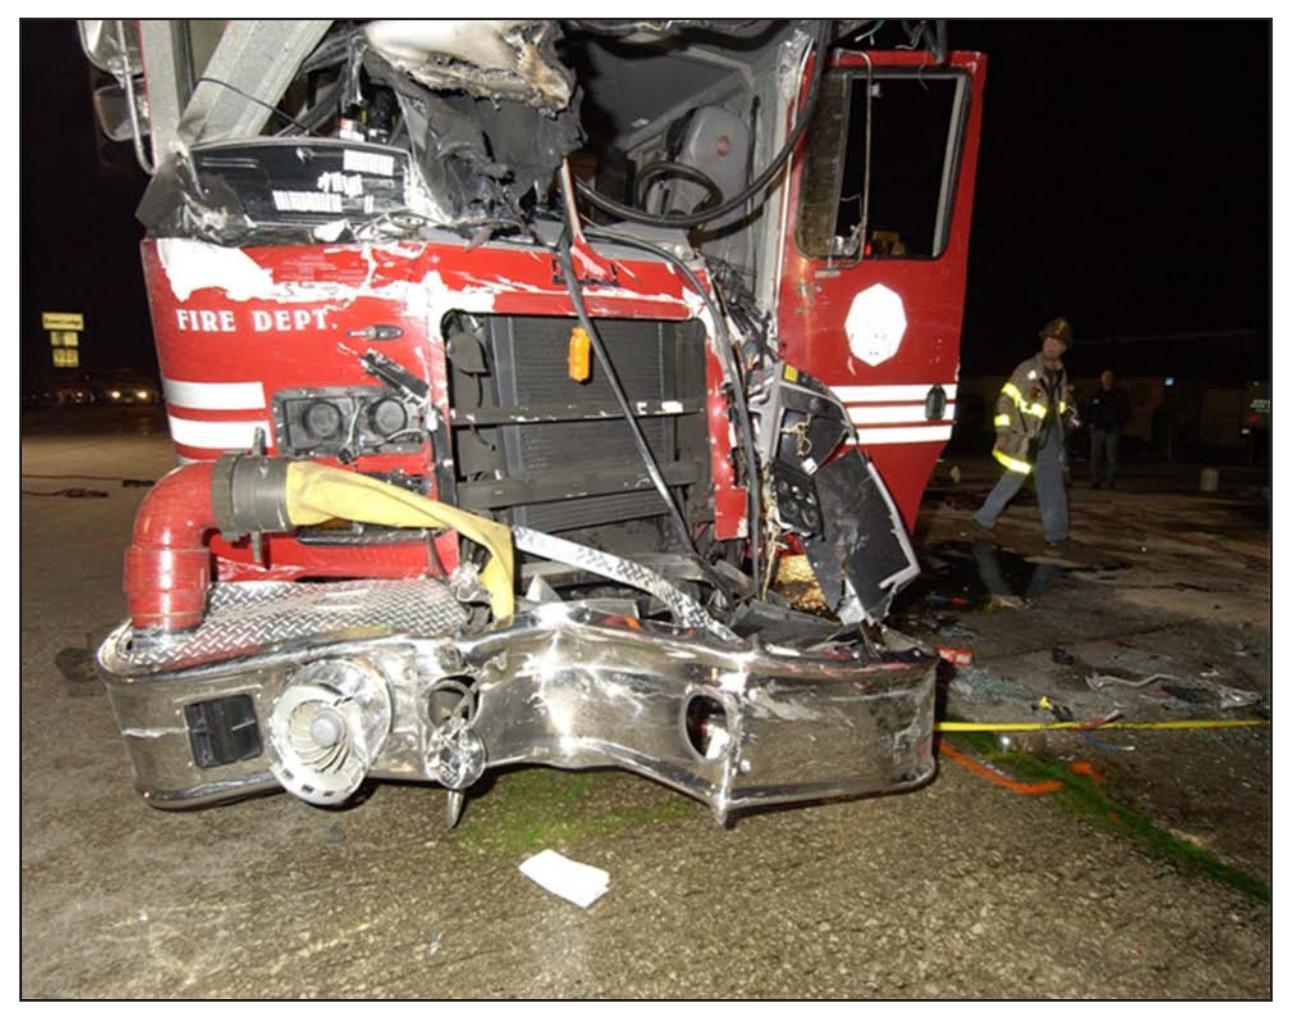
On April 27, 2004, at approximately 1735 hours, a call came in for a garage fire in a local township. Three fire departments, including the two involved in the crash, responded via automatic-aid response.^c The victim and two fire fighters responded in Unit 1. Three career fire fighters from another department responded in Unit 2. According to the state police report, at approximately 1742 hours, Unit 2 was heading east on R1 when it entered the intersection where the crash occurred. Unit 2 had a sending unit for the emergency traffic light control system and the traffic light was green as it entered the intersection. As Unit 2 crossed the northbound necessary to meet the requirements of NFPA lane of the intersection, it was struck by an engine from the victim's department (Unit 1) just behind the enclosed cab (Photo 1). Note: No speed estimates were available. Upon impact, the victim (who was unrestrained) was thrown forward striking his head on the interior of the cab. Unit 1 then rotated clockwise approximately 180 degrees and rolled onto its left side. According to the police report, during this rotation, the victim was ejected through the windshield and landed on the northeast side of the intersection. As the front of the cab of Unit 1 collapsed inward (Photo 2),

causing crushing injuries. The driver of Unit 1 had to be extricated and hospitalized. The rear passenger of Unit 1, who was restrained, received minor injuries. He was taken to a local hospital where he was treated and released. After being struck, Unit 2 rotated clockwise about 320 degrees before coming to rest on the east side of the intersection facing northeast. The three fire fighters in Unit 2, who were wearing restraints at the time of the incident, had minor injuries. They immediately exited their apparatus to help the fire fighters in Unit 1. Later they were taken to a hospital where they were treated and released. The victim was transported to a local hospital where he was pronounced dead on arrival.

Photo 2. Crushed front end of Unit 1
