FinishLine

Iron Stain on Wood

Forest
Products
Laboratory

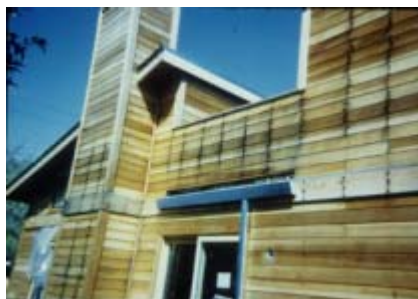
Iron stain, an unsightly blue-black or gray discoloration, can occur on nearly all woods. Oak, redwood, cypress, and cedar are particularly prone to iron stain because these woods contain large amounts of tannin-like extractives. The discoloration is caused by a chemical reaction between extractives and iron in steel products, such as nails, screws, and other fasteners and appendages. Steel used in contact with wood must not corrode. This can be accomplished by using stainless steel or by coating the steel.

Problems have been associated with traces of iron left on the wood from cutting or slicing; cleaning the surface with steel wool, wire brushes, or iron tools; using finishes stored in rusty containers; and using iron-containing or iron-contaminated finishes. Iron dust from metalworking and even plant fertilizers can be sources of iron. Urine on wood floors will hasten the reaction with iron in wood extractives, producing the discoloration.

A simple test can be used to determine whether wood discoloration is caused by iron. Apply a saturated solution of oxalic acid in water or a saturated solution of sodium hydrogen fluoride (sodium bifluoride) to the stained wood surface.

If the solution removes the stain, then iron is present on the wood. If the solution does not remove the stain, try applying bleach to the stained area. If it removes the stain, the discoloration was probably caused by mildew.

Oxalic acid reacts with iron tannates to form a colorless complex. After treating wood with oxalic acid, thoroughly wash the surface with fresh, warm water to remove excess acid. If all sources of iron are not removed or protected from corrosion, staining will occur again.
