Wooden Artifacts in Cemeteries: A Reference Manual

Anthony & Associates, Inc.
P.O. Box 271400
Fort Collins, Colorado 80527

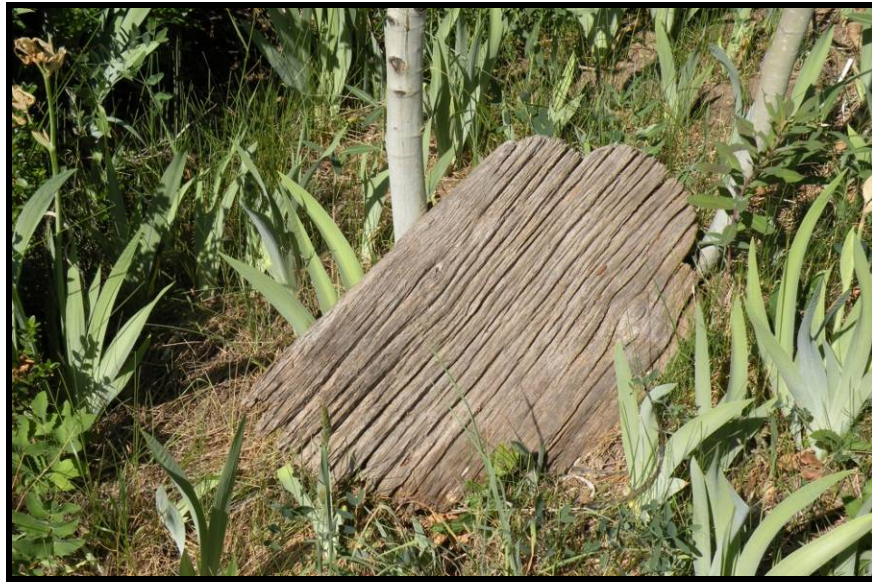
Figure 1. A grave marker with the gray wood typical from UV exposure and weathering-caused cracks and checks that allow moisture penetration.

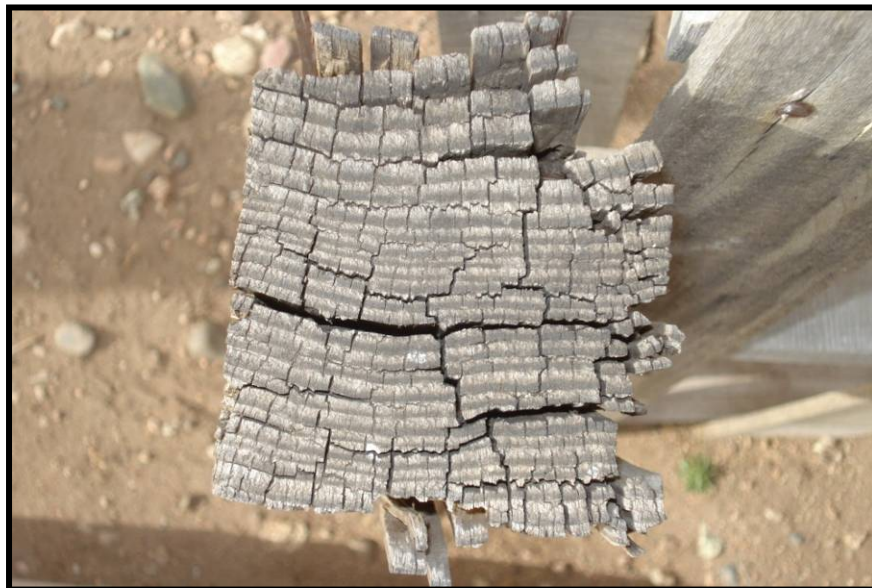
Figure 2. The top of a grave enclosure corner post showing splits developing from cyclic moisture or freeze/thaw episodes.

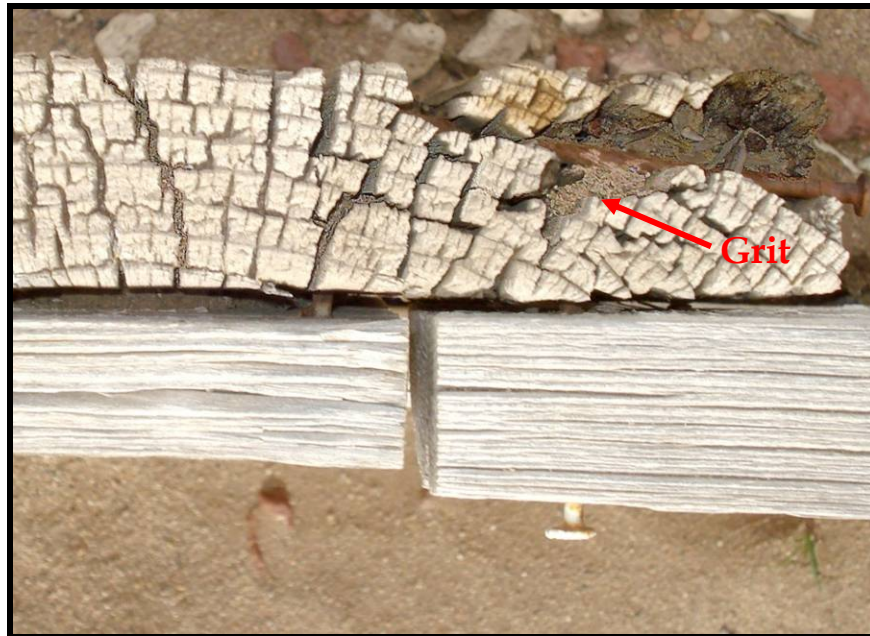
Figure 3. Detail of a grave enclosure post with weathering and sand and grit accumulating within the crevices.

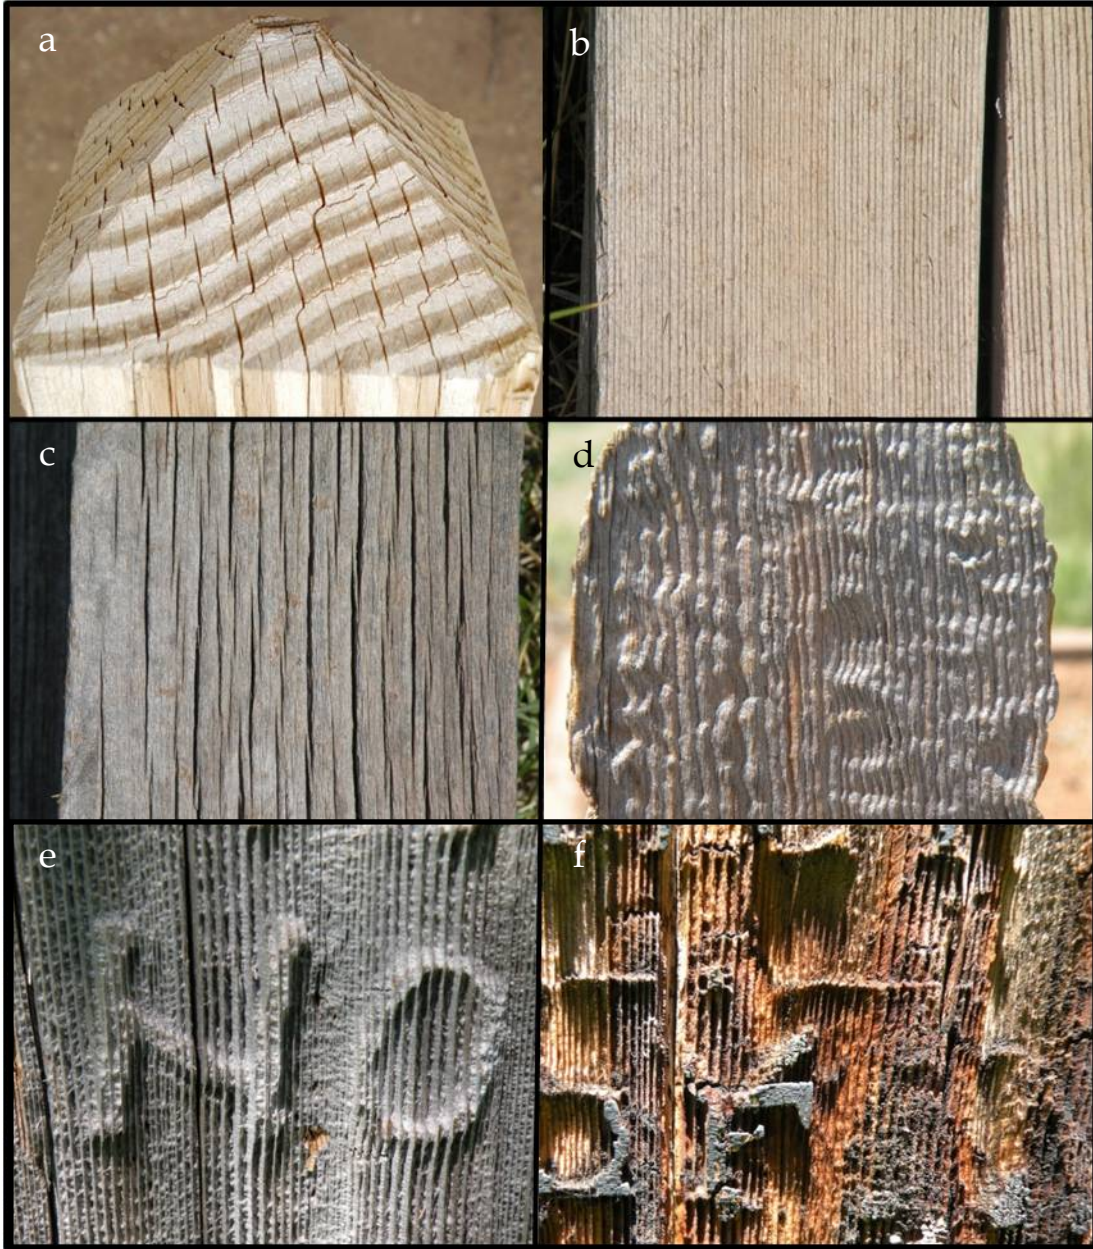
Figure 4. Examples of weathering ranging from some surface checking and slight discoloration (a through c) to extensive erosion of the softer earlywood (d through f).

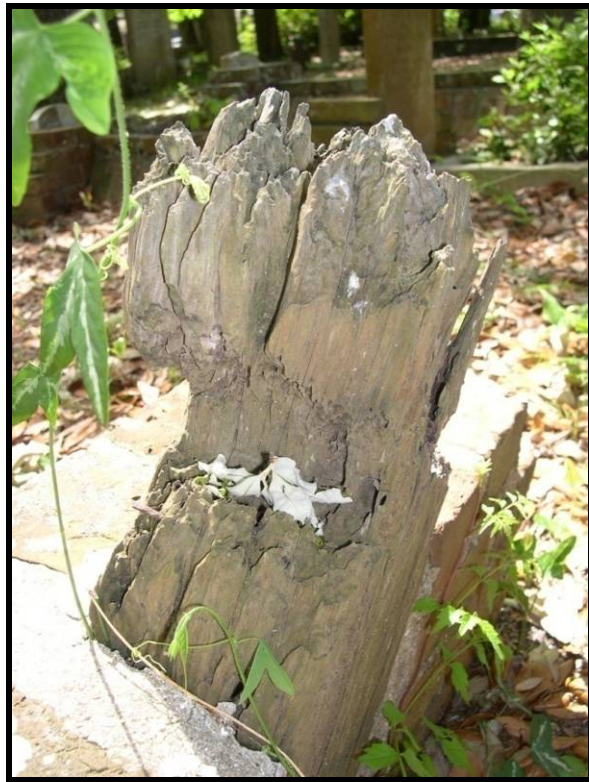
Figure 5. A small, almost unrecognizable, key-shaped foot marker with organic debris collecting within heavily weathered and insect-damaged crevices.

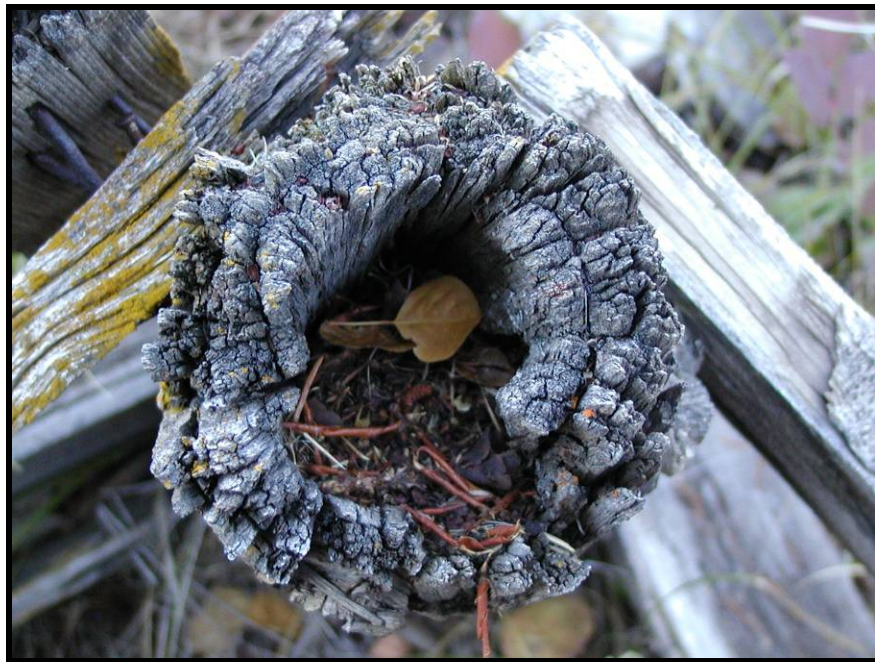
Figure 6. A grave enclosure corner post with debris collecting in a deteriorated area. This is an example of weathering that can lead to cavities susceptible to decay.

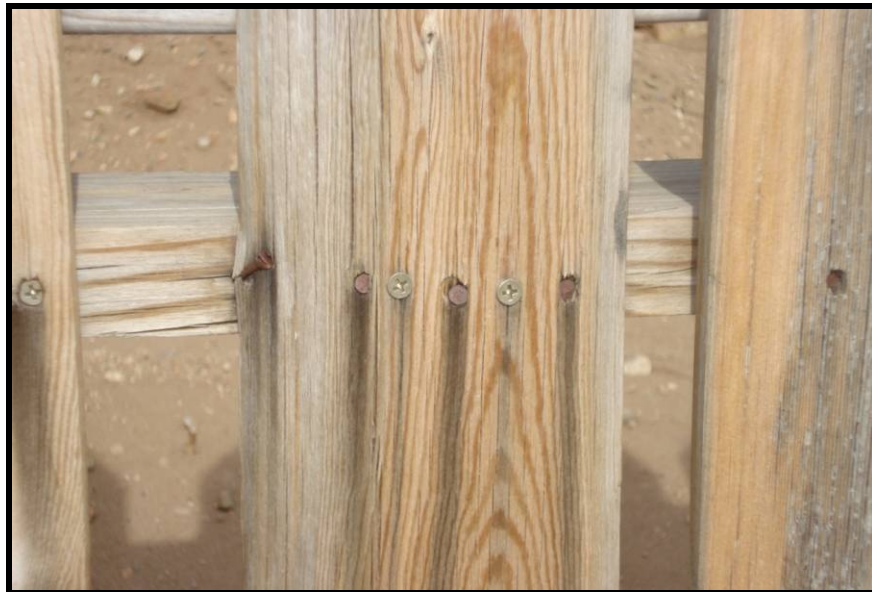
Figure 7. Stains on a grave enclosure caused by the combination of moisture and a chemical reaction between extractives in the wood and the metal fasteners.

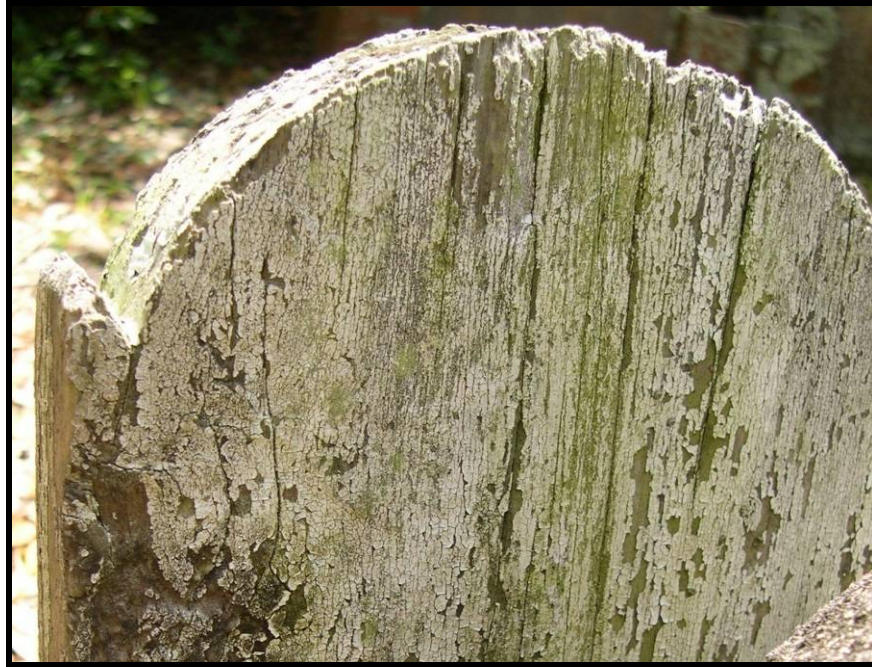
Figure 8. The back of a painted wooden grave marker with green mold growth.

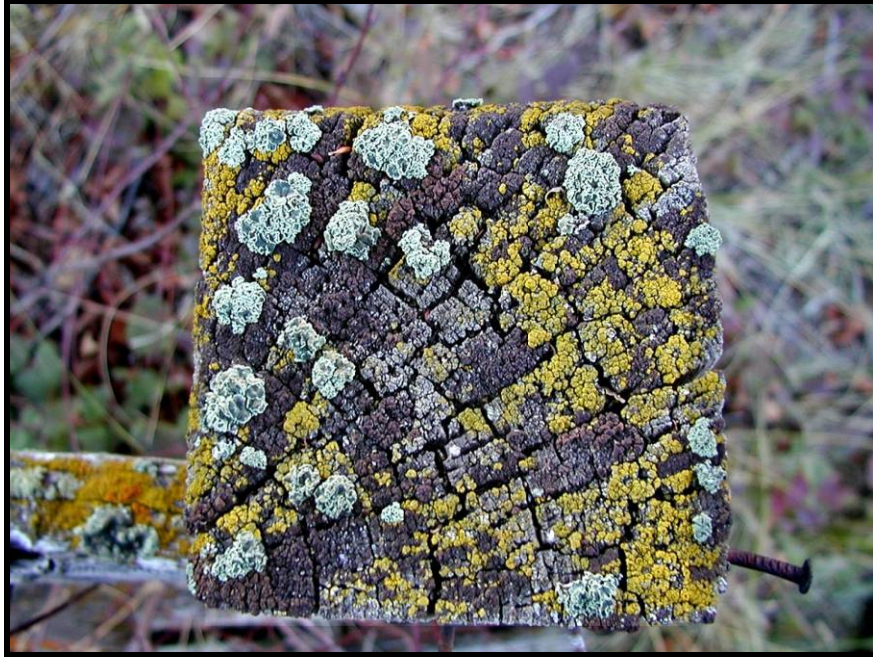
Figure 9. Lichens growing on a grave enclosure corner post.

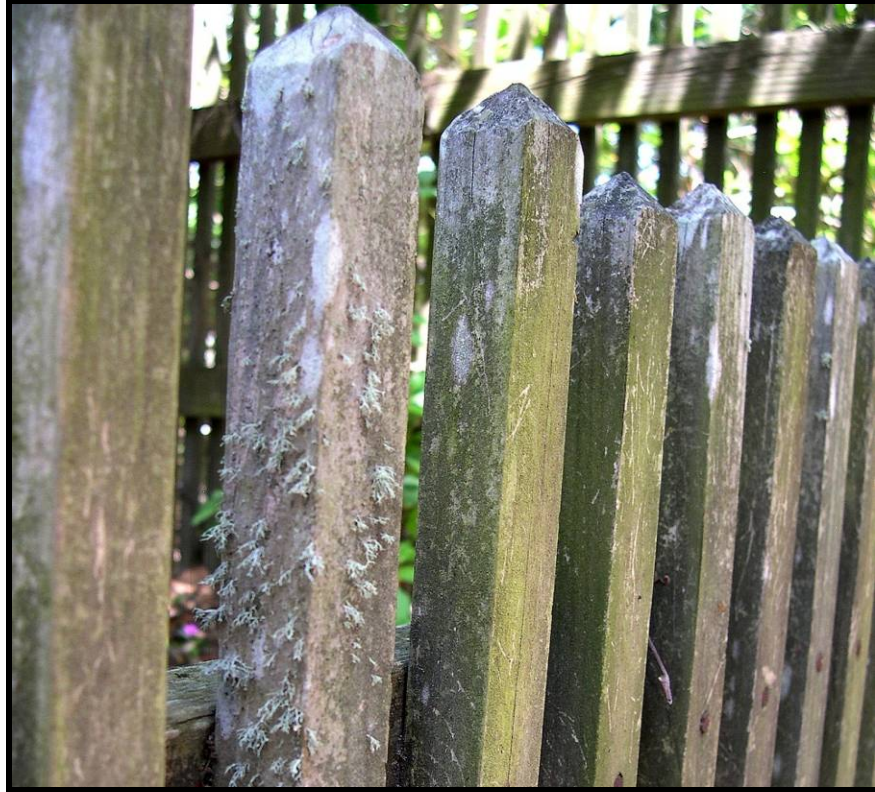
Figure 11. Fructicose lichens and green mold growing on grave enclosure pickets.

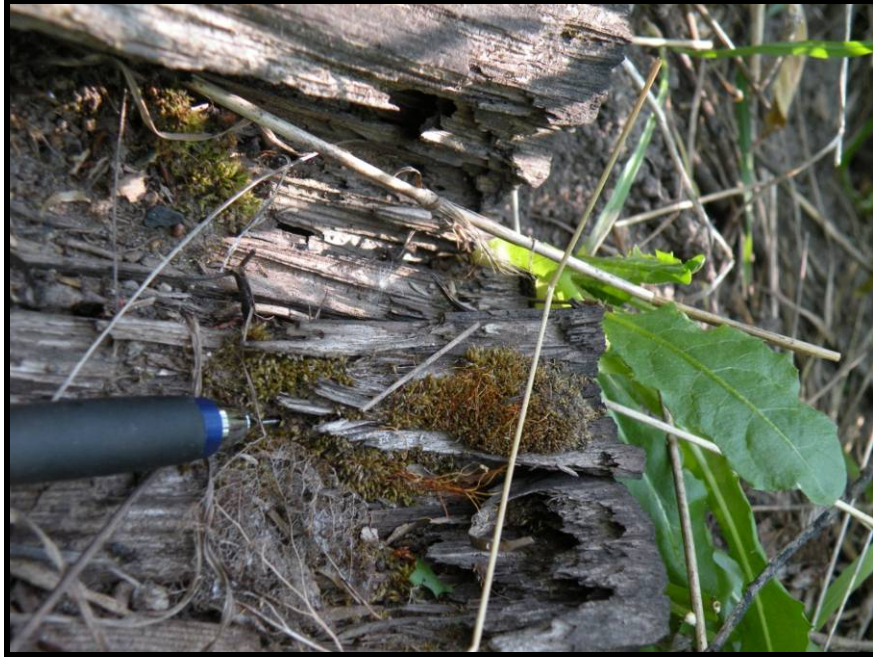
Figure 12. Moss on a grave enclosure. Pencil is for scale.

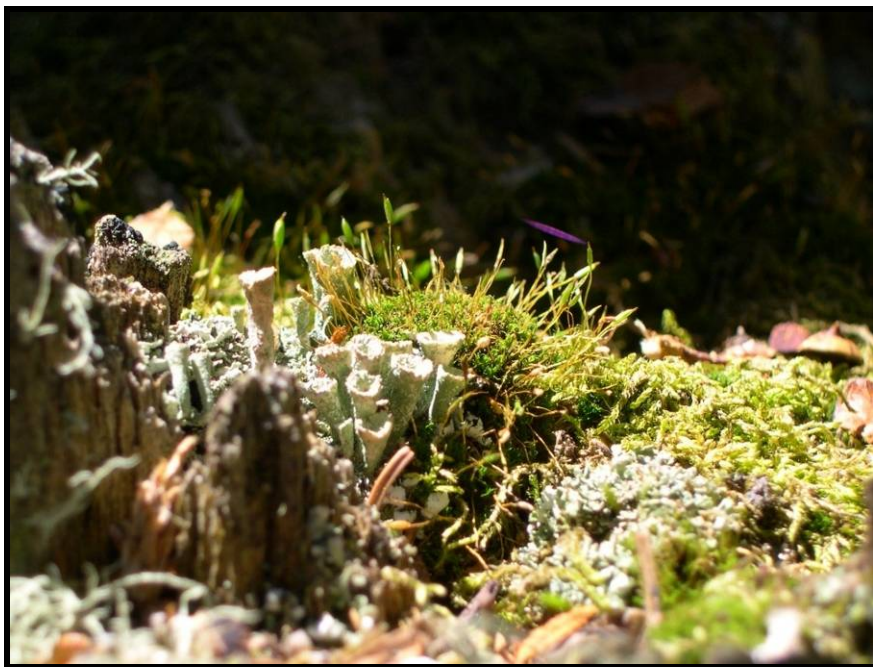
Figure 13. A variety of lichens and moss growing on a log stump, indicating high levels of moisture and low levels of sun exposure.

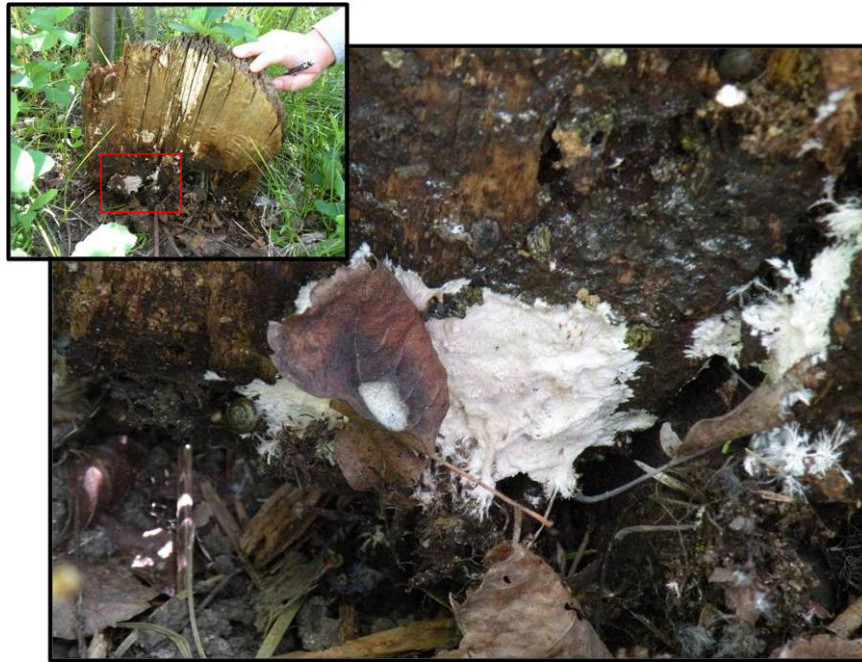
Figure 14. Cottony white fungal fruiting body found on a marker.

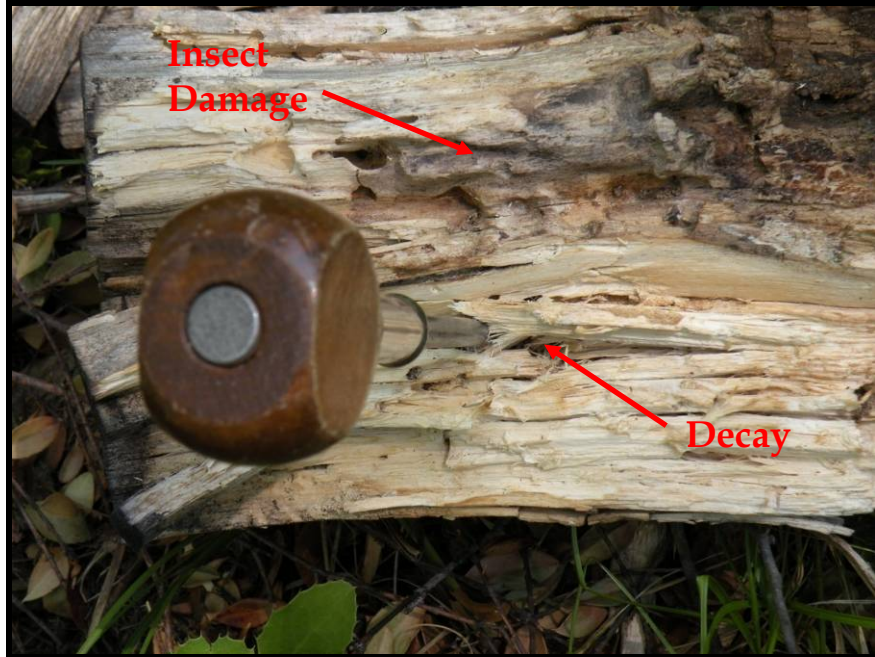
Figure 15. Example of decay (bottom half) and minor insect damage (top half) on the face of a marker at ground level. Awl illustrates ease of penetration into the decayed wood.

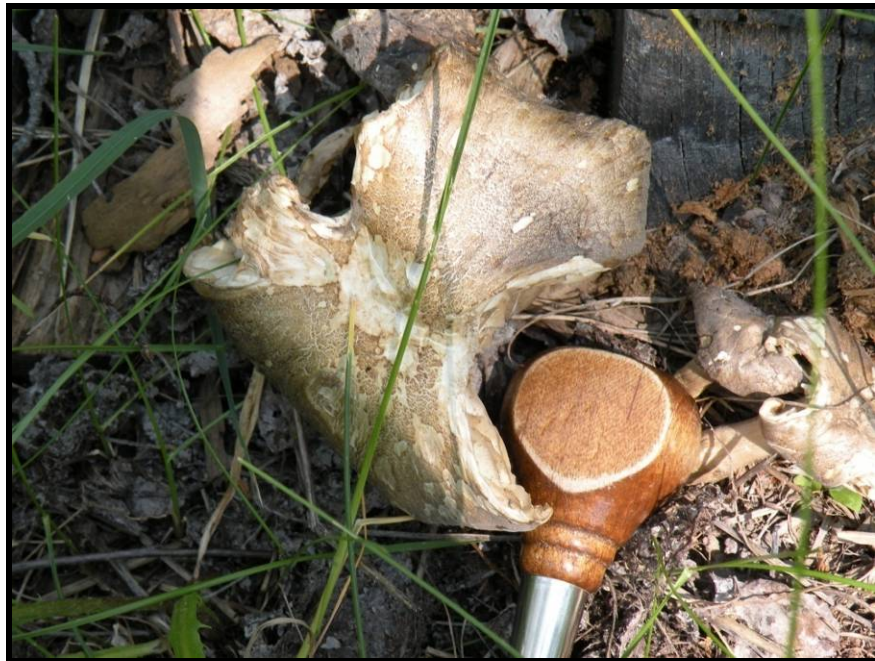
Figure 16. Fruiting body found in association with a decaying wooden marker. Awl is shown for scale.

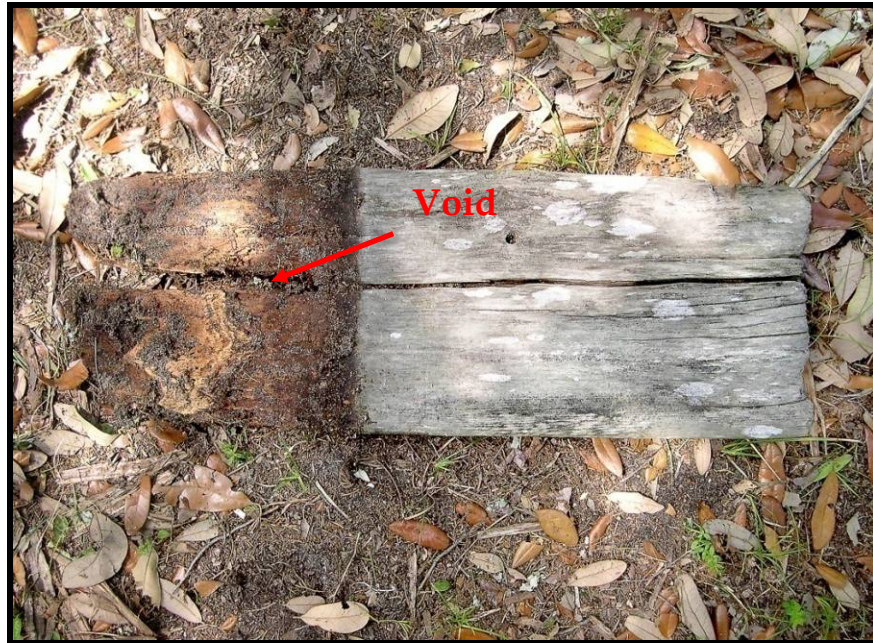
Figure 17. An example of moisture wicking along the grain of a grave marker and creating a void below ground as the decay progresses.

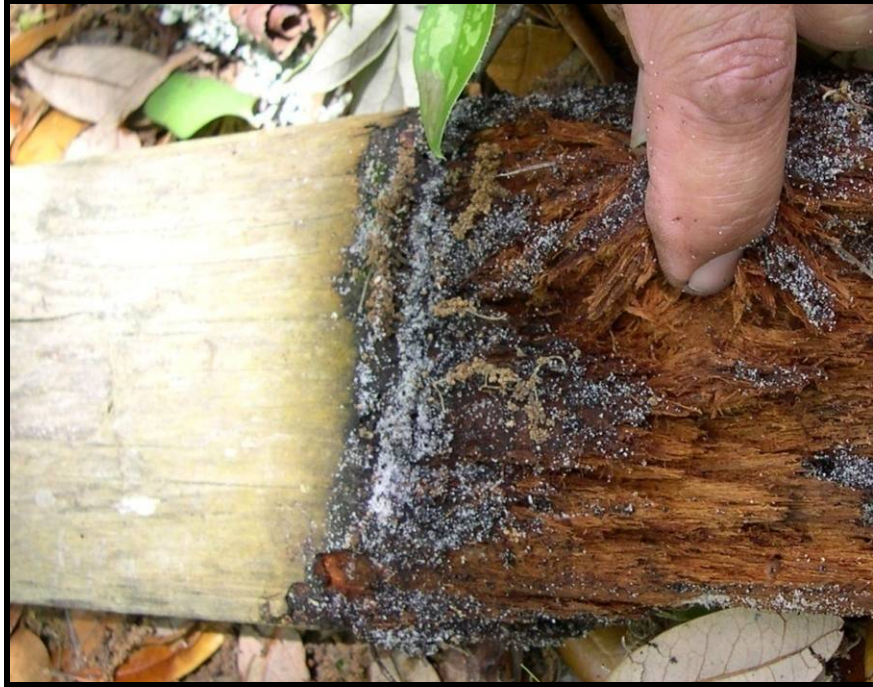
Figure 18. Evidence of advanced decay – the wood is soft and easily breaks apart.

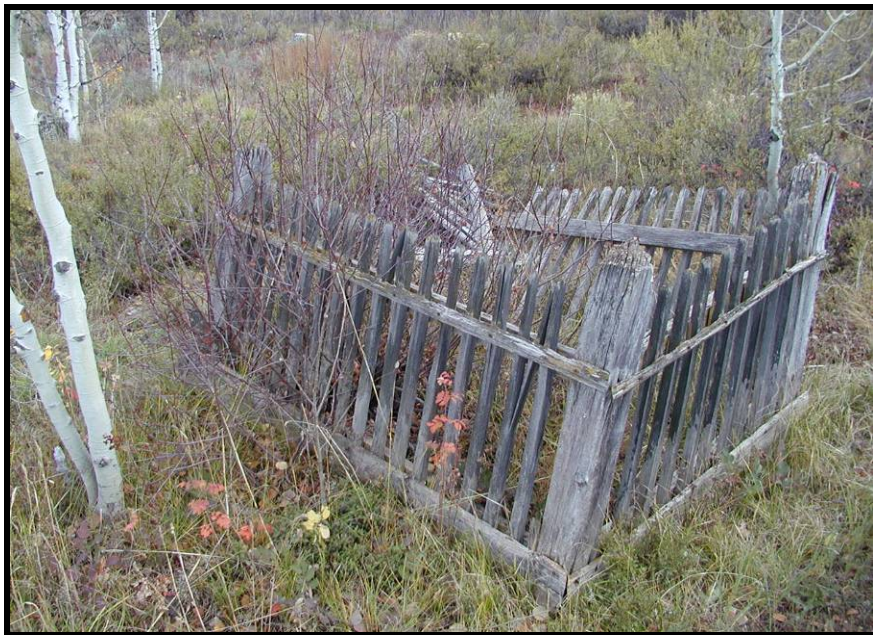
Figure 19. A grave enclosure in partial collapse due, in part, to decay of the corner posts at ground level.

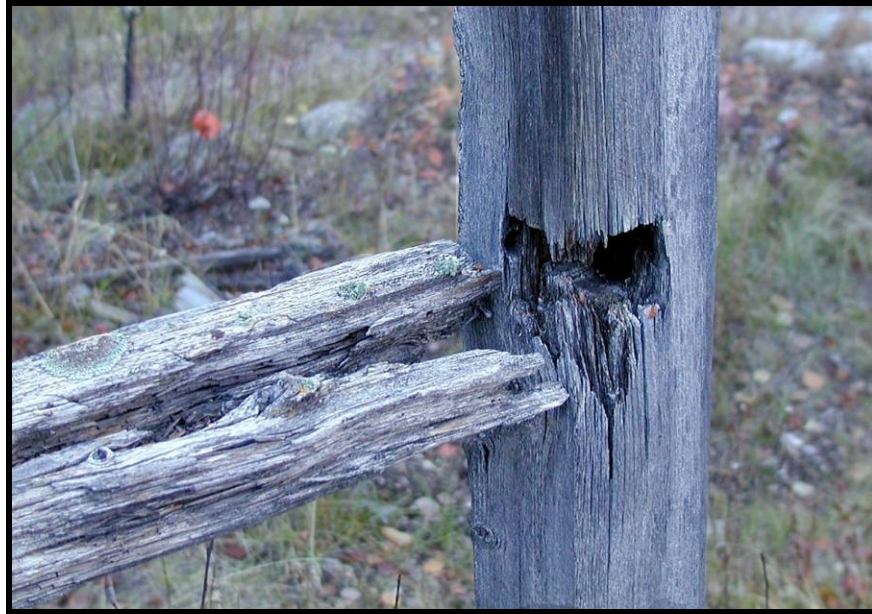
Figure 20. A grave enclosure corner post with signs of internal decay.

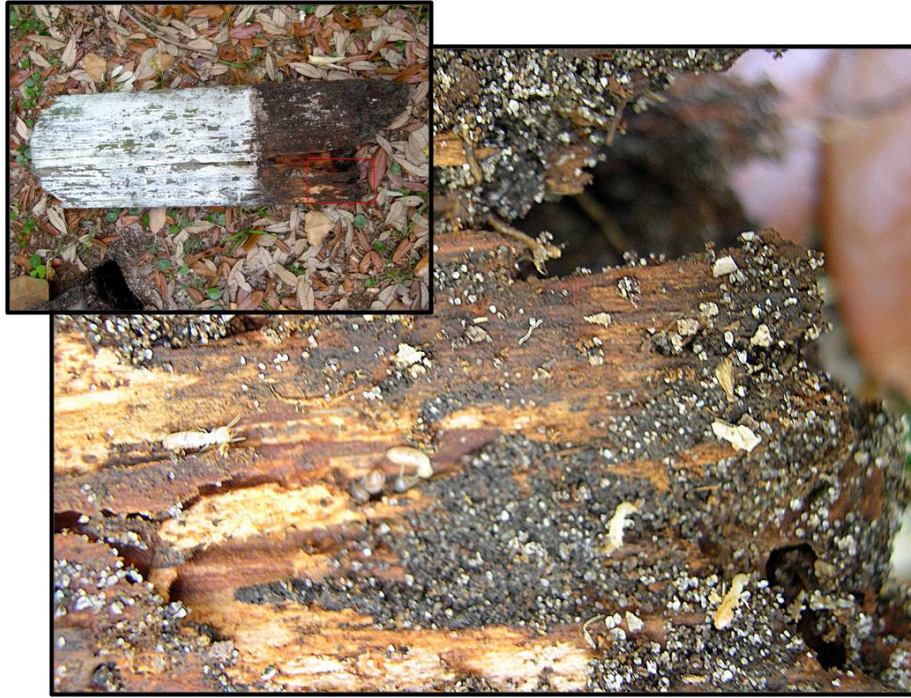
Figure 21. Subterranean termites found on the in-ground portion of a wooden grave marker.

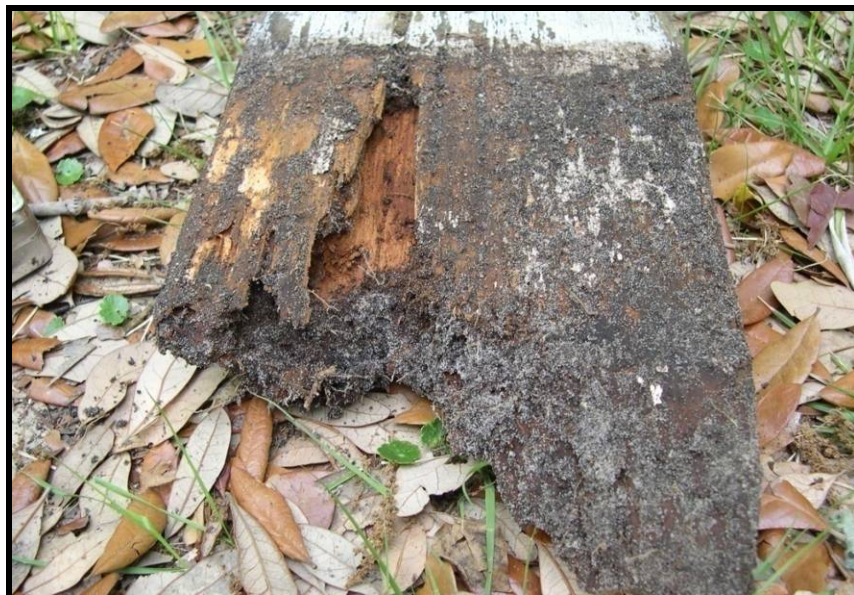
Figure 22. Loss of wood in the underground portion of a grave marker by subterranean termites.

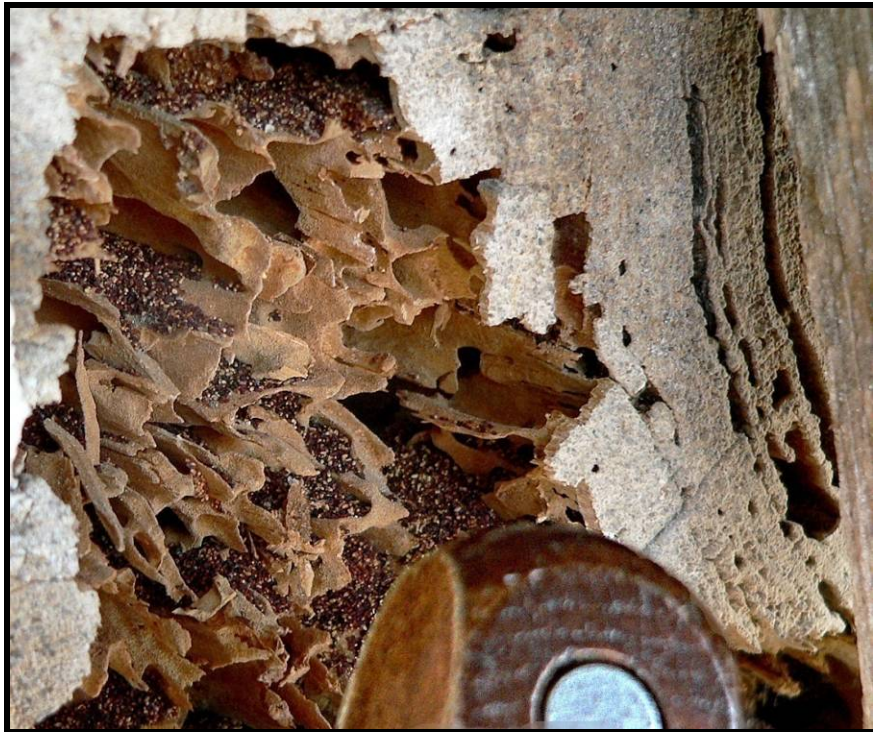
Figure 23. Typical drywood termite galleries discovered after breaking through a thin shell of sound-looking wood. Note the collection of fecal pellets.

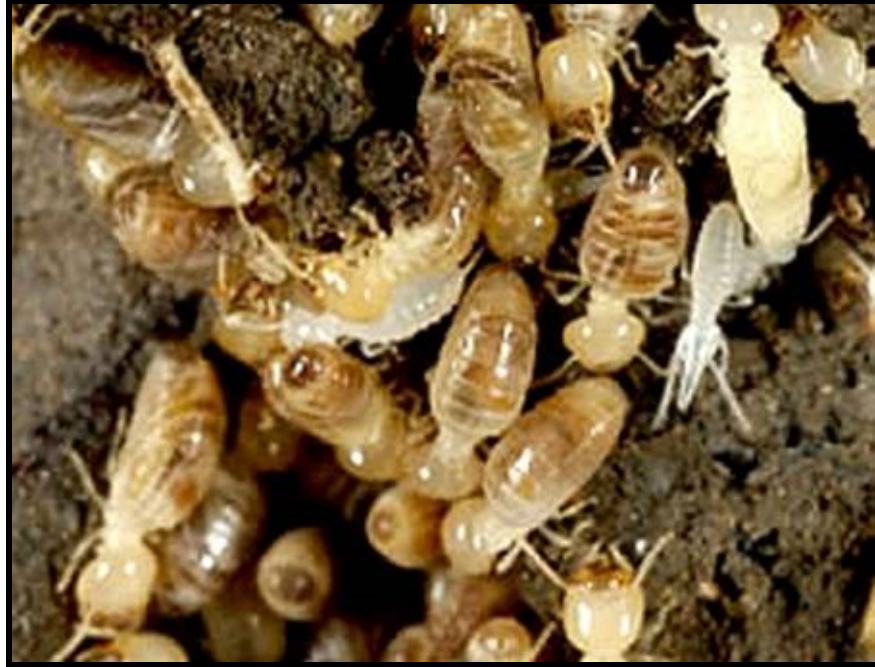
Figure 24. Drywood termites, magnified 500%. Image from <http://www.termitetreatment.com/>.

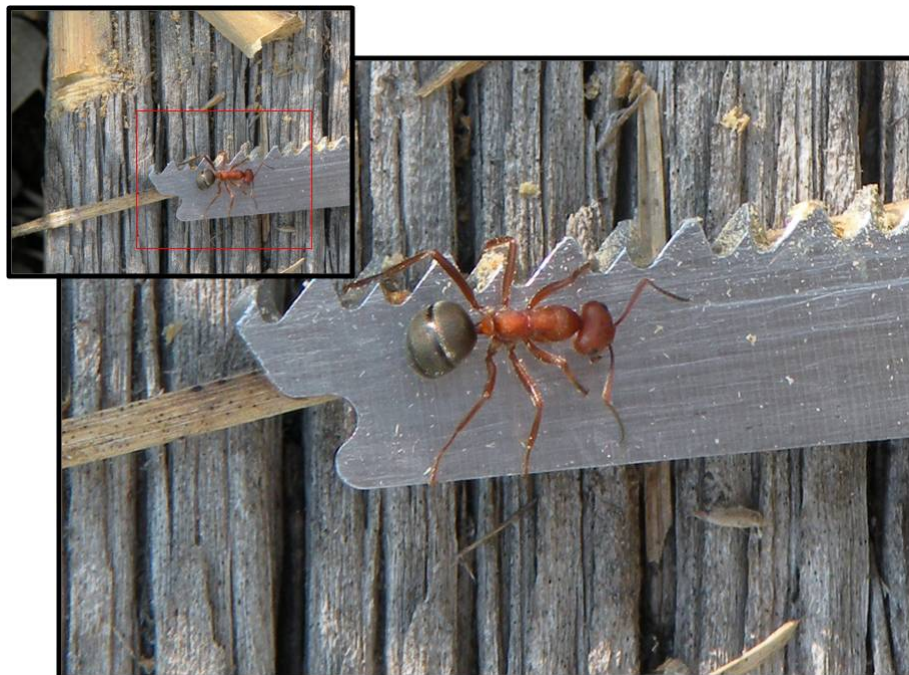
Figure 25. Detail of a carpenter ant. Carpenter ants are typically $3/8 - 1/2$ inch in length.

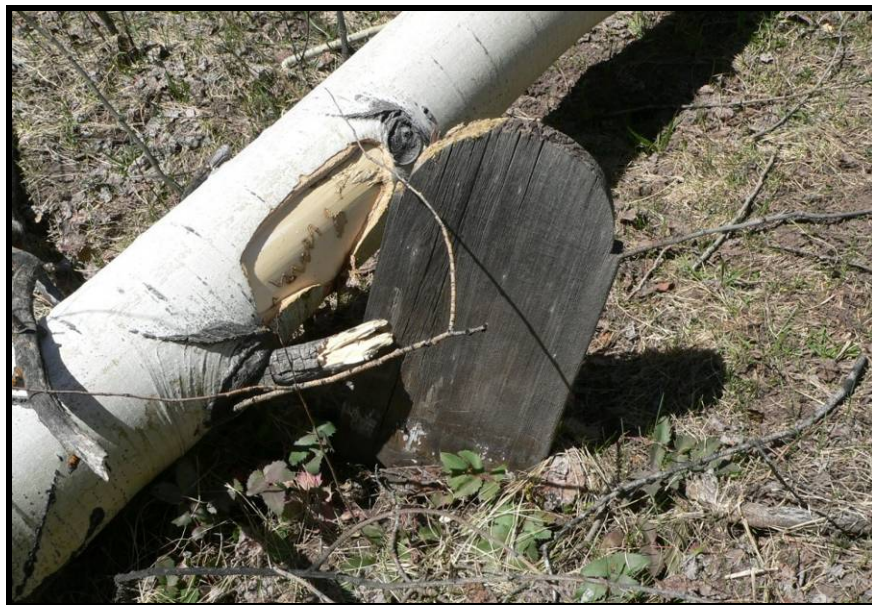
Figure 26. A fallen tree grazed this marker on the way down, damaging the top of the marker and pushing it partially out of the ground.

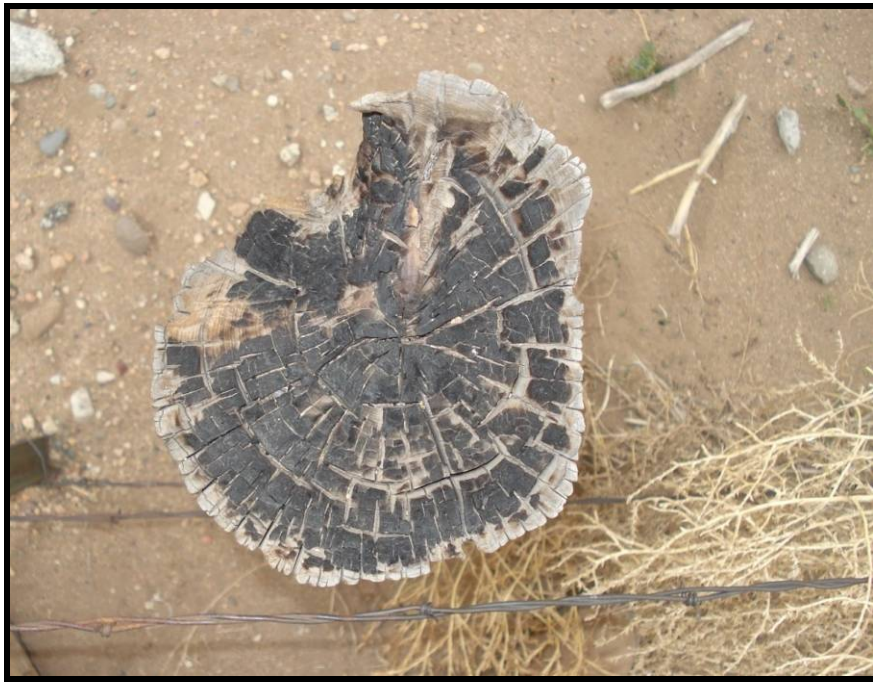
Figure 27. A cemetery fence post damaged by fire.

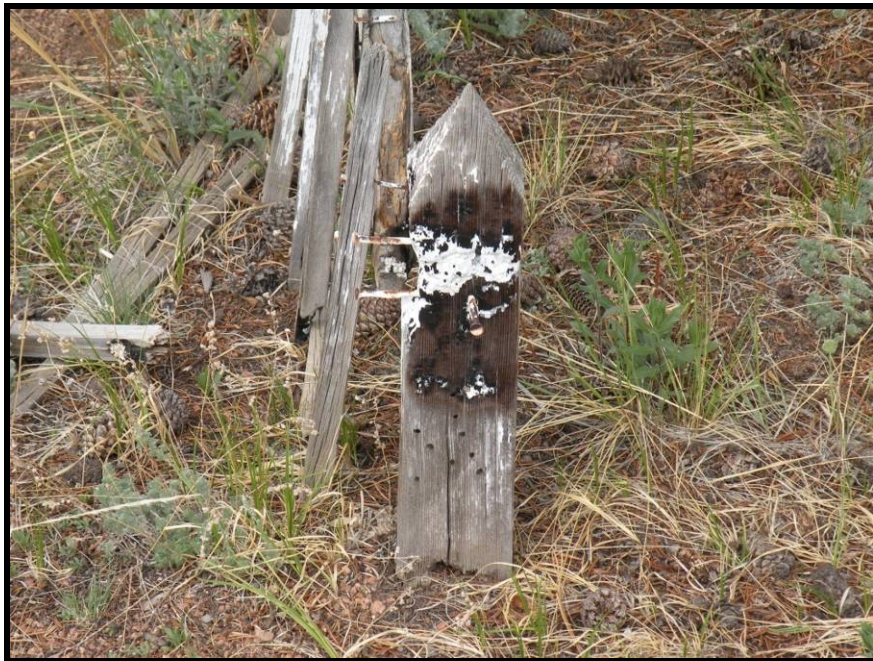
Figure 28. A grave enclosure corner post damaged by fire.

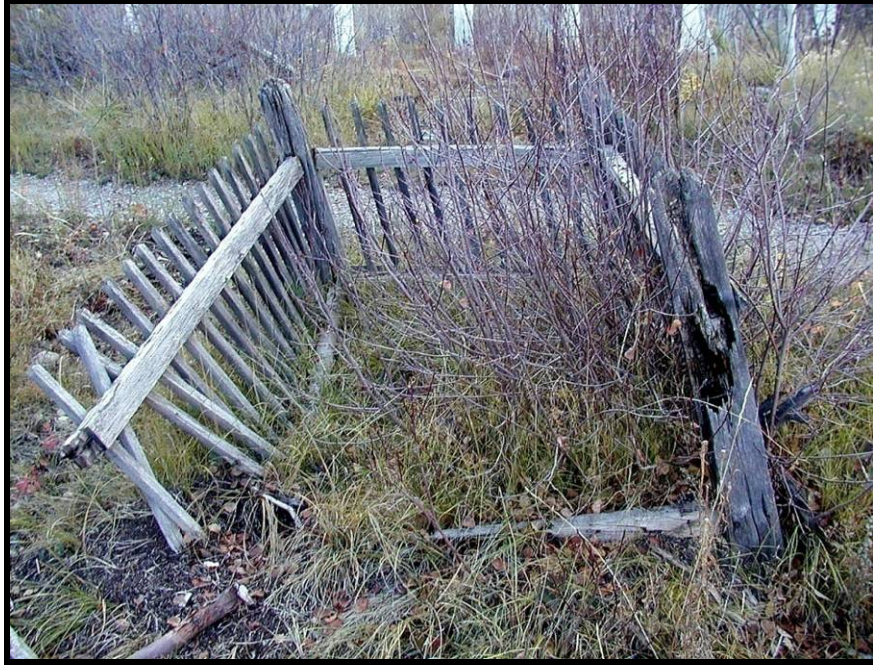
Figure 29. A grave enclosure damaged by decay and overgrowth of an invasive shrub in combination with decay of the corner posts.

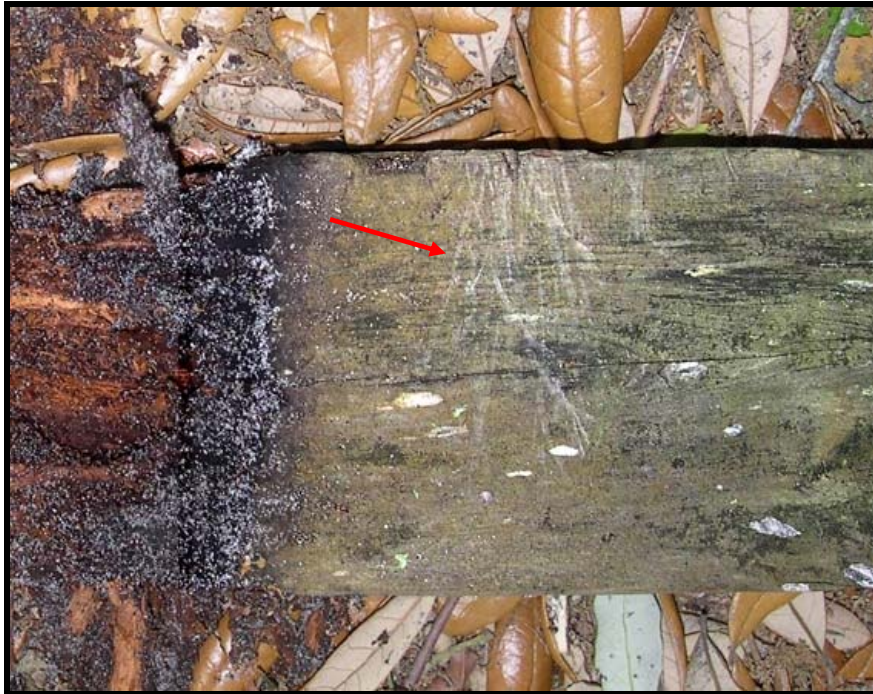
Figure 30. A grave marker showing damage from a weed trimmer.

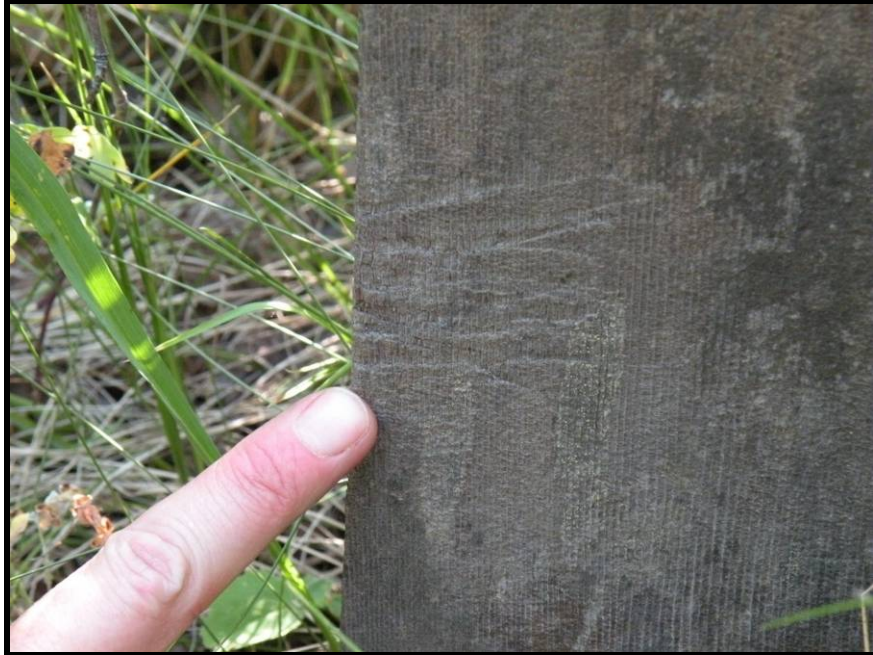
Figure 31. Damage on the edge of a wooden marker caused by a weed trimmer.

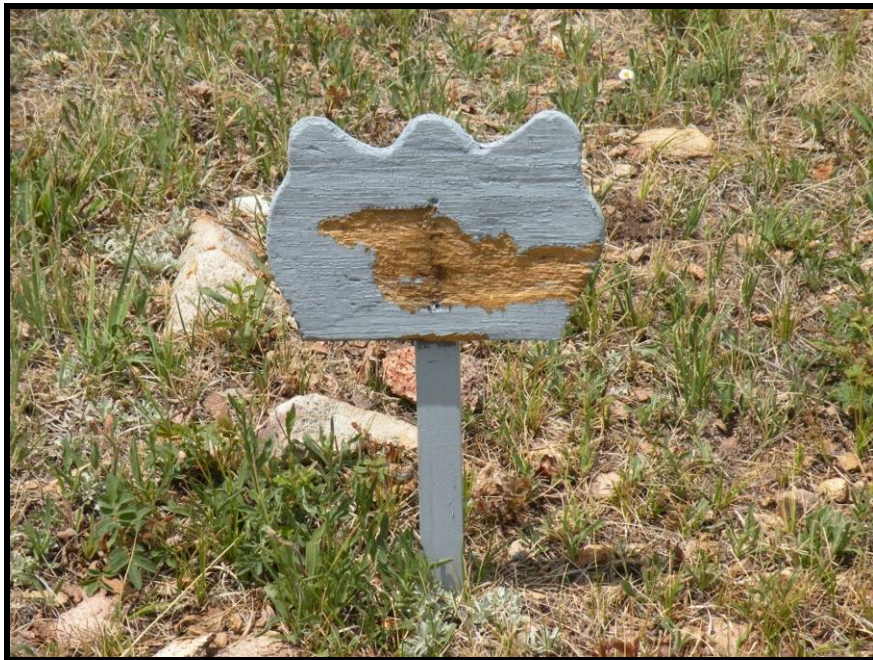
Figure 32. A wooden plaque marking a grave with the surface chewed off by animals.

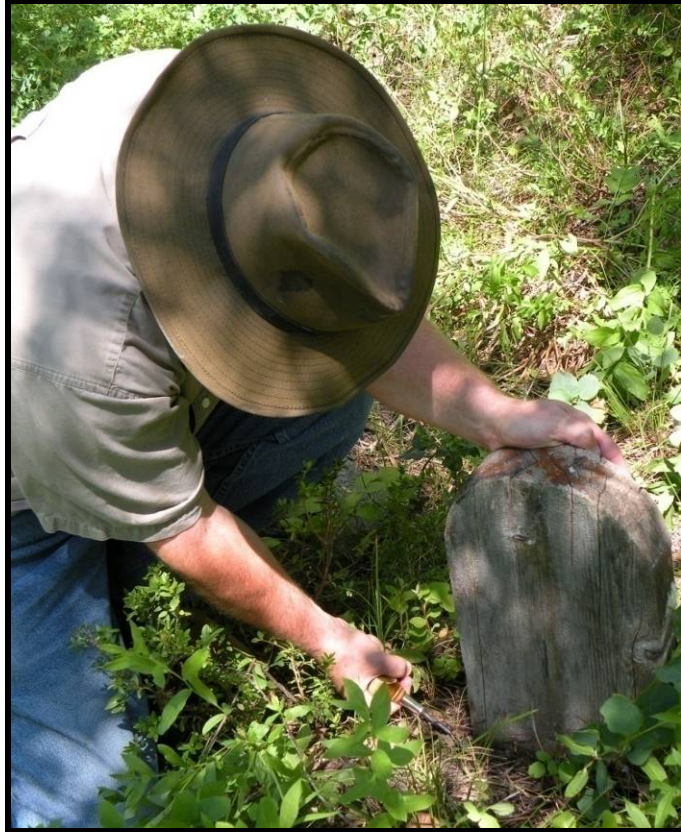
Figure 33. Probing at the base of a marker with an awl to check for deterioration.

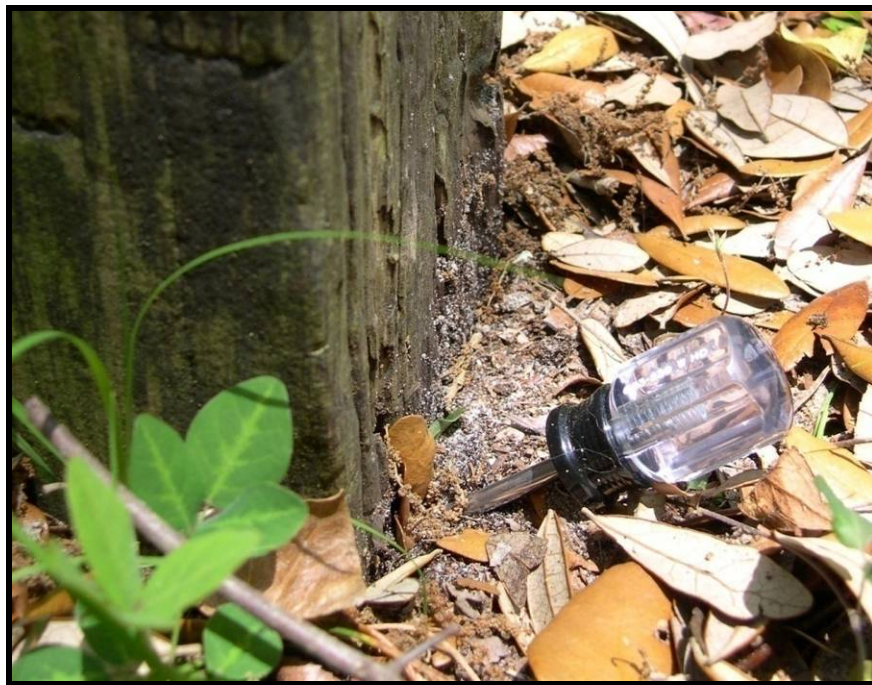
Figure 34. An awl at the base of a grave marker. Based on the length of penetration, this marker has approximately $\frac{1}{2}$ inch of punky wood below the ground surface.

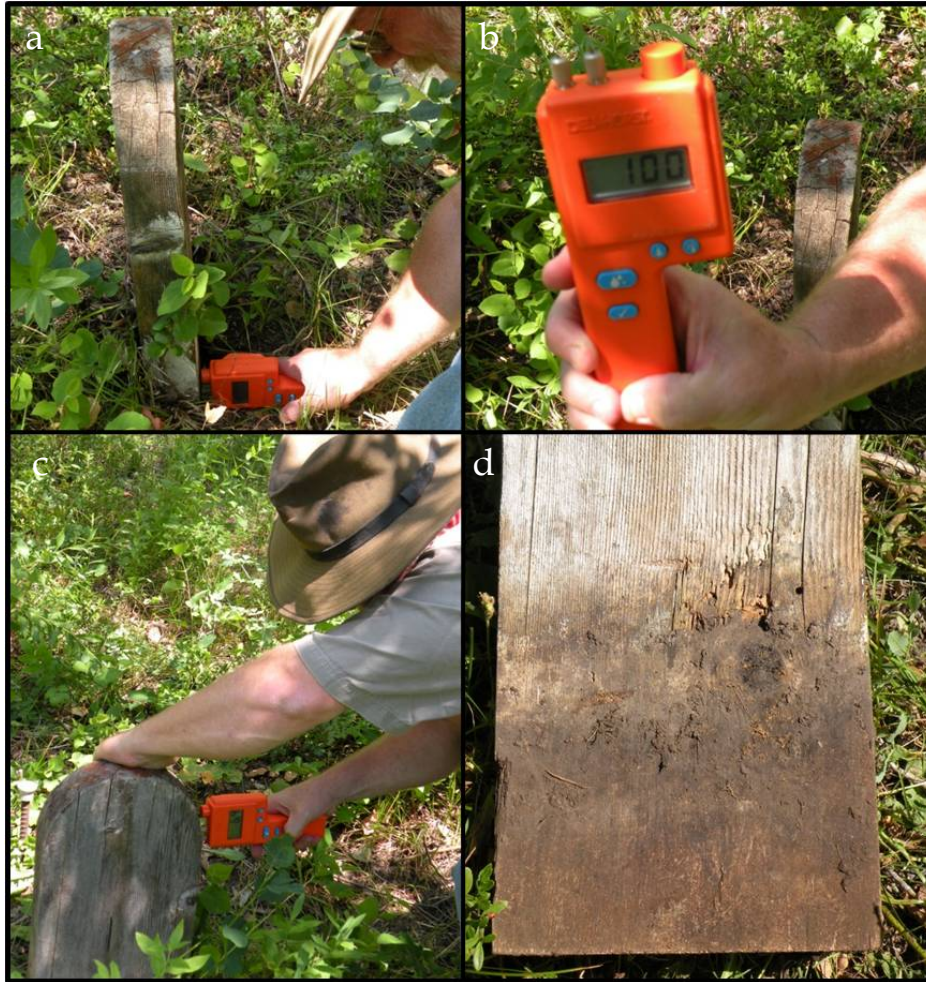
Figure 35. Taking moisture readings on a grave marker using a resistance-type meter. Image (a) shows a reading being taken at the base of the marker; (b) shows the digital readout of 10 percent; (c) shows another reading being taken at the top of the marker (where the moisture content reads 6 percent); and (d) shows the base of the marker after it was removed from the ground – the base is in exceptionally good condition with very minor deterioration, consistent with the low moisture content readings.

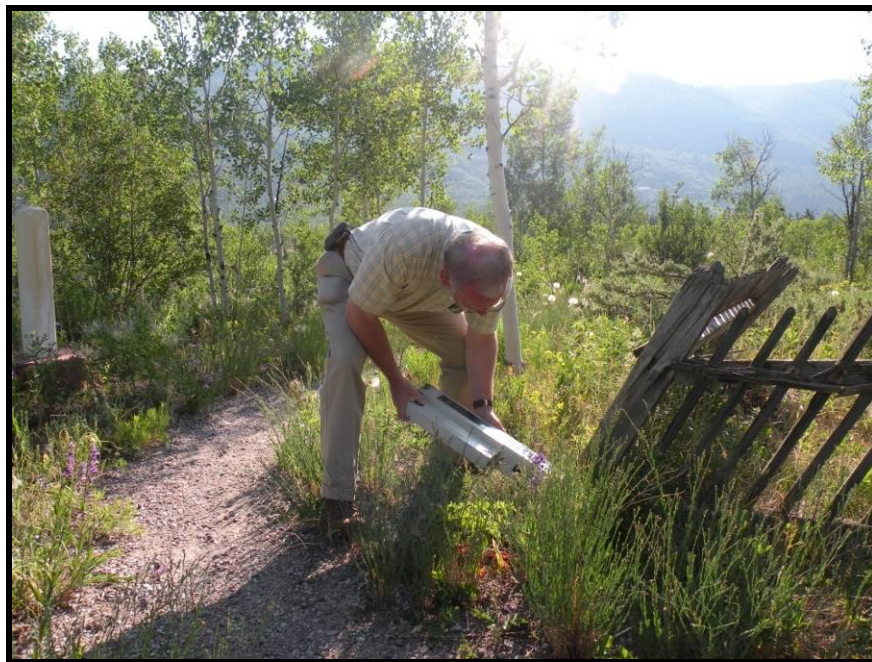
Figure 36. Resistance drilling a corner post of a wooden grave enclosure.

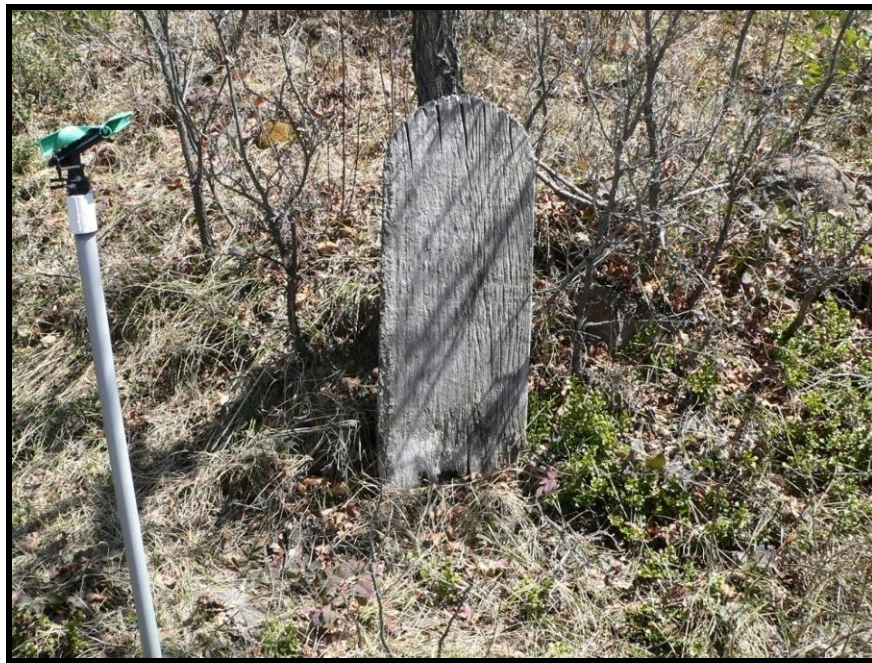
Figure 37. A water sprinkler located directly next to an old wooden marker that is showing signs of decay at the base.
