Wooden Artifacts in Cemeteries: A Reference Manual

Anthony & Associates, Inc.
P.O. Box 271400
Fort Collins, Colorado 80527

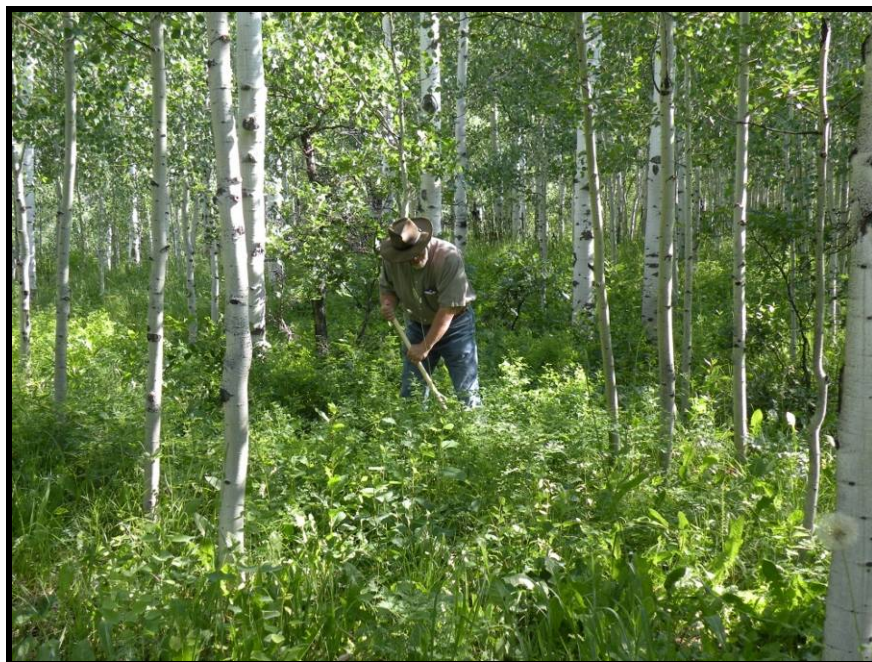
Figure 38. The vegetation in this cemetery is so dense that a rake must be used to search the ground for markers.

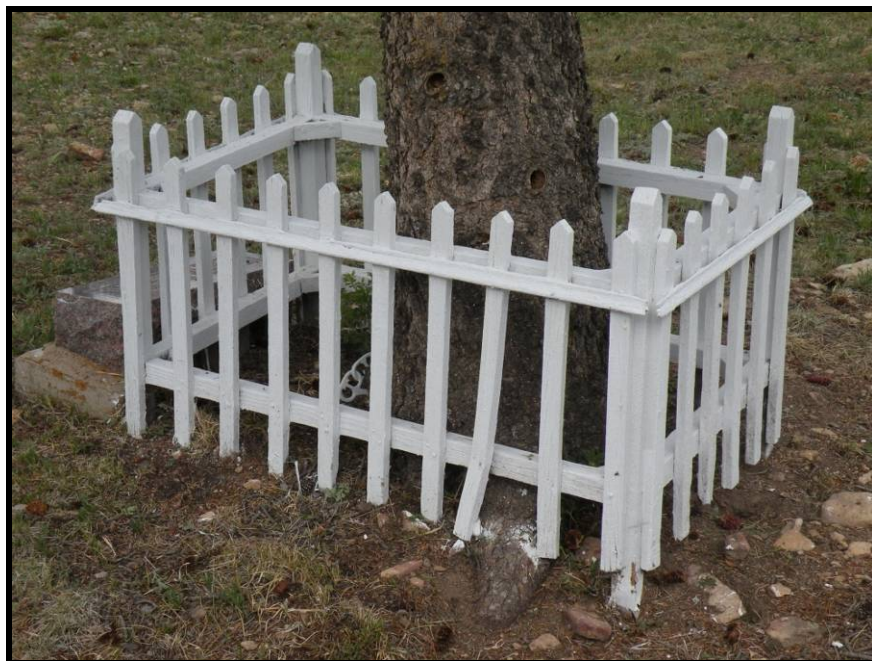
Figure 39. A freshly painted grave enclosure. Note the deformed pickets due to the tree root growth.

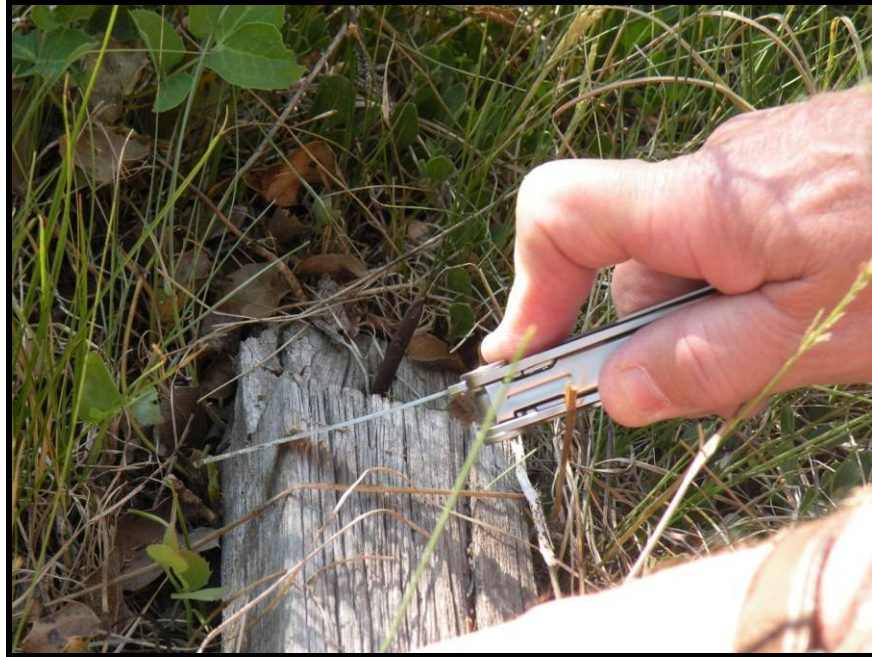
Figure 40. Cutting a sample from a grave enclosure rail.

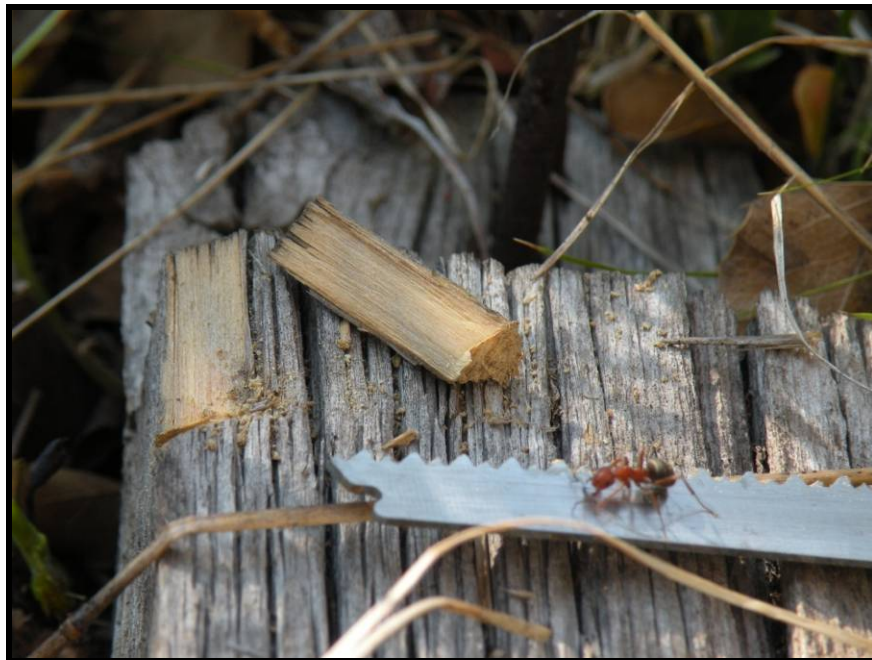
Figure 41. The sample after removal from the enclosure rail. Ant and saw blade are for scale.

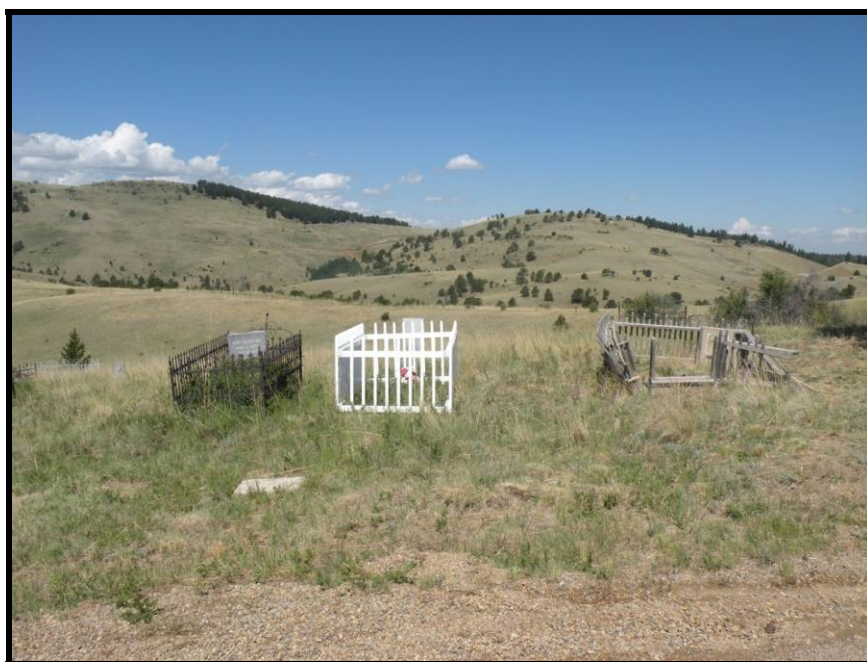
Figure 42. Historic wrought iron and wooden grave enclosures flanking an out-of-place grave enclosure made out of vinyl.

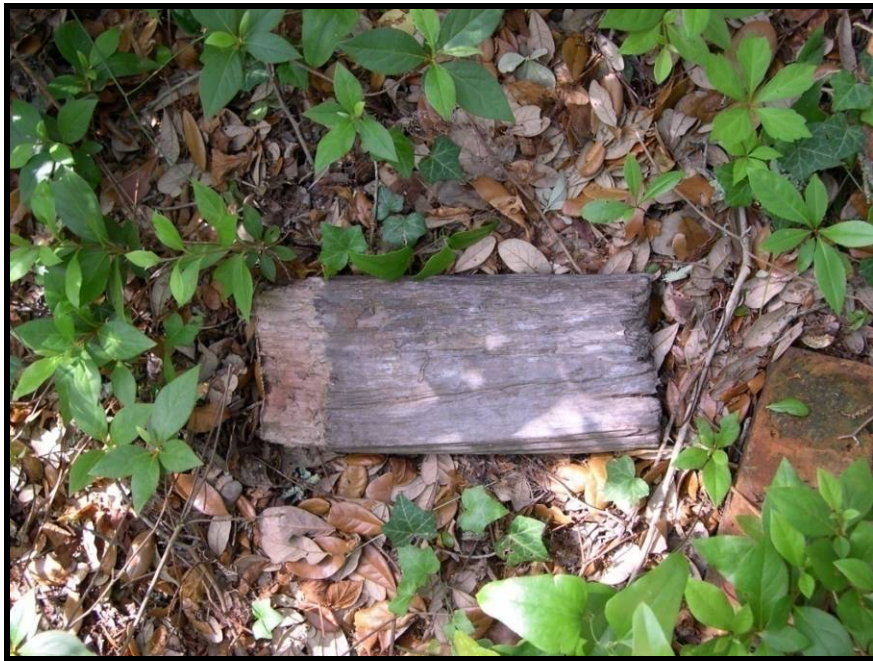
Figure 43. A previously repaired grave marker that has failed and is no longer in situ.

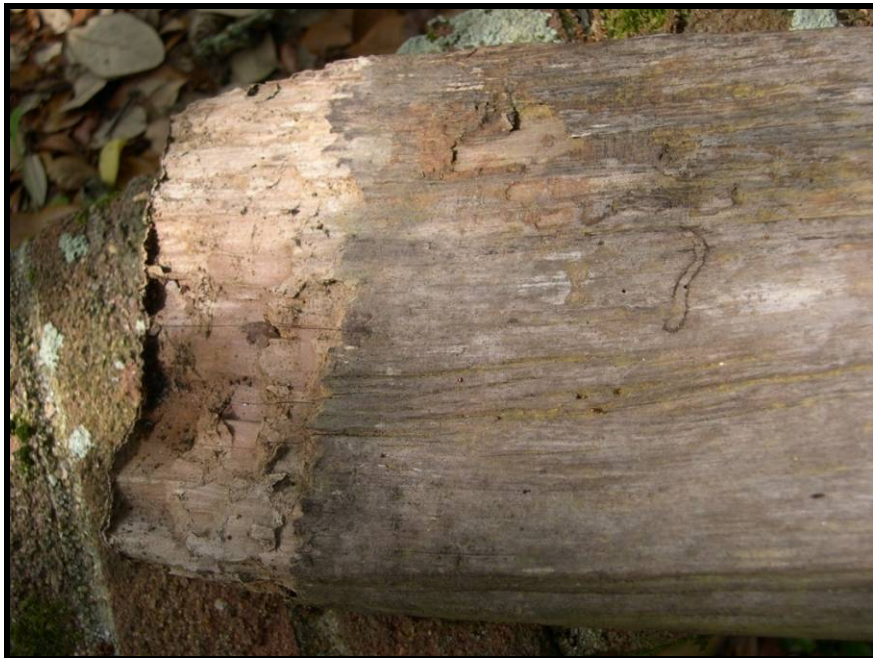
Figure 44. A detail of the repaired end of the marker in Figure 43; the epoxy remains even though the below ground portion of the marker has deteriorated.

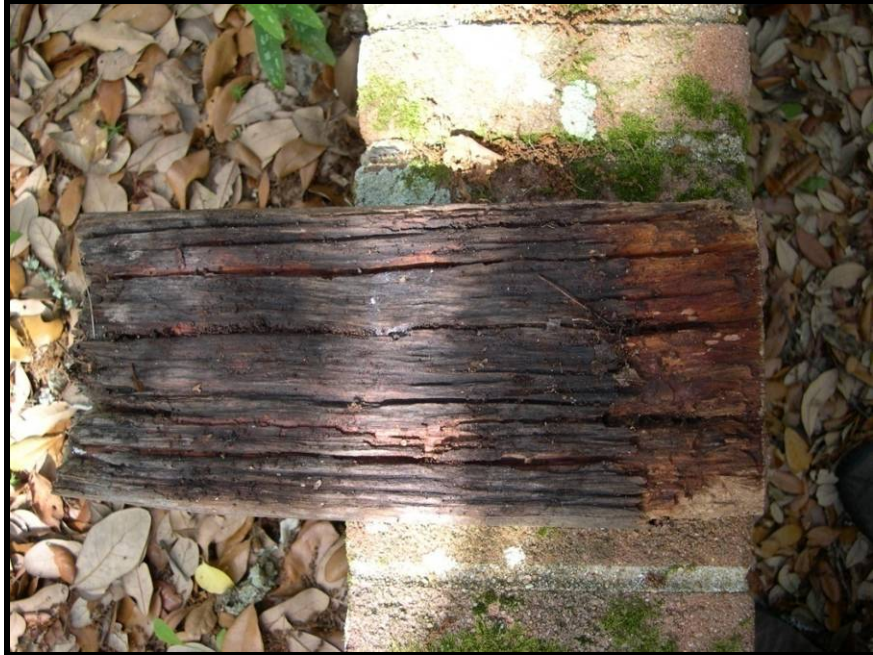
Figure 45. The back side of the same grave marker from Figures 43 and 44. This side was in ground contact and is significantly deteriorated after an unknown length of time on the ground.

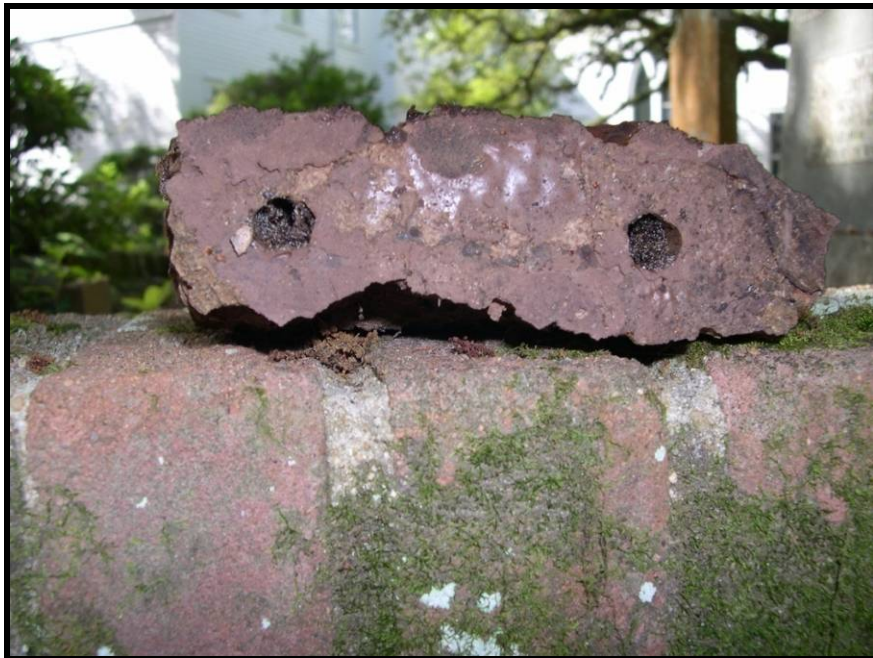
Figure 46. The repaired end of the marker (from Figures 43, 44, and 45) shows that the epoxy is in good condition but the wooden dowels have rotted away.

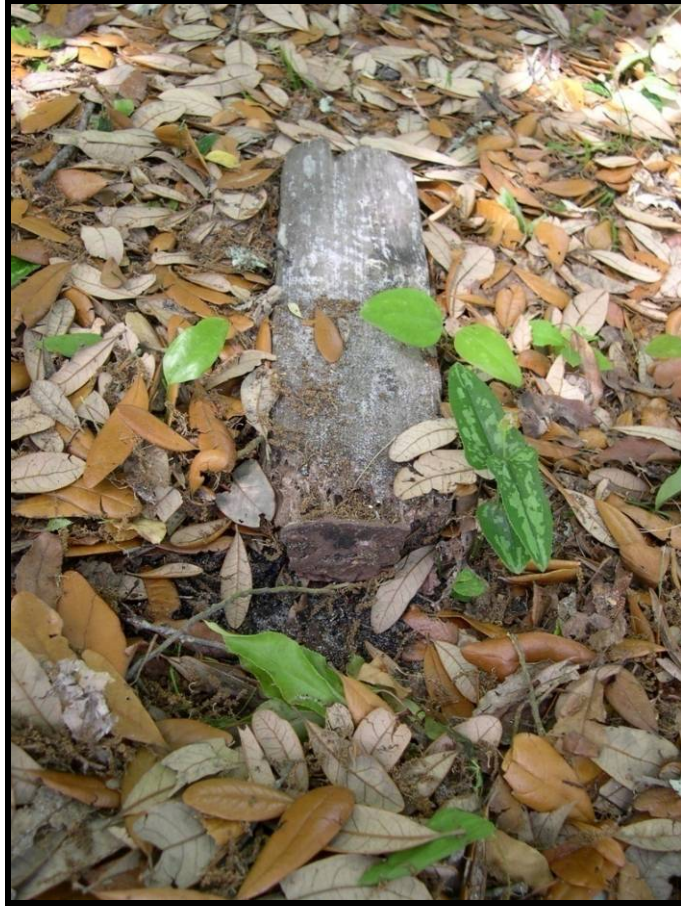
Figure 47. Another grave marker with a repair that has failed and is no longer in situ.

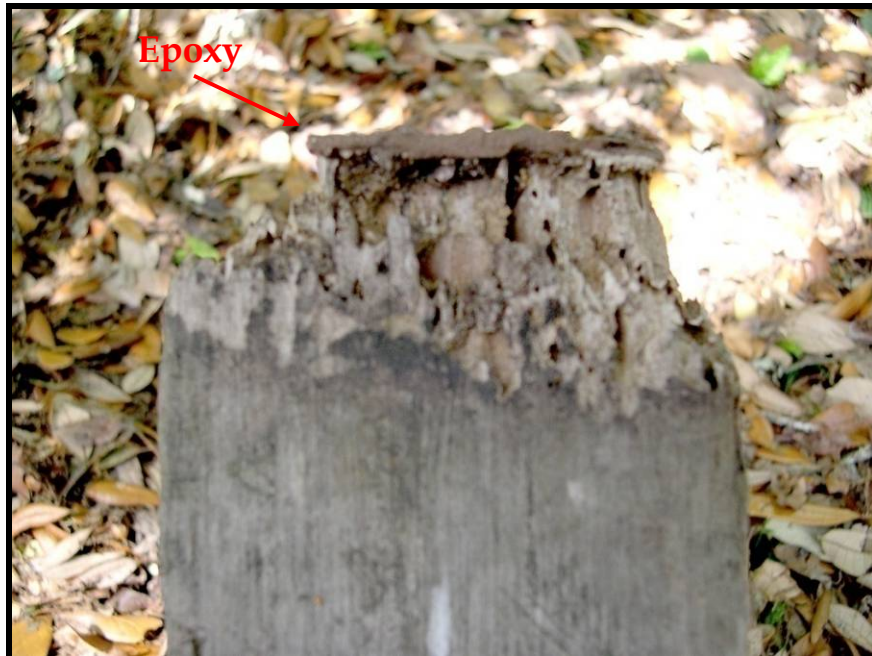
Figure 48. The repaired end of the marker from Figure 47 shows evidence of subterranean termites and epoxy that remains despite the degradation.

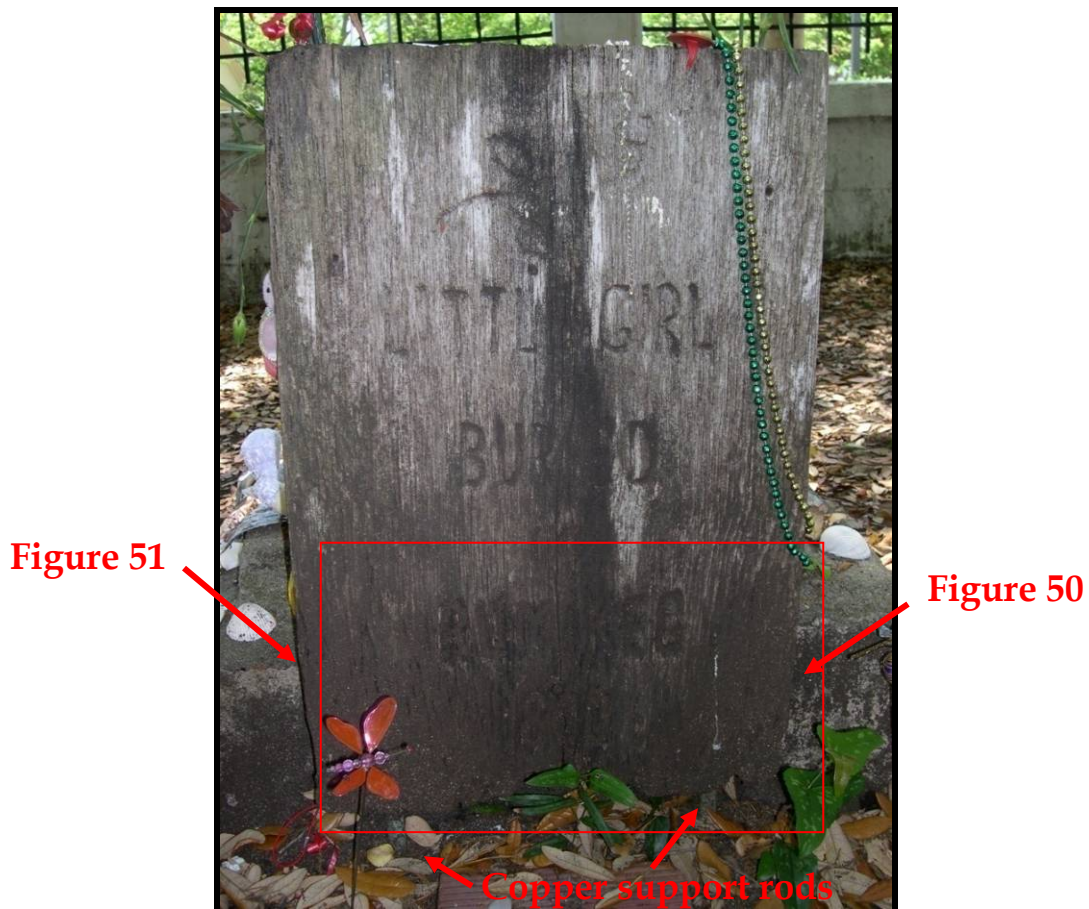
Figure 49. The grave marker of the little girl buried in a rum keg. Note the copper support rods.

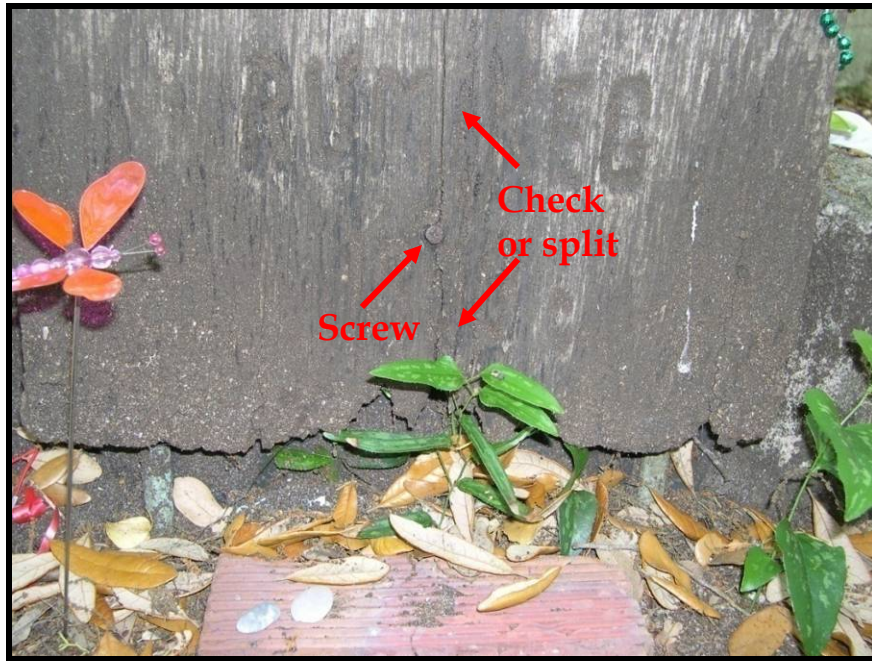
Figure 50. A detail of the base of the marker showing two copper supports. The wooden marker is no longer in contact with the ground. Note the screw on the face used to hold the historic marker in place and the check likely caused by its installation.

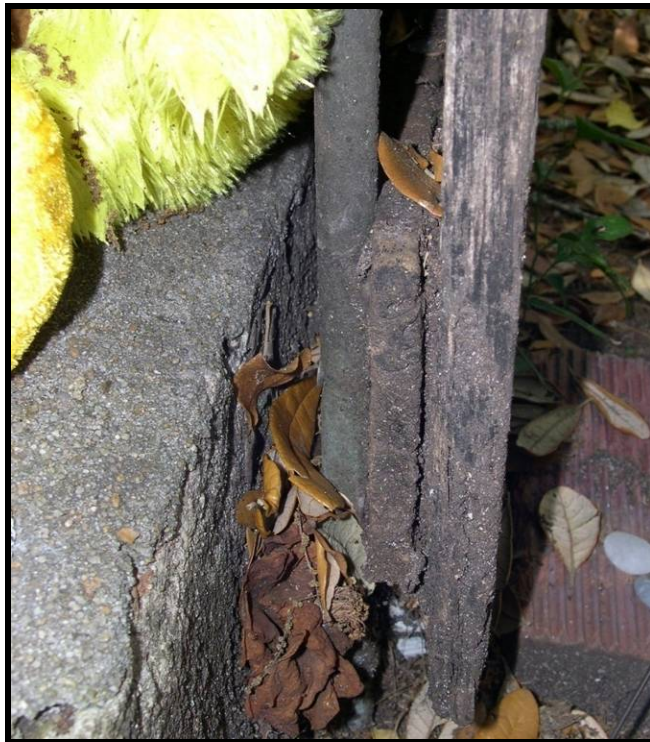
Figure 51. A close-up of the side view of the repair showing the wood the marker has been sandwiched to and the copper pipe, along with organic debris.

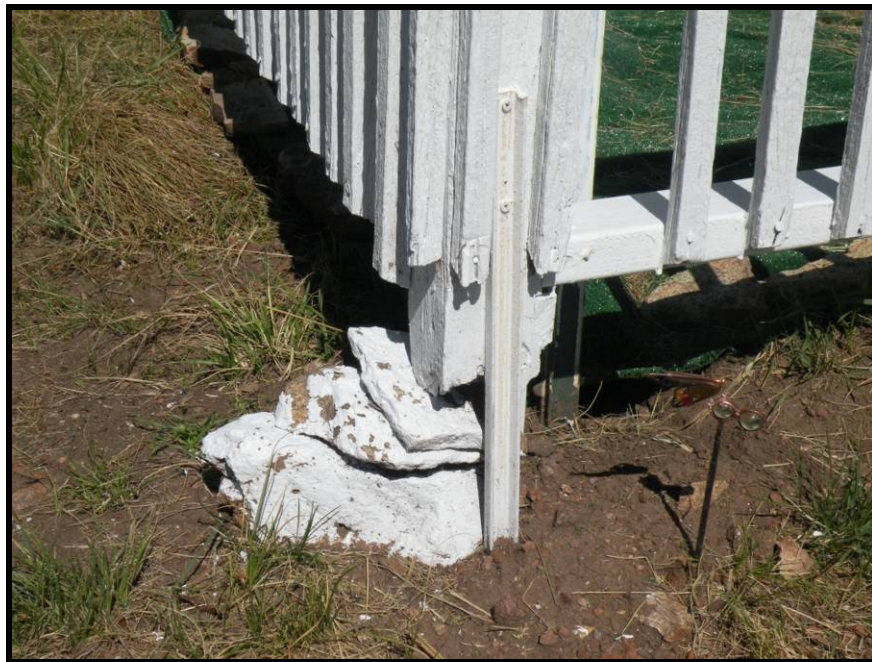
Figure 52. The deteriorated base of a grave enclosure corner post has been replaced by a channeled metal rod and natural stones, painted white.

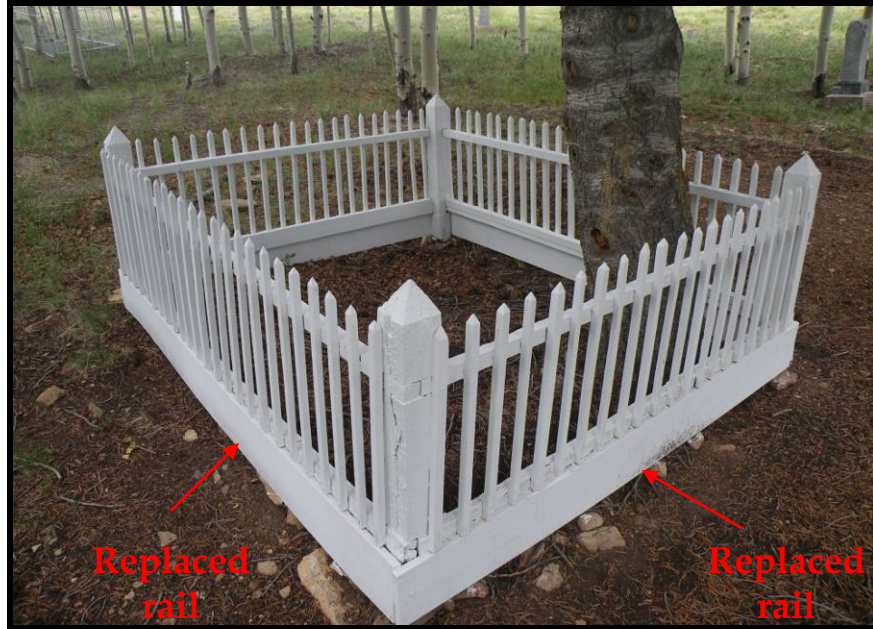
Figure 53. This grave enclosure has had its base rail replaced and the degraded corner posts now sit on stone piers.

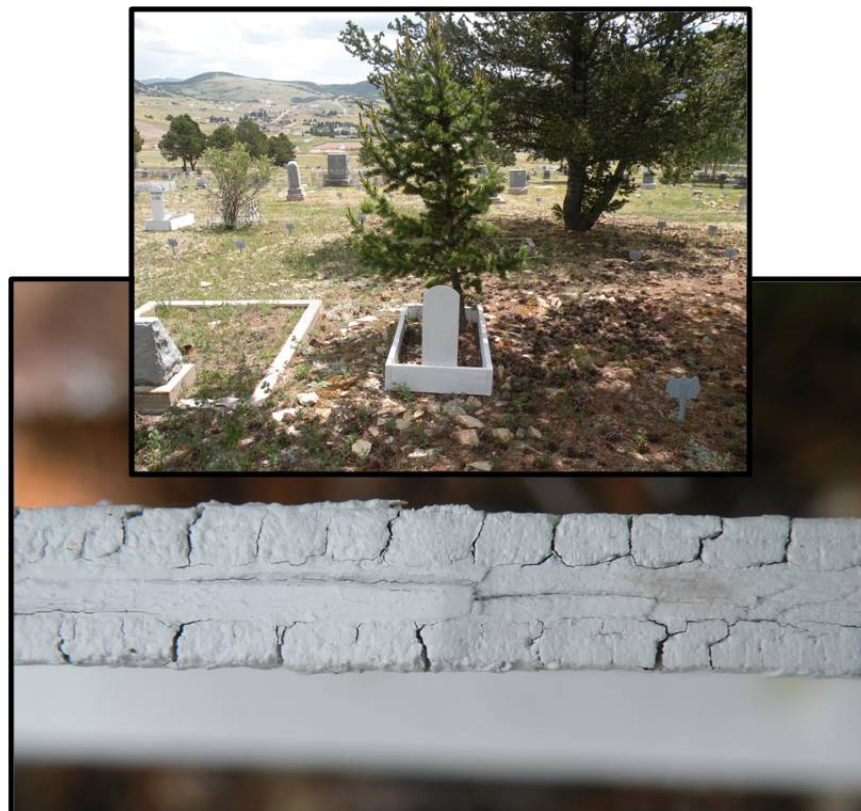
Figure 54. The top photograph shows a grave marker and grave curb. The original wooden marker was replaced with one of plywood, a material not suited for exterior conditions. The bottom photograph is a close-up of the top of the marker; through the paint the effects of weathering and the beginning of de-lamination are evident.
