Performance of Portable T-Section Glulam Timber Bridges

Written for Presentation at the
1997 Annual International Meeting
sponsored by
ASAE

Summary:

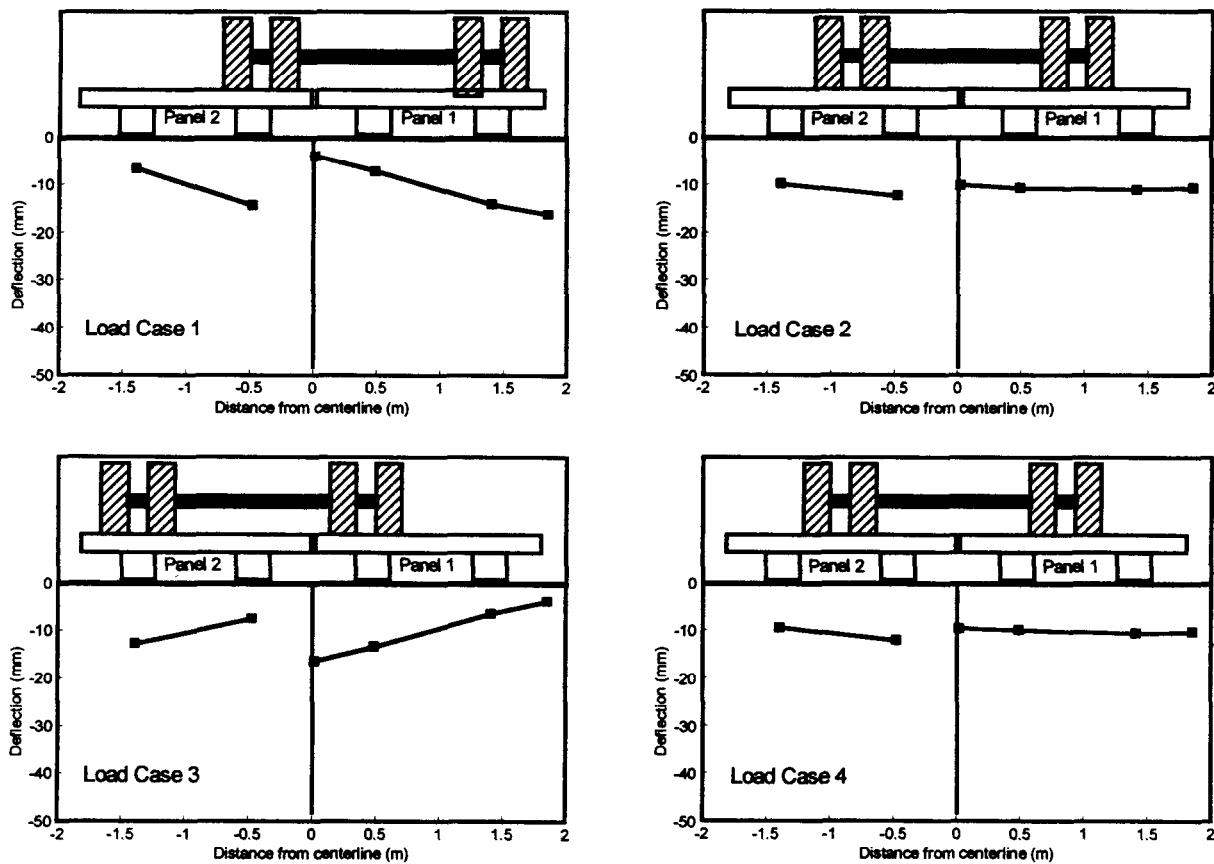
Figure 6. Transverse deflection for the load test of the Georgia Pacific bridge measured at the bridge centerspan (looking north). Bridge cross-section and vehicle positions are shown to aid interpretation and are not to scale.

Transverse load test deflection plots for the Georgia Pacific bridge are shown in Figure 6 as viewed from the south end (looking north). For each load test, no permanent residual deformation was measured at the conclusion of the testing. Additionally, there was no detectable movement at either of the footings. For Load Case 1 and Load Case 3, the symmetry of loading resulted in deflection profiles that are approximately mirror images of one another. Deflection differences of corresponding data points for the two positions were within approximately 1 mm (0.04 in.). Maximum deflections for these load cases occurred in Panel 1 and measured 16.2 mm (0.64 in.) at the outside panel edge for Load Case 1 and 16.5 mm (0.65 in.) at the interior panel edge for Load Case 3. It is probable that the maximum deflection for Load Case 1 occurred at the interior edge of Panel 2; however, deflections at that point were not measured. The greater deflections recorded at the outside panel edges were expected since the truck was loading the flange in its weak axis.

For Load Case 2 and Load Case 4, deflections were nearly identical and differences at corresponding data points for the two load cases are within 1 mm (0.04 in.). With the wheel line centered on Panel 1 for Load Case 2, the approximately uniform load distribution across the panel width resulted in similar deflections at each data point. For Load Case 4, it was anticipated that the Panel 2 deflections would also be uniform and approximately equal those for Panel 1, Load Case 2. The approximate 2.5 mm (0.10 in.) difference in the Load Case 4 web deflections for Panel 2 is likely due to minor differences in the truck transverse position. The maximum deflection recorded for Load Case 4 corresponds to a deflection value of approximately $L/975$, at 55% of design bending moment.
