**Progress Report on Los Alamos National Laboratory
Cerro Grande Fire Rehabilitation Activities
One Year After Burned Area Rehabilitation**

LA-UR-02-4921
Issued: August 2002

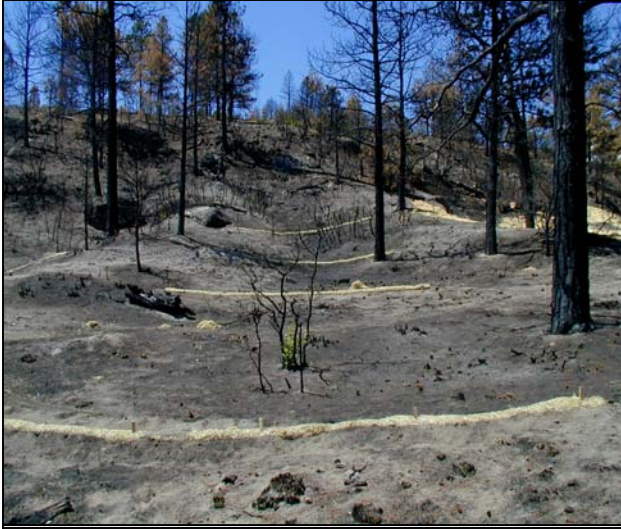
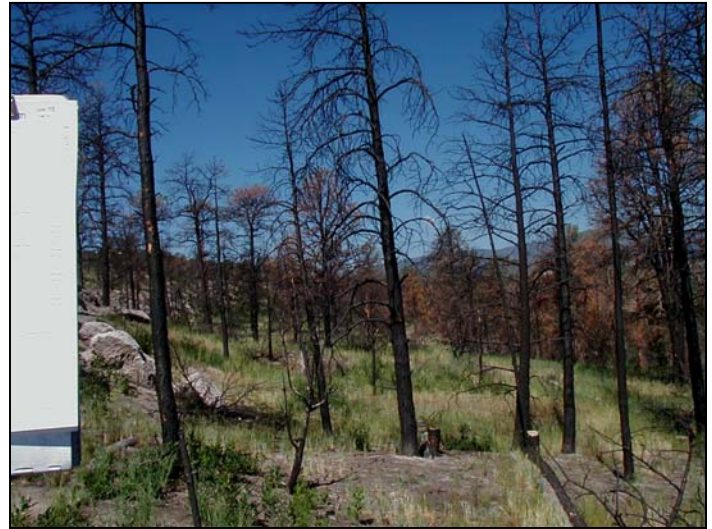
Rehabilitation Unit 15, June 2000

Rehabilitation Unit 15, June 2001

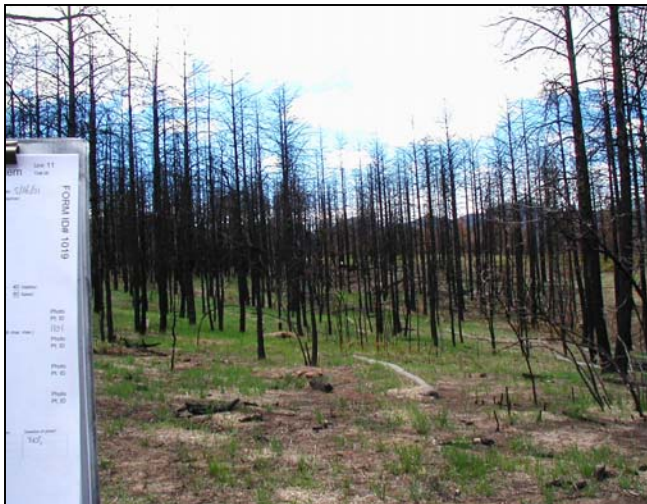
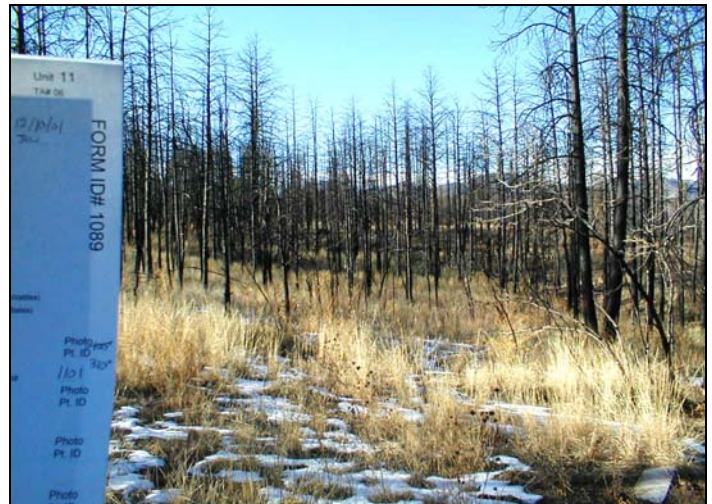
Rehabilitation Unit 11, May 2001

Rehabilitation Unit 11, December 2001

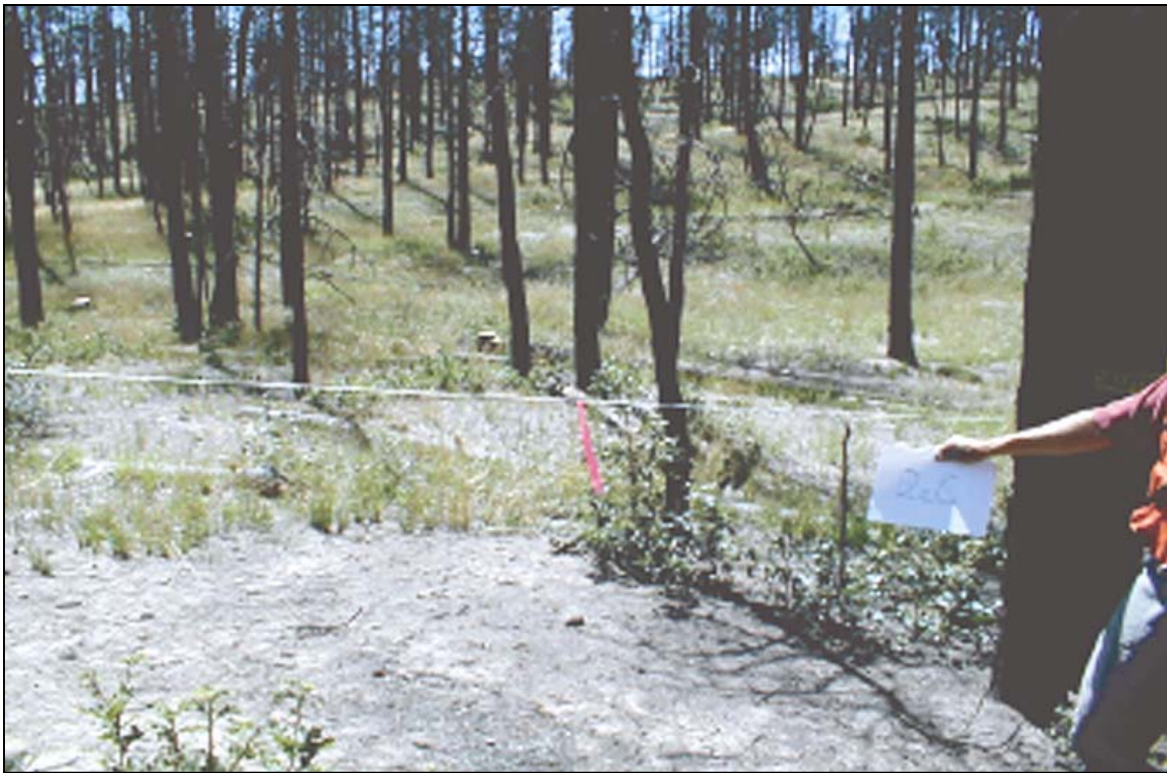
Field conditions one year after treatment. Area in foreground was not treated, area in background was.
