NIOSH HEALTH HAZARD EVALUATION REPORT

**HETA # 2005-0346-3008
Dixie Regional Medical Center
Saint George, Utah**

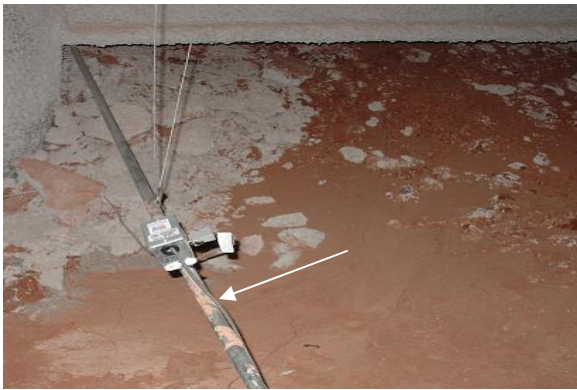
Figure 3. One of the moisture sensing cables (arrow) installed in the crawlspace under the DRMC River Road facility to help detect future water leaks.

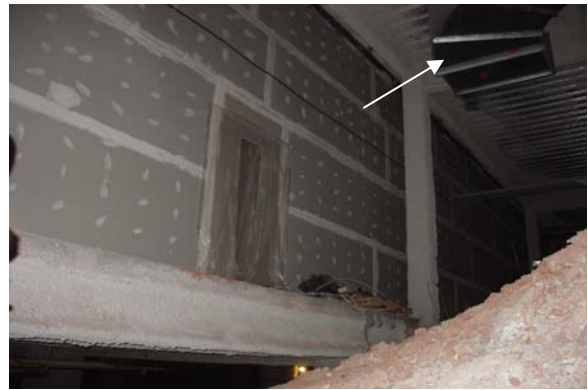
Figure 4. Ventilation supply ductwork from AHU2 running through a portion of the crawlspace under the DRMC River Road facility.

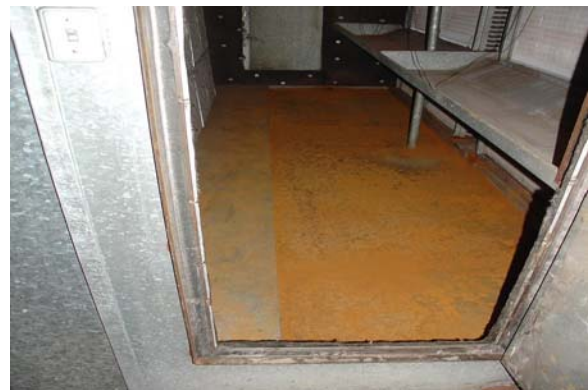
Figure 6. Rust caused by standing water in SF 101 at the DRMC 400 East facility. The standing water results from an excess of condensate collected during periods of rain/high humidity that overwhelms collection basins.

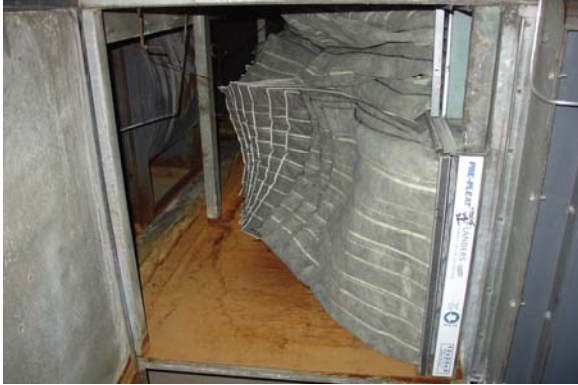
Figure 7. Rust caused by standing water in SF 101 at the DRMC 400 East facility. The excess condensate during periods of rain/high humidity typically saturates the filters. This is typical of many AHUs at 400 East.

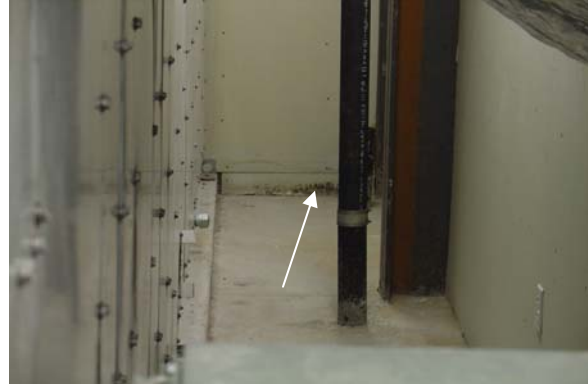
Figure 8. Water damage and small amount of mold (arrow) in rooftop air handler room for AHU 4th West. The AHU has a ducted air return, so the room does not serve as a return air plenum.

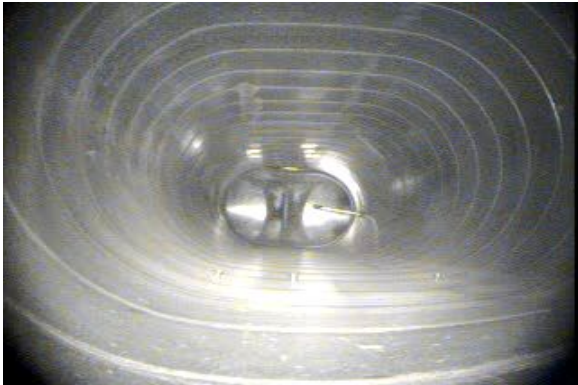
Figure 9. Snapshot from video examination of the inside of the supply duct above the ceiling in the C-section area on the third floor of the DRMC 400 East facility. The ductwork was clean and free from any visible dirt deposits.
