WATER OPERATION AND MAINTENANCE BULLETIN

No. 180

June 1997

CONDITION ASSESSMENT OF PARSHALL FLUMES IN COLORADO

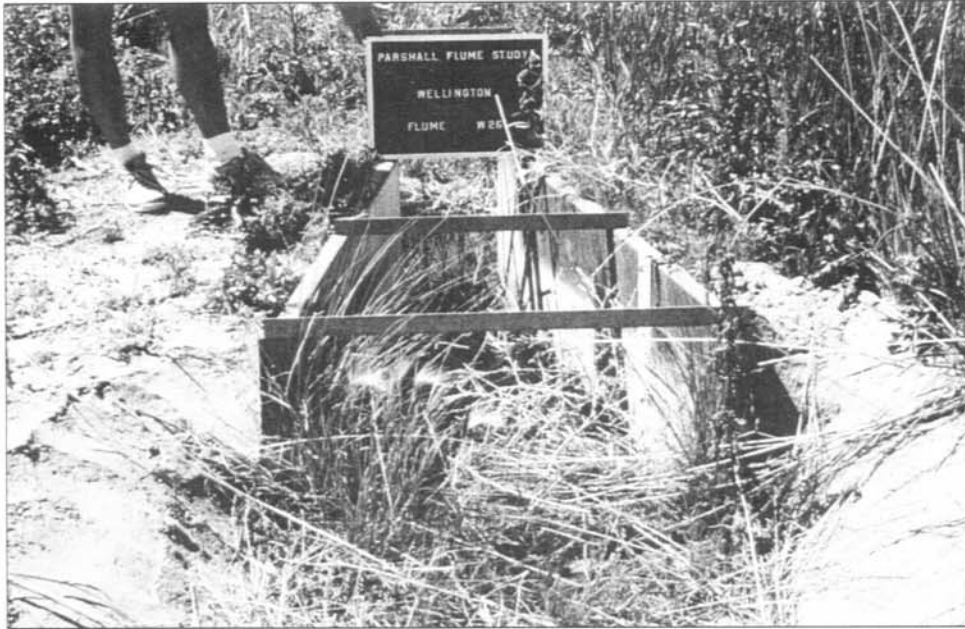
The physical integrity of each flume was documented during the field assessment. The flumes were comprised of either metal (49%) or concrete (51%). A summary of the flume conditions is presented in Table 3. More than one condition may exist for each flume. Therefore, the sum of observations exceeds the number of flumes assessed. A total of 392 defects was observed at the 149 flume sites. The sample flumes were comprised of metal (49%) and of concrete (51%). Examples of commonly observed conditions include: nine flumes (6%) were found to have bent components (i.e., sidewall, brace, etc.); 50 flumes (33.6%) have blockage at the entrance; ten flumes had grass/vegetation at the entrance

Figure 6.—Vegetation at flume entrance.

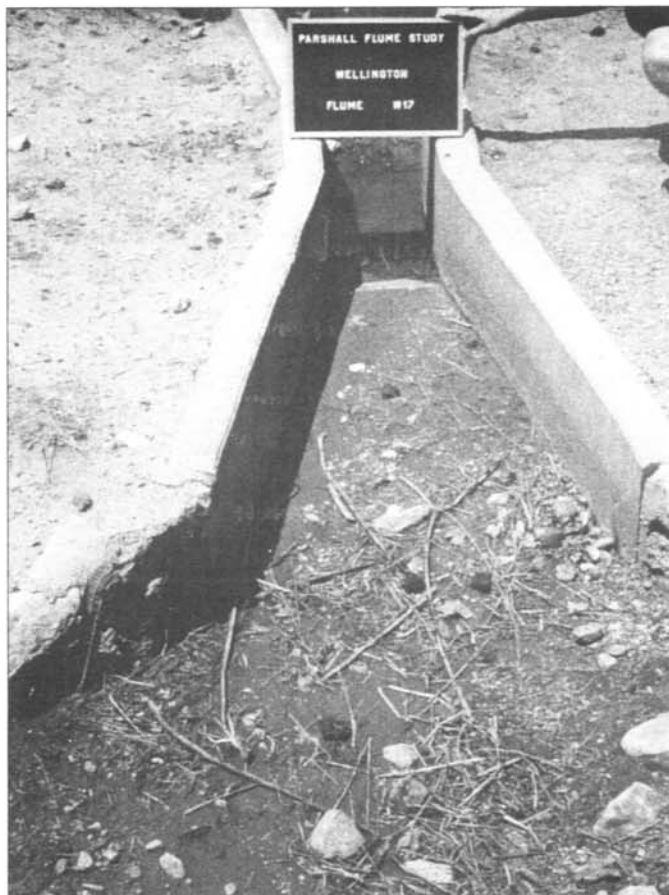
(Figure 6); and 25 flumes (16.8%) were observed to have sand and/or debris in the throat (Figure 7). Flume settlement resulted in the collapse of a portion of the flume structure as observed in Figures 8 through 10.

Figure 7.—Siltation in flume throat.

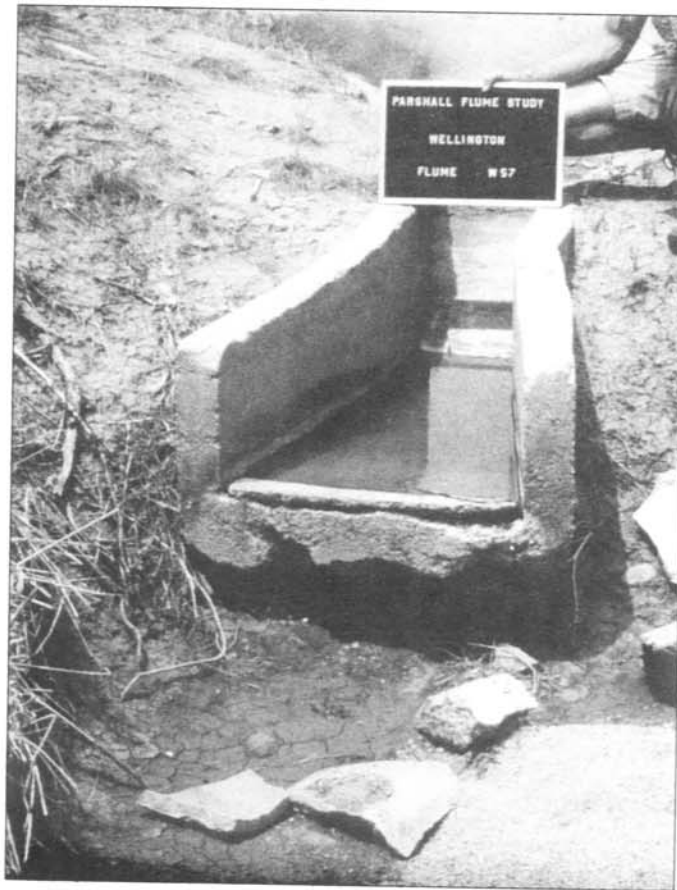
Figure 8.—Erosion and undermining at flume outlet.

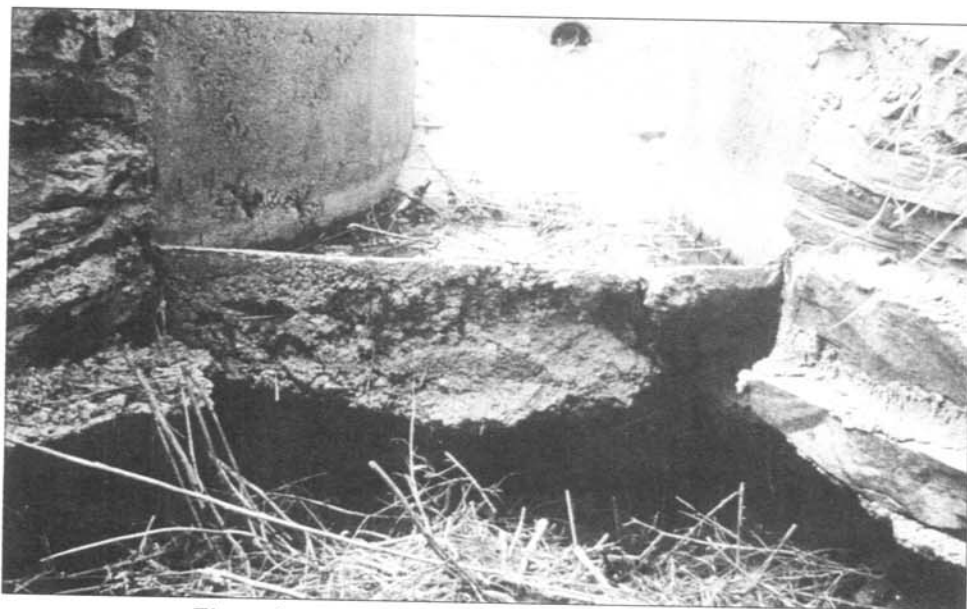
Figure 9.—Erosion and undermining at flume outlet.

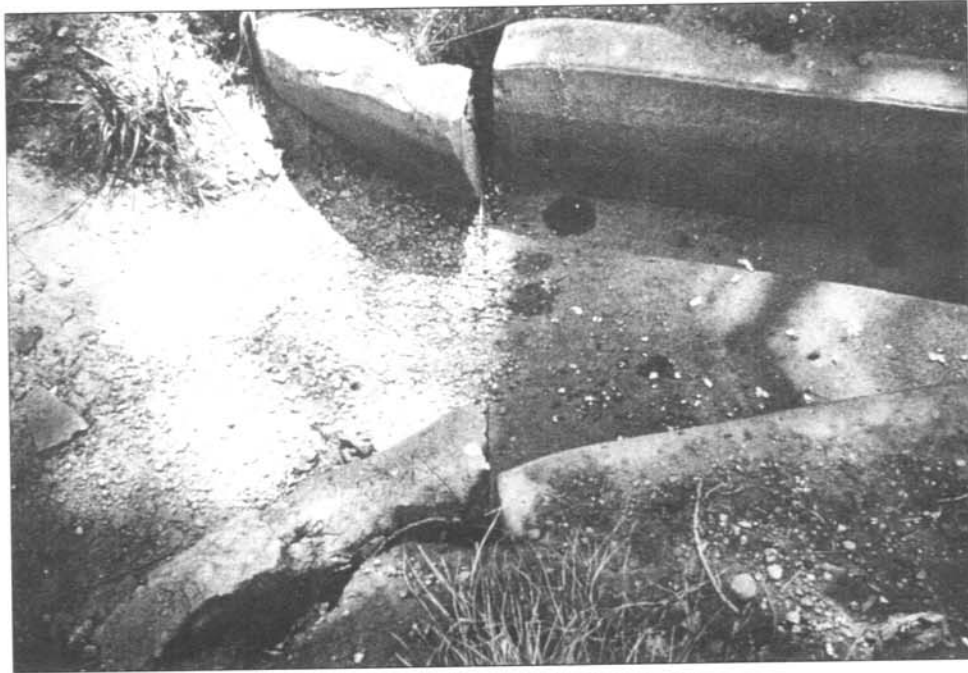
Figure 10.—Settlement at flume outlet.

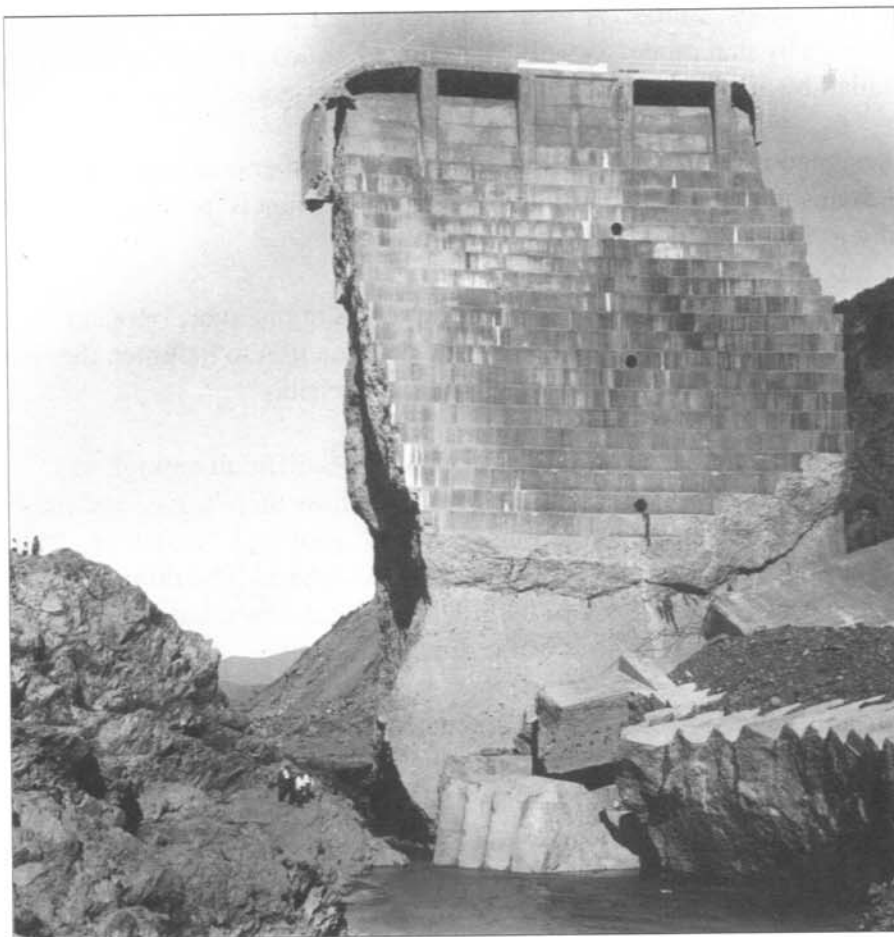
Ground view looking upstream at the mass of Block 1 with Blocks 5/6 in right foreground. Note level of schist detritus atop Block 5, well above the channel bed, which is still flowing when this photo was taken four days after the failure. Huber Collection, University of California Water Resources Center Archives.

The dam was unknowingly built against a bedrock paleo landslide, difficult enough to recognize today, let alone in the 1920s, Rogers said. "We know now there's over 100 major dams in the United States that have also been built against [such geology]," he added. "They haven't failed yet, but that information is of critical import to designers. The thing keeping those dams in place is the inherent redundancy of their design, not the fact that their designers adequately recognized the geological conditions of the site."

Dams built against landslides have a much greater chance of failing. "When the ground or the rock has slid in a landslide, it dilates or increases in volume," Rogers explained. "That increase in volume sets up a whole bunch of cracks, and water can go through those cracks quite easily."
