Non-destructive and Failure Evaluation of Tubing from a Retired Steam Generator

Argonne National Laboratory

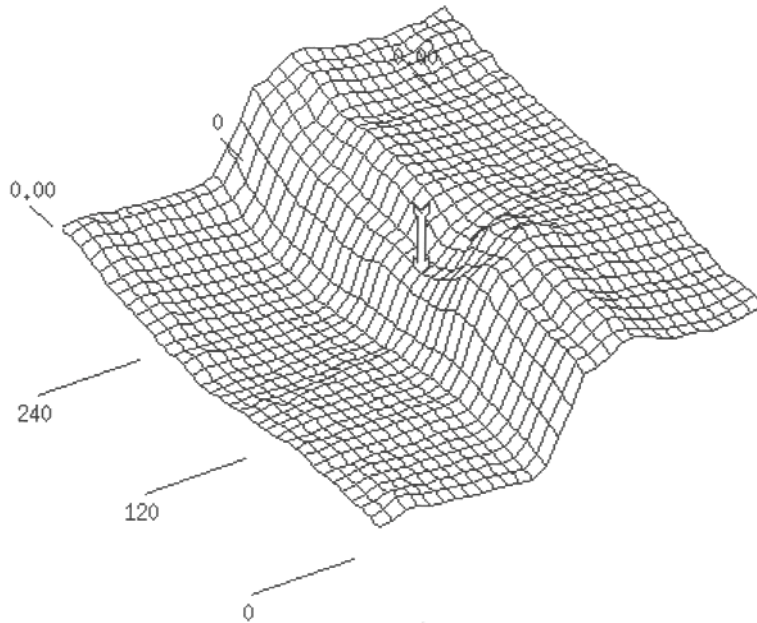
Figure 2.1 C-scan plot of tube R45 C40 using a 2.9-mm (0.115-in.)-diameter MRPC showing the top of tube sheet in December 1995. No crack call was made at that time. The tube axis is from lower left to upper right, with 360° of the tube shown. The roll transition is indicated by the arrow.

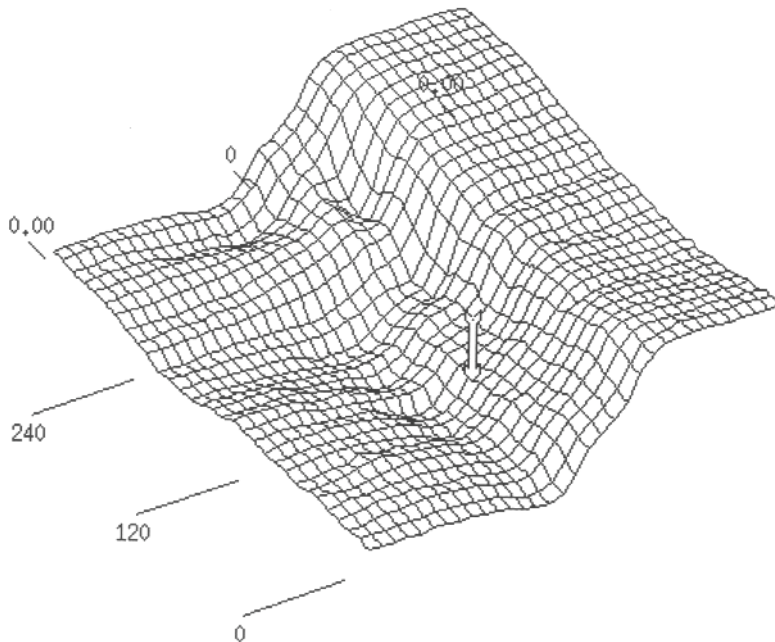
Figure 2.2 C-scan plot of tube R45 C40 using a 2.9-mm (0.115-in.)-diameter MRPC showing the top of tube sheet in July 1997. Multiple axial and circumferential cracks were called at that time. The tube axis is from lower left to upper right, with 360° of the tube shown. The roll transition is indicated by the arrow. The variation in EC signal between 1995 and 1997, from the same type of pancake coil, can easily be seen.

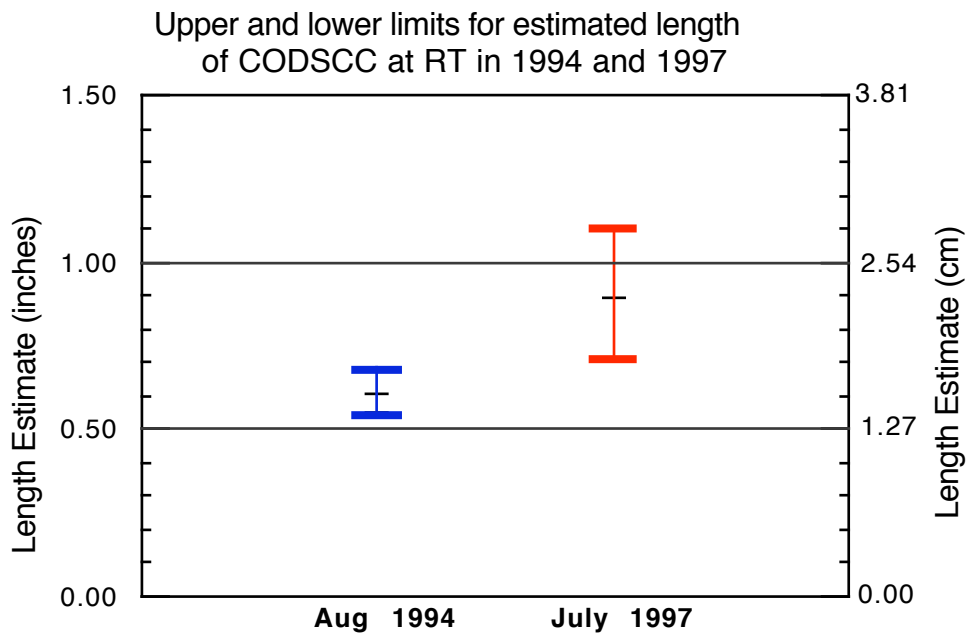
Figure 2.5 Graph showing estimated length with range of uncertainty for circumferential outer diameter stress corrosion crack (CODSCC) at top of tube sheet in tube R39-C46 of retired steam generator before (August 1994) and after (July 1997) unplugging. The data suggest growth of the SCC during the time tube 39-46 was plugged.

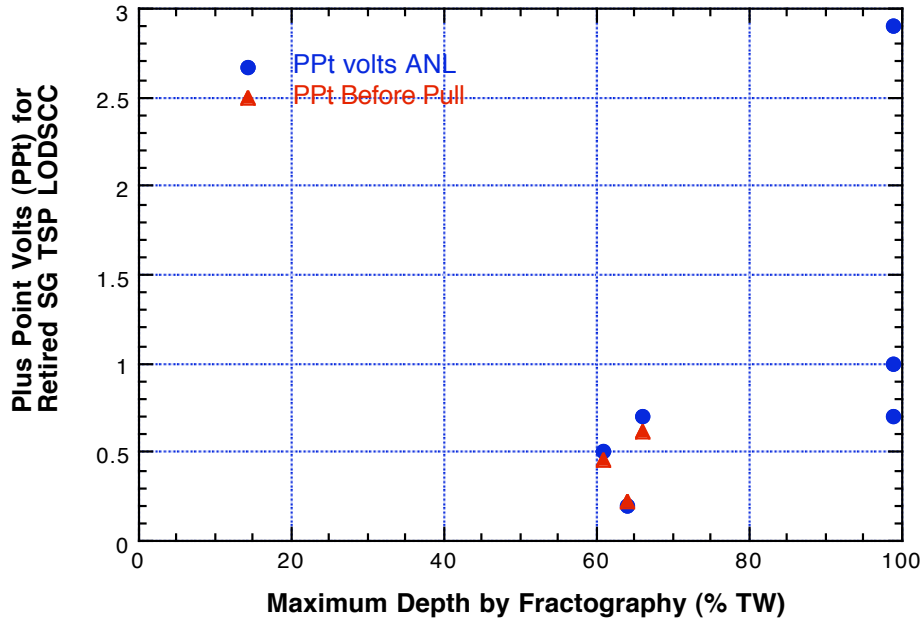
Figure 3.3 Graph of EC Plus Point (PPt) volts vs. maximum depth determined at Argonne by fractography for axial ODSCC at TSP intersection in retired steam generator. The two ODSCC at 100% TW at 1.0 and 0.7 V leaked at 5.2 ksi (36 MPa) and 7.1 ksi (49 MPa), respectively (+Point data before pulling is not available).

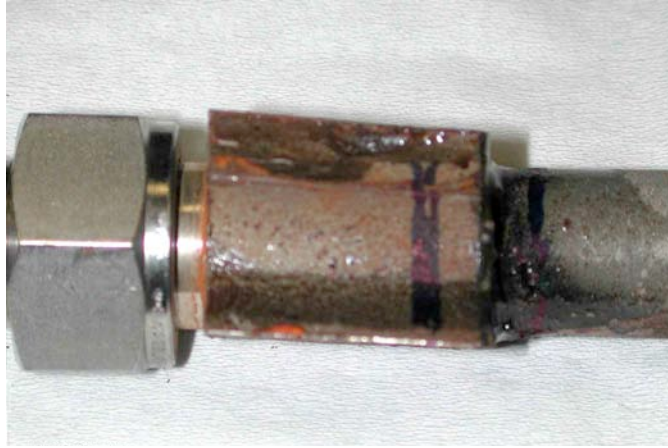
Figure 3.5 Photograph of Alloy 600, 19.1-mm (3/4-in.) diameter, test section #8 from retired steam generator after pressure testing. Some tube sheet material remains around the tube after reducing its size for pressure testing. Fittings to carry out the pressure test are attached to the ends of the tube. The top of the TS is on the right side of the photograph at the end of the tube.

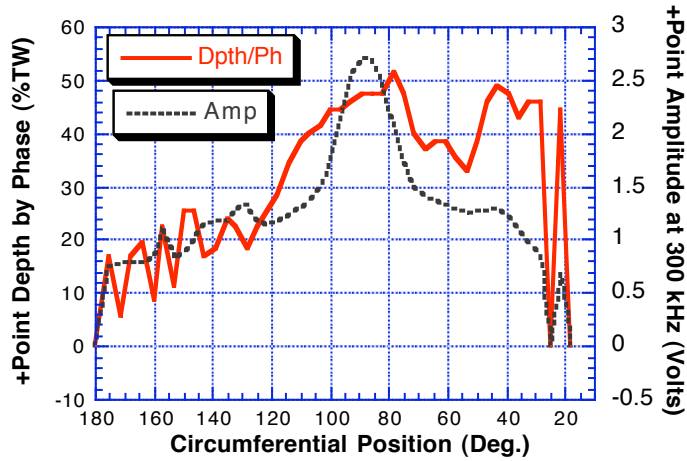
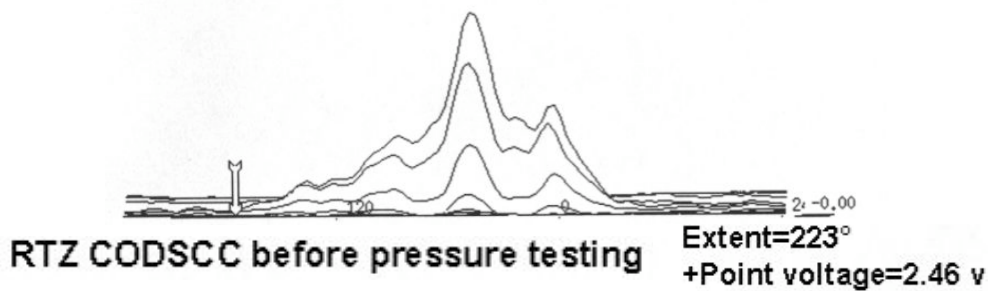
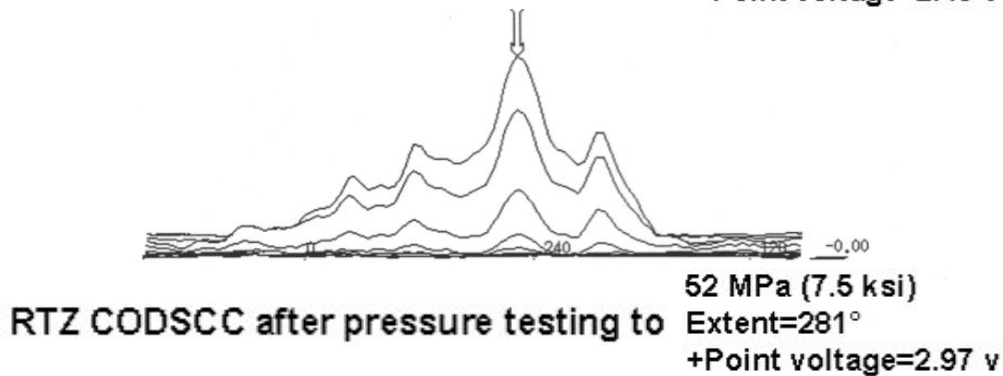
Figure 3.6 EC +Point profiles of CODSCC in RTZ with 50% TW depth (tube #6). The 1994 call was SCI with 0.73 V from a pancake coil. The 1997 +Point maximum signal was 1.54 V. The 2002 +Point maximum signal was 2.46 V. EC cross sections of this CODSCC were taken from standard +Point c-scans at 300 kHz. Pressure testing to 51.7 MPa (7.5 ksi) resulted in an increase in the extent of the crack (223° to 281°) and an increase in +Point voltage (2.46 to 2.97 V). A leak appeared at 35.2 MPa (5.1 ksi).

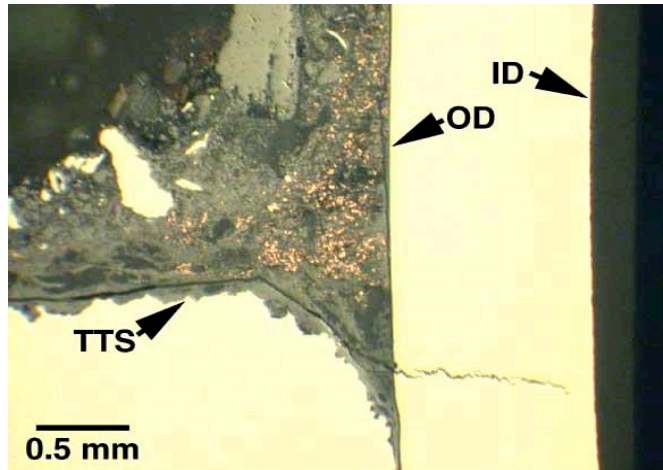
Figure 3.7 Micrograph of CODSCC in RTZ of tube #6 just below the top of the tube sheet. The cross section is through the point of maximum +Point voltage. The crack, which leaked, is only about 80% TW at this point (not 100% TW).

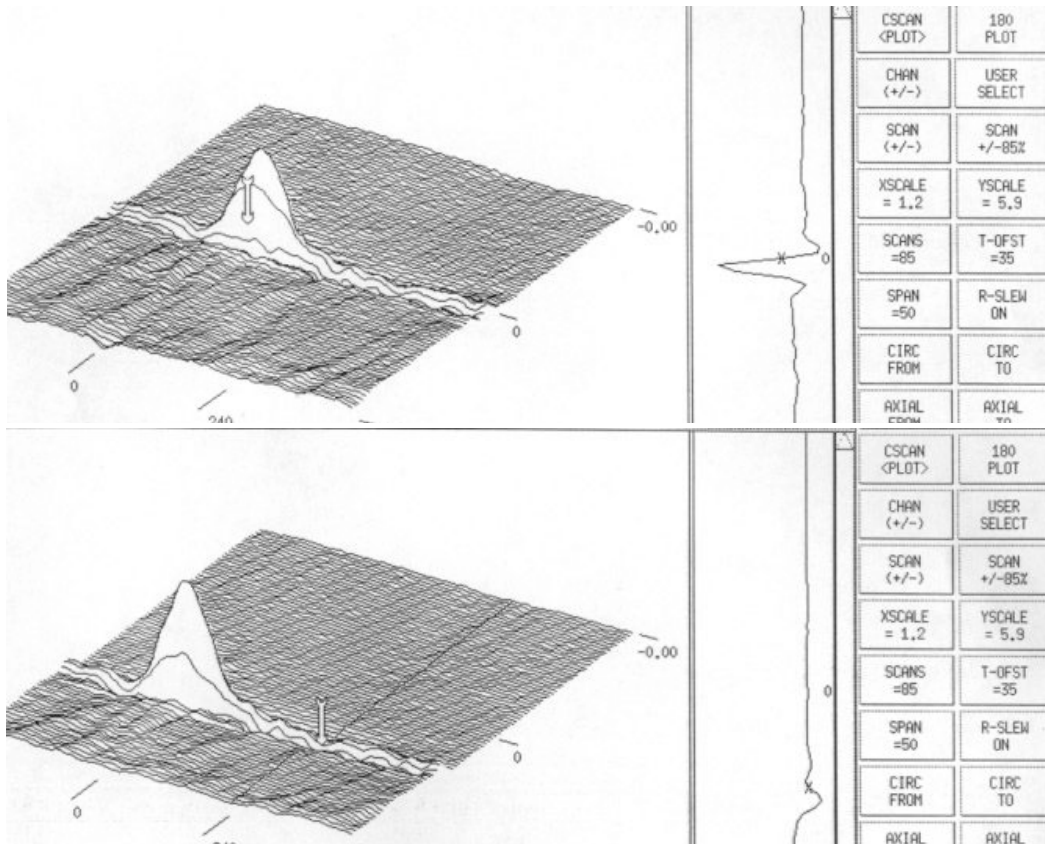
Figure 3.8 Image of +Point c-scans of tube sheet test section #8 at 300 kHz, before (top) and after (bottom) pressure testing to 50.3 MPa (7300 psi). The pressure test resulted in an increase in the 300 kHz +Point signal from 2.37 to 3.08 V with a very small increase in +Point estimated depth (87% to 91%TW). No significant increase in length was observed.

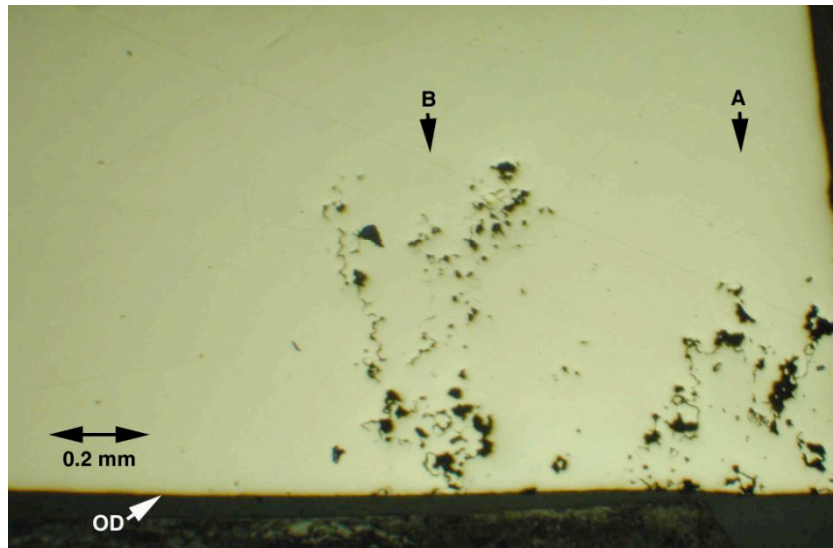
Figure 3.9 Micrograph of cross-section perpendicular to the tube axis 0.5 mm below the TTS of #8. Axially oriented intergranular attack (IGA) is observed at the OD to depths of 65% TW. Flaw complexity adds to confusion in resolving flaw morphology from the EC signal.

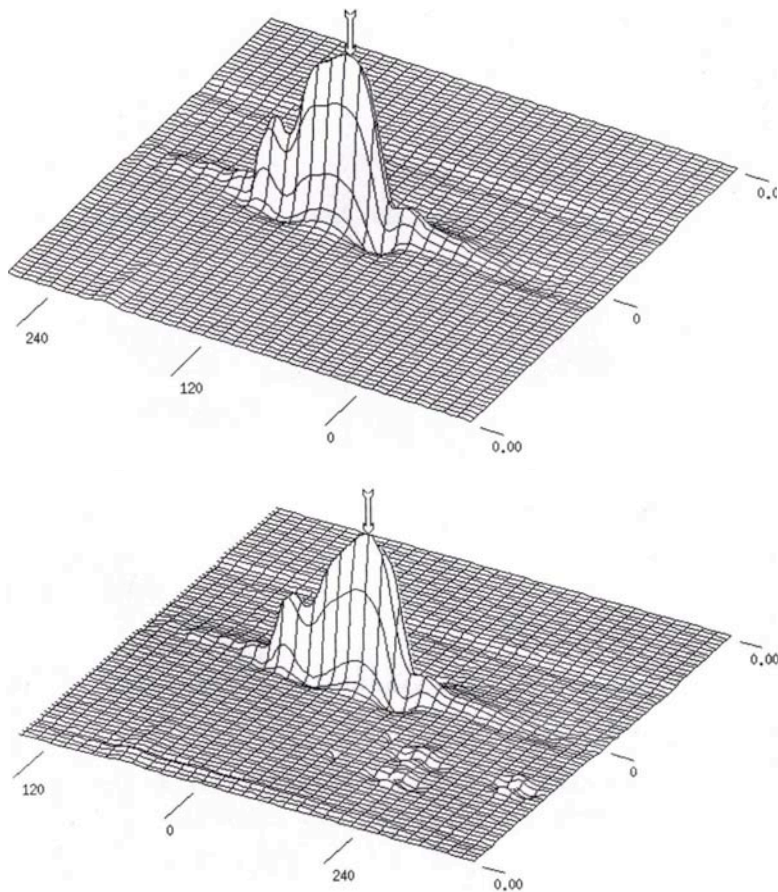
Figure 3.10 C-scan EC +Point profiles of CODSCC (90%TW initial depth, estimated) in RTZ of tube # 9 before (top) and after (bottom) pressure testing to 52 MPa (7500 psi) with no leak.

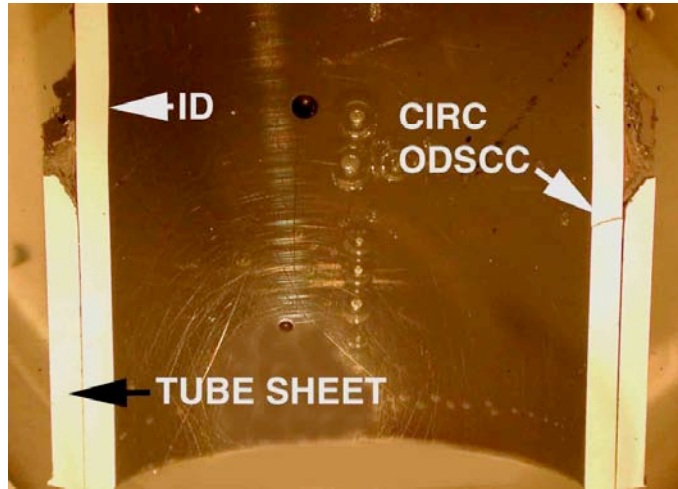
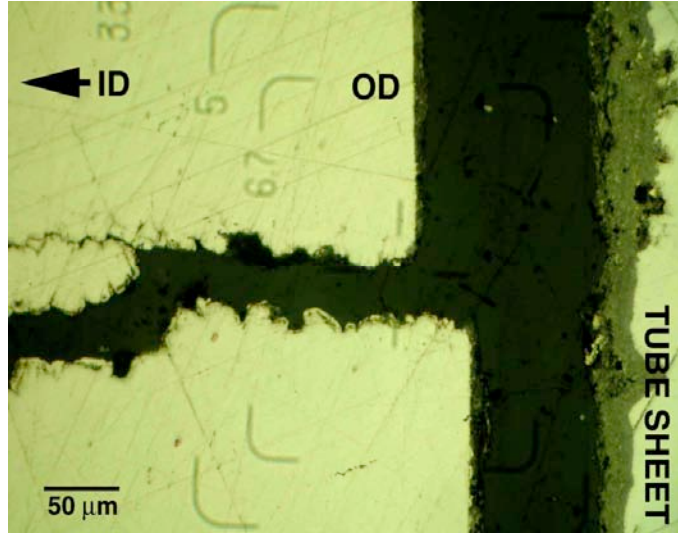
Figure 3.11 Metallographic sectioning micrographs of CODSCC in tube #9 after pressure testing to 52 MPa (7500 psi). Throughwall crack just below the top of the tube sheet.

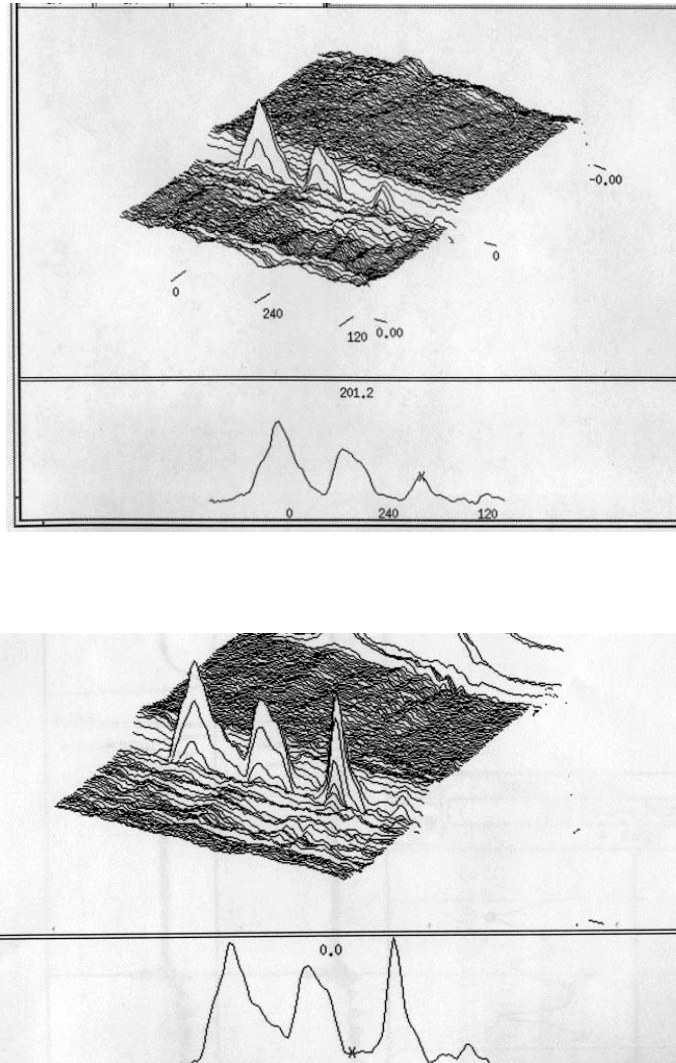
Figure 3.12 EC results (+Point C-scan) for tube #7, which was never plugged but leaked at 50 MPa (7300 psi). This CODSCC had a +Point depth of 50% TW. Three distinct cracks are indicated with growth in amplitude of the peaks (before, top; after, bottom), consistent with the tube eventually leaking under pressure. This tube was never plugged and had a +Point signal of 0.78 V in 1997 and 0.76 V in 2002.

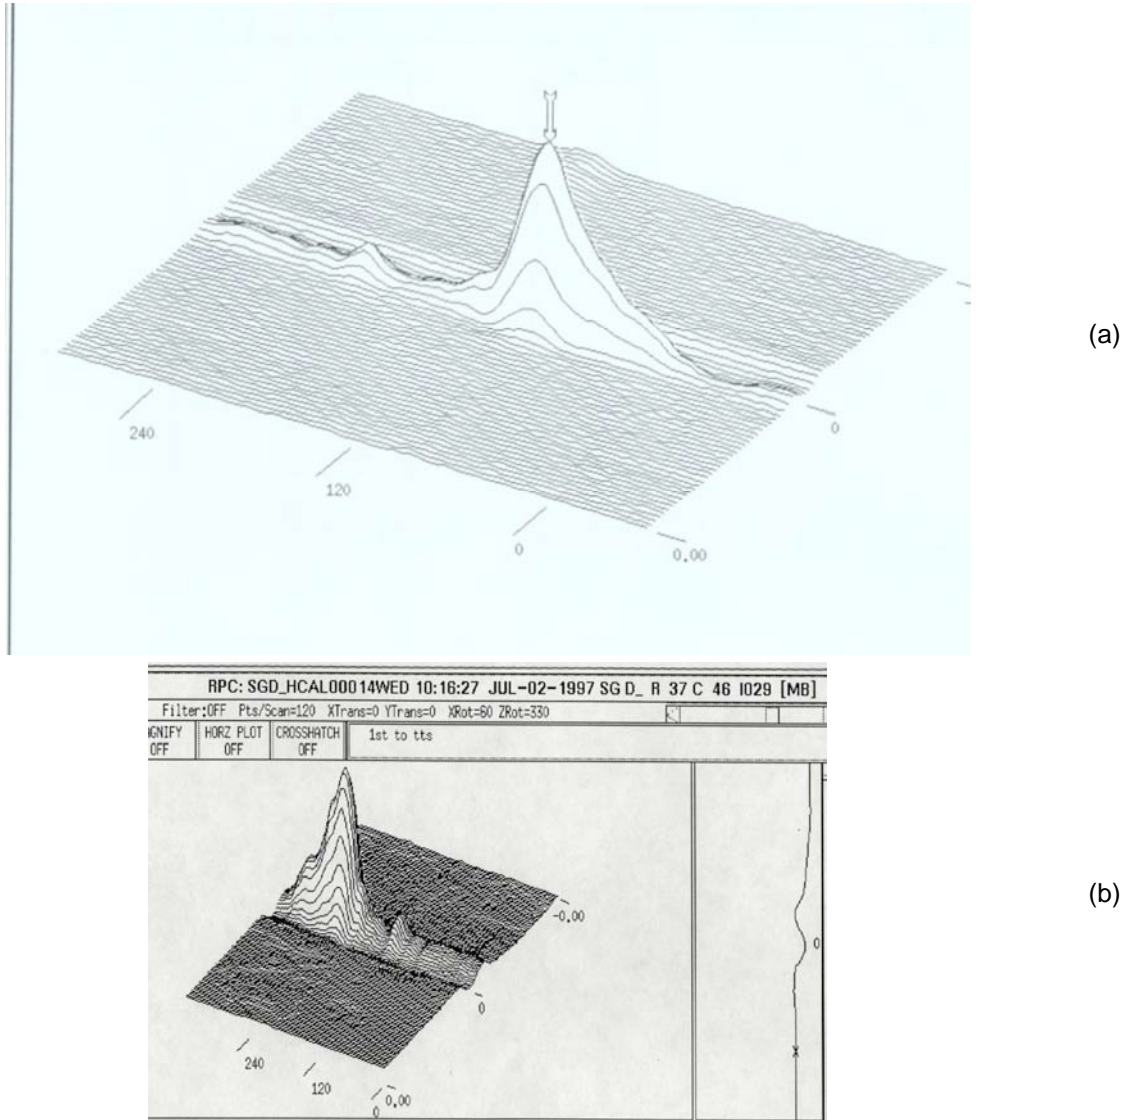
Figure 3.13 +Point signal of retired SG tube sheet #1 in (a) 2004 and (b) 1997. The 2004 image of the CODSCC in the RTZ was generated using +Point probe at 300 kHz. The three-letter code for the flaw before the TS section was removed in 1997 was MAI/MCI (plugged in 1993). The +Point at 300 kHz was 7.9 V in 2004 (80% TW by phase analysis) and 4.4 V in 1997 (80% TW by phase analysis).

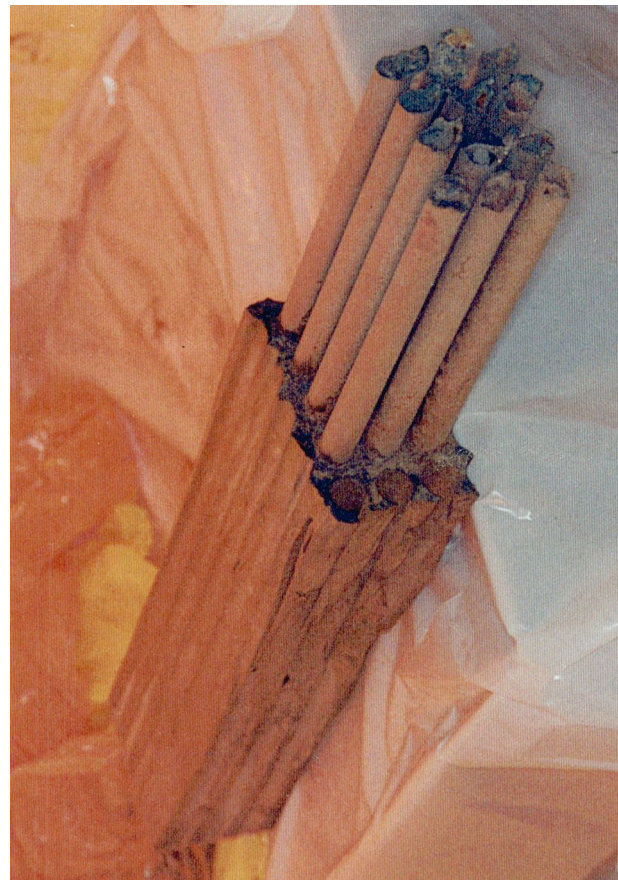
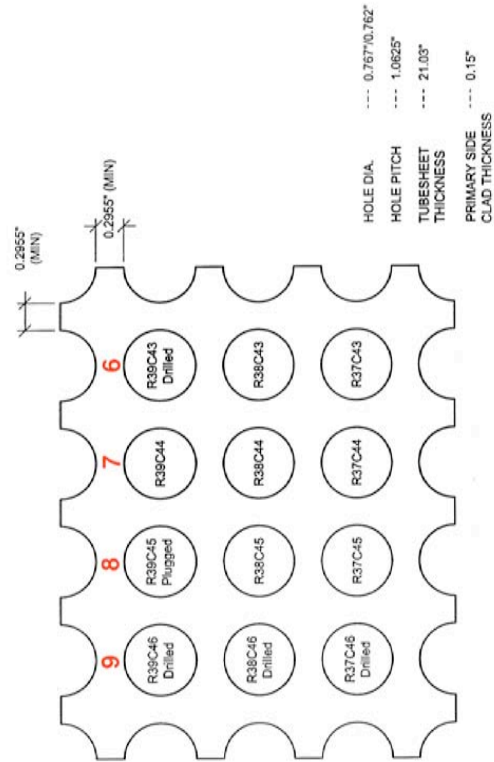
Figure 3.16 Tube sheet section TS1 removed from steam generator D (SGD) (4x3 array of 19-mm (3/4-in.) tubes).

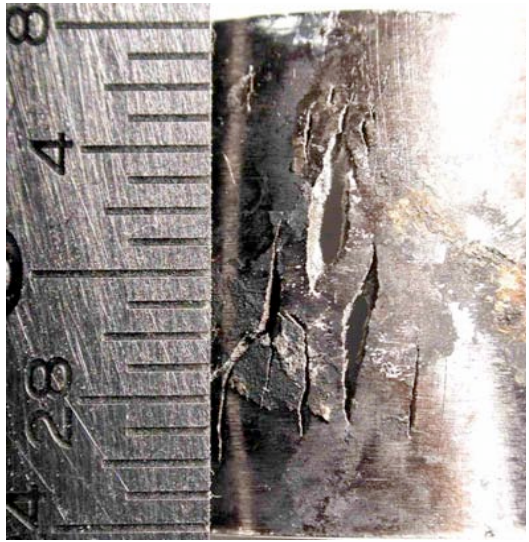
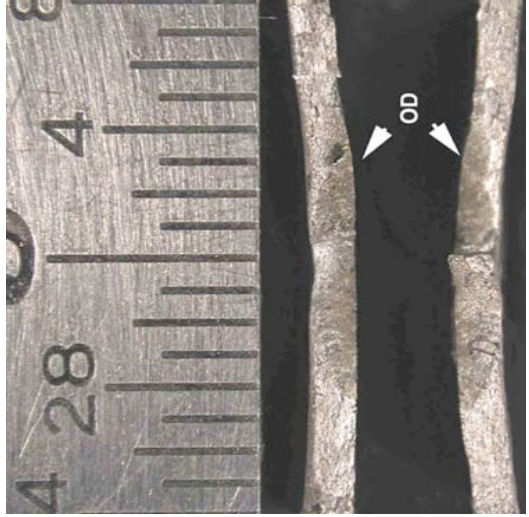
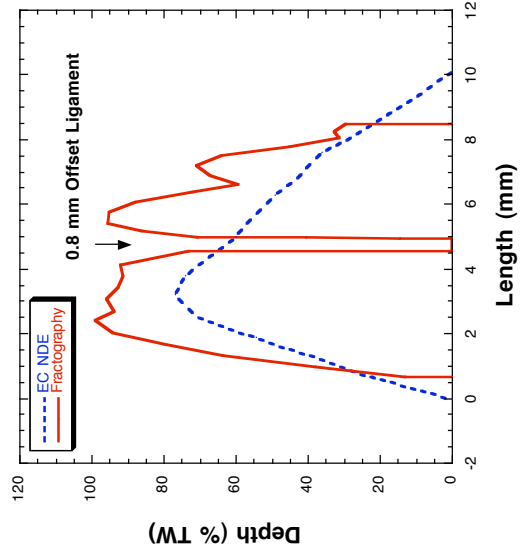
Figure 3.20 Comparison of fractography profile and NDE for axial ODSCC in 19-mm (3/4-in.) diameter tube specimen 4-43-2 (SGD). Area with the darker contrast represents the crack face. The complex character and ligament are the cause of the slight undersizing (NDE, blue dotted curve; fractography, red smooth curve) of the eddy current profiles. The arrow in graph indicates a 0.8-mm offset.

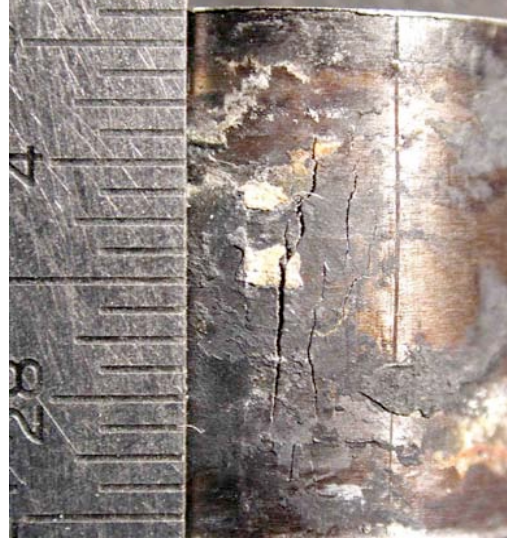
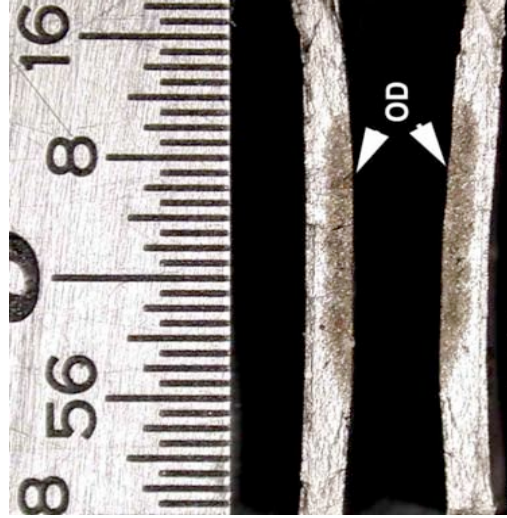
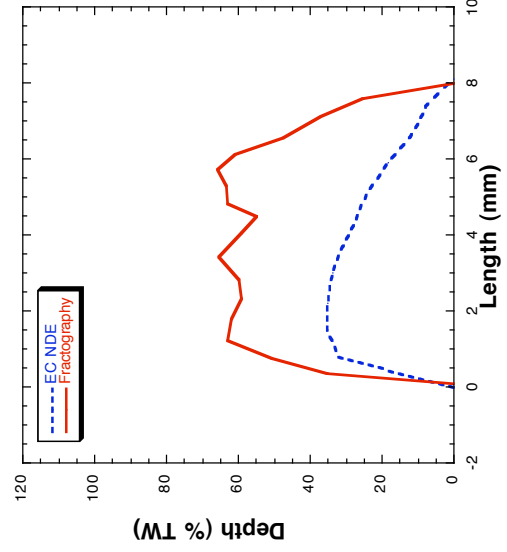
Figure 3.21 Comparison of fractography profile and NDE for axial ODSCC in 19-mm (3/4-in.) diameter tube specimen 5-51-2. The complex character is the cause of the undersizing (NDE, blue dotted curve; fractography, red smooth curve) of the eddy current profiles.

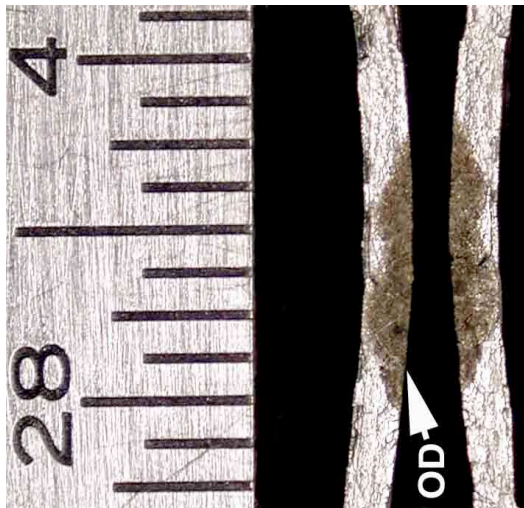
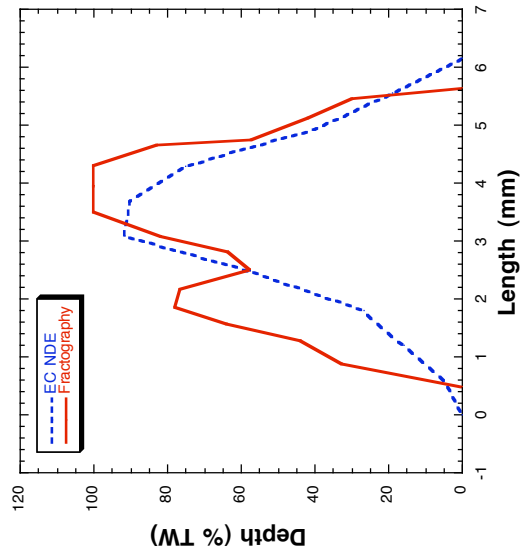
Figure 3.22 Comparison of fractography profile and NDE for axial ODSCC in 19-mm (3/4-in.) diameter tube specimen 7-24-3. The fractography shows that two cracks have merged together. The NDE (blue dotted curve) and fractography (red smooth curve) are in good agreement.

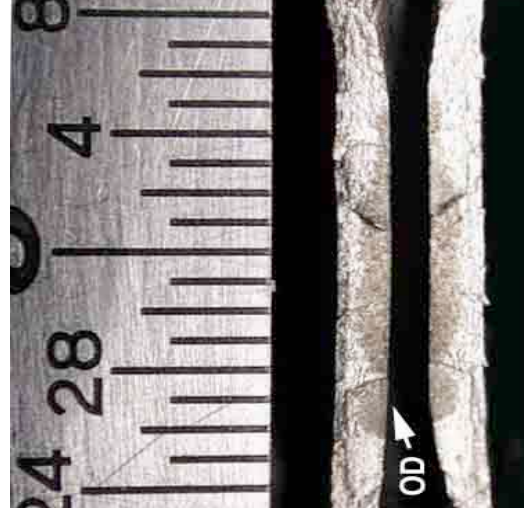
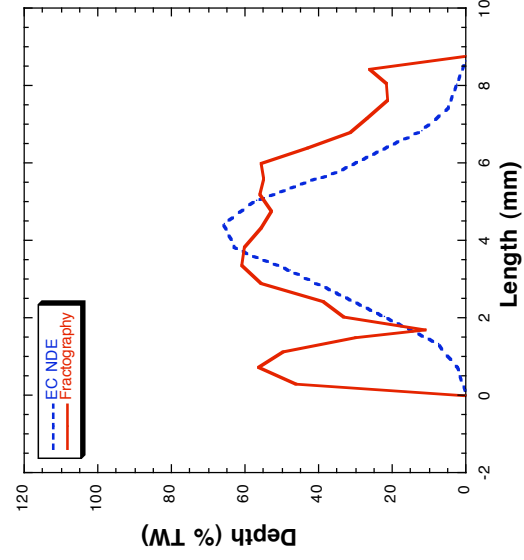
Figure 3.23 Comparison of fractography profile (red smooth curve) and NDE (blue dotted curve) for axial ODSCC in 19-mm (3/4-in.) diameter tube specimen 14-55-3.

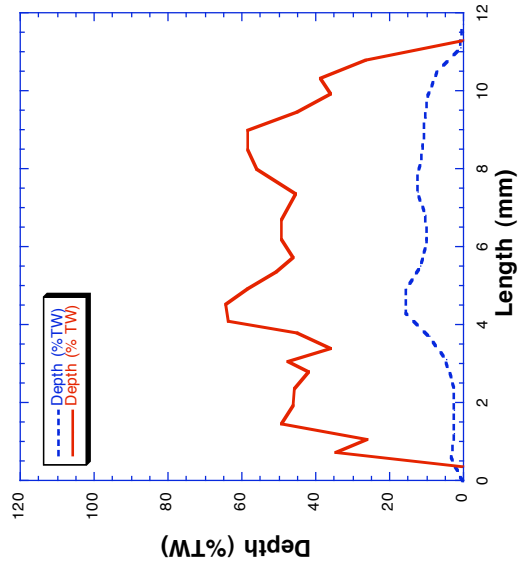
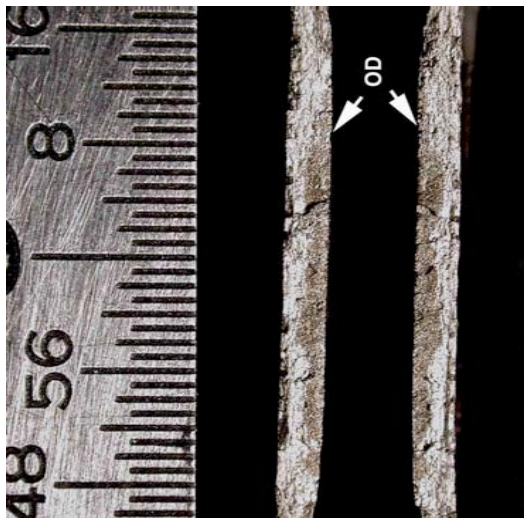
Figure 3.24 Comparison of fractography profile (red smooth curve) and NDE (blue dotted curve) for axial ODSCC in 19-mm (3/4-in.) diameter tube specimen 14-55-5. Multiple small cracks merged into one large axial crack.

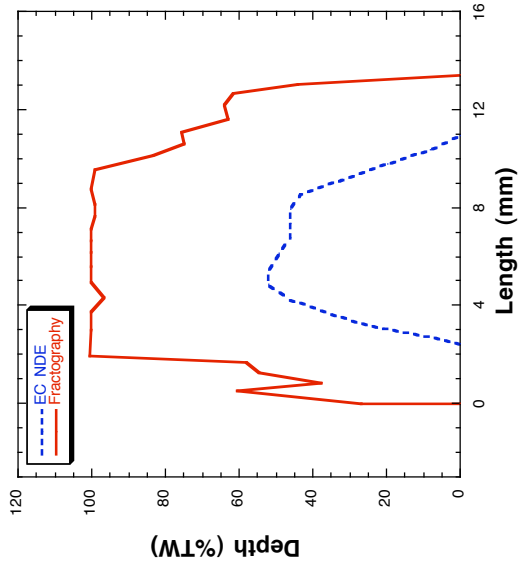
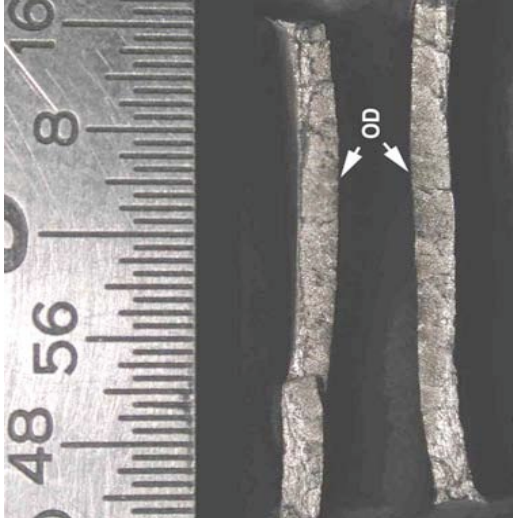
Figure 3.25 Comparison of fractography profile (red smooth curve) and NDE (blue dotted curve) for axial ODSCC in 19-mm (3/4-in.) diameter tube specimen 39-57-2.

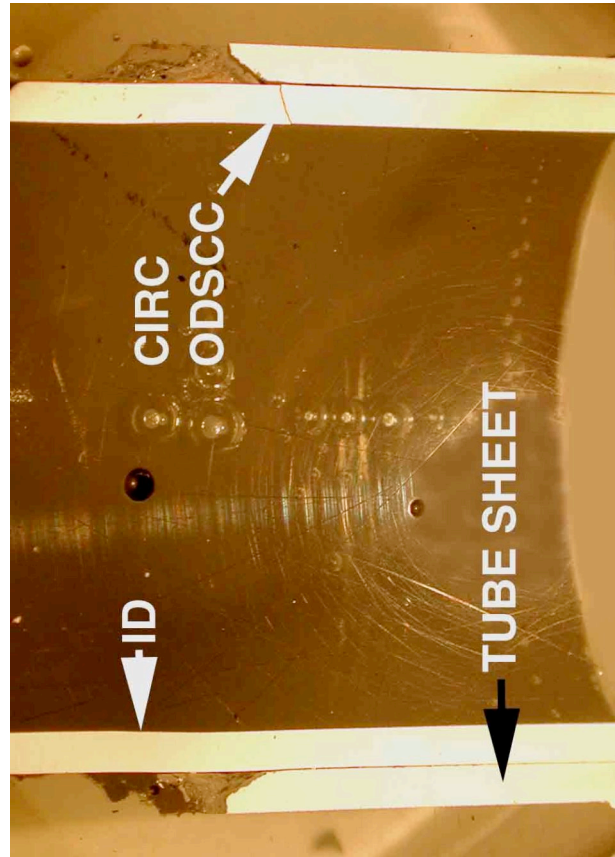
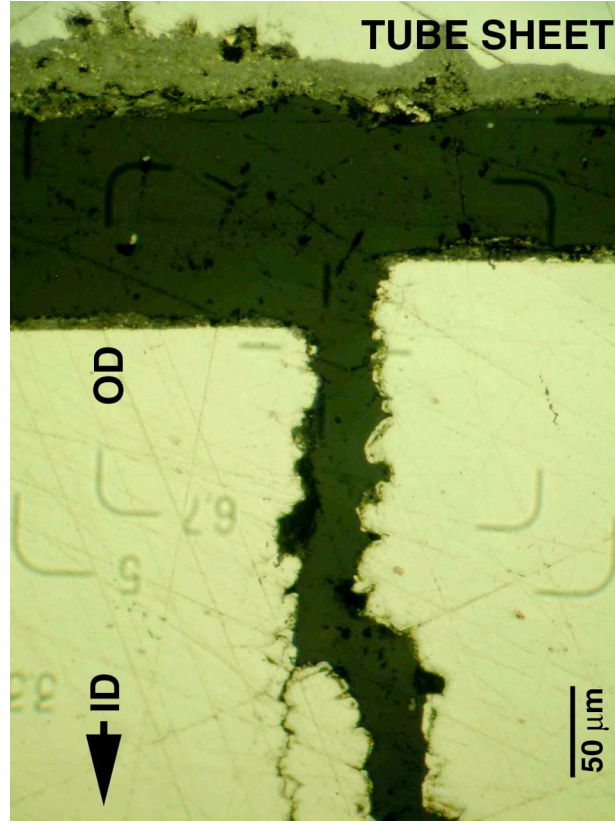
Specimen ID	Crack Type (All in TSP Region)	Max Depth (%)		Length (mm)	
		EC	Fractograph	EC	Fractograph
4-43-2	Axial OD	77	100	10	8
5-51-2	Axial OD	35	66	8	8
7-24-3	Axial OD	92	100	6	5
14-55-3	Axial OD	66	61	9	9
14-55-5	Axial OD	15	64	12	11
39-57-2	Axial OD	52	100	9	13

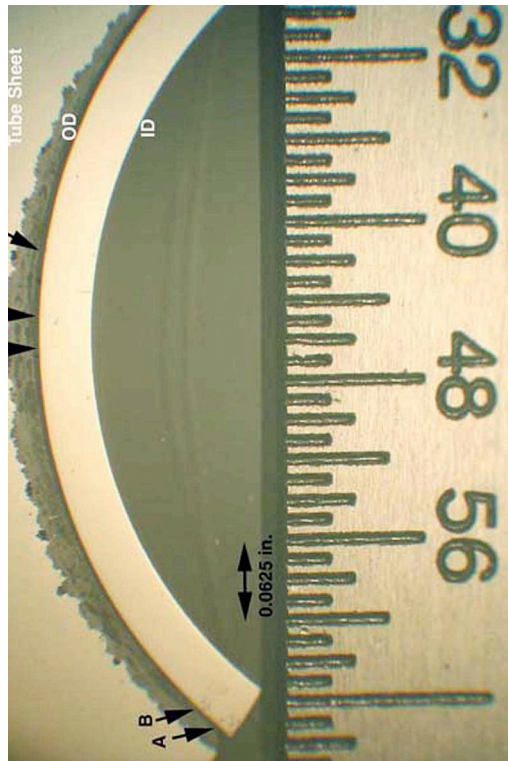
Figure 3.26 (a) Through-wall circumferential ODSCC in R39 C46 (ANL No. 9) Alloy 600 tube just below TTS. (b) Through-wall circumferential ODSCC in R39 C46 (ANL No. 9) Alloy 600 tube near TTS. Crack opening is about 0.04 mm (1.6 mils). The crack is a couple of mm below the roll transition.

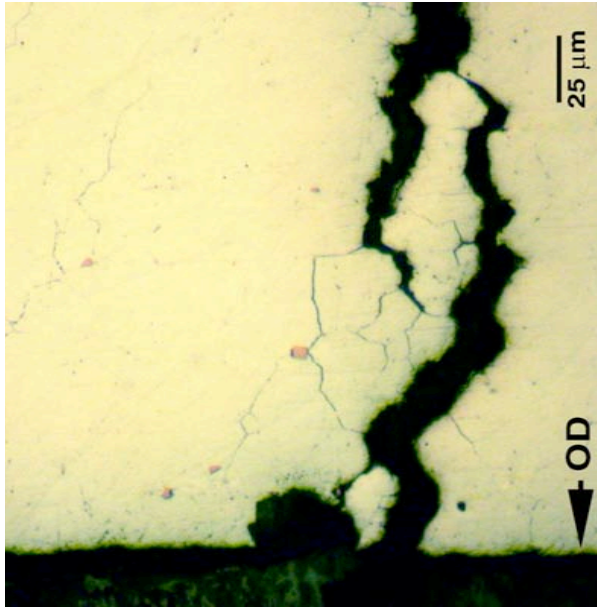
Figure 3.31
 Cross-sectional optical metallograph of SG R39 C43 (ANL No. 6) specimen showing ODSCC in Alloy 600 tube. Note secondary cracks and branching.

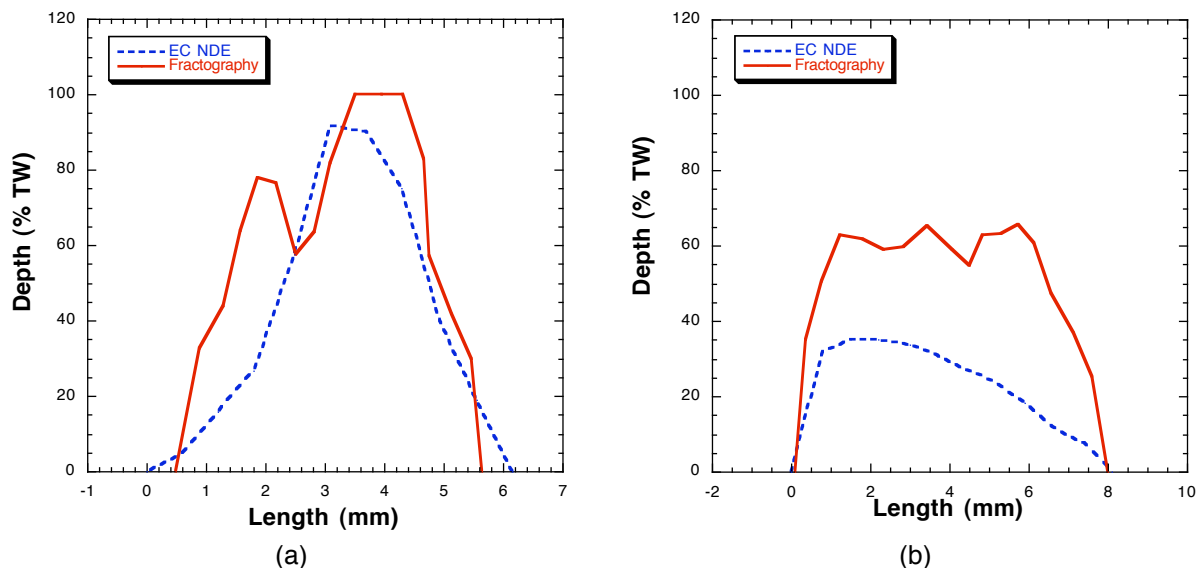
Figure 6.1 Crack depth profiles by EC/NDE (blue dotted) and fractography (red smooth) of tube (a) 7-24-3 and (b) 5-51-2.

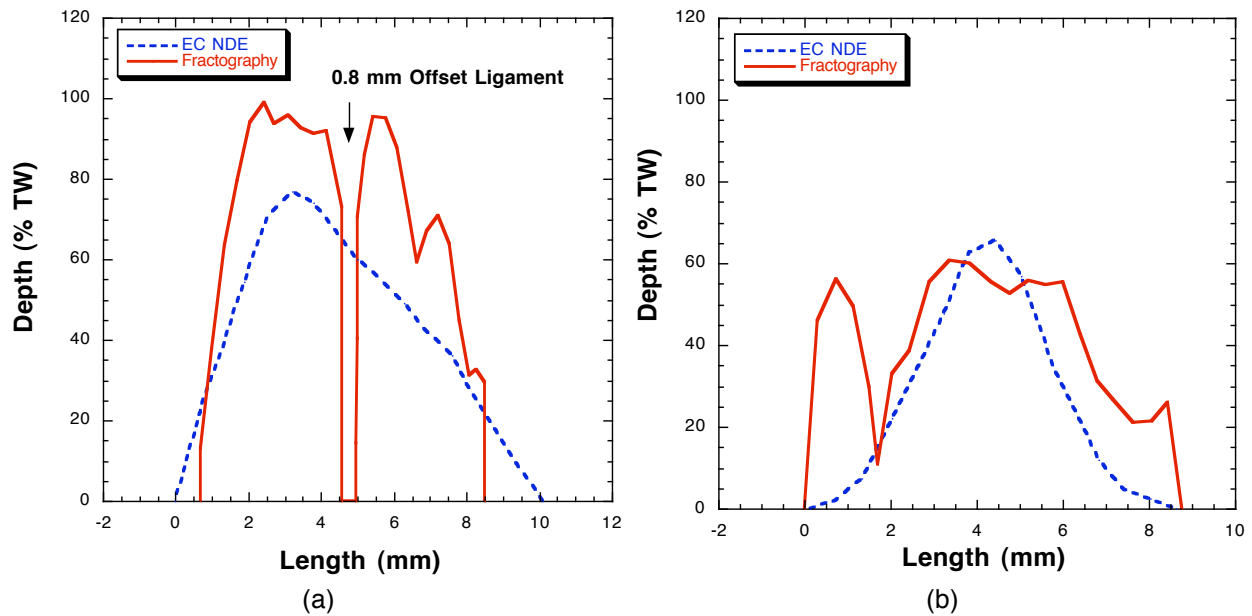
Figure 6.2 Crack depth profiles by EC/NDE (blue dotted) and fractography (red smooth) of tube (a) 4-43-2 and (b) 14-55-3.

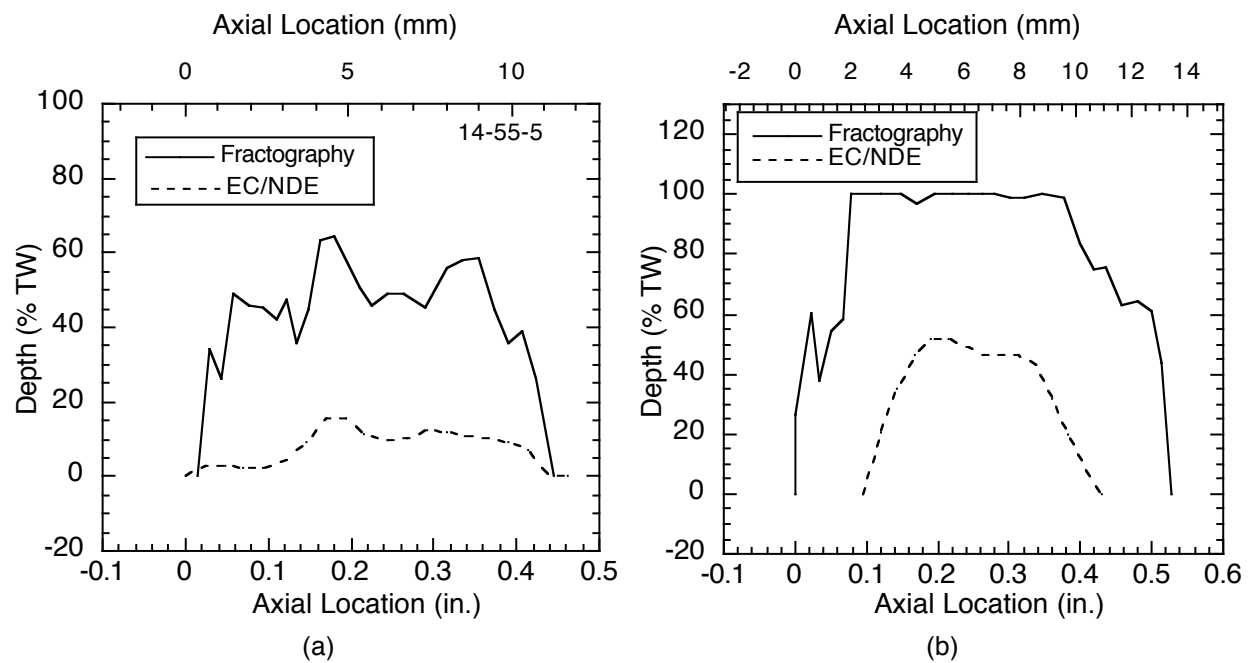
Figure 6.3 Crack depth profiles by EC/NDE and fractography of tube (a) 14-55-5 and (b) 39-57-2.

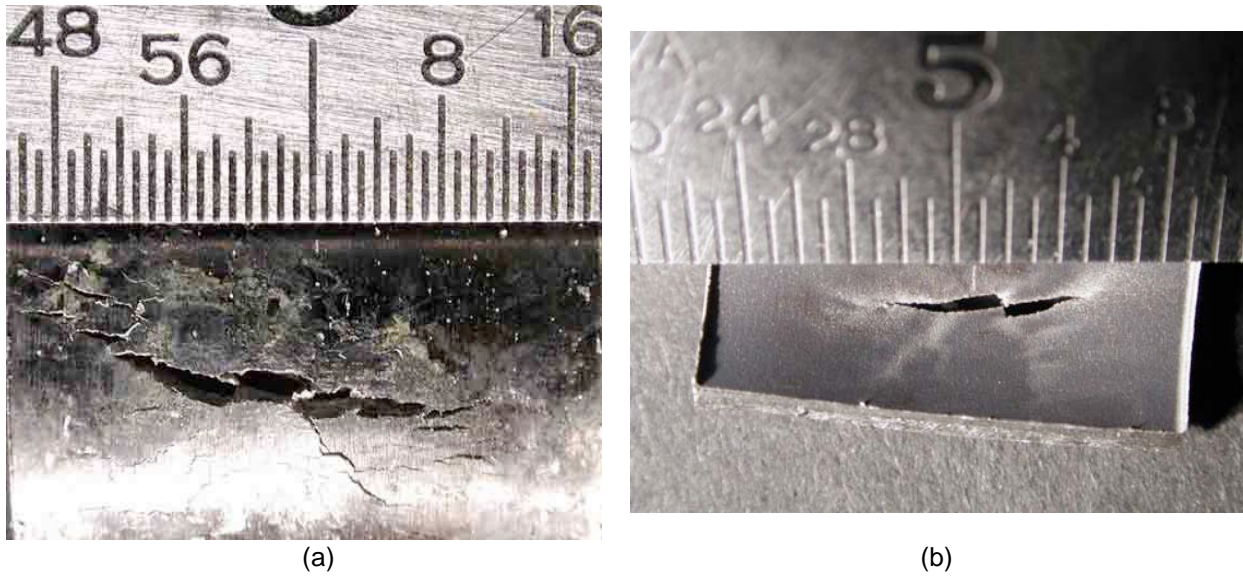
Figure 6.4 Picture of (a) OD and (b) ID surfaces of specimen 39–57–2 after the end of the test.

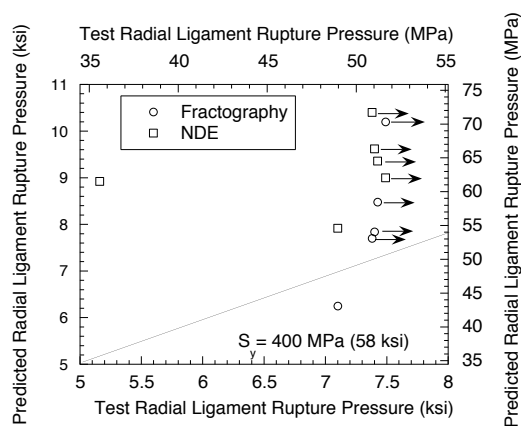
Figure 6.6
Observed vs. predicted radial ligament rupture pressures based on fractography and EC/NDE. Right arrows indicate no leakage during tests. The squares are for predictions based on NDE profiles before the test. The circles are for predicted rupture pressures based on fractography after the test.

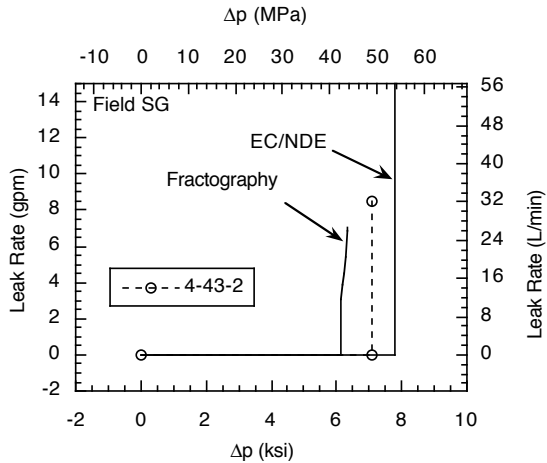
Figure 6.7
Observed variation of leak rate with pressure for Test 4-43-2 and the predicted leak rate variations based on crack profiles determined from EC/NDE (before testing) and fractography (after testing).

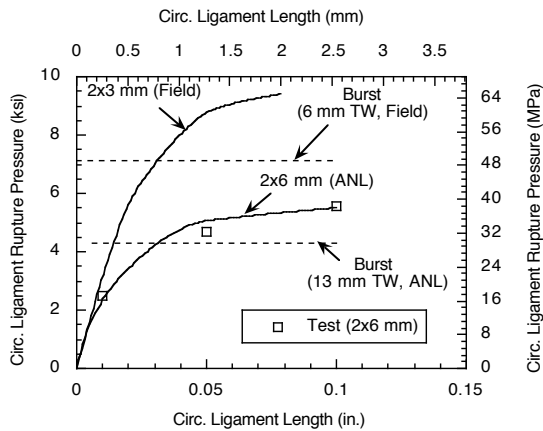
Figure 6.9
Predicted vs. observed circumferential ligament pressures for tests conducted at ANL on 2 x 6 mm axial throughwall cracks separated by a circumferential ligament of various lengths. Also shown are the predicted circumferential ligament rupture pressures for 2 x 3 mm cracks using the same predictive model but modified to account for the flow stress difference between the ANL tubes and the field tubes.

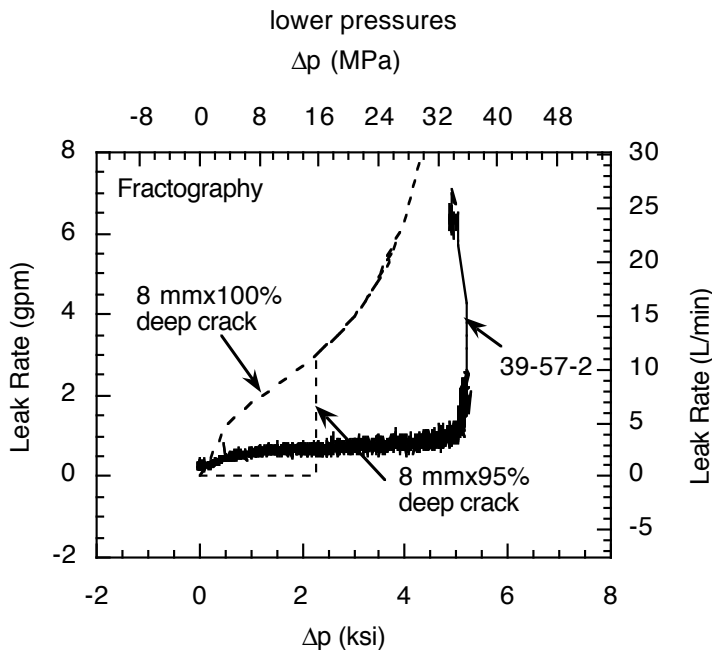
Figure 6.10
Observed and predicted leak rate vs. pressure plots for specimen C39-R57. The noisy signal suggests leakage at low pressure but no leakage at the was observed.

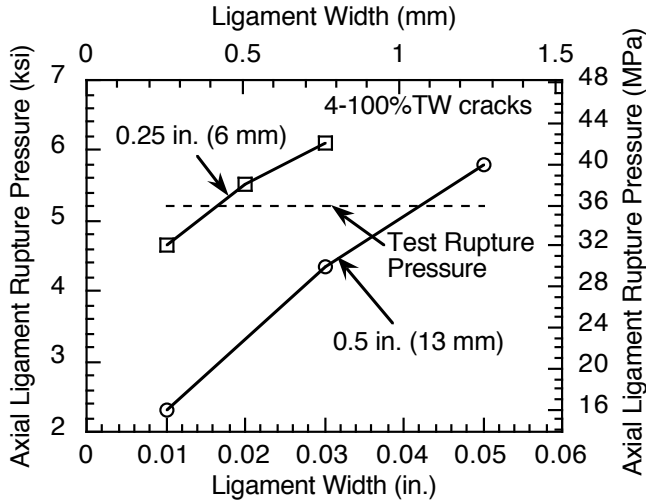
Figure 6.11
FEA (finite element analysis)–predicted axial ligament rupture pressures for 6- and 13-mm long 100% TW axial cracks separated by three axial ligaments with various ligament widths.

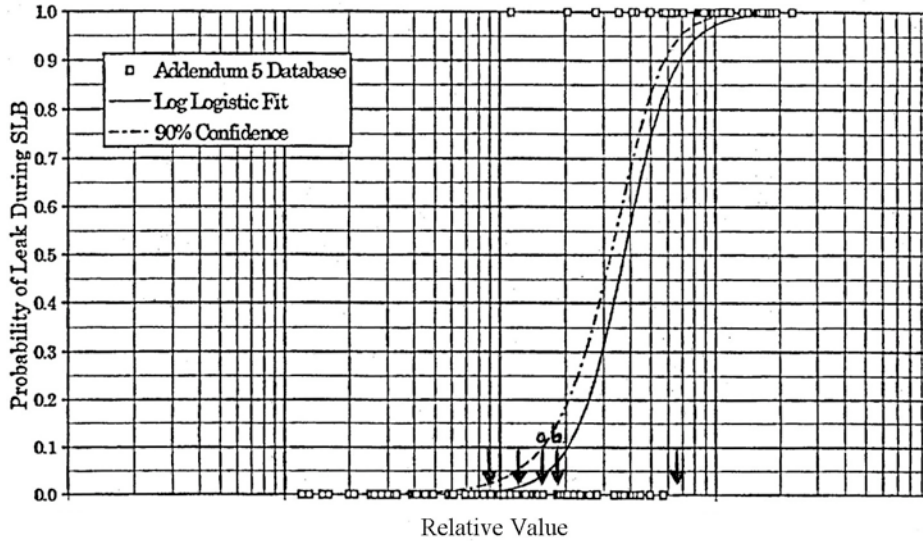
Figure 6.12 Relative bobbin coil amplitudes (before pulling) for the retired SG 19-mm ($\frac{3}{4}$ -in.) diameter tubes with TSP SCC that were pressure tested at room temperature at Argonne are shown as arrows. The Argonne tube data can be compared with other 19-mm ($\frac{3}{4}$ -in.) diameter field tubes that were pressure tested (Ref. 4). Tubes that did not leak at 17.6 MPa (2560 psi) are plotted as a probability of leakage of 0.0; those that did leak are plotted as a probability of leakage of 1.0. None of the retired steam generator tubes tested at Argonne leaked at pressures less than 17.7 MPa (2560 psi). Tubes a and b leaked at much higher pressures.
