Non-destructive and Failure Evaluation of Tubing from a Retired Steam Generator

Argonne National Laboratory

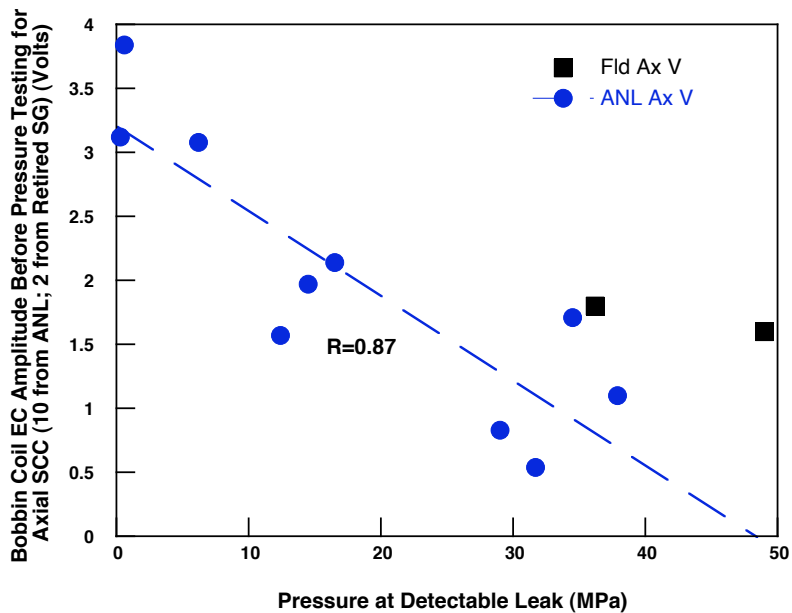
Figure 6.13 Graph of bobbin coil voltage before pressure testing for 10 axial ODSCCs grown at Argonne and 2 axial ODSCCs from the TSP of retired SGD versus the pressure at first observable leak. The linear fit correlation coefficient for the SCCs grown at Argonne under identical conditions is 0.87. In all cases samples were free of signal-distorting deposits.
