3.3. Insulation

3.3.1. Deposits in Fiberglass Samples

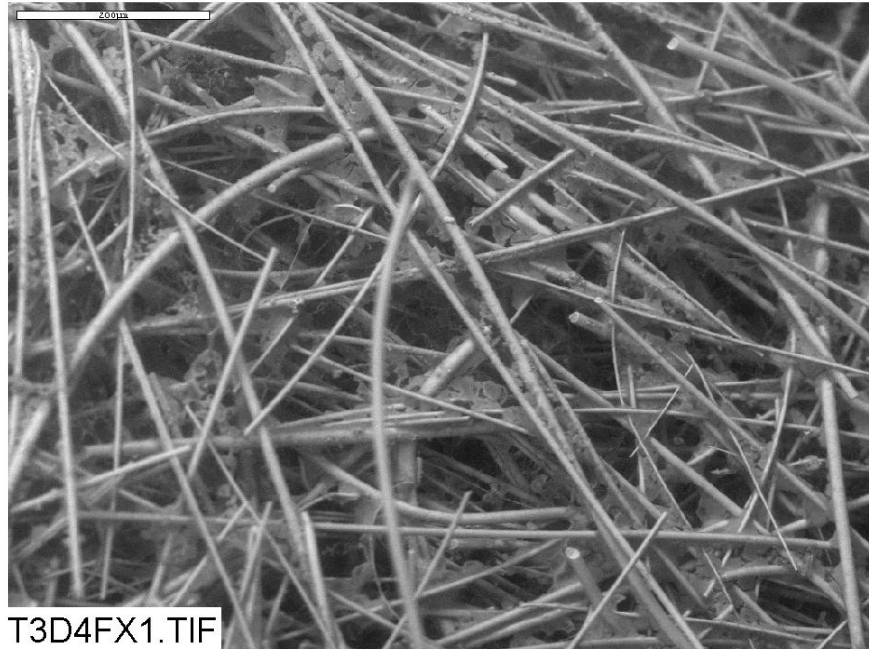
Figure 3-17. ESEM image of a Test #3, Day-4 low-flow exterior fiberglass sample, magnified 150 times. (T3D4FX1, 4/12/05)

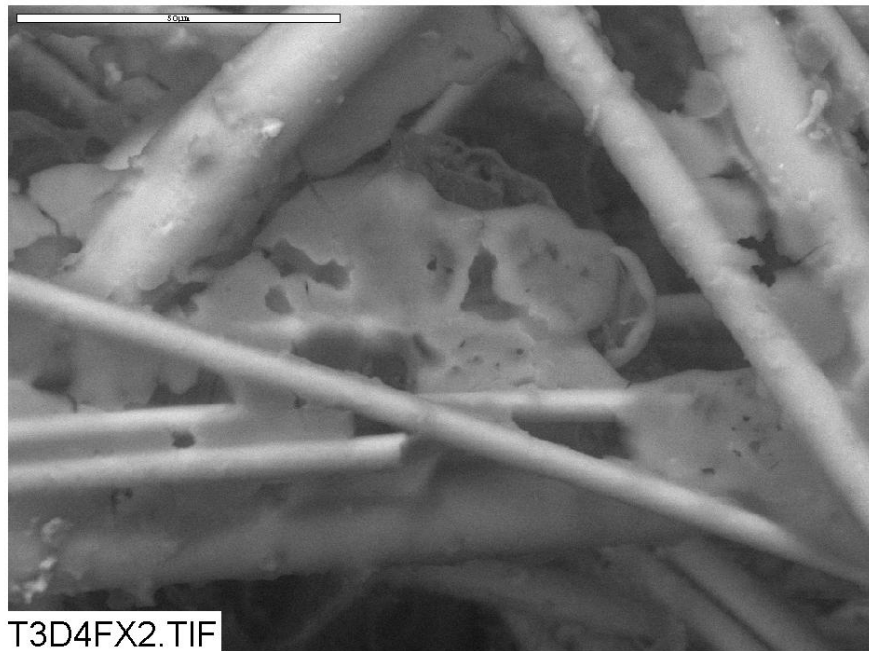
Figure 3-18. ESEM image for a Test #3, Day-4 low-flow exterior fiberglass sample, magnified 1000 times. (T3D4FX2, 4/12/05)

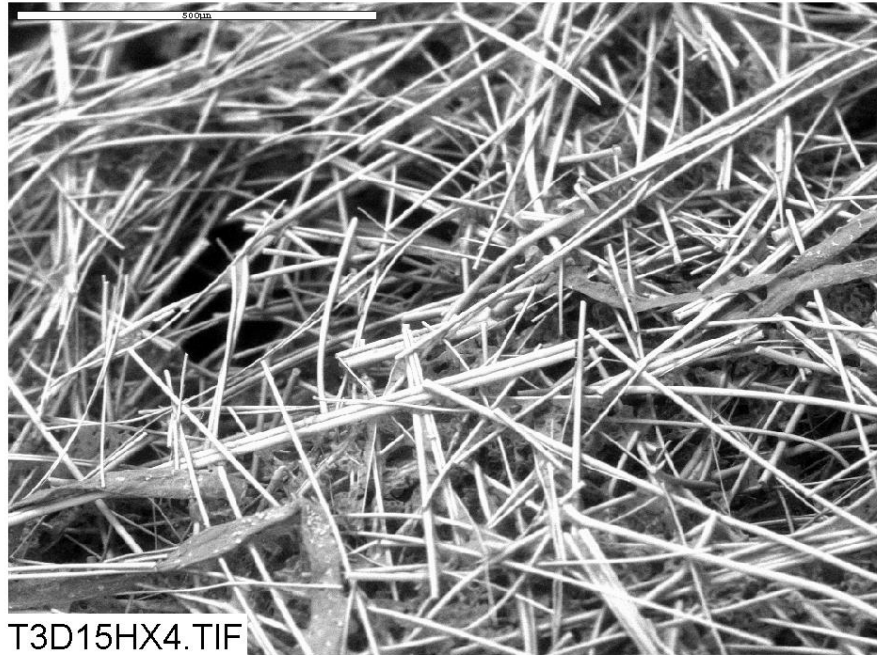
No significant difference was found between Day-15 high-flow and low-flow fiberglass samples, except for some large flat fibers found on the Day-15 high-flow exterior fiberglass samples (see lower left corner of Figure 3-39). These large flat fibers, which were likely from the submerged cal-sil samples (see Appendix H), were physically attached/retained on the exterior of the fiberglass samples. No large flat fibers were found in the interior of the fiberglass samples. Again, dark deposits and white flocculence were found with ESEM and SEM results, respectively, on Day-15 high-flow fiberglass samples. There was no significant difference in the amount of deposits on the exterior and interior fiberglass samples. Similarly, EDS results verified that the deposits on the exterior and interior samples were commonly composed of O, Si (possible), Na, Ca, and small amount of Mg, Al, B, and P, suggesting the deposits' likely chemical origin. Figures 3-39 through 3-50 show the Day-15 high-flow fiberglass results.

Figure 3-39. ESEM image of a Test #3, Day-15 high-flow exterior fiberglass sample, magnified 110 times. (T3D15HX4, 4/22/05)

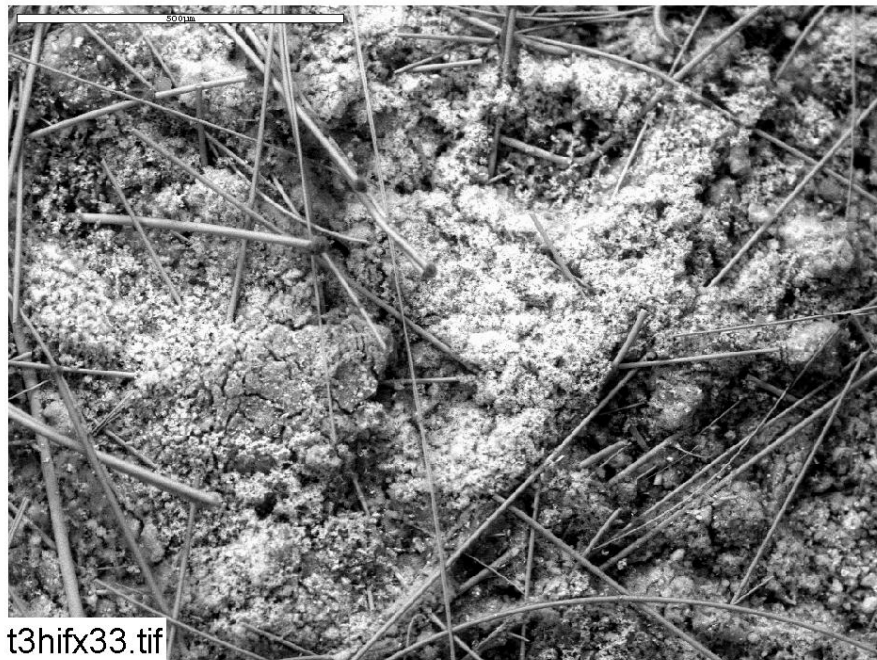
Compared with other high- and low-flow fiberglass samples, Day-30 high-flow exterior samples contained a significant amount of particulates. As opposed to the exterior samples, the interior samples were relatively clean, suggesting that the particulate deposits were physically attached/retained on the fiberglass exterior. EDS results show that the particulate deposits were composed of a significant amount of P, which is different from the previous fiberglass samples. The deposits' high P, Ca, and O content suggests that the deposits were $\text{Ca}_3(\text{PO}_4)_2$, which relates to the white gel (cream) formed during the injection of TSP. That $\text{Ca}_3(\text{PO}_4)_2$ was likely precipitated out from the testing solution, followed by sedimentation/transportation onto the Day-30 high-flow fiberglass exterior. Figures 3-55 through 3-59 show the Day-30 high-flow fiberglass results.

Figure 3-55. ESEM image of a Test #3, Day-30 exterior high-flow fiberglass sample, magnified 100 times. (t3hifx33, 5/11/05)

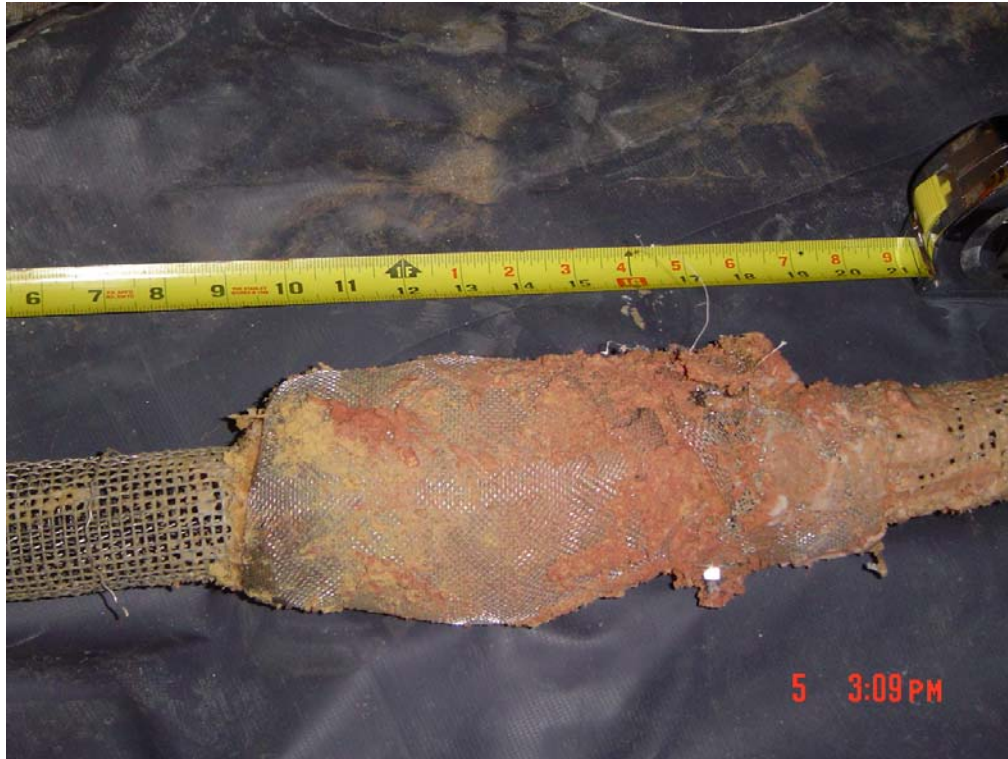
Figure 3-60 shows the drain collar after it was removed from the tank. When the tank was drained, the drain collar was totally surrounded by sediment. Both the exterior fiberglass sample that was farthest from the drain screen and the exterior sample that was next to the drain screen have very significant amounts of particulate deposits. Inspection revealed the development of a continuous coating on the drain collar exterior, including particulate deposits that were likely physically retained or attached. The amount of deposits on the drain collar exterior was greater than on high- and low-flow fiberglass samples. The ESEM images showed that two types of material were retained; an amorphous material that appeared darker in the ESEM images and a lighter granular material. The EDS results indicate that these materials had different P and Si content. The lighter particulate deposits (see Figure 3-62) have a higher percentage of P and a lower percentage of Si than the dark deposits, suggesting that light particulate deposits are likely composed of $\text{Ca}_3(\text{PO}_4)_2$ precipitates and dark deposits of cal-sil particles. Both kinds of deposits could have been transported and/or deposited/retained on the drain collar fiberglass exterior. As opposed to what was found on the exterior sample, no significant deposits were found in the drain collar interior sample, suggesting that that almost all of the particulate deposits were physically retained at the fiberglass exterior. The result is consistent with findings for the Day-30 high-flow fiberglass samples. Figures 3-61 through 3-70 show the drain Day-30 drain collar fiberglass results.

Figure 3-60. Drain screen collar removed from the tank.

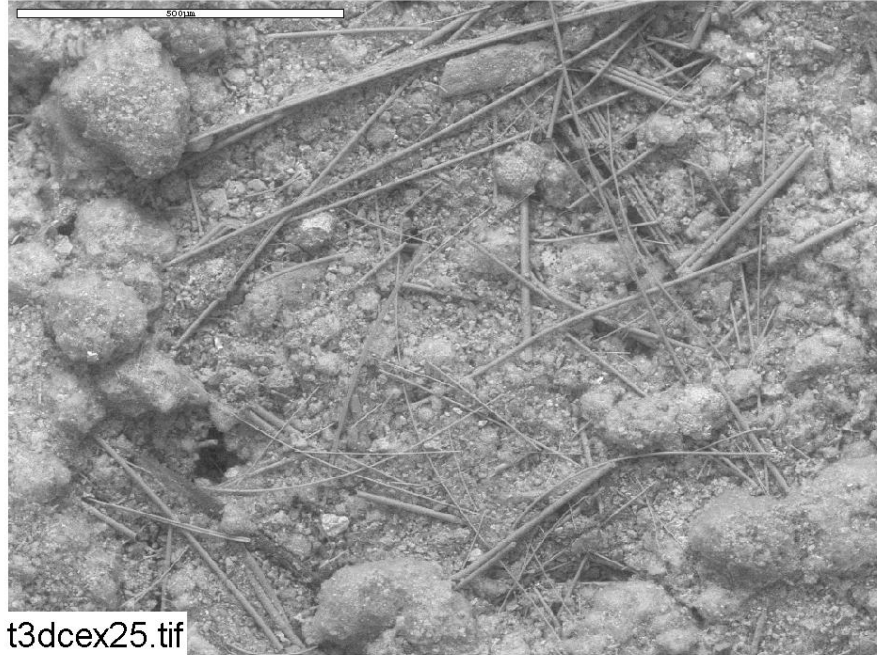
Figure 3-61. ESEM image of a Test #3, Day-30 exterior fiberglass sample on the drain collar (away from the drain screen), magnified 100 times. (t3dcex25, 5/6/05)

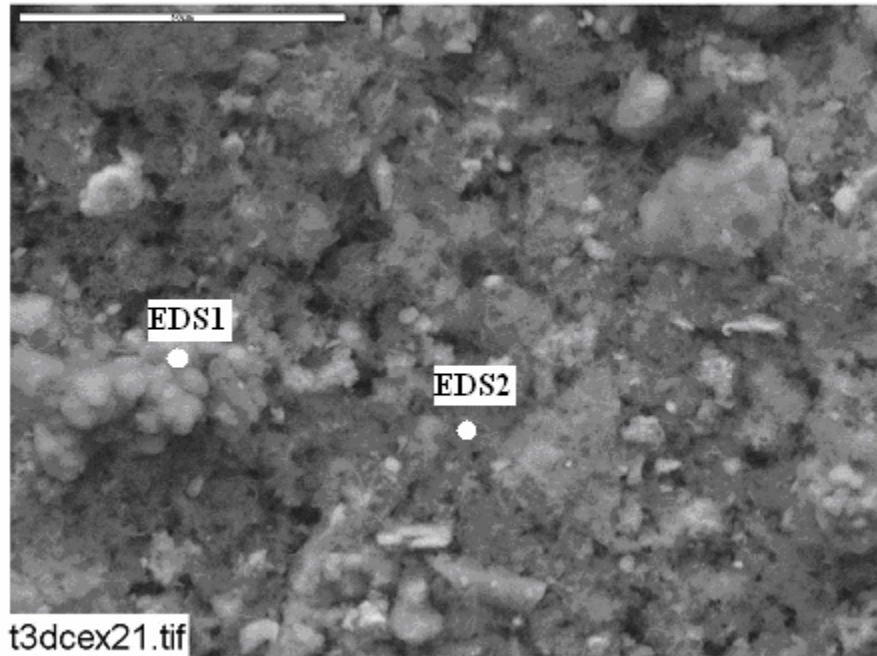
Figure 3-62. ESEM image of a Test #3, Day-30 exterior fiberglass sample on the drain collar (away from the drain screen), magnified 1000 times. (t3dcex21, 5/6/05)

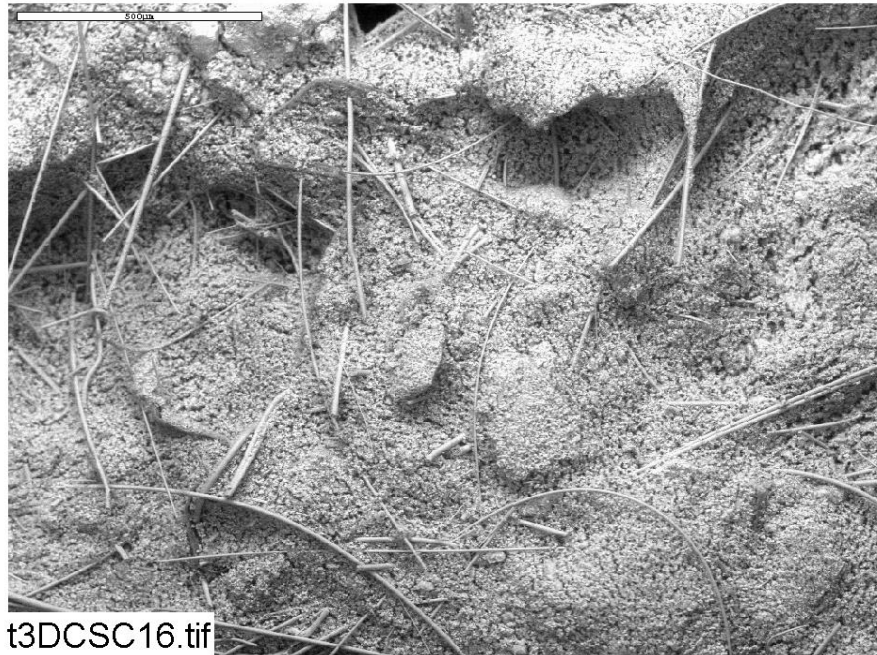
Figure 3-66. ESEM image of a Test #3, Day-30 exterior fiberglass sample on the drain collar (adjacent to the drain screen), magnified 100 times. (t3DCSC16, 5/6/05)

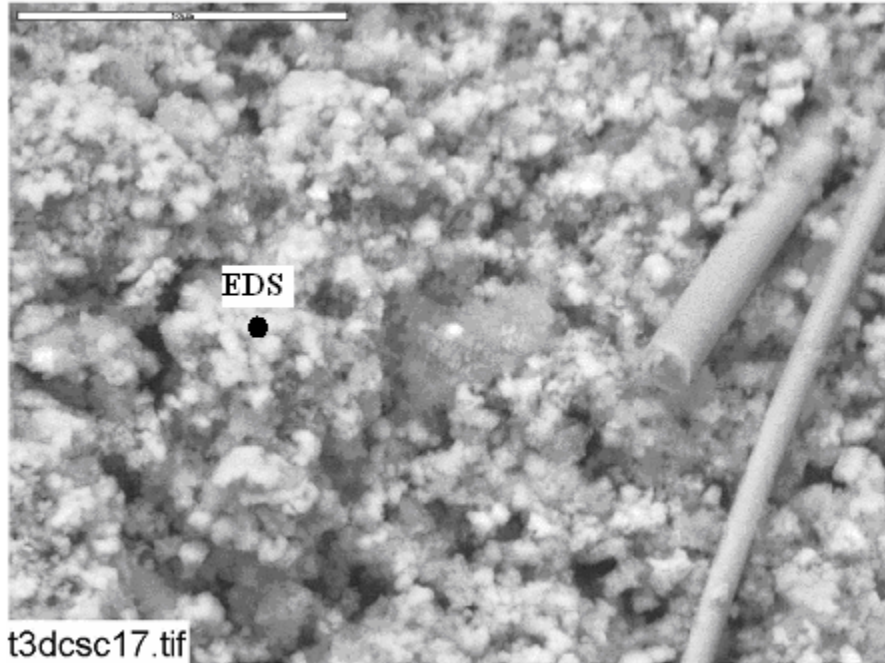
Figure 3-67. ESEM image of a Test #3, Day-30 exterior fiberglass sample on the drain collar (adjacent to the drain screen), magnified 1000 times. (t3dcsc17, 5/6/05)

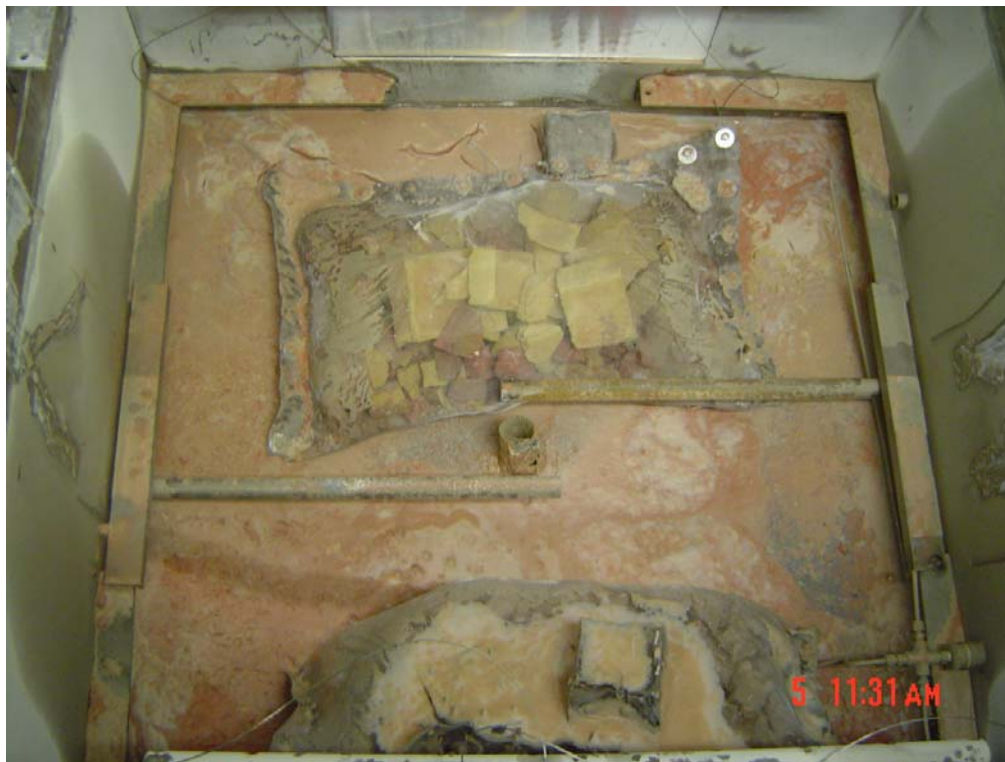
The test fluid was drained from the tank at the end of the 30-day test. Figure 3-71 shows the bottom of the tank after the tank was emptied. The birdcage is the cube in the center bottom of the figure, covered on its top with and sitting in light-colored gel-like material. For the Day-30 fiberglass sample within the birdcage, SEM images indicate large deposits (Figure 3-72) as well as a continuous coating (Figure 3-74) over the exterior of the fiberglass. The amount of particulate deposits within the birdcage was greater than on high- and low-flow fiberglass samples. The EDS result shows that the large particulate deposits had higher P and lower Si percentages than did the continuous coating shown in Figure 3-74. As with the particulate deposits on the drain collar, the large deposits are likely composed of $\text{Ca}_3(\text{PO}_4)_2$ precipitates, while the continuous coating was likely cal-sil particles. Both kinds of deposits were physically transported and/or deposited/retained on the birdcage fiberglass exterior. Compared with the exterior sample, the interior sample was relatively clean. Only small amounts of deposits were found. These deposits were similar to the deposits observed on high- and low-flow interior samples, which were likely caused by chemical precipitation during the drying process. Again, this result suggests that almost all of the particulate deposits were physically retained at the fiberglass exterior, consistent with conditions on the Day-30 high-flow and drain-collar fiberglass samples. Figures 3-72 through 3-79 show the Day-30 birdcage fiberglass results.

Figure 3-71. Tank bottom after the test fluid was drained.

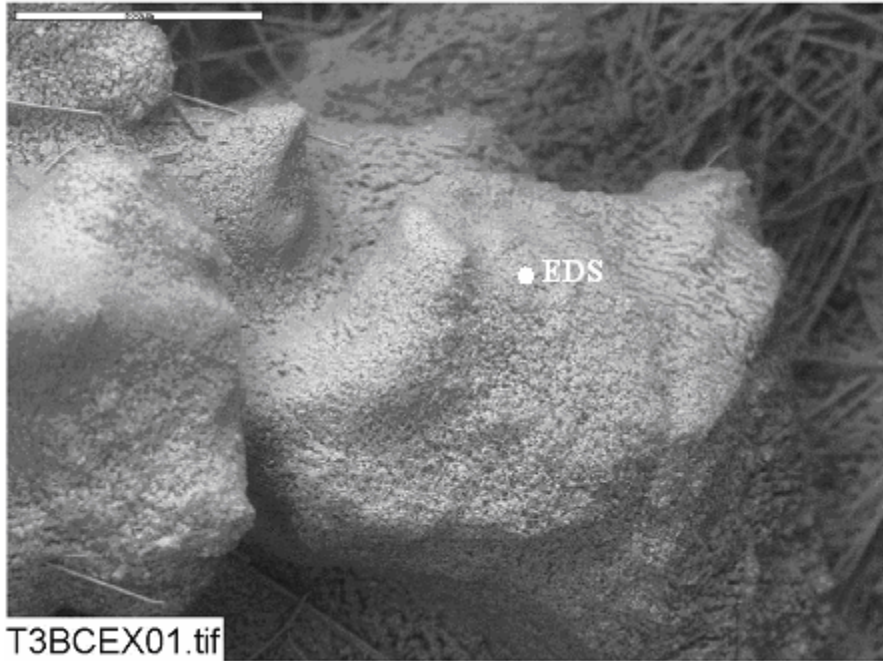
Figure 3-72. ESEM image of a Test #3, Day-30 exterior fiberglass sample within the birdcage, magnified 80 times. (T3BCEX01, 5/6/05)

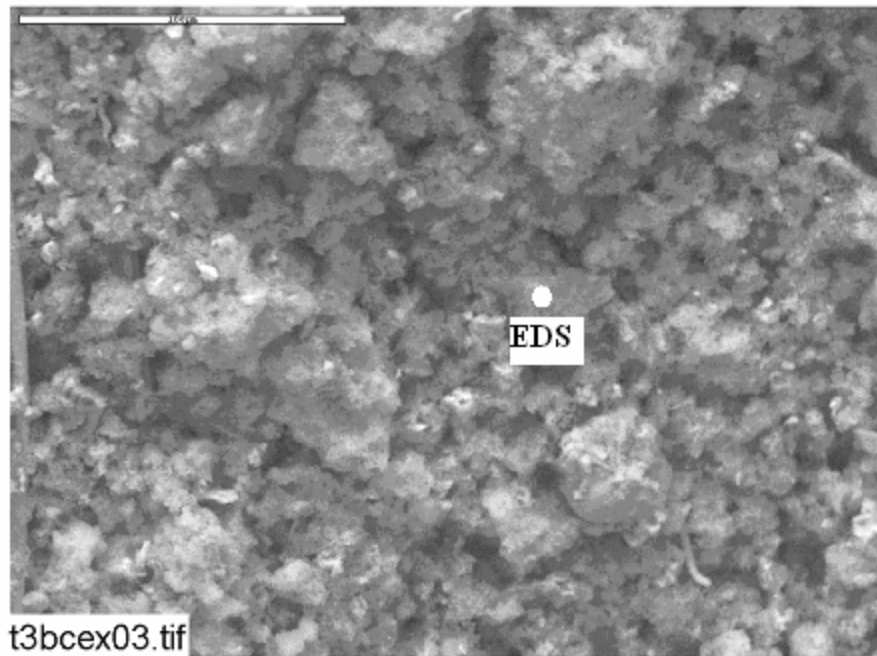
Figure 3-75. ESEM image of a Test #3, Day-30 exterior fiberglass sample within the birdcage, magnified 500 times. (t3bcex03, 5/6/05)
