Appendix C3

ESEM/EDS Data for Test #3, Day-30 Drain Collar Fiberglass

Appendix C4

SEM/EDS and ESEM/EDS Data for Test #3, Day-30 Birdcage Fiberglass

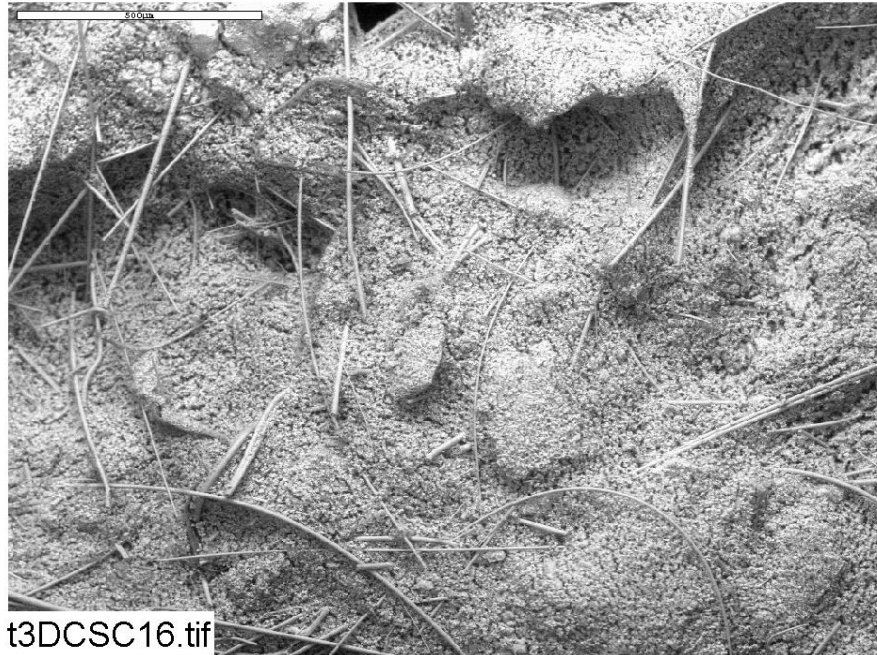
Figure C3-1. ESEM image magnified 100 times for a Test #3, Day-30 exterior fiberglass sample on the drain collar (adjacent to the drain screen). (t3DCSC16)

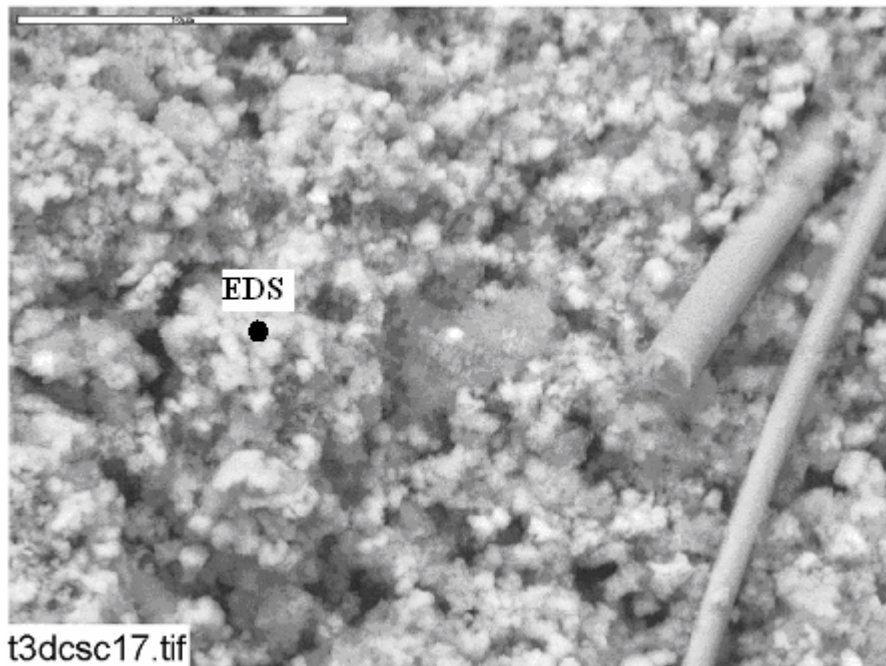
Figure C3-2. ESEM image magnified 1000 times for a Test #3, Day-30 exterior fiberglass sample on the drain collar (adjacent to the drain screen). (t3dcsc17)

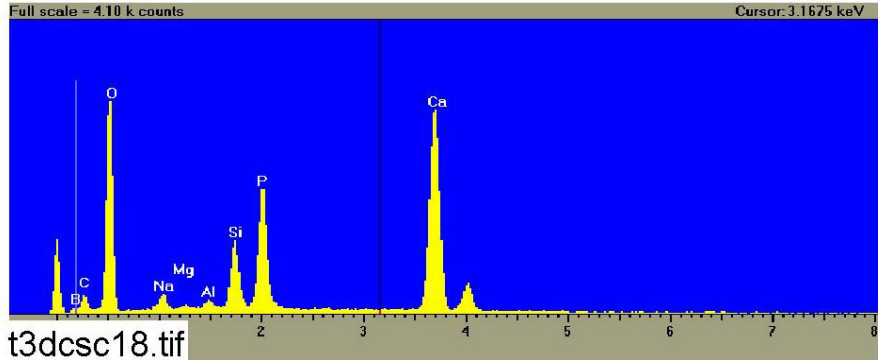
Figure C3-3. EDS counting spectrum for the particulate deposits shown in Figure C3-2. (t3dcsc18)

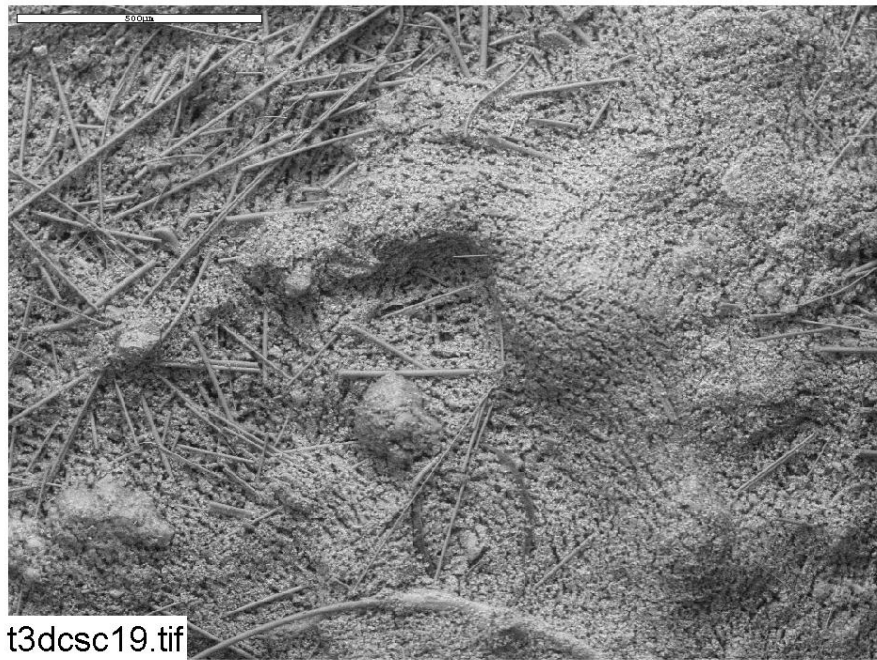
Figure C3-4. ESEM image magnified 70 times for a Test #3, Day-30 exterior fiberglass sample on the drain collar (adjacent to the drain screen). (t3dcsc19)

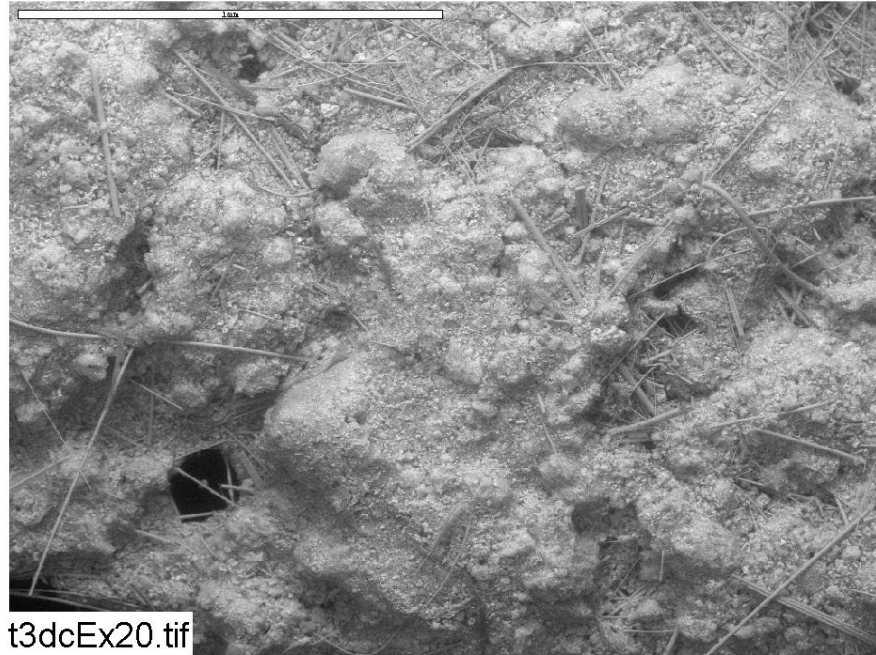
Figure C3-5. ESEM image magnified 70 times for a Test #3, Day-30 exterior fiberglass sample on the drain collar (away from the drain screen). (t3dcEx20)

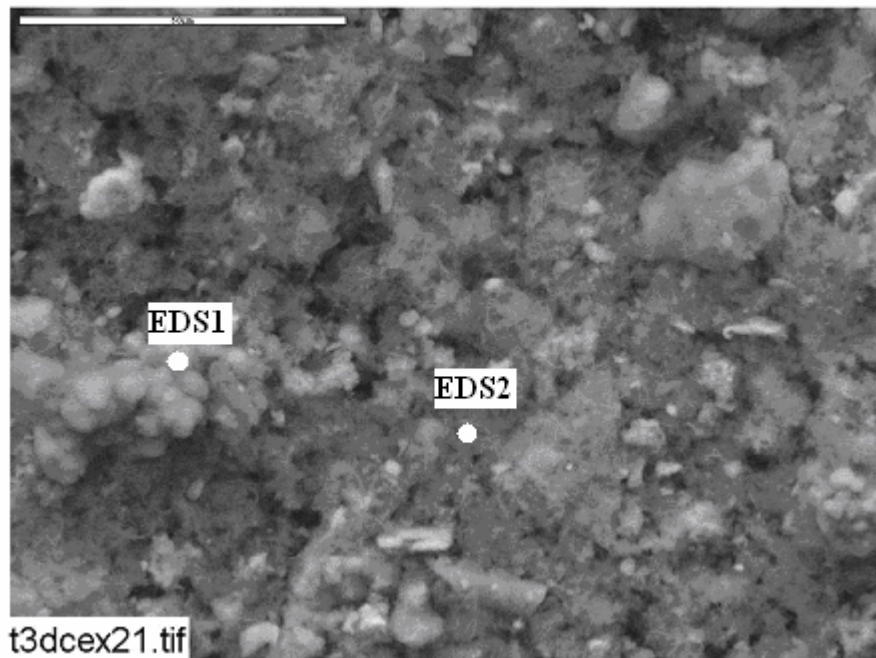
Figure C3-6. ESEM image magnified 1000 times for a Test #3, Day-30 exterior fiberglass sample on the drain collar (away from the drain screen). (t3dcex21)

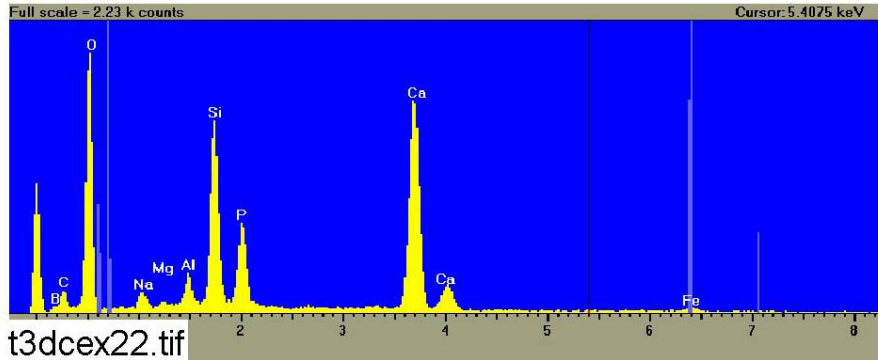
Figure C3-7. EDS counting spectrum for the light particulate deposits (EDS1) shown in Figure C3-6. (t3dcex22)

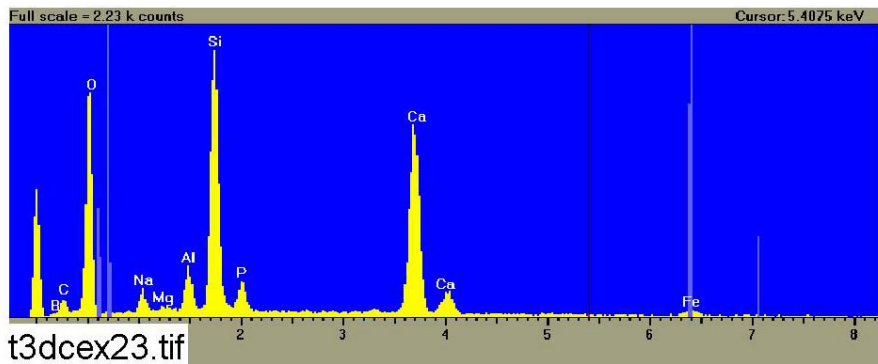
Figure C3-8. EDS counting spectrum for the dark deposits (EDS2) shown in Figure C3-6. (t3dcex23)

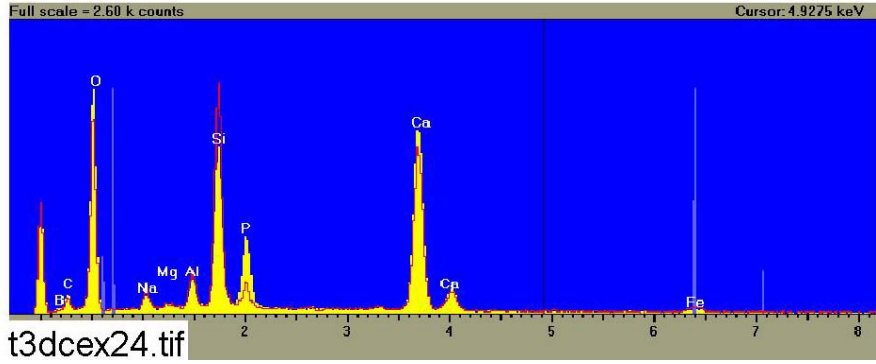
Figure C3-9. Comparison of EDS counting spectra between Figure C3-7 (yellow) and Figure C3-8 (red). (t3dcex24)

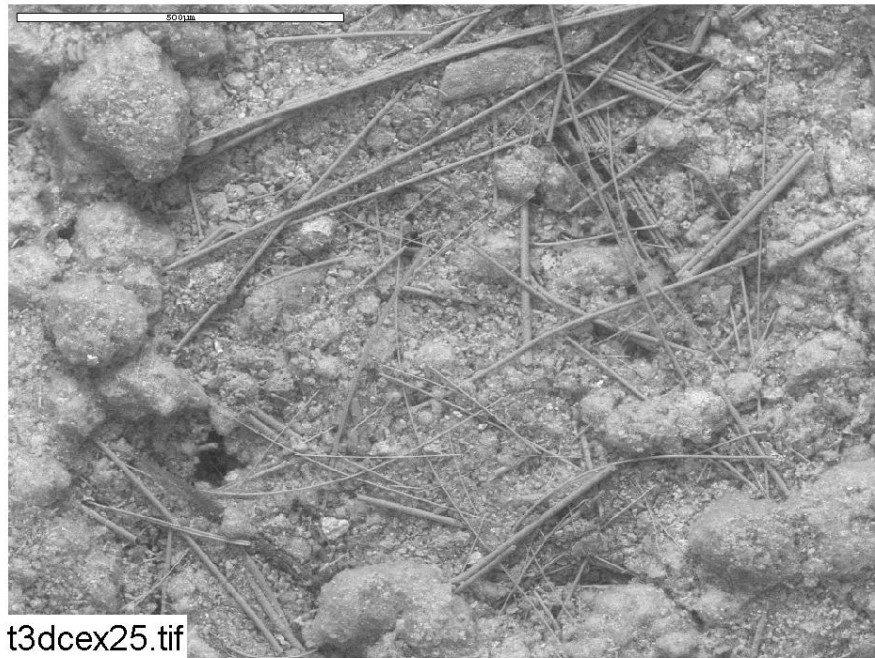
Figure C3-10. ESEM image magnified 100 times for a Test #3, Day-30 exterior fiberglass sample on the drain collar (away from the drain screen). (t3dcex25)

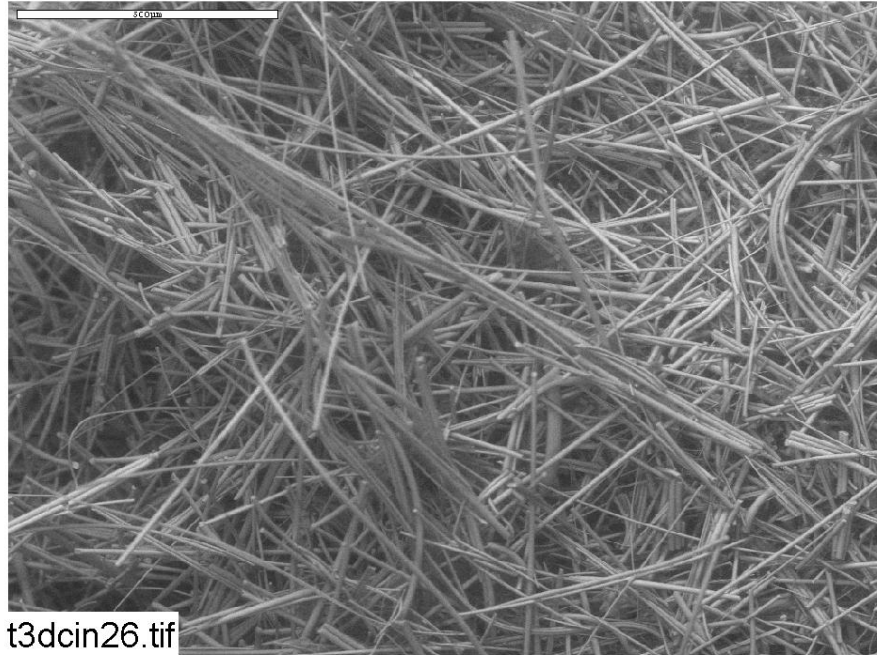
Figure C3-11. ESEM image magnified 80 times for a Test #3, Day-30 interior fiberglass sample on the drain collar. (t3dcin26)

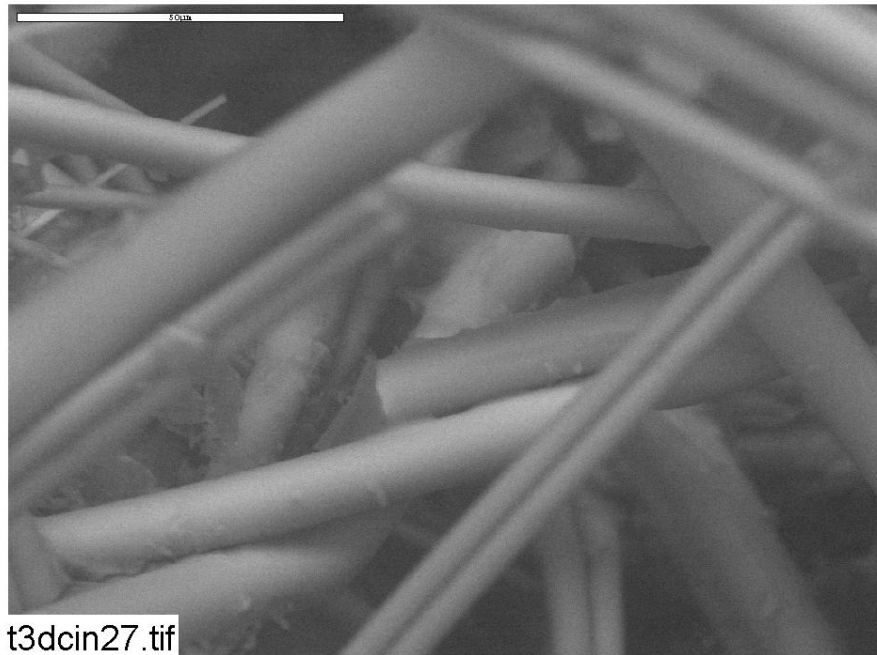
Figure C3-12. ESEM image magnified 1000 times for a Test #3, Day-30 interior fiberglass sample on the drain collar. (t3dcin27)

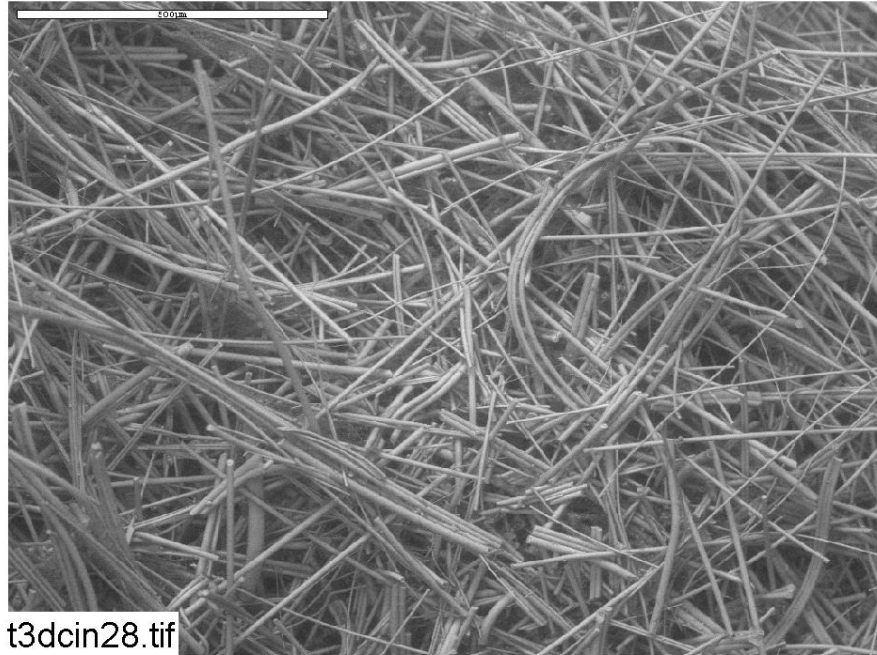
Figure C3-13. ESEM image magnified 100 times for a Test #3, Day-30 interior fiberglass sample on the drain collar. (t3dcin28)

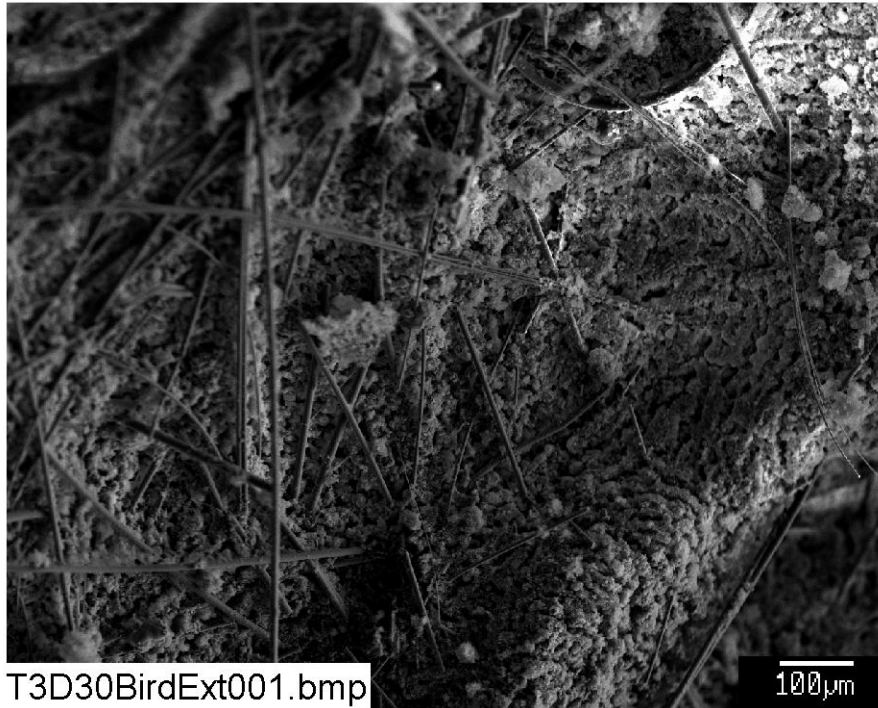
Figure C4-1. SEM image magnified 100 times for a Test #3, Day-30 exterior fiberglass sample within a birdcage. (T3D30BirdExt001)

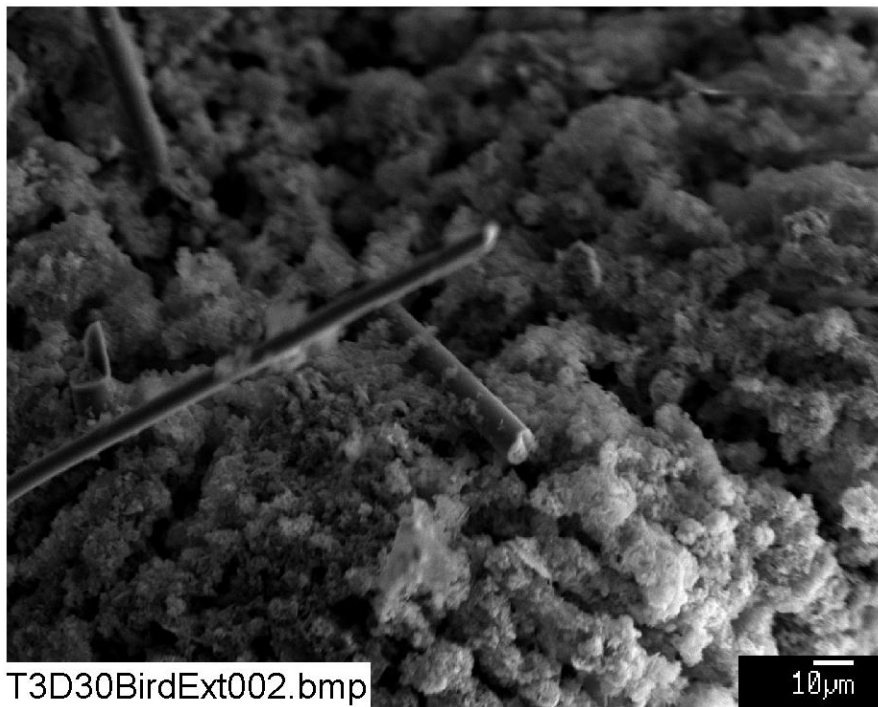
Figure C4-2. SEM image magnified 550 times for a Test #3, Day-30 exterior fiberglass sample within a birdcage. (T3D30BirdExt002)

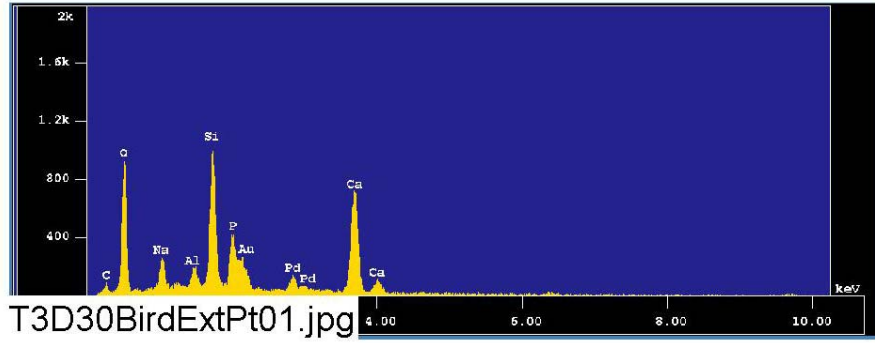
Figure C4-3. EDS counting spectrum for the large masses of particulate deposits shown in Figure C4-2. (T3D30BirdExtPt01)

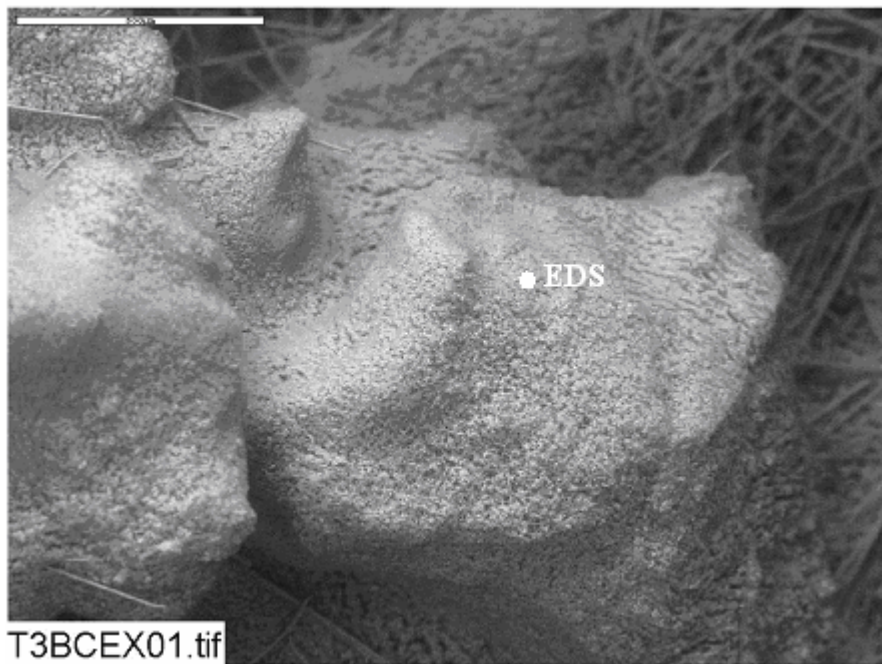
Figure C4-4. ESEM image magnified 80 times for a Test #3, Day-30 exterior fiberglass sample within a birdcage. (T3BCEX01)

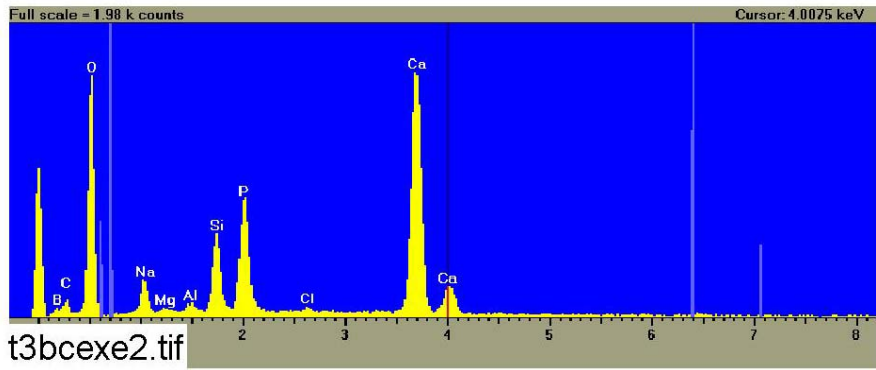
Figure C4-5. EDS counting spectrum for the the large deposits shown in Figure C4-4. (t3bcexe2)

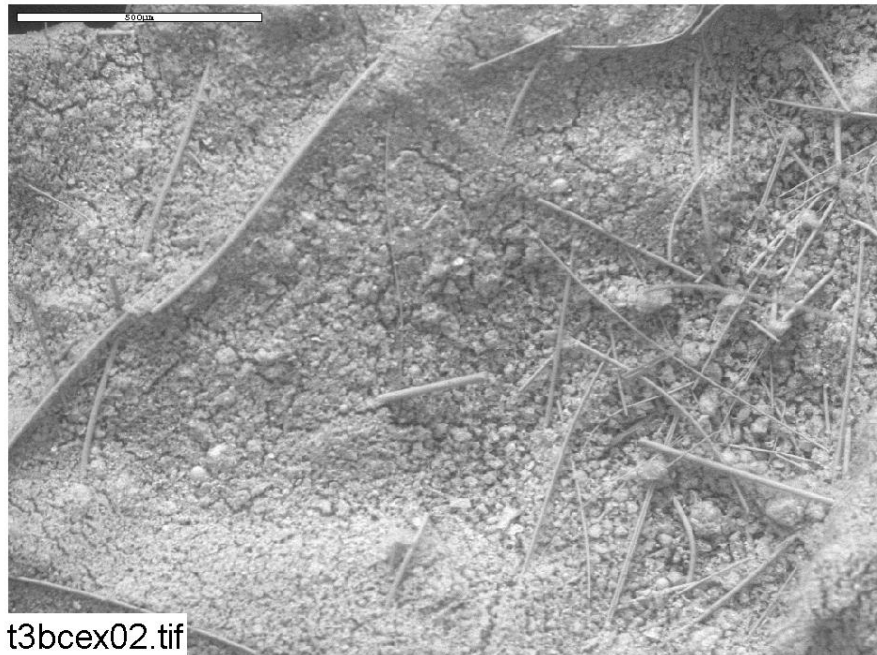
Figure C4-6. ESEM image magnified 80 times for a Test #3, Day-30 exterior fiberglass sample within a birdcage. (t3bcex02)

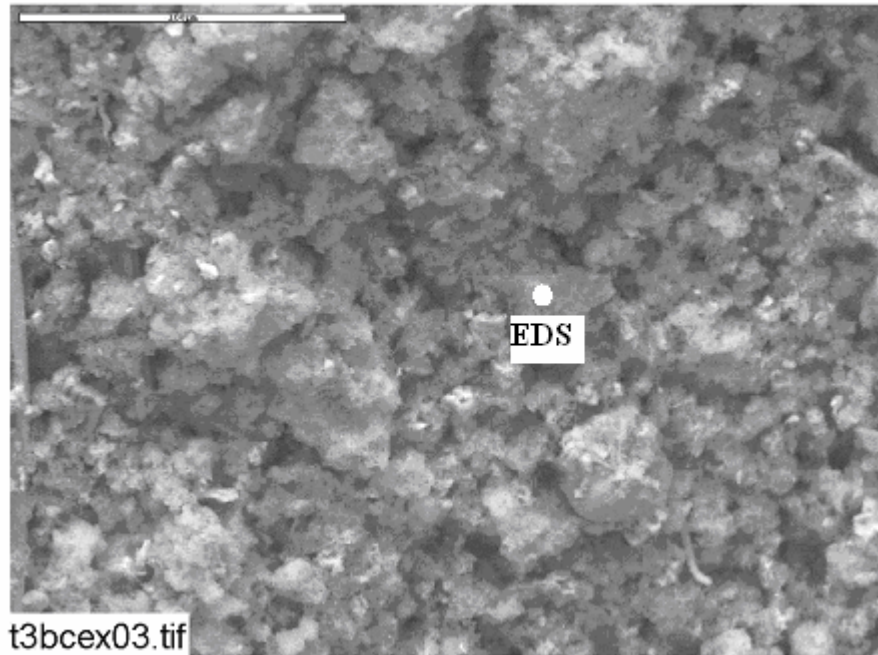
Figure C4-7. ESEM image magnified 500 times for a Test #3, Day-30 exterior fiberglass sample within a birdcage. (t3bcex03)

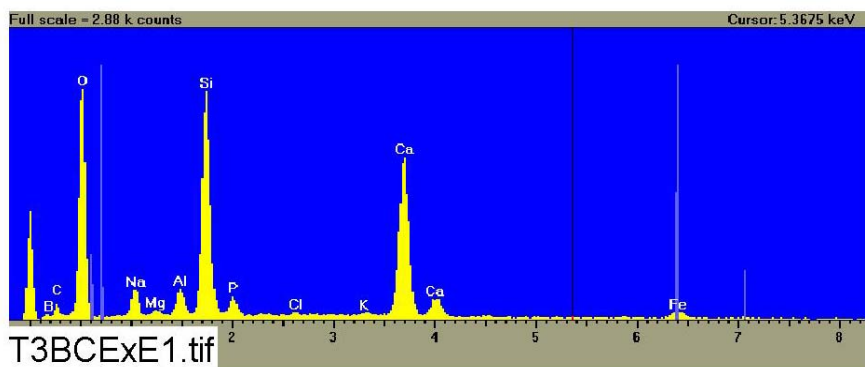
Figure C4-8. EDS counting spectrum for the deposits shown in Figure C4-7. (T3BCExE1)

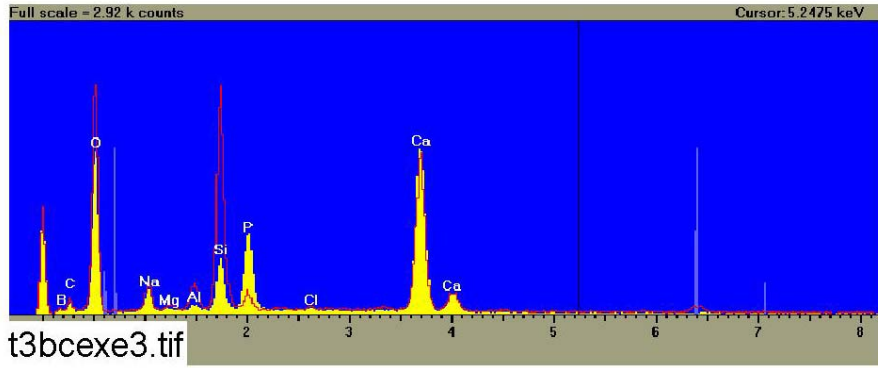
Figure C4-9. Comparison of EDS counting spectra of Figure C4-5 (yellow) and Figure C4-8 (red). (t3bcexe3)

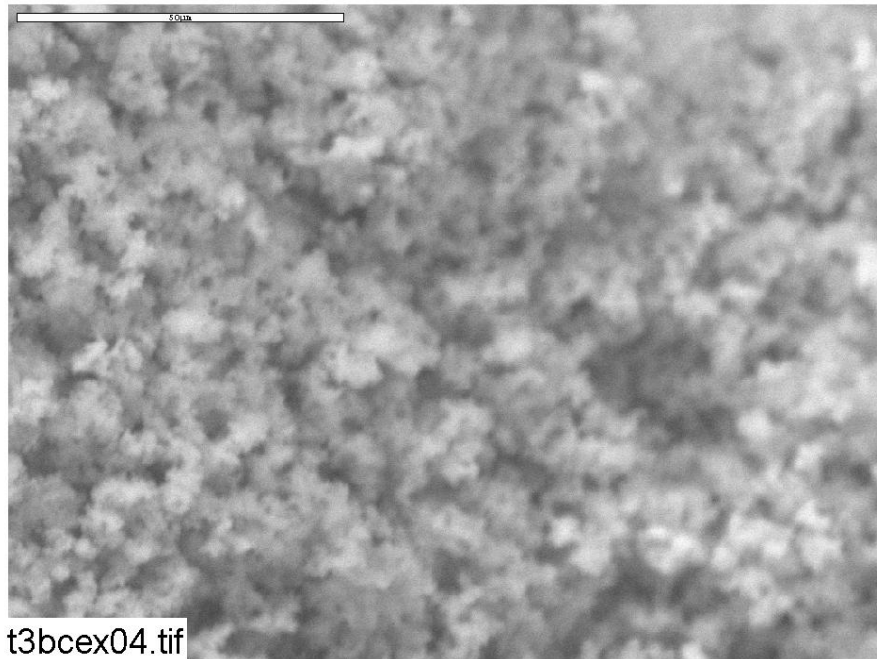
Figure C4-10. ESEM image magnified 1000 times for a Test #3, Day-30 exterior fiberglass sample within a birdcage. (t3bcex04)

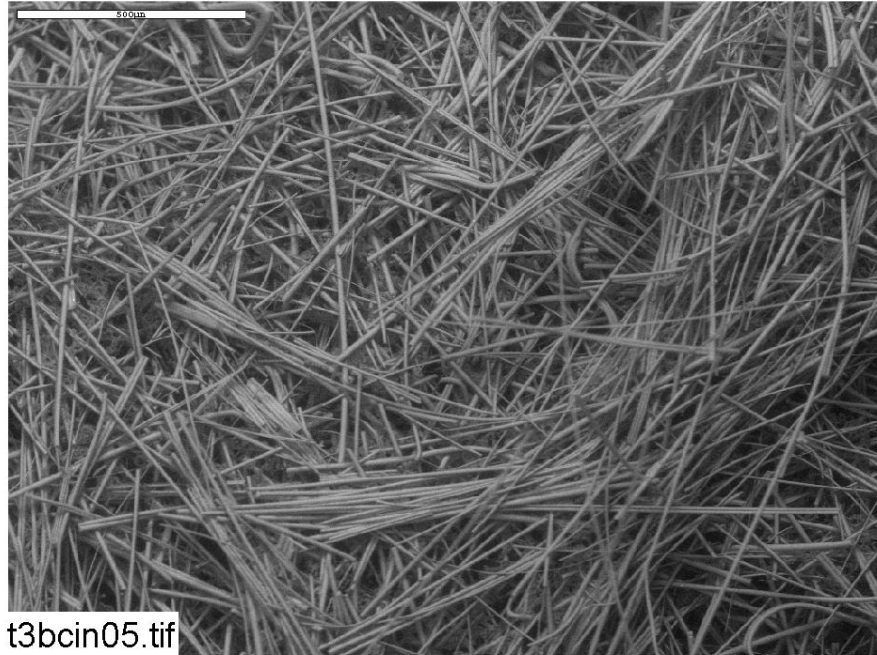
Figure C4-11. ESEM image magnified 80 times for a Test #3, Day-30 interior fiberglass sample within a birdcage. (t3bcin05)

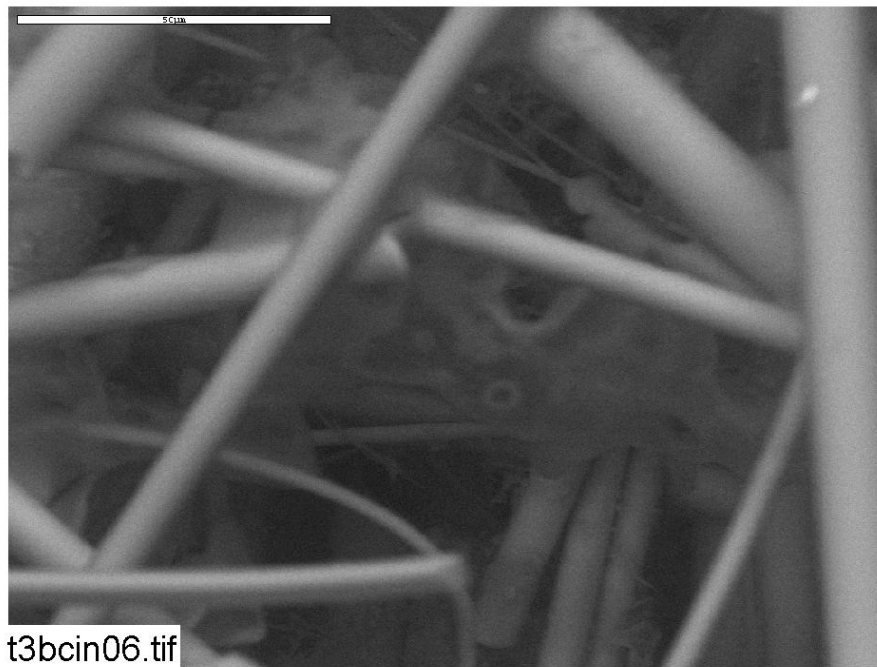
Figure C4-12. ESEM image magnified 950 times for a Test #3, Day-30 interior fiberglass sample within a birdcage. (t3bcin06)

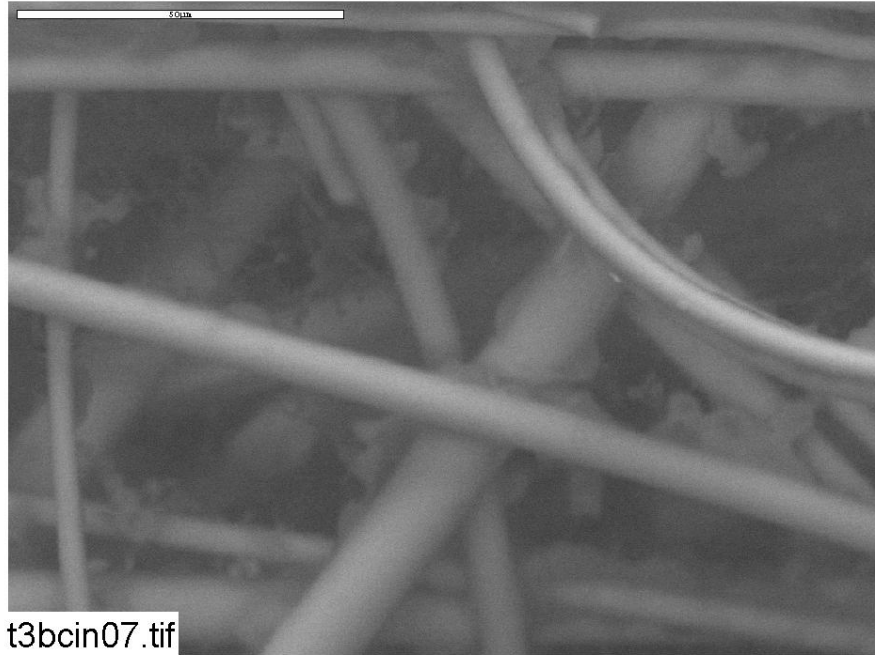
Figure C4-13. ESEM image magnified 1000 times for a Test #3, Day-30 interior fiberglass sample within a birdcage. (t3bcin07)
