Appendix D

ESEM and SEM/EDS Data for Test #3, Day-30 Corrosion Products

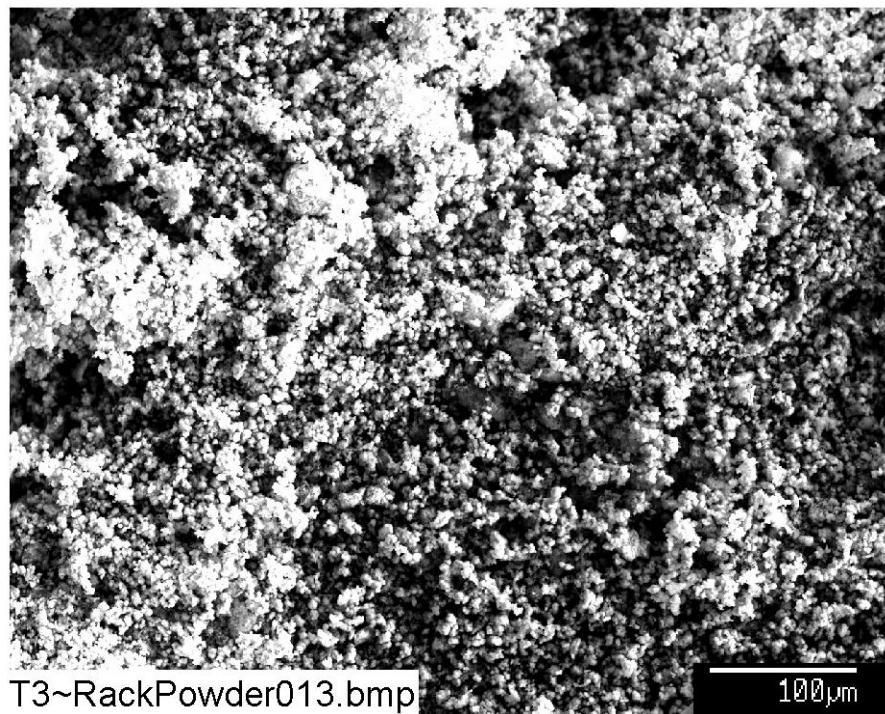
Figure D-1. SEM image magnified 200 times for a Test #3, Day-30 powder on the submerged rack. (T3~RackPowder013)

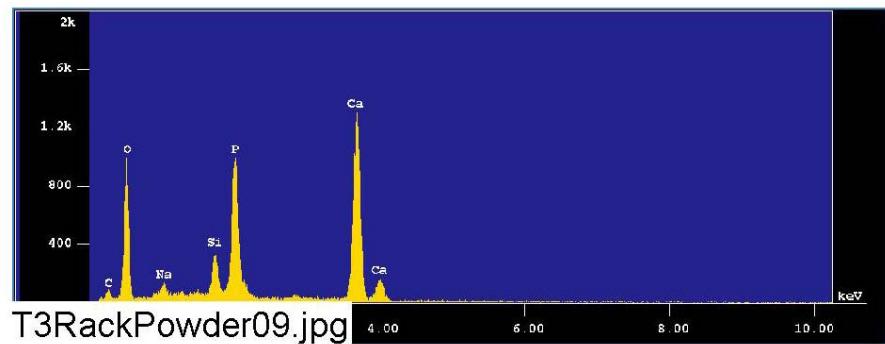
Figure D-2. EDS counting spectrum for the powder on the submerged rack shown in Figure D-1. (T3RackPowder09)

The results from the chemical composition analysis for T3RackPowder09 are given in Table D-1.

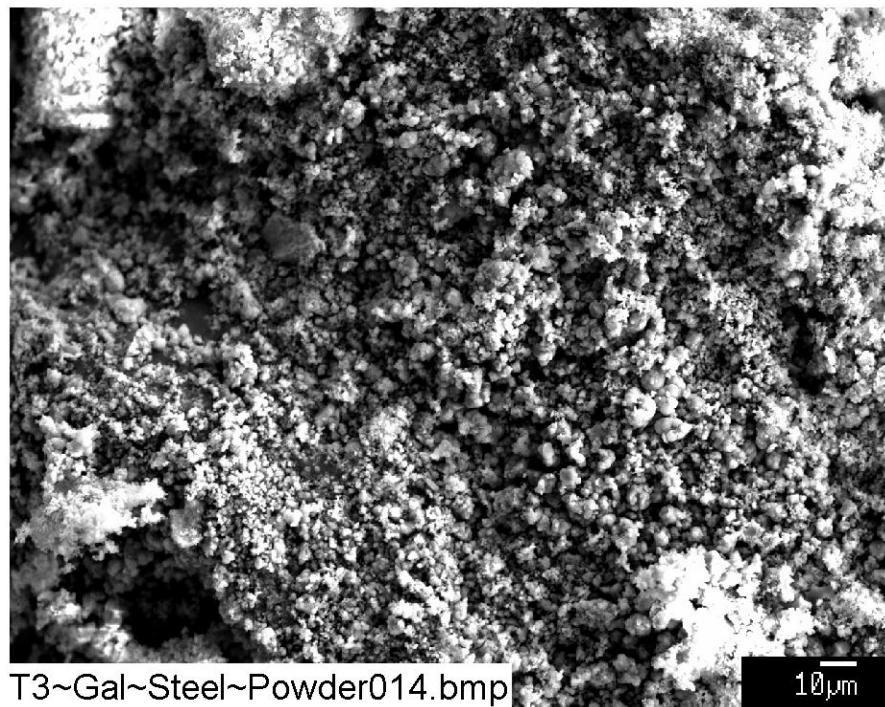
Figure D-3. SEM image magnified 500 times for a Test #3, Day-30 powder on a submerged galvanized steel coupon. (T3~Gal~Steel~Powder014)

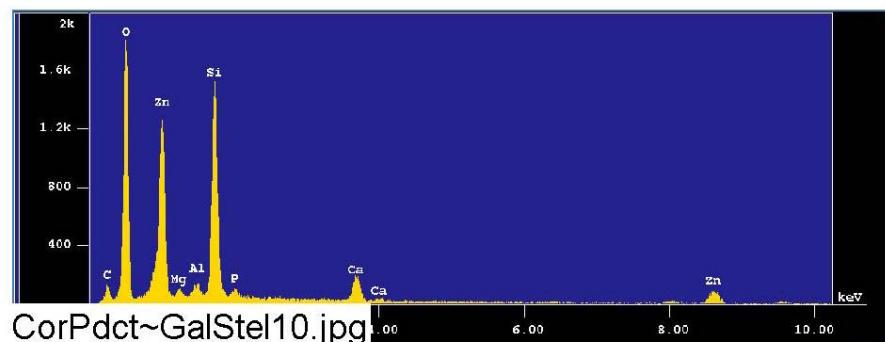
Figure D-4. EDS counting spectrum for the white powder on galvanized steel shown in Figure D-3. (CorPdct~GalStel10)

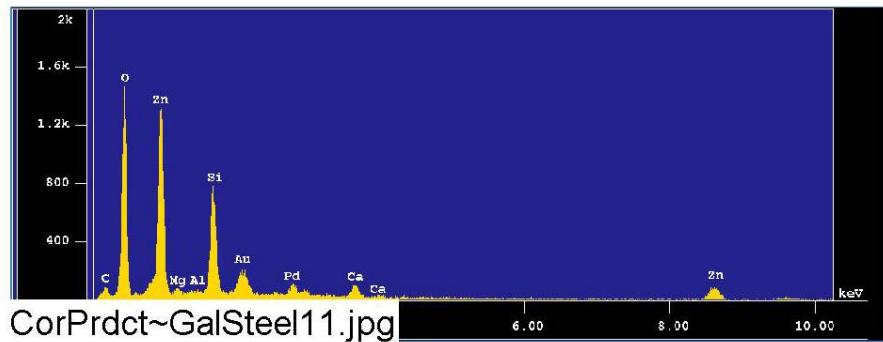
Figure D-5. EDS counting spectrum for the dark powder on galvanized steel shown in Figure D-3. (CorPrdct~GalSteel11)

The results from the chemical composition analysis for CorPrdct~GalSteel11 are given in Table D-2.

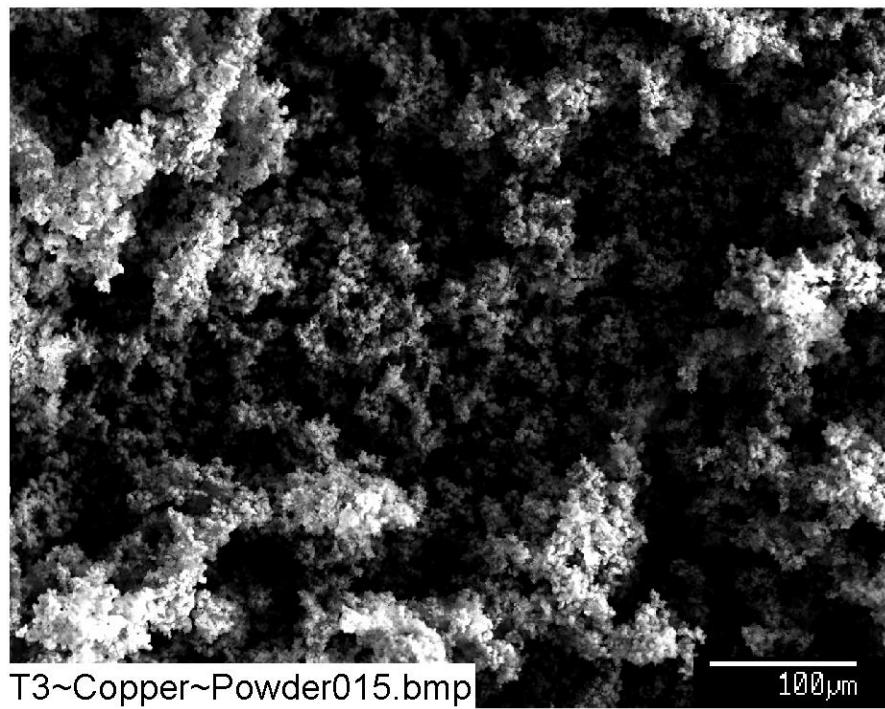
Figure D-6. SEM image magnified 500 times for a Test #3, Day-30 powder on a submerged copper coupon. (T3~Copper~Powder015)

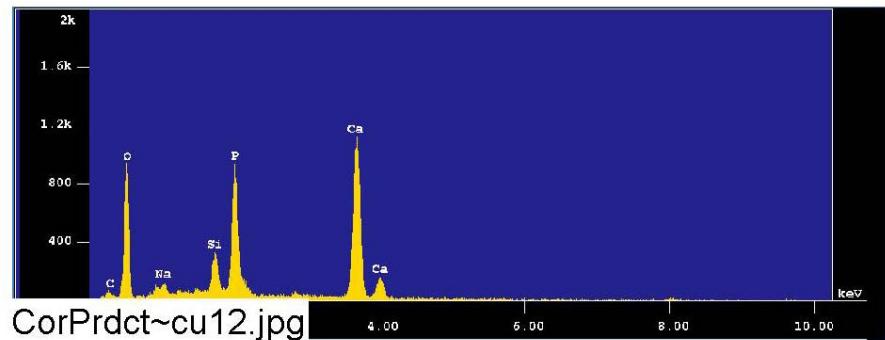
Figure D-7. EDS counting spectrum for the powder on copper shown in Figure D-6. (CorPrdct~cu12)

The results from the chemical composition analysis for CorPrdct~cu12 are given in Table D-3.

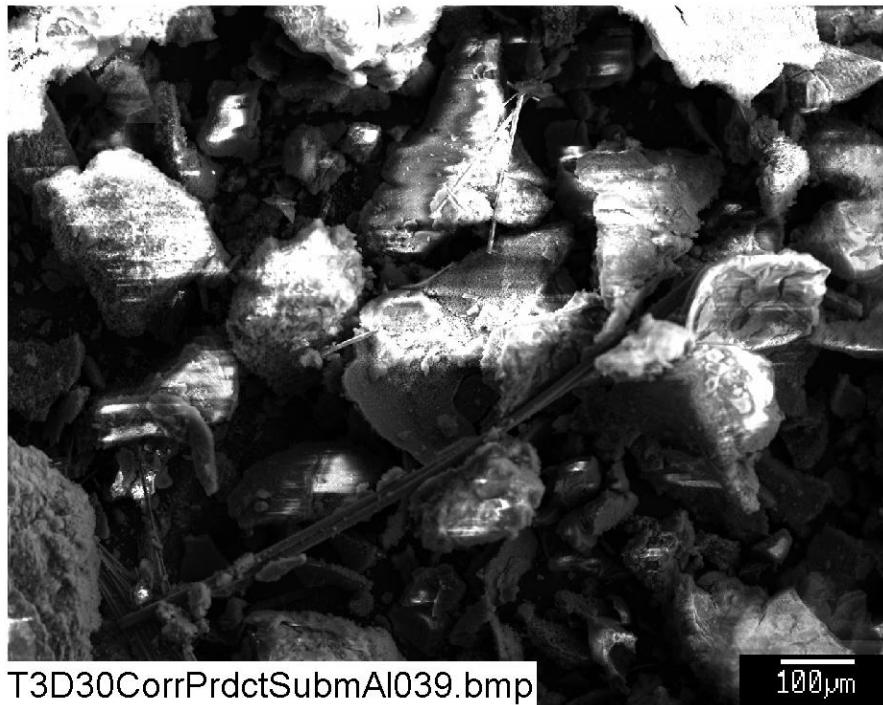
Figure D-8. SEM image magnified 100 times for Test #3, Day-30 corrosion products on a submerged aluminum coupon. (T3D30CorrPrdctSubmAl039)

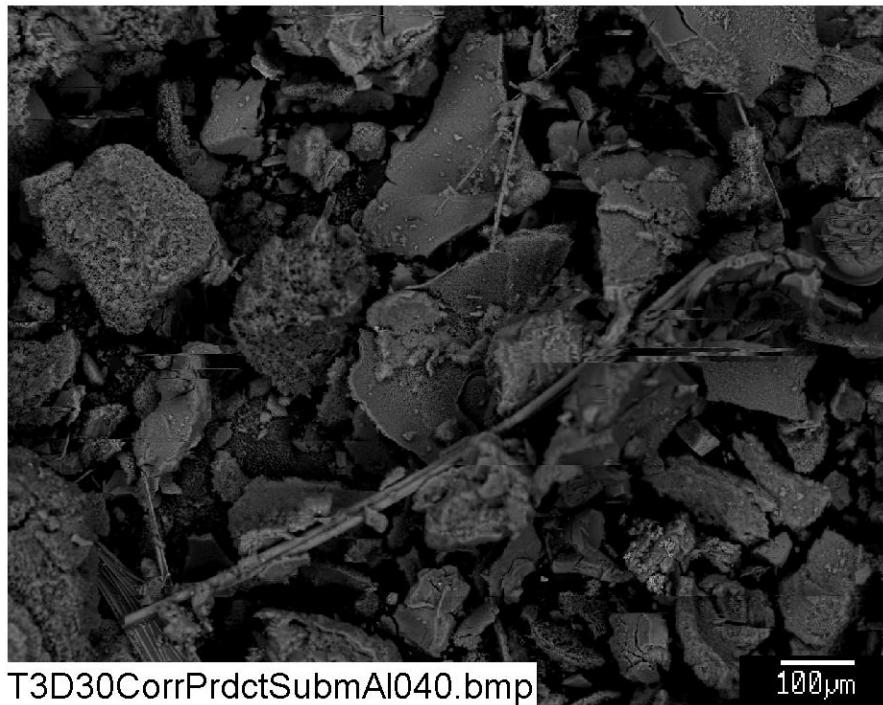
Figure D-9. Backscattered SEM image magnified 100 times for Test #3, Day-30 corrosion products on a submerged aluminum coupon. (T3D30CorrPrdct SubmAl040)

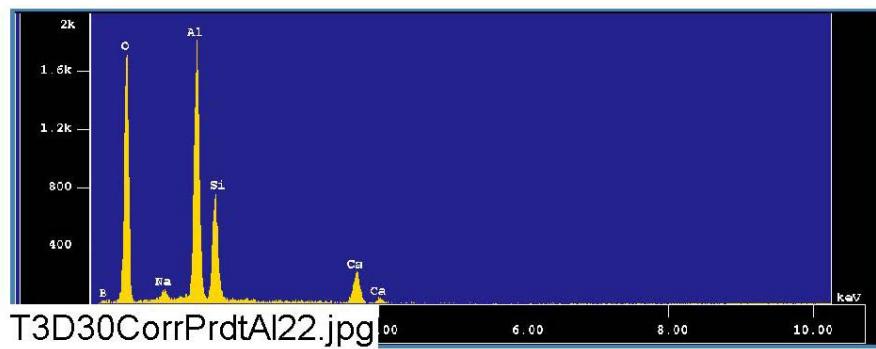
Figure D-10. EDS counting spectrum for the corrosion products (particles) shown in Figure D-9.
(T3D30CorrPrdtAl22)

The results from the chemical composition analysis for T3D30CorrPrdtAl22 are given in Table D-4.

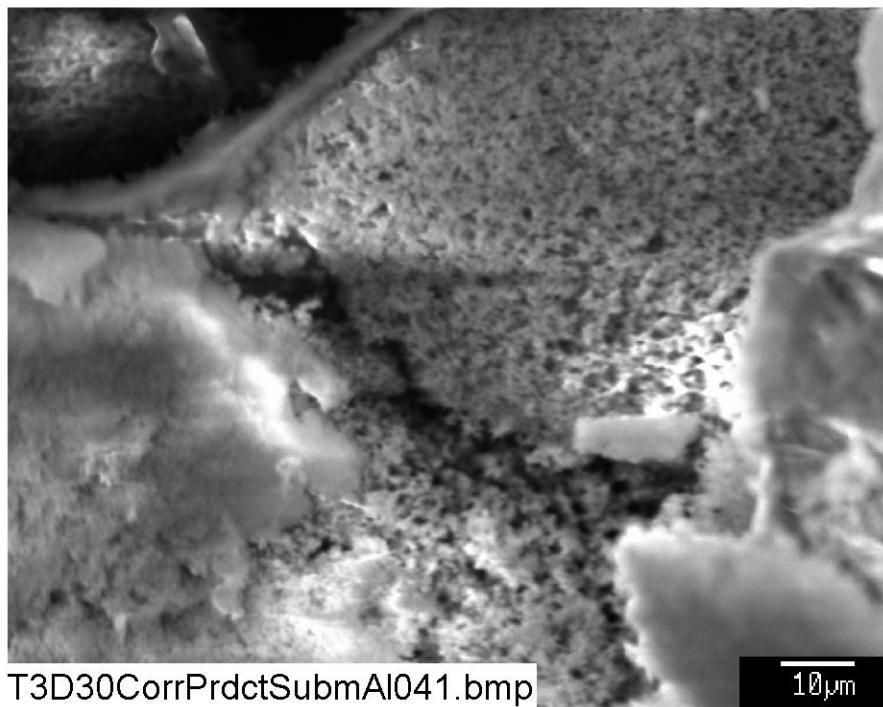
Figure D-11. SEM image magnified 1000 times for Test #3, Day-30 corrosion products on a submerged aluminum coupon. (T3D30CorrPrdctSubmAl041)

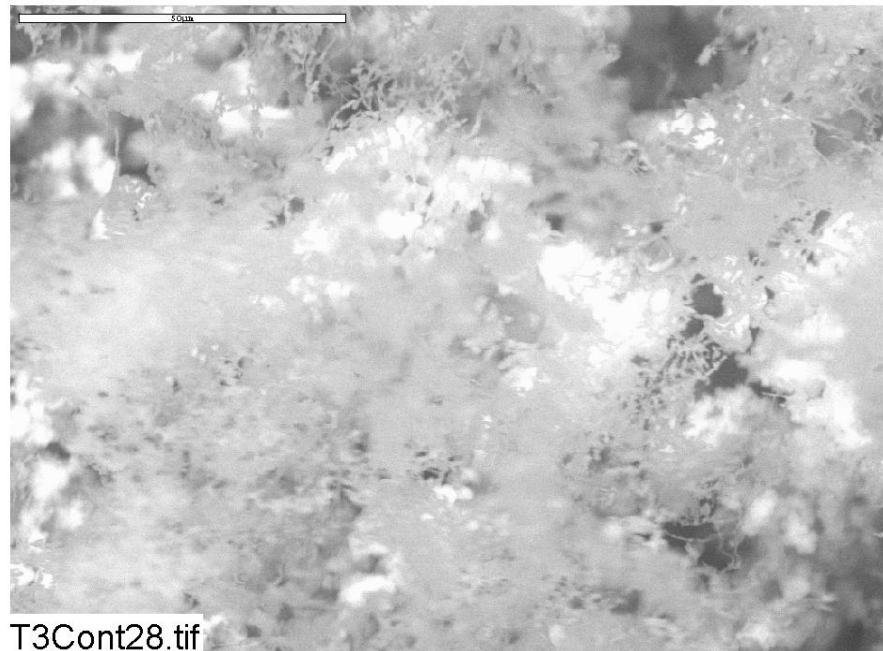
Figure D-12. ESEM image magnified 1000 times for Test #3, Day-30 corrosion products on a submerged concrete coupon. (T3cont28)

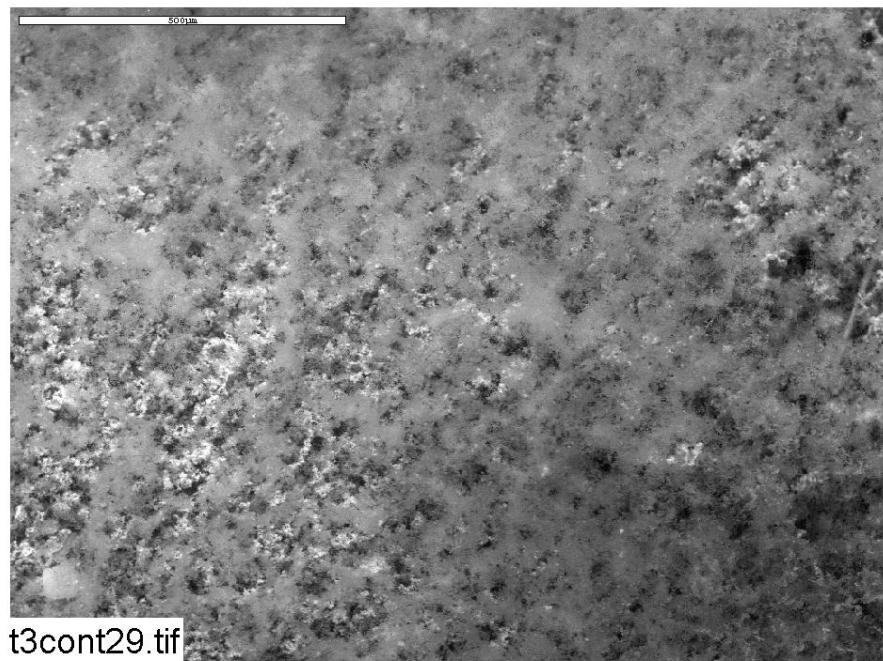
Figure D-13. ESEM image magnified 100 times for Test #3, Day-30 corrosion products on a submerged concrete coupon. (t3cont29)

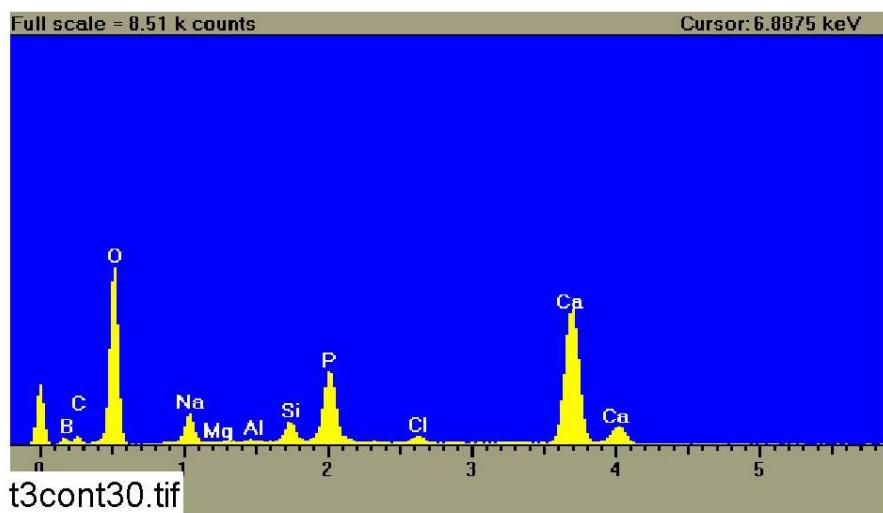
Figure D-14. EDS counting spectrum for the corrosion products (particles) shown in Figure D-13. (t3cont30)
