Appendix D1

ESEM and SEM/EDS Data for Test #2, Day-16 Fiberglass in High- and Low-Flow Zones

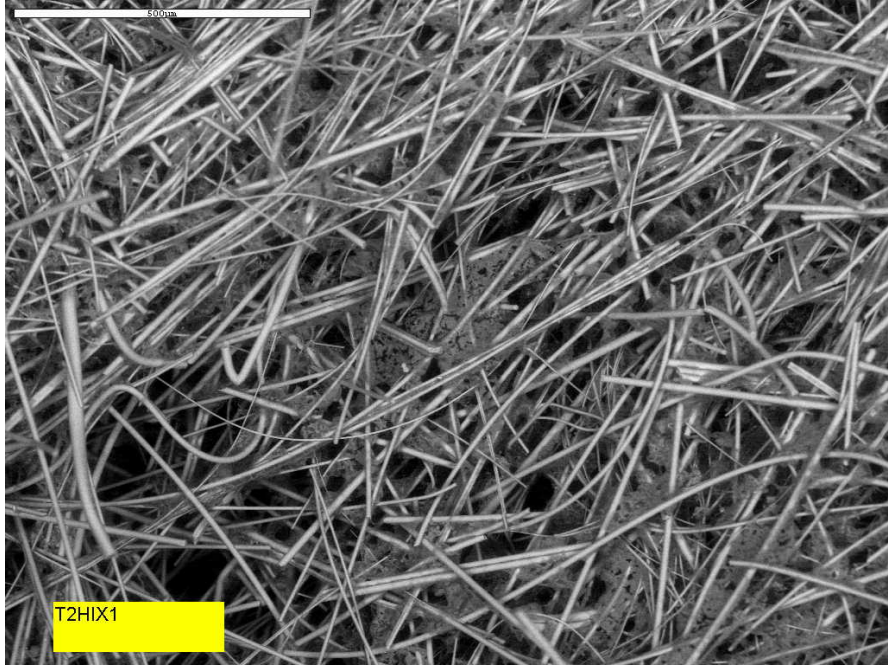
Figure D1-1. Back-scattered electron (BSE) image overview. (T2HIX1)

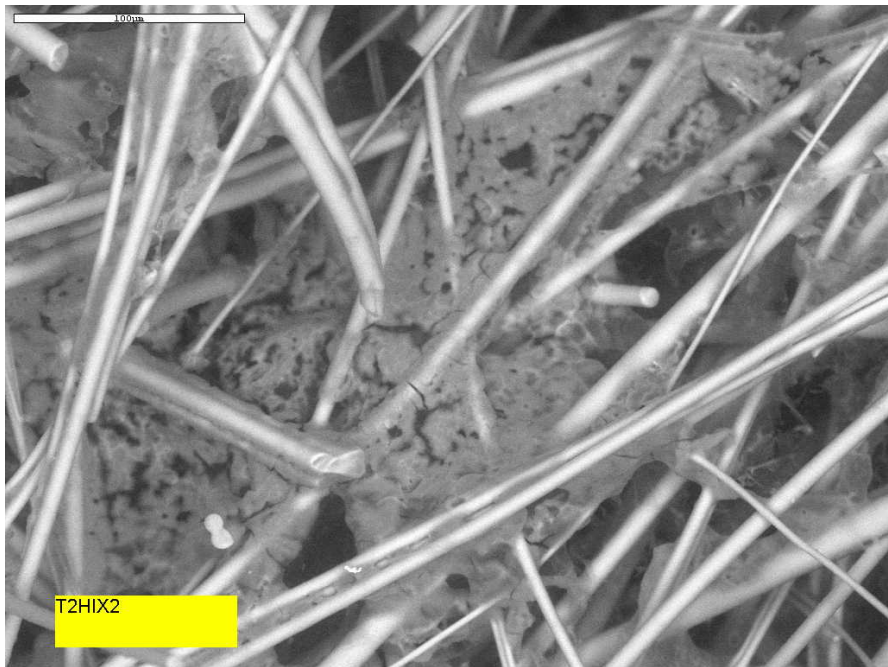
Figure D1-2. BSE image on center of Figure D1-1. (T2HIX2)

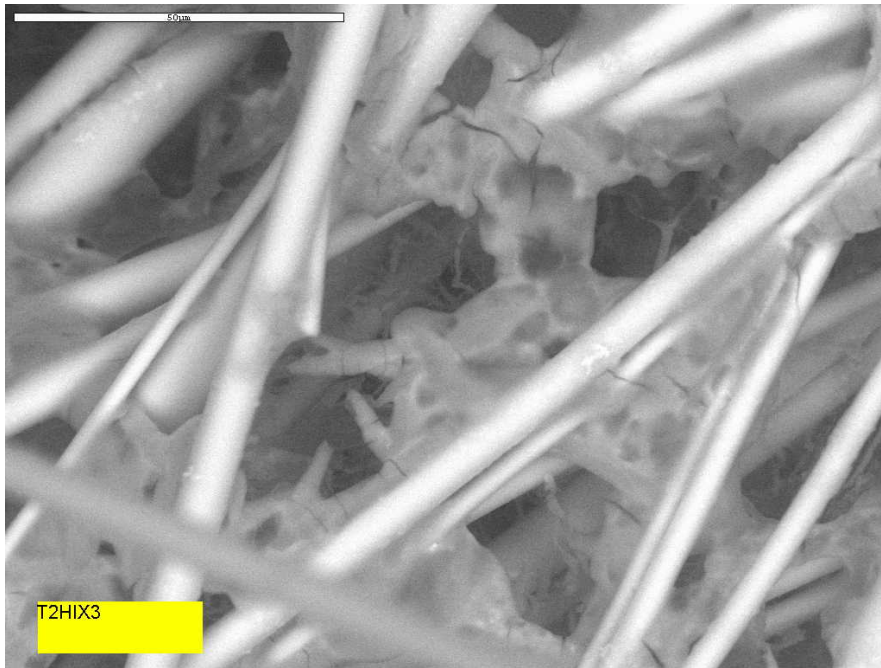
Figure D1-3. BSE image at 1000 times magnification. (T2HIX3)

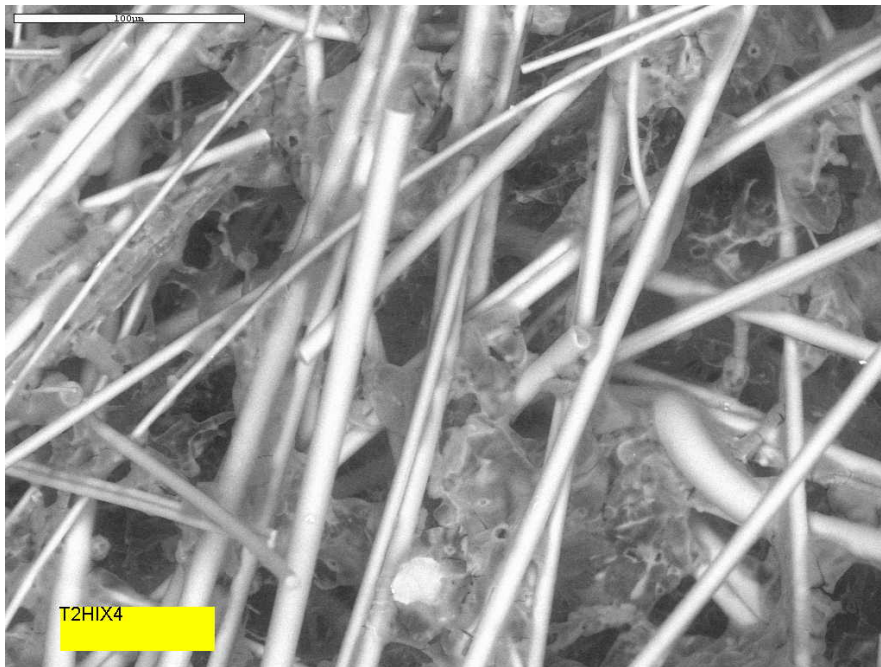
Figure D1-4. BSE image at another angle on the center of the image. (T2HIX4)

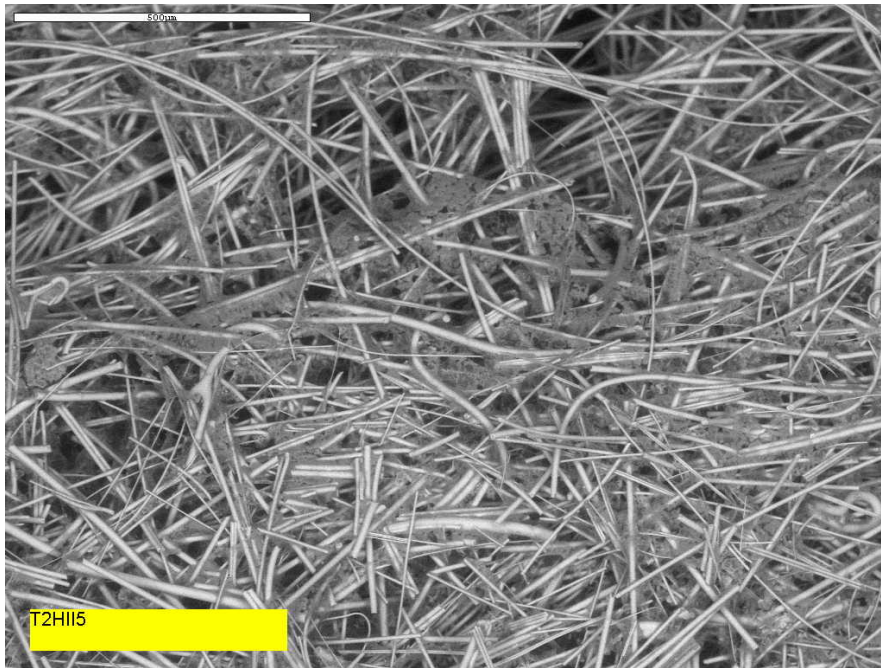
Figure D1-5. SEM image overview for interior of high flow. (T2HII5)

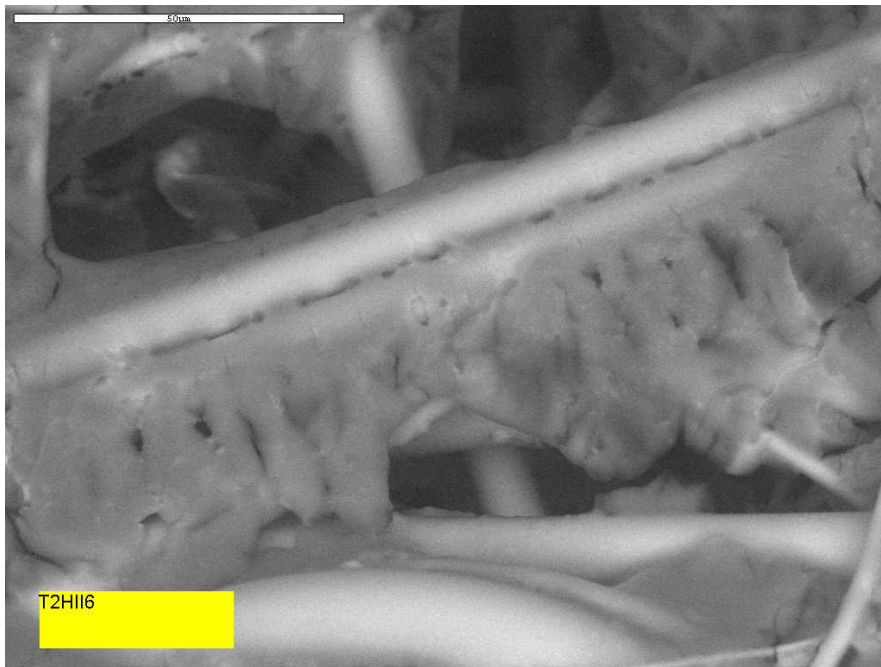
Figure D1-6. SEM image of Figure D1-5 at 1000 times magnification. (T2HII6)

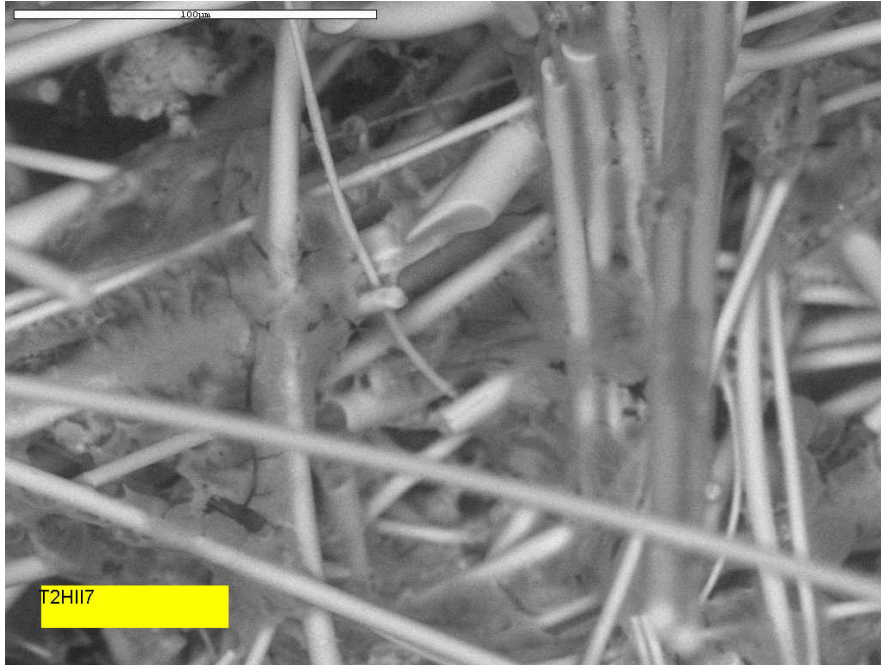
Figure D1-7. SEM image of high-flow interior for another sample area. (T2HII7)

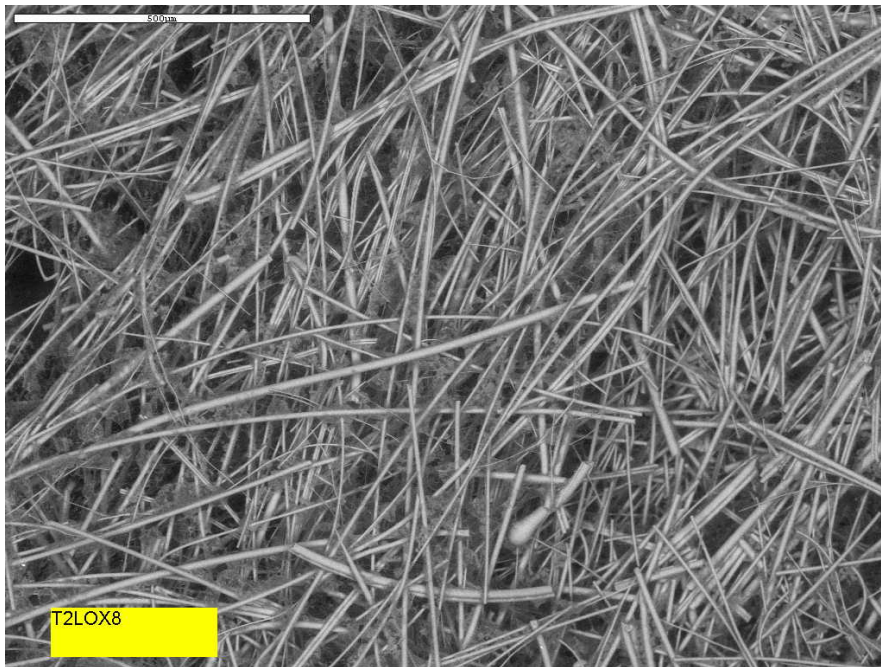
Figure D1-8. SEM image overview for exterior of the low-flow sample. (T2LOX8)

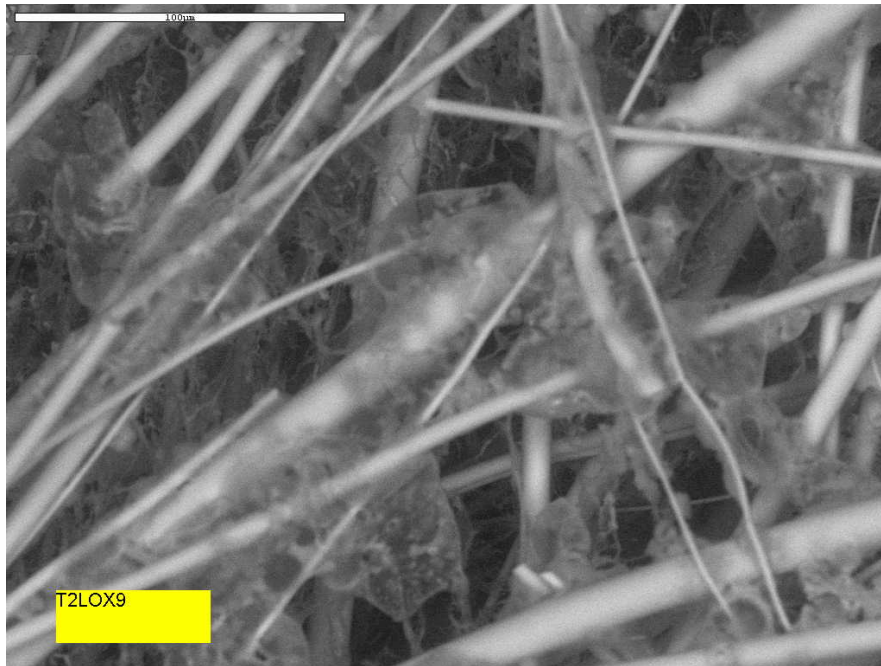
Figure D1-9. SEM image of the upper left portion of Figure D1-8, low-flow exterior. (T2LOX9)

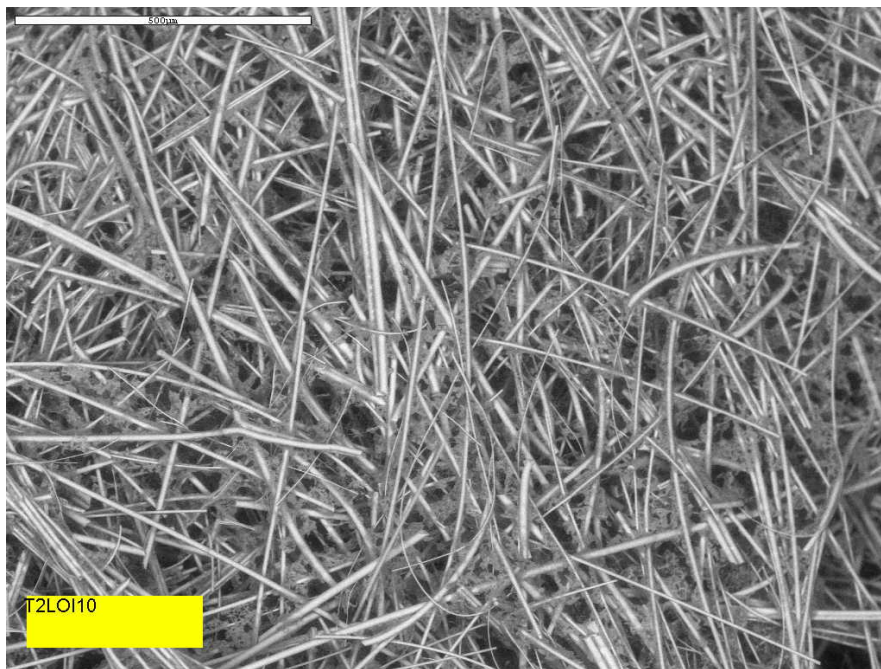
Figure D1-10. SEM image overview for interior of the low-flow sample. (T2LOI10)

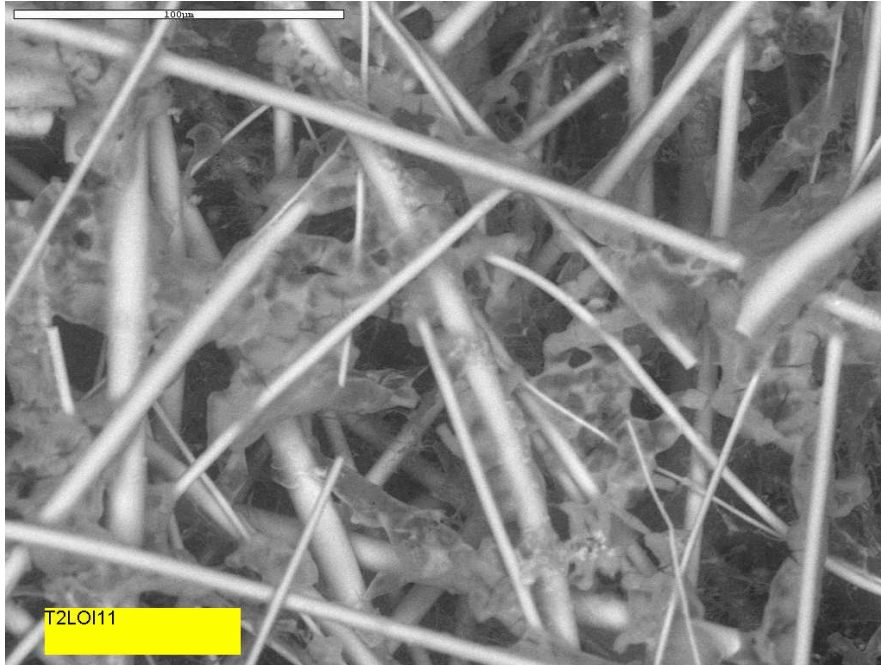
Figure D1-11. SEM image on the center of Figure D1-10, low-flow interior. (T2LOI11)

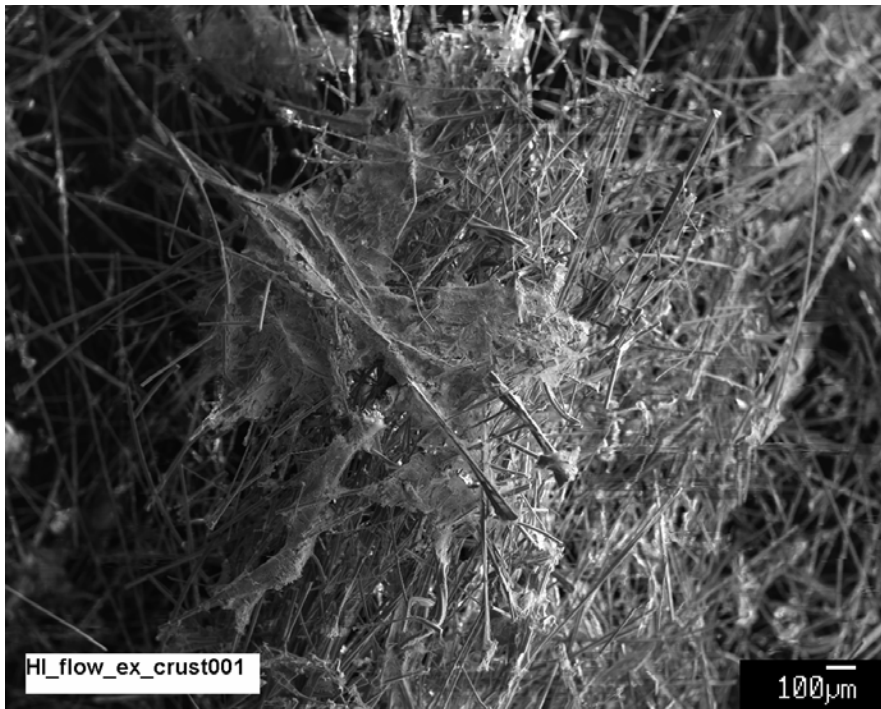
Figure D1-12. SEM image overview of exterior crust. (HI_flow_ex_crust001)

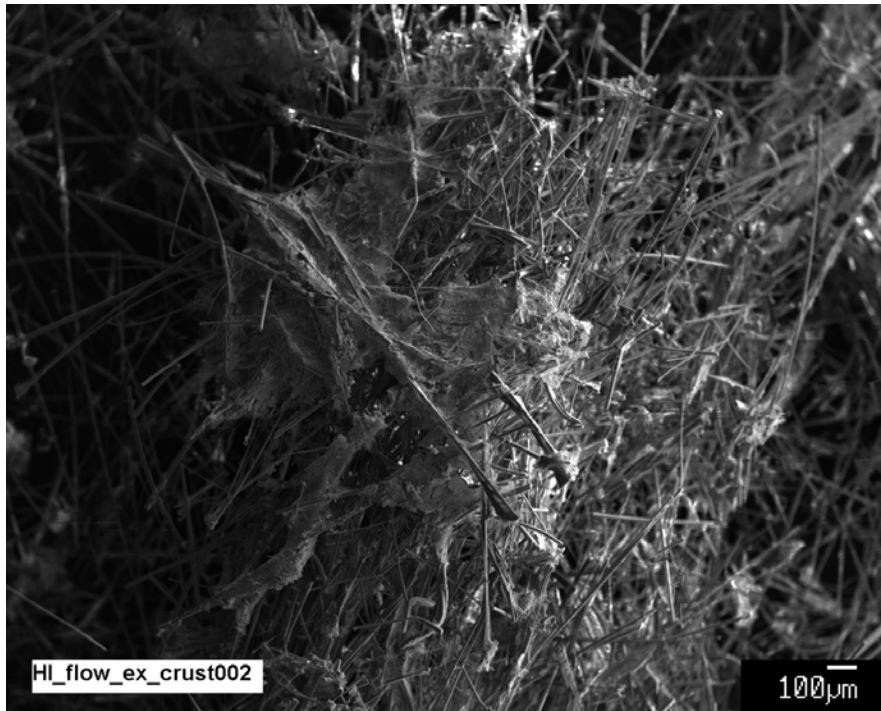
Figure D1-13. SEM image overview of the same area of Figure D1-12. (HI_flow_ex_crust002)

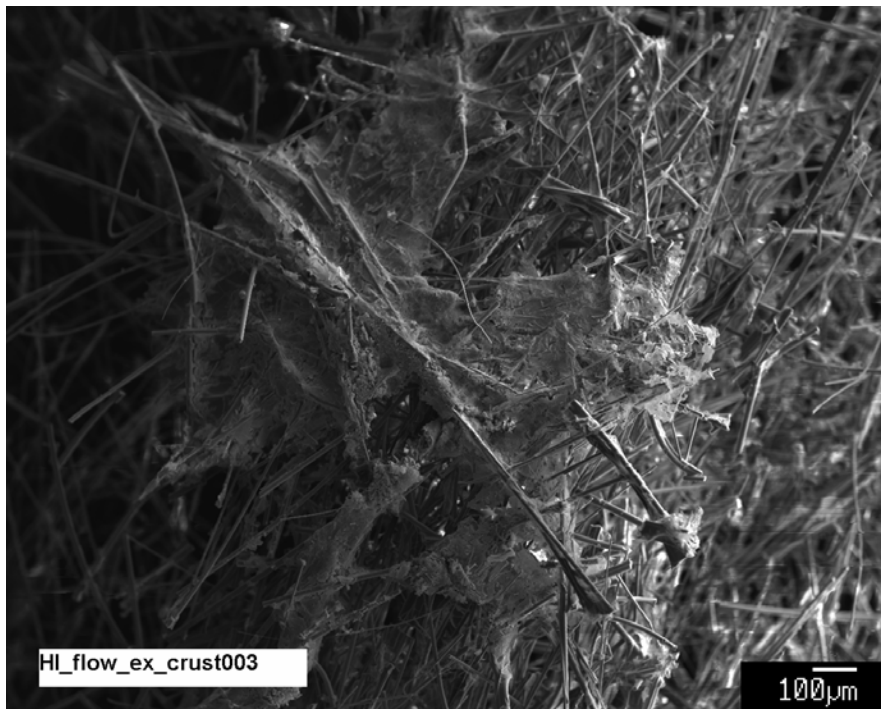
Figure D1-14. SEM image close-up view of crust. (HI_flow_ex_crust003)

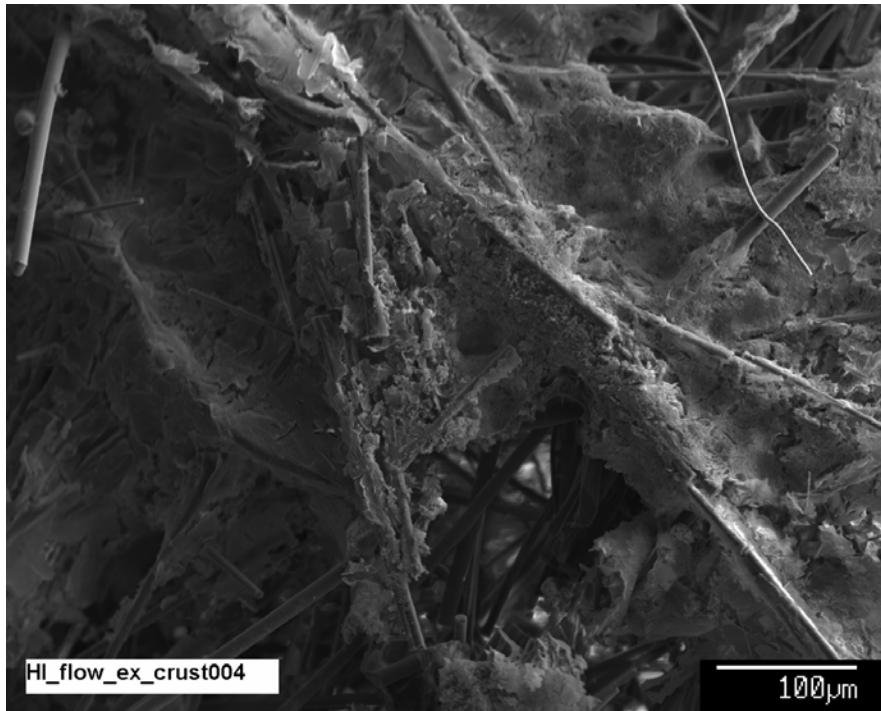
Figure D1-15. SEM image of crust at 150 times magnification. (HI_flow_ex_crust004)

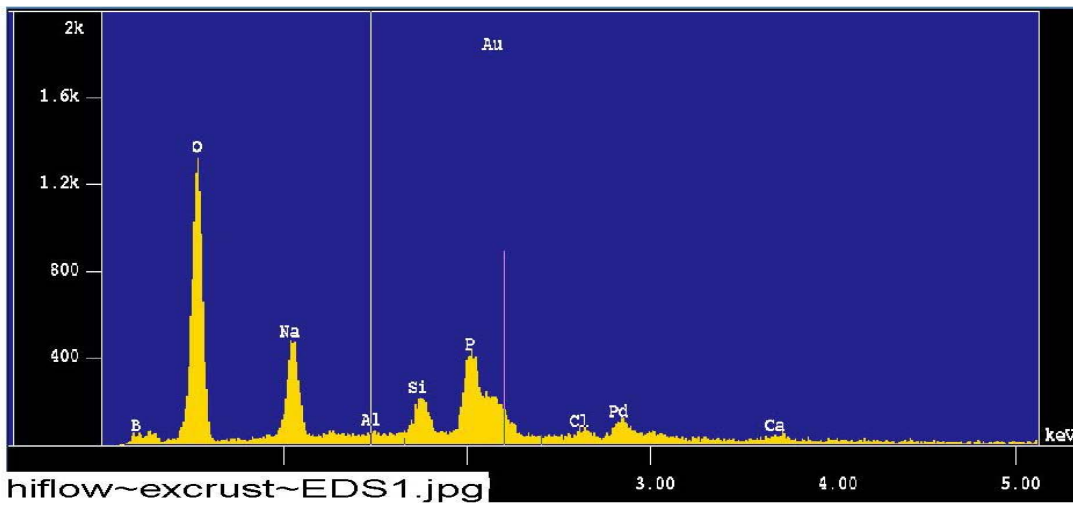
Figure D1-16. Counting spectrum image of the deposit area in Figure D1-15. (hiflow~excrust~EDS1)

The results from the chemical composition analysis for hiflow~excrust~EDS1 are given Table D1-1.

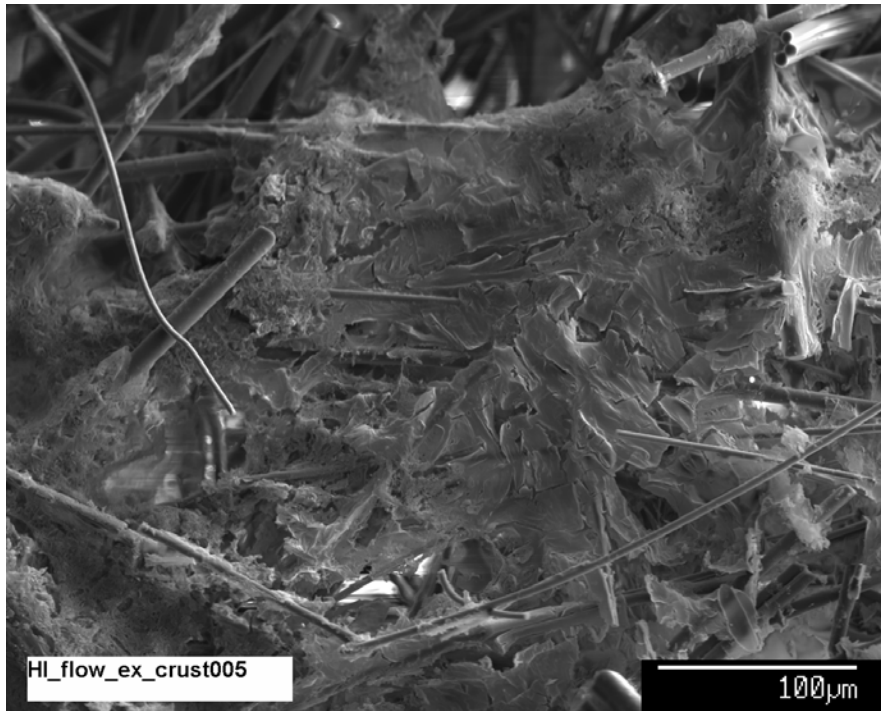
Figure D1-17. SEM image of a new exterior crust area at 270 times magnification. (HI_flow_ex_crust005)

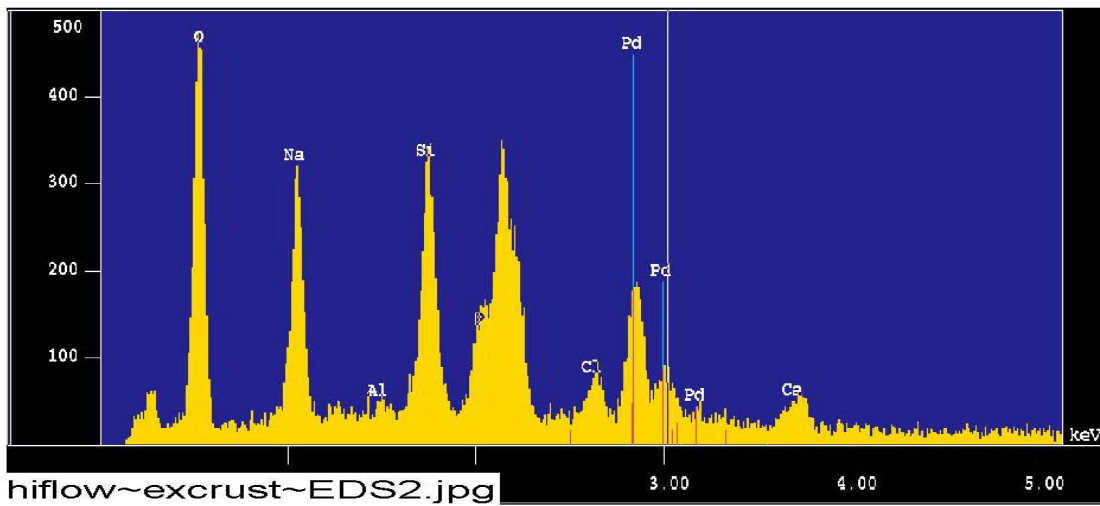
Figure D1-18. Counting spectrum image of the deposit area in Figure D1-17. (hiflow~excrust~EDS2)

The results from the chemical composition analysis for hiflow~excrust~EDS2 are given in Table D1-2.

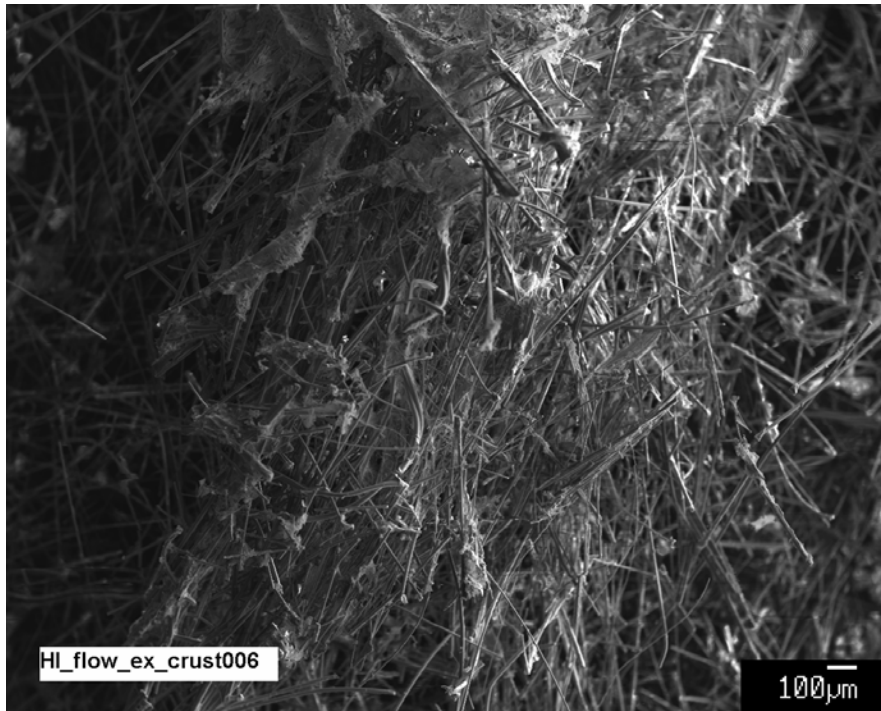
Figure D1-19. SEM image overview of another area for the exterior crust. (HI_flow_ex_crust006)

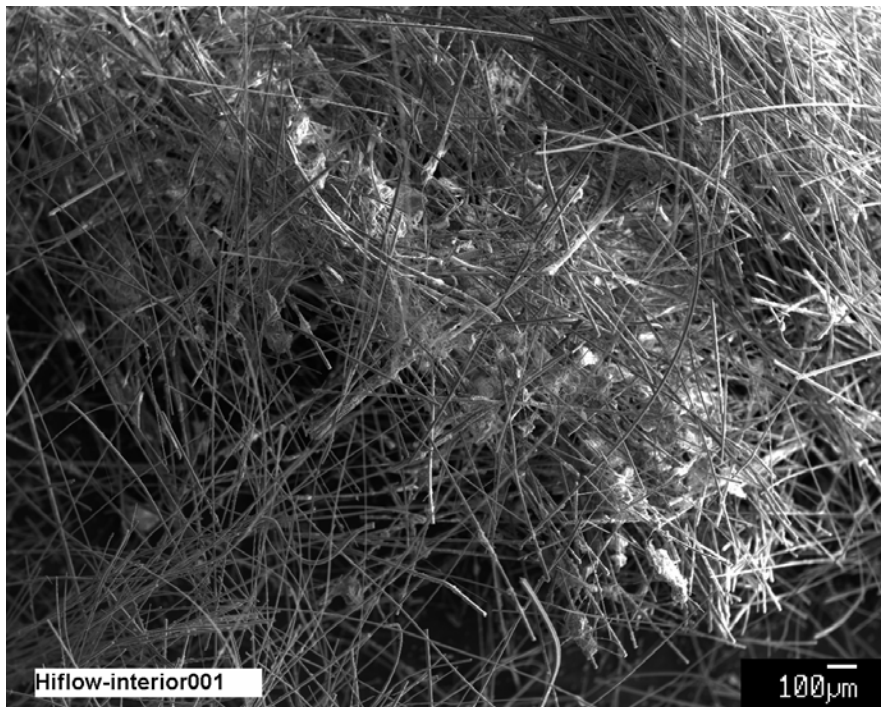
Figure D1-20. Test #2, Day-16 SEM image overview. (Hiflow-interior001)

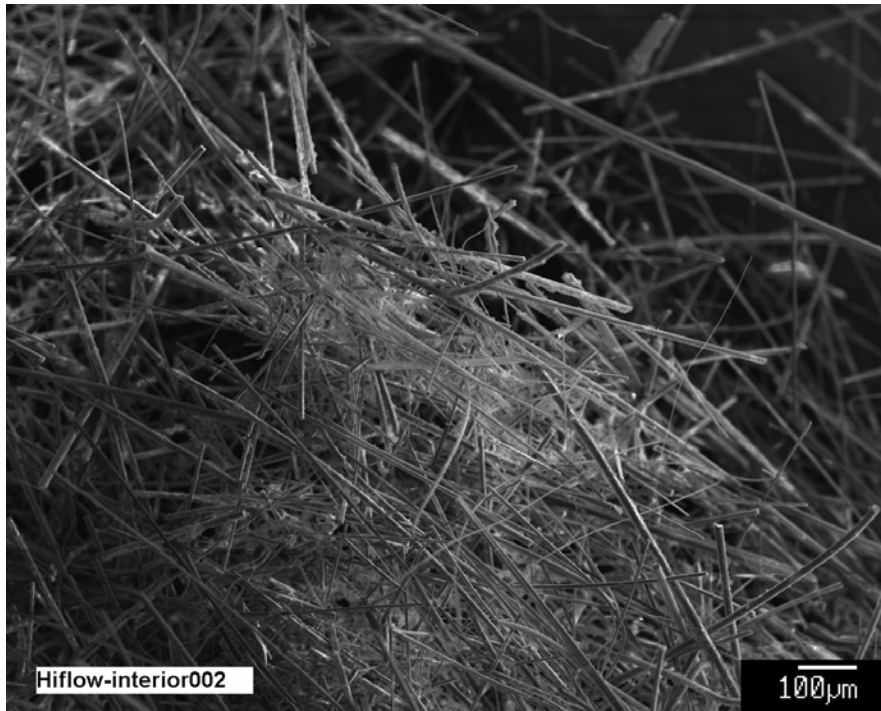
Figure D1-21. Test #2, Day-16 SEM image for high-flow interior. (Hiflow-interior002)

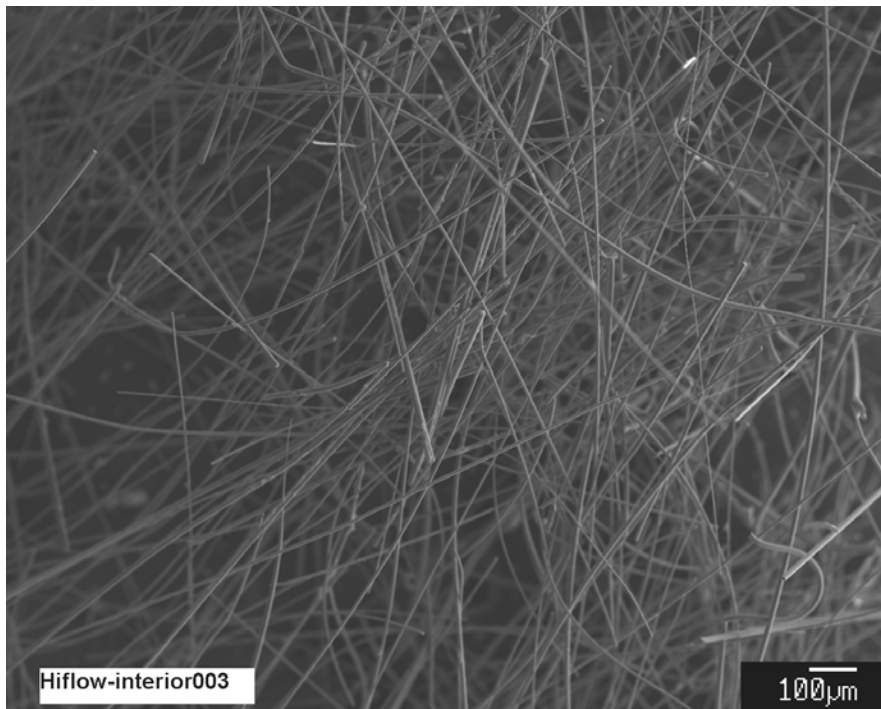
Figure D1-22. Test #2, Day-16 SEM image showing clean fibers. (Hiflow-interior003)

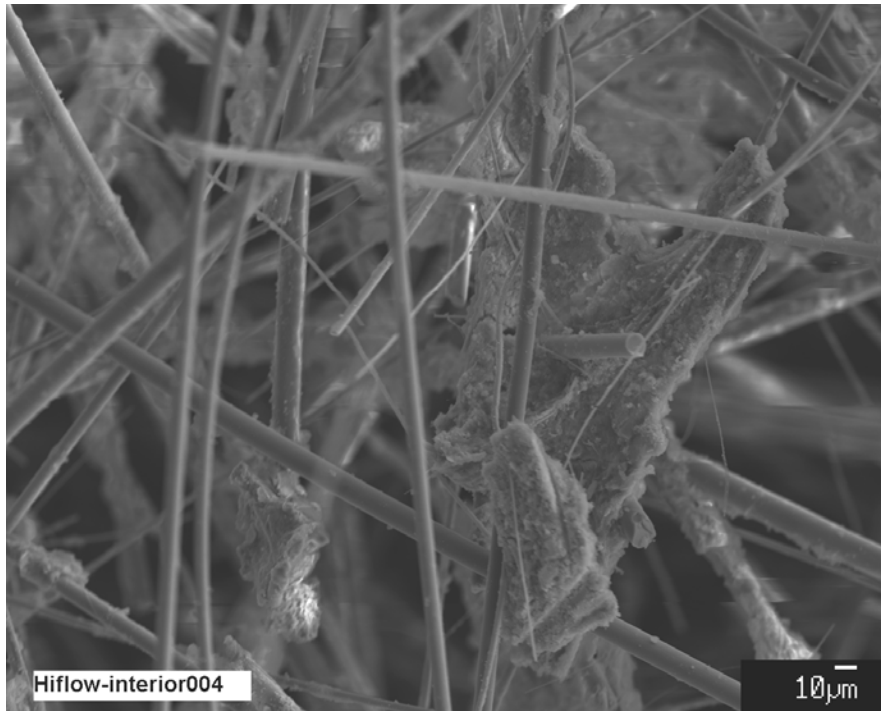
Figure D1-23. Test #2, Day-16 SEM image of deposits for high-flow interior. (Hiflow-interior004)

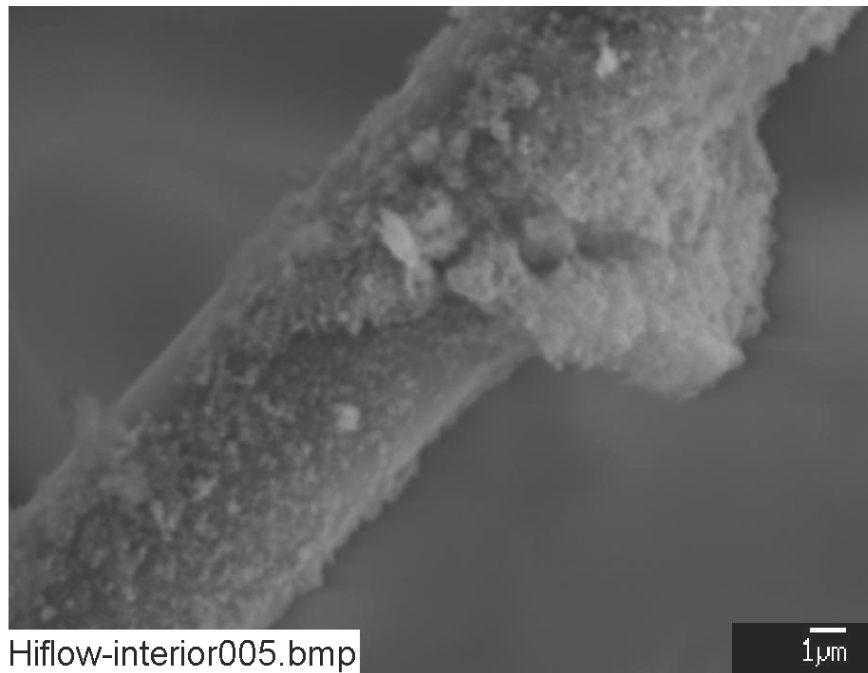
Figure D1-24. Test #2, Day-4 SEM image zoomed in on deposits on fiberglass, magnification 5000 times. (Hiflow-interior005)

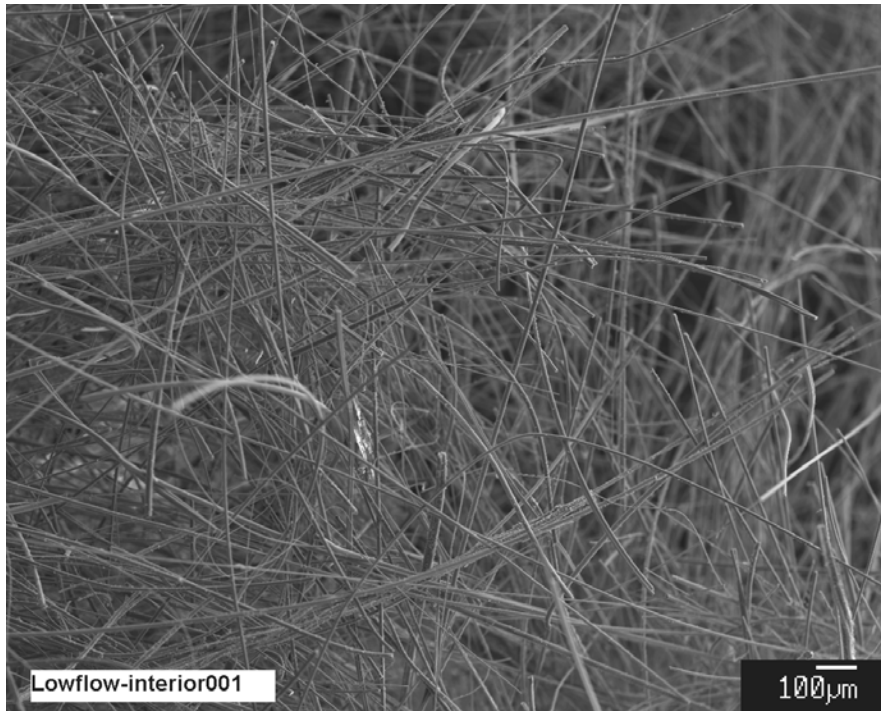
General Observations: Low-flow interior looks cleaner than high-flow interior.
No crusts, only small particles.
Images Lowflow-interior001 through 004 taken on the same region

Figure D1-25. Test #2, Day-16 SEM image overview for low-flow interior. (Lowflow-interior001)

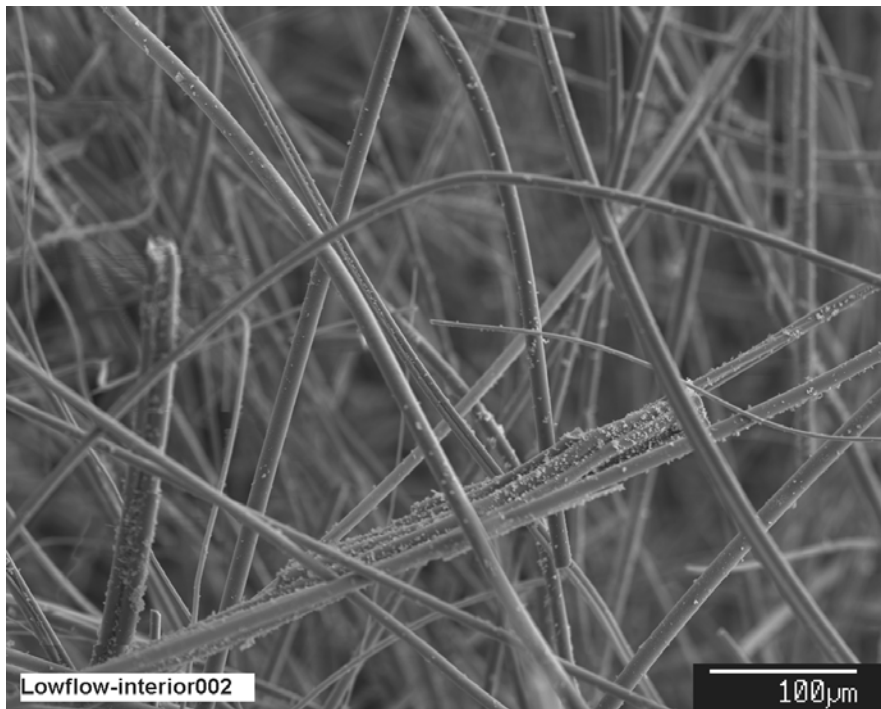
Figure D1-26. Test-2 Day-16 SEM close-up image of Figure D1-25. (Lowflow-interior002)

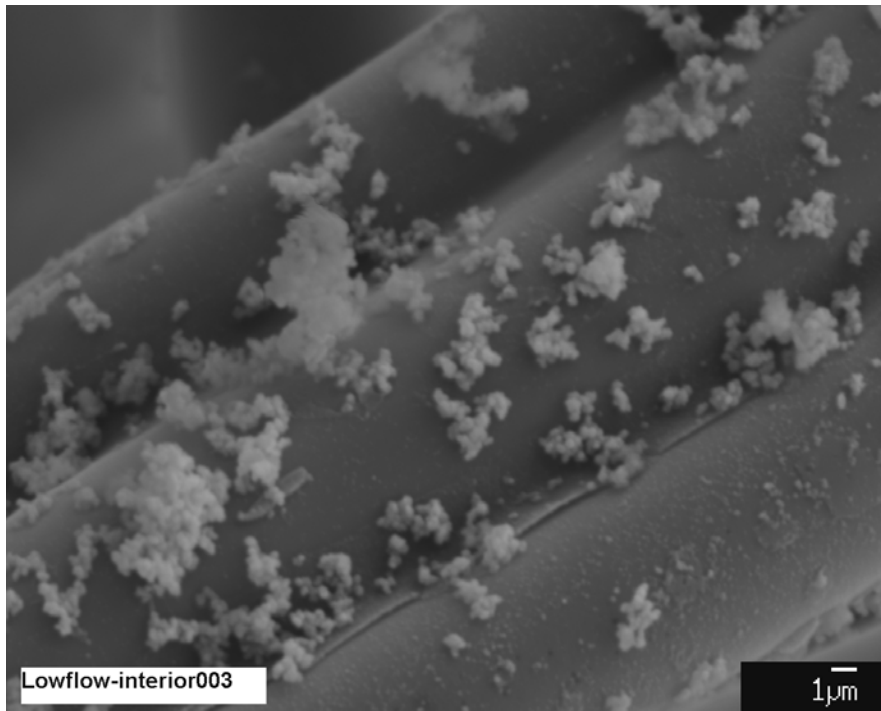
Figure D1-27. Test #2, Day-16 SEM image at 3500 times magnification of deposits shown in Figure D1-26. (Lowflow-interior003)

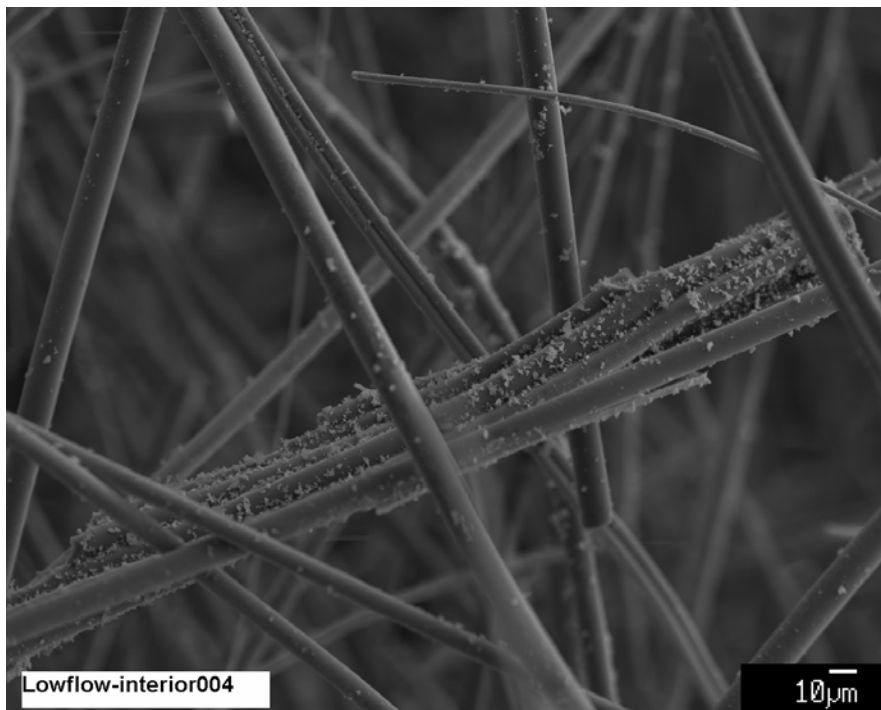
Figure D1-28. Test #2, Day-16 SEM image at 370 times magnification showing close-up of deposits in Figure D1-26. (Lowflow-interior004)

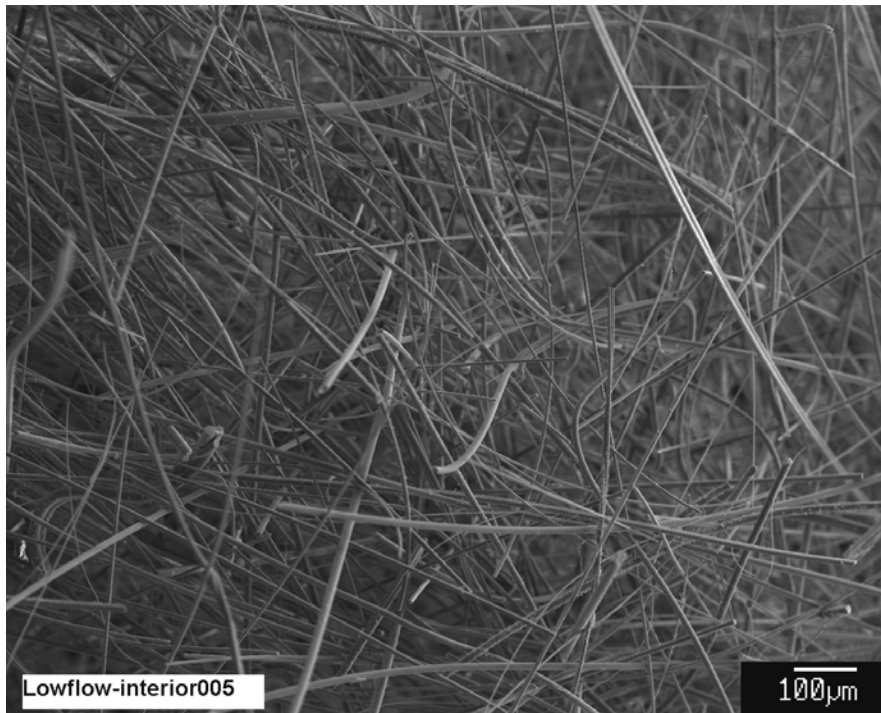
Figure D1-29. Test #2, Day-16 SEM image overview of a new sample area. (Lowflow-interior005)

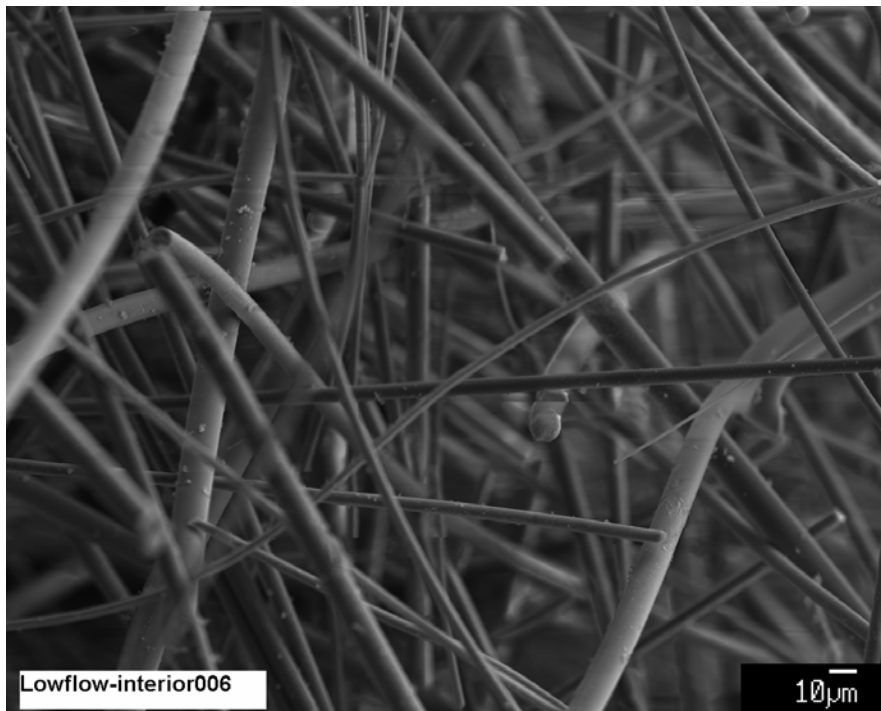
Figure D1-30. Test #2, Day-16 SEM image zooming in on Figure D1-29. (Lowflow-interior006)

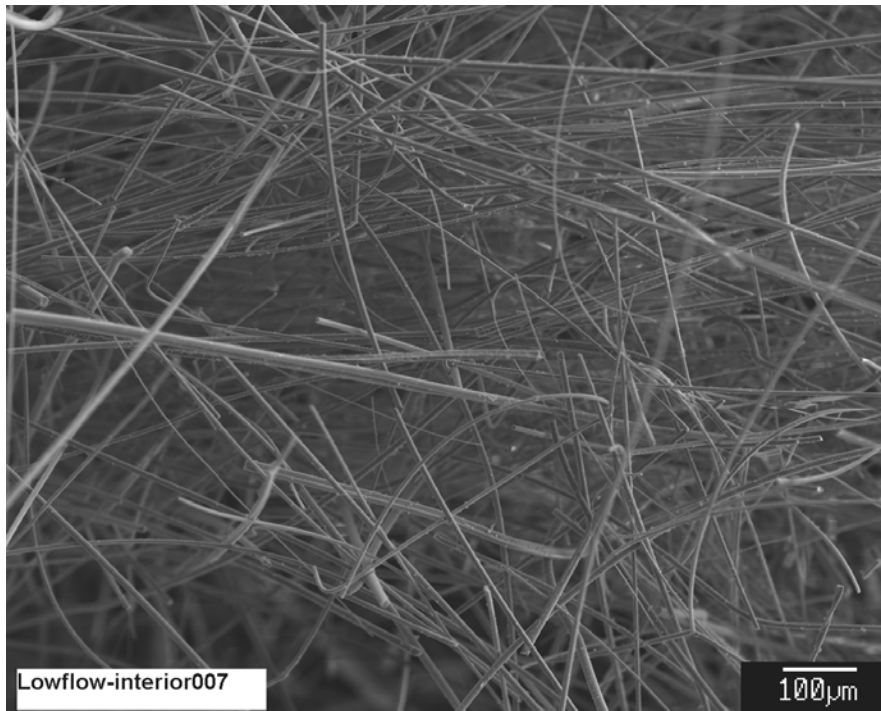
Figure D1-31. Test #2, Day-16 SEM image showing a cleaner appearance than seen in some high-flow interior samples. (Lowflow-interior007)

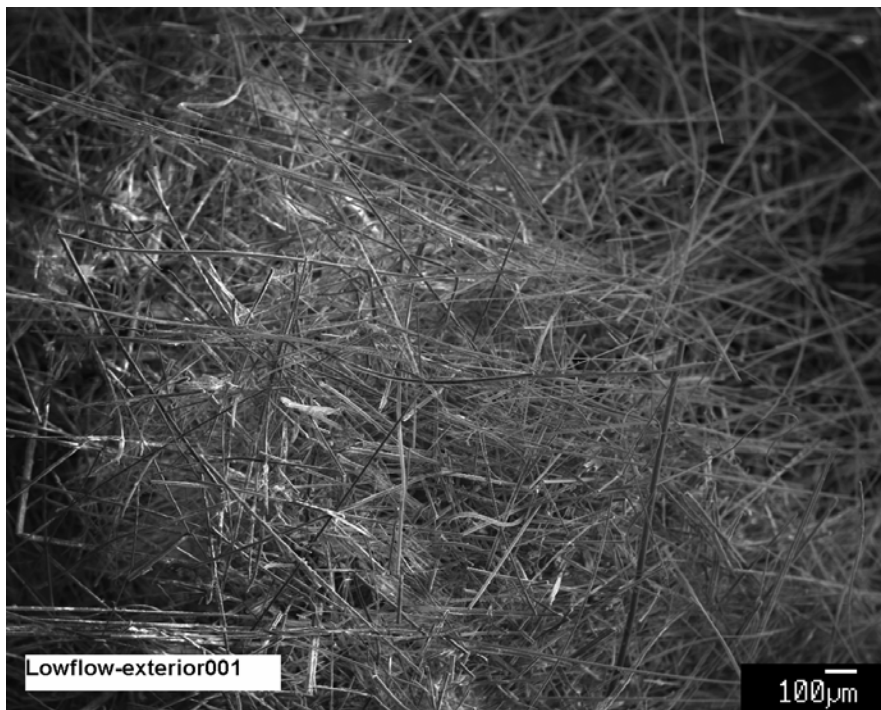
Figure D1-32. Test #2, Day-16 SEM image overview for low-flow exterior. (Lowflow-exterior001)

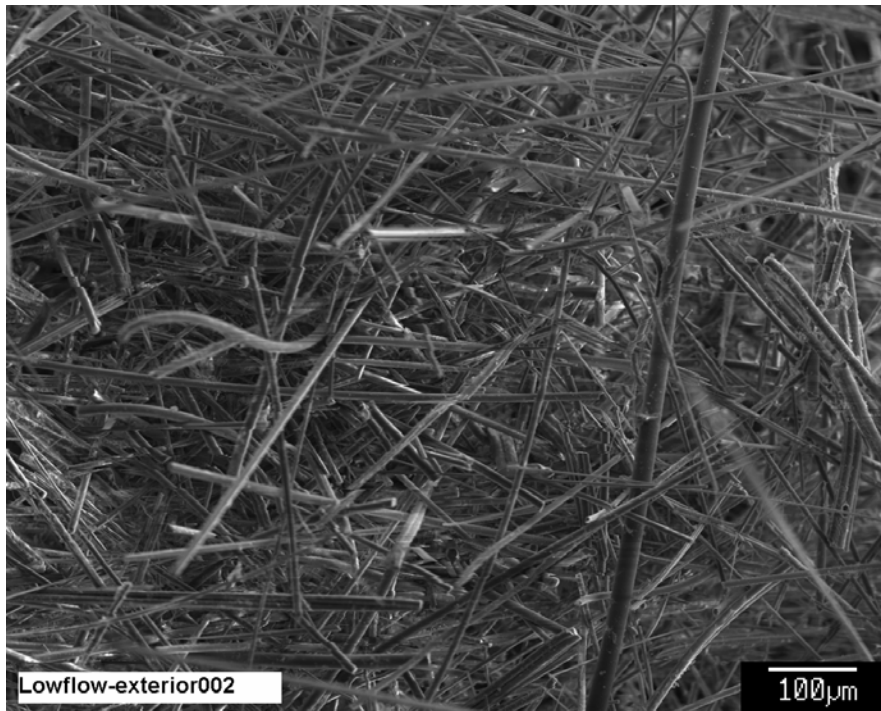
General Observations: Although sputtered again, some problems with charging remain.

Figure D1-33. Test #2, Day-16 SEM image close-up (charging) of Figure D1-32. (Lowflow-exterior002)

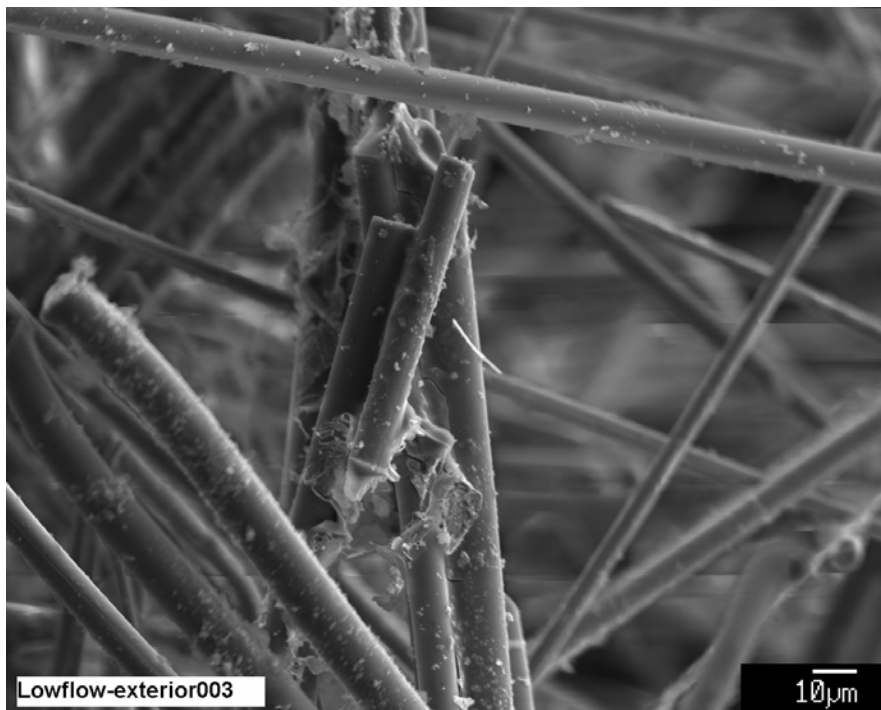
Figure D1-34. Test #2, Day-16 SEM image zooming in on deposits at 600 times magnification. (Lowflow-exterior003)

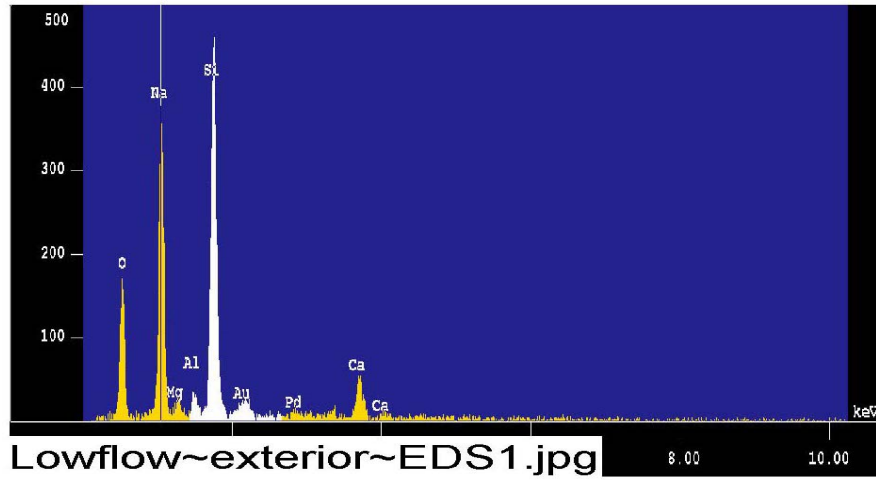
Figure D1-35. Test #2, Day-16 counting spectrum image for a particle on the fiberglass shown in Figure D1-34. (Lowflow~exterior~EDS1)

The results from the chemical composition analysis for Lowflow~exterior~EDS1 are given in Table D1-3.

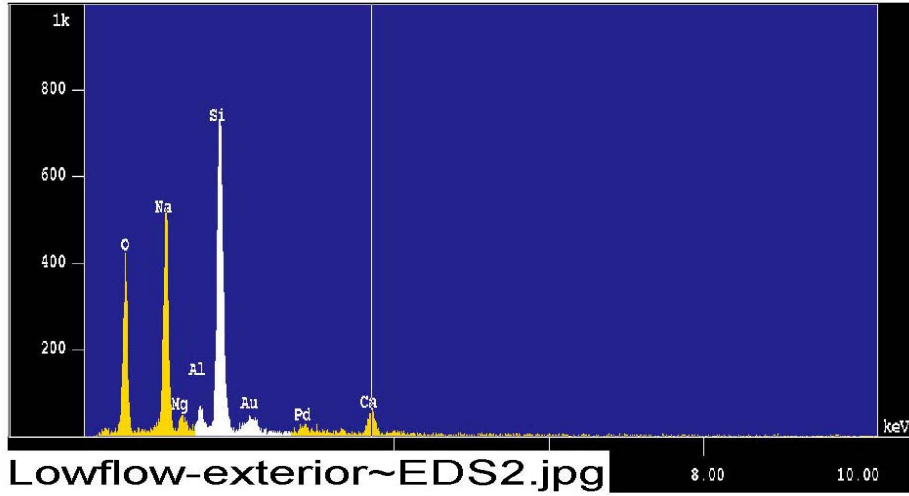
Figure D1-36. Test #2, Day-16 counting spectrum for a particle on the fiberglass shown in Figure D1-34. (Lowflow-exterior~EDS2)

The results from the chemical composition analysis for Lowflow~exterior~EDS2 are given in Table D1-4.
