Research  
Paper  
FPL-RP-645

# Feasibility of Producing Value-Added Wood Products from Reclaimed Hemlock Lumber

July 2007

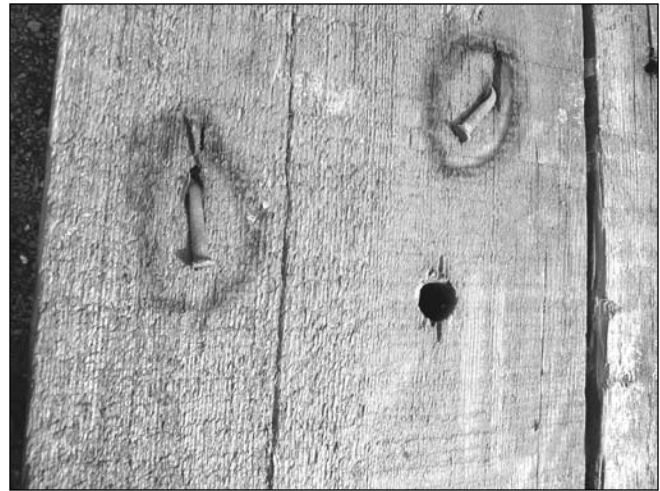
**Figure 3—Exposed cut shank nails marked for removal. Also shown is a surface check that may go deep into the lumber piece, affecting potential wood product yield.**

degree to which it had been cleaned of nails. Inspection revealed that the de-nailing was only partially completed with about 90% of members being fully free of nails (Fig. 3). More importantly, we found many pieces with broken-off nail shanks that were difficult to see. An inexpensive but effective hand-held metal detector (Wizard Industries, Inc., Glendale, California) was used to locate the metal. By the time the lumber reached the millwork facility, it had been scanned with the detector several times. Assuring that no metal remains in the wood is critical for avoiding possible moulder damage and preventing the cost of sharpening or replacing profile knives.

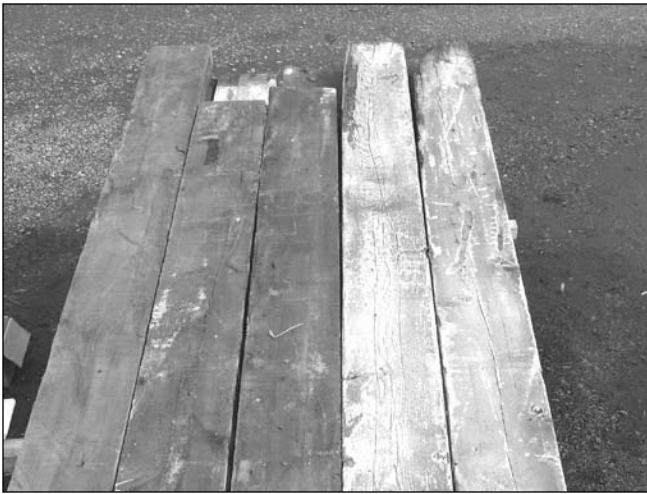
The visual inspection also revealed various degrees of surface checking related to in-service drying. Three pieces were so heavily and deeply checked that they were rejected outright as unsuitable for processing. Instead of processing these pieces into millwork, we used them as test pieces to set up the bandmill. All others were lightly checked and allowed for processing. Other surface conditions included the presence of paint coatings and what appeared to be either cement or plaster (Fig. 4). These materials can quickly dull moulder knives and must be removed to maintain knife sharpness and finished surface quality.

**Figure 4**—Some lumber was clean, whereas other pieces had been painted or had surface contamination of cement or plaster.

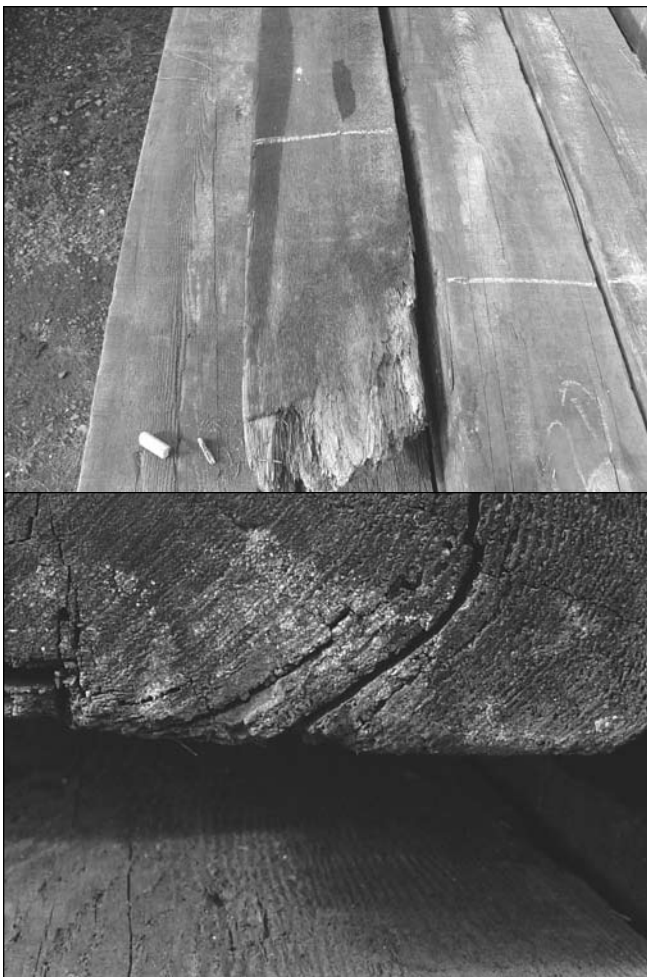
Decay, shake, and end splits were also evident on a number of the lumber pieces. In some cases, advanced decay extended 1 to 2 ft on one or both ends of the 3 by 12 lumber. This likely was due to water from leaky roofs wetting the ends of the roof-support joists (Fig. 5).

**Figure 5**—The decayed ends of the 3 by 12 joists were marked with a line for cutting (top). Ring shake, or separation between growth rings, is common in hemlock and was found in many pieces (bottom).

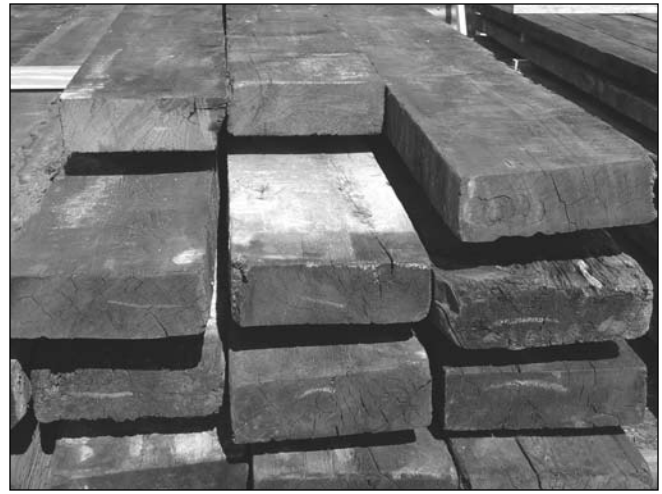
The lumber was all rough sawn without prior surfacing to a standard thickness. As a result, thickness and width varied 1/4 in. or more (Fig. 6).

**Figure 6**—The thickness of the lumber studied varied because it was originally installed rough sawn.

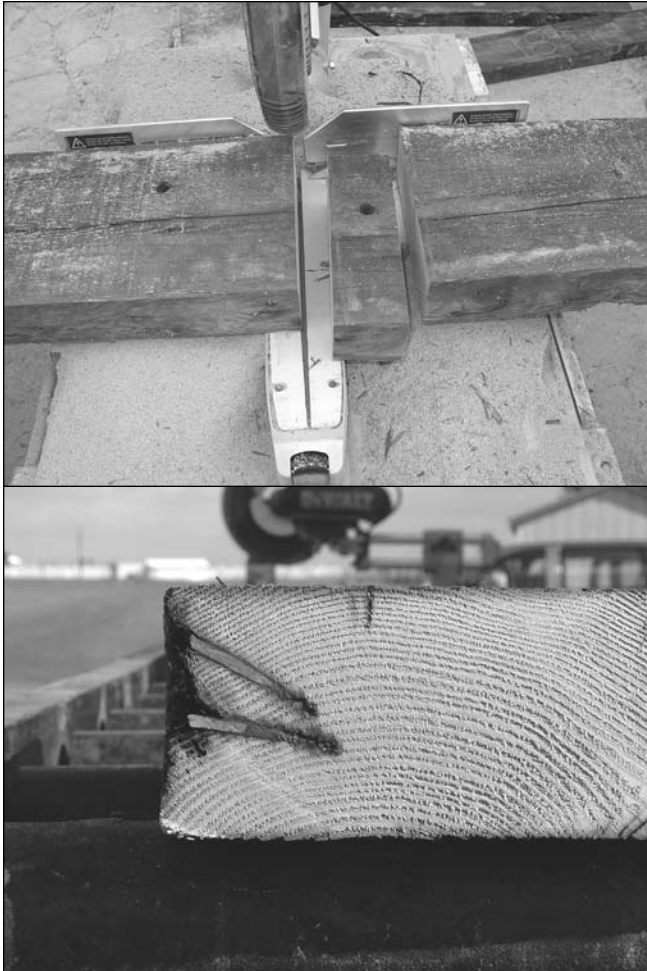
Exposed nails were removed prior to cross cutting using hammers, crowbars, and pliers. In many cases, the exposed head of the nail broke off during pulling (or had previously rusted off), which left the nail shank visually undetectable and embedded in the wood (Fig. 9). For this reason, we used a hand-held metal detector to locate nails and other embedded metal hardware. We found we needed to periodically calibrate and adjust detector sensitivity. It was very important to detect and remove this metal before molding the wood to final profile. While a cross-cut circular saw with carbide blades can tolerate some abuse from hitting a nail,

**Figure 9—Cross-cutting to remove decay and defects (top); broken off nails in lumber (bottom).**

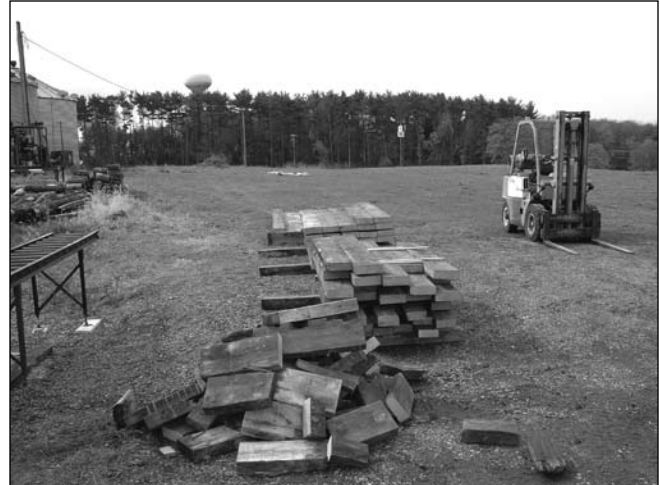
**Figure 10—Waste generated through cross-cutting out defect.**

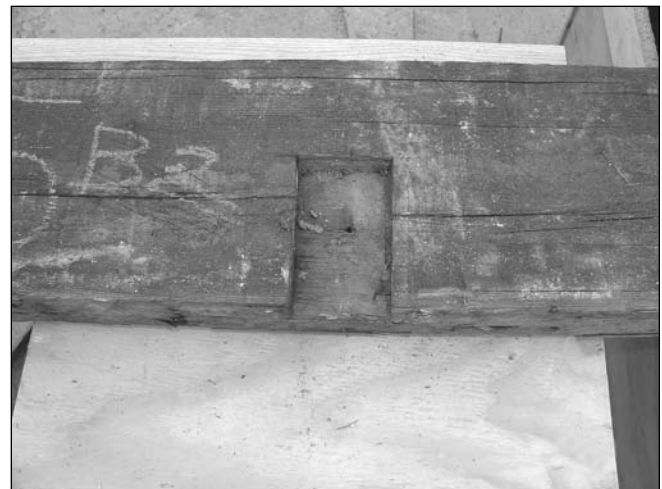
**Figure 13—Flaw limiting recovery of a matched pair of feedstock pieces.**

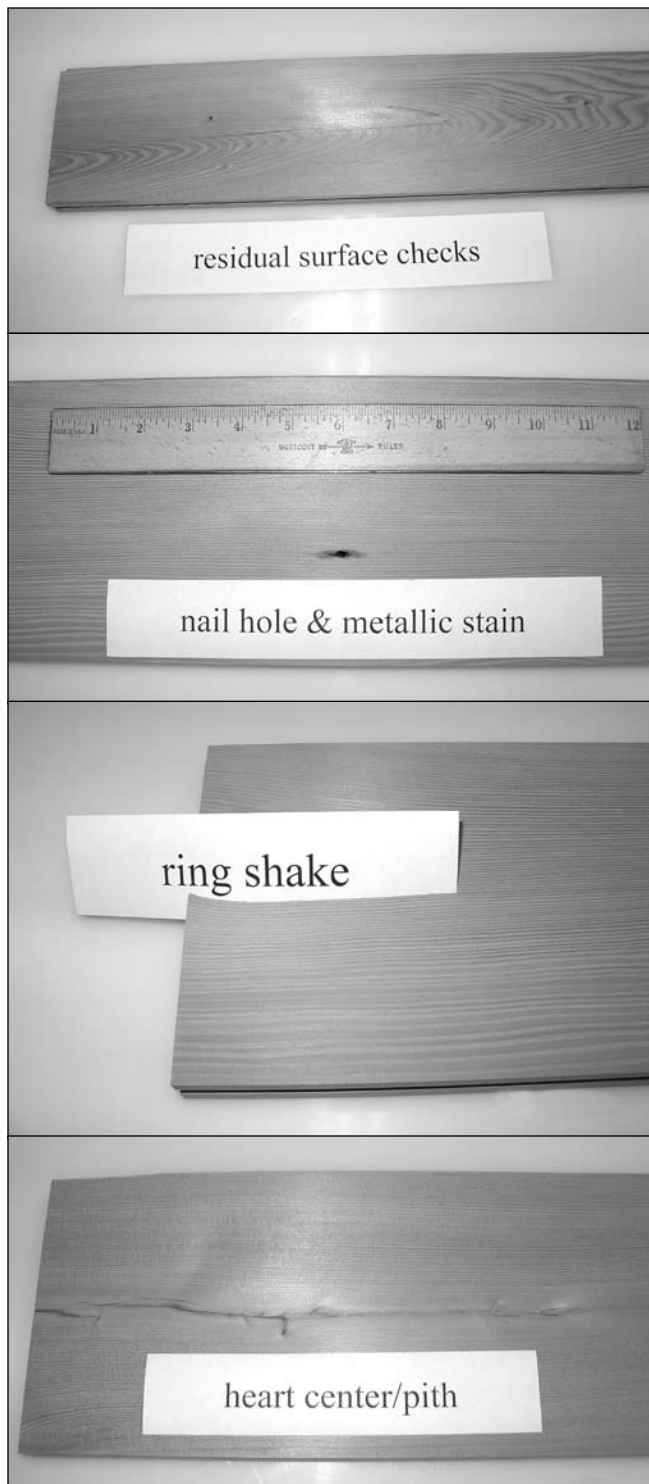
Shallow residual surface checks, ring shake, face-nail holes, and metallic stain appeared to be the most prevalent defects found in the finished product. Some pieces also contained heart center/pith (from those pieces of feedstock originally from box-heart pieces of lumber). These defects found after processing are shown in Figure 16.

**Figure 15—Typical defects found after moulding the lumber. Flooring pattern shown.**

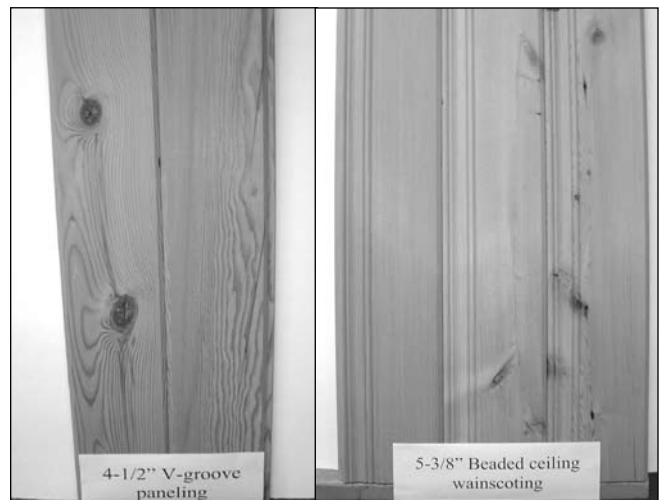
**Figure 17—Grade quality for V-groove paneling (left) and beaded ceiling (right) with common allowable defects.**

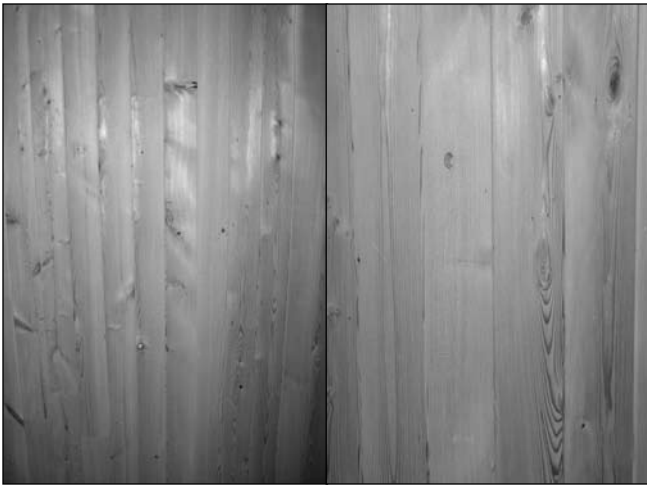
**Figure 18—V-groove paneling of mixed grade qualities (left) and the higher C grade quality (right).**
