A Summary of a NIOSH fire fighter fatality investigation

March 5, 1999

Forest Ranger II Dies After Receiving Second- and Third-Degree Burns Operating a Crawler Tractor (Bulldozer) While Clearing Vegetation During a Wildland Fire - Arkansas

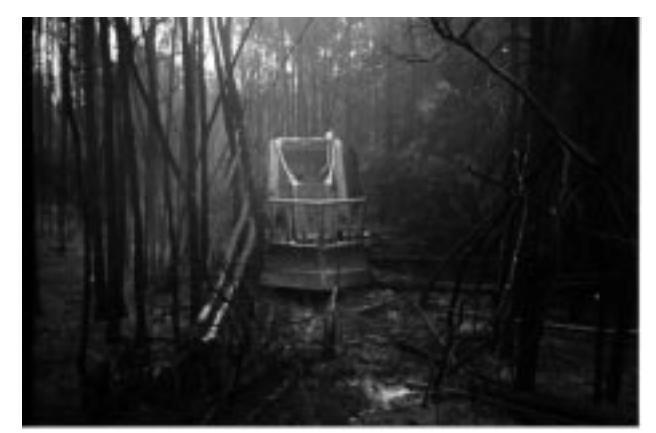
Figure 1. Bulldozer at Incident Scene

Shortly after the lead bulldozer pulled off the main plow line to seek cover, the victim apparently realized the fire was going to overtake him, and he began to backup his bulldozer. He moved the bulldozer backward approximately 10 to 15 feet when the edge of the V-blade on the front of the bulldozer caught on an eight-inch diameter tree (see Figure 1). It appears the bulldozer may have stalled, and the victim exited the bulldozer through the left side of the cab. Since the bulldozer did not receive any significant burn damage (e.g., the plastic seat cover, the gauges and the hydraulic hoses were still intact), it is believed that the victim received radiant burns after exiting the bulldozer. After the victim was on the ground he started walking back toward the area where the fourth bulldozer was operating. The bulldozer operator saw the victim walking toward him with the legs of his pants burned away and with apparent burns to his legs, hands, and face. The operator helped the victim walk back to the Pump Station Road about 1/4 mile away. In the interim an

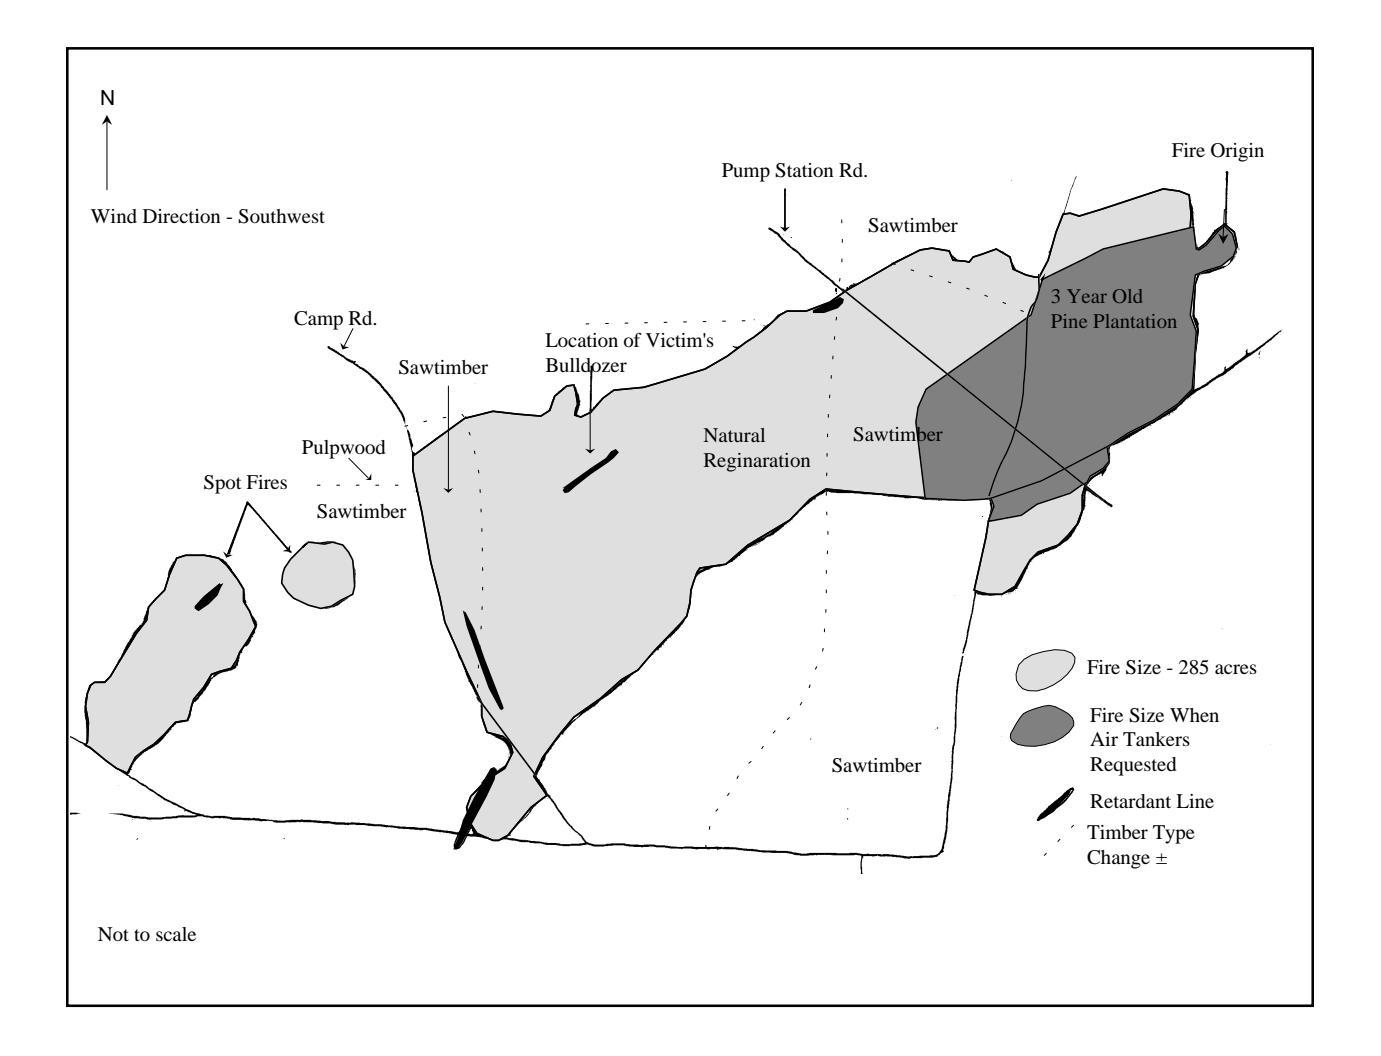
Figure 2. Map of Wildland Fire Incident Site

The IC was directing operations on Camp Road (see Figure 2) where volunteer fire departments had deployed their engines and personnel to water down the area and protect nearby homes, while the County Forester was directing bulldozer operations on the north fire line. The bulldozer operations consisted of a total of four bulldozers and a Forest Ranger (one of the bulldozer operators was a timber company co-operator). To control the spread of fire, the crew was using the direct attack strategy operating about 20 to 25 feet away from the fire, by clearing and plowing lines about 9 feet wide. The dense natural regeneration trees about 25 feet high
