A Summary of a NIOSH fire fighter fatality investigation

May 18, 2000

Motor-Vehicle Incident Claims Life of Volunteer Fire Fighter Who Was Responding to Alarm - Ohio

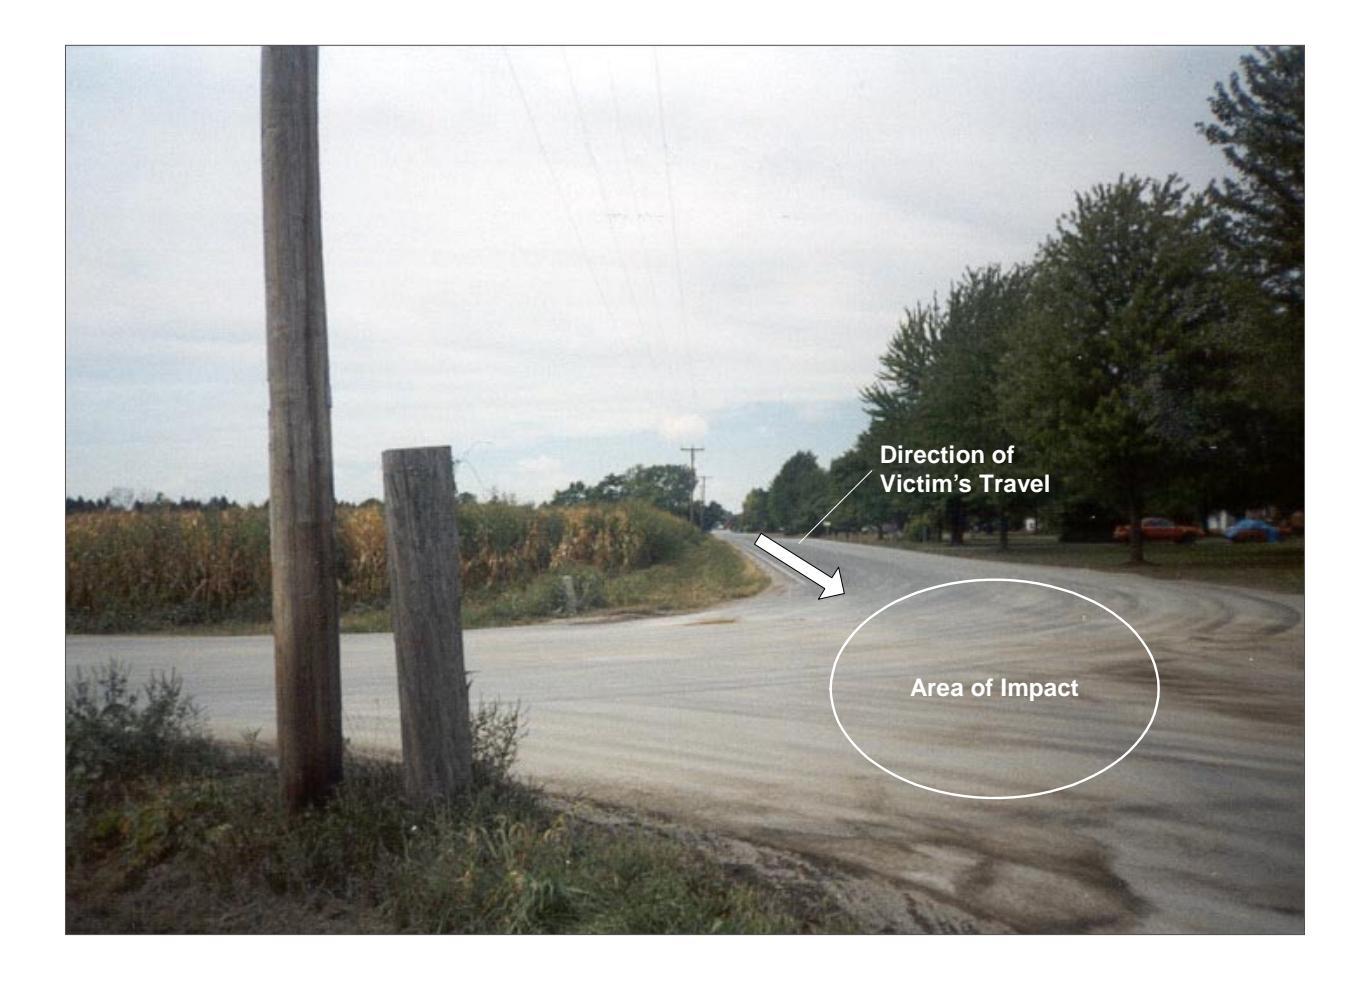
Figure 1. Incident Site: Intersection

The victim was traveling eastbound on a two-lane state highway. A tandem dump truck was stopped at the stop sign of a road that intersected the one on which the victim was traveling. The driver of the dump truck started a left turn, heading westbound onto the road the victim was traveling. *Note: The intersection was partially obscured by a corn crop*

planted in the area bordering this intersection. The corn was approximately 6 feet in height (see Figure 1). The driver of the dump truck stated that when he was stopped at the stop sign, he saw the victim's vehicle with its headlights turned on approximately 450 feet away. As he proceeded into the intersection, he stopped the dump truck when he noticed the victim quickly approaching. The victim collided with the front axle of the dump truck. Note: The driver of the dump truck recalled seeing the victim's red light only when the victim was in close proximity. It is believed that the victim activated his light and siren when he saw the dump truck at the intersection. At 0659 hours, the driver of Engine 81, en route to the fire, noticed a large dump truck stopped in the middle of an intersection approximately 1/4 mile in front of him. Approaching the intersection, he advised Central Dispatch of a motor vehicle incident involving a large dump truck and a full-size automobile. The vehicle involved in the incident was that of a fellow fire fighter (the victim). He requested a mutual aid department be sent to the fire while he responded to the motor vehicle incident. At approximately 0704 hours, a fire fighter (Fire Fighter #1) en route to the original call of a kitchen fire, arrived by POV at the motor-vehicle incident site. At this time the driver of Engine 81 notified Central Dispatch to ask the local EMS and a back up department to respond to the motor-vehicle incident. Fire Fighter #1 was instructed by the driver of Engine 81 to go to the station approximately 1/2 mile away to get the Brush Truck which contained the jaws-of-life. The driver of Engine 81 approached the vehicle and found that the victim had no pulse and was unresponsive. At approximately 0707 hours, the local EMS and Fire Fighter #1 returning with the Brush Truck, arrived simultaneously at the incident site. The driver of Engine 81 and a member of the local EMS removed the jaws-of-life from the Brush Truck and began extrication. At approximately 0709 hours, two trucks from a neighboring fire

Intersections are the most likely place for an incident to occur. When approaching an intersection, the driver/operator should slow the emergency vehicle to a speed that allows a complete stop in the intersection if necessary. The emergency vehicle should be brought to a complete stop if obstructions, such as buildings or trucks, block the driver/ operator's view of the intersection. The emergency vehicle should only proceed if the driver can account for all lanes and ascertains that it is safe to proceed. In this incident the victim's visibility was obstructed due to the time of day that the incident occurred (0655 hours), the weather (minimal fog with a slight dew on the road surface), and the decreased visibility of the intersection due to the crops (corn) planted in the fields bordering this intersection.

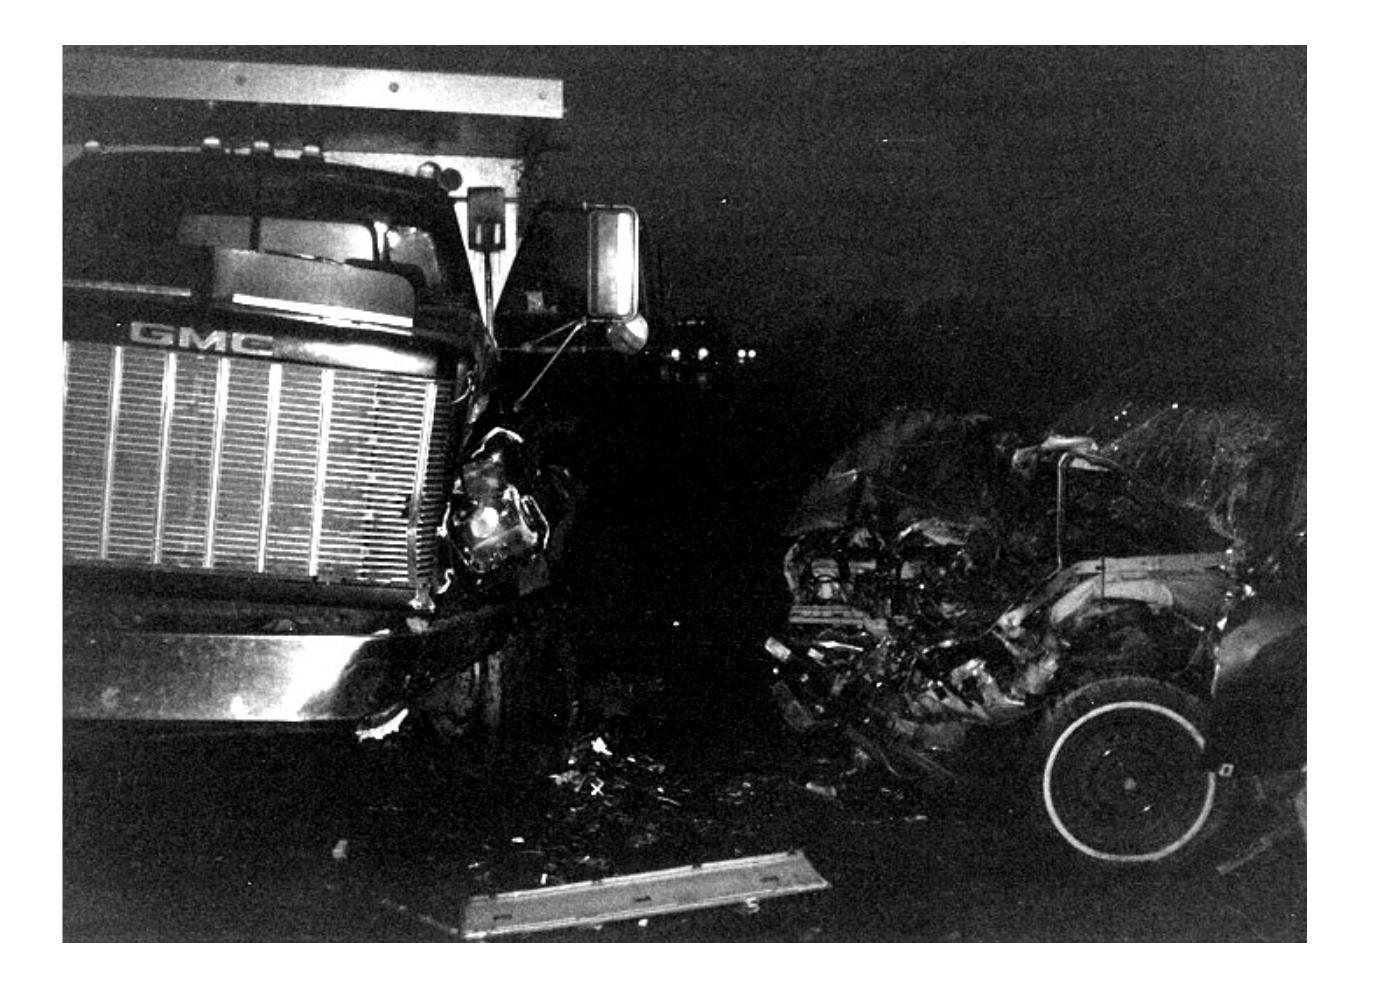
Figure 2. Vehicles Involved

roadway, the victim may not have seen the truck until the collision. The victim's vehicle struck the dump truck's front axle, and the victim was killed instantly. At 0702 hours, the driver of Engine 81 informed Central Dispatch of a motor-vehicle incident at an intersection near the fire station which involved a tandem dump truck and the POV of a fellow fire fighter. After approximately 40 minutes of extrication, the victim was removed from the vehicle and was pronounced dead at the scene by the local coroner.

The incident occurred at the intersection of a state road approximately $\frac{1}{2}$ mile from the fire station. The road was a standard two-lane asphalt road with a dashed center line in the eastbound lane (the direction of the victim's travel), a solid yellow line in the westbound lane and white fog lines separating the road edge from the shoulder. The posted speed limit is 55 mph. The intersection where the incident occurred was partially obscured by a corn field. The weather conditions at the time of the incident were as follows: a relative humidity of 97%, an ambient air temperature of 64° F, and a visibility of 4.0 miles. The road was wet from light rain at the time of the incident. The victim's POV was a 1989 Cadillac DeVille. His POV was equipped with a single-mounted red deck light, which met the requirements in the Ohio Revised Code Section 4511.45. At the time of the incident the victim was wearing his seat belt (lap and shoulder). The dump truck was a 1974 GMC Brigadier. It had three axles and a gross vehicle weight rating (GVWR) of 54,500 lbs. At the time of the incident, the truck was carrying 18 tons of stone, causing it to be over its weight limit by 3,800 lbs. The truck was not equipped with a seatbelt (lap or shoulder).
