ITS
NUMBER 4

Interpreting The Secretary of the Interior's Standards for Rehabilitation

Subject: Inappropriate Replacement Doors

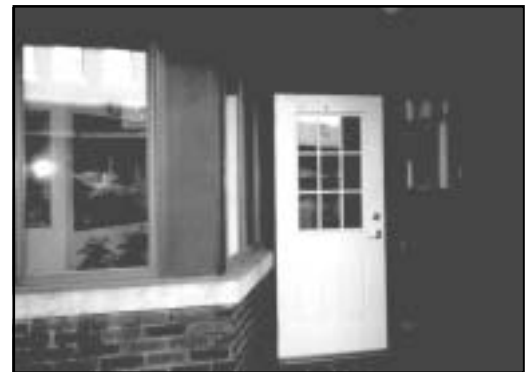
Incompatible "stock" door.

The storefront windows were replaced with simple, contemporary windows with dark-colored frames that were compatible with the historic building. But the "stock" white entrance door with its nine-pane glass and snap-in muntins above two vertical panels was not compatible with the historic building. In order to bring the project into compliance with the Standards, remedial work involved replacing the stock door with a simple glazed wood door that was compatible in both design and color with the historic building.

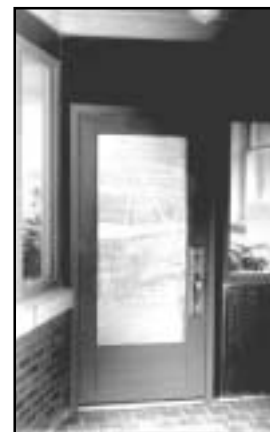
Appropriate replacement door.
