**ITS**  
NUMBER 9

**Interpreting  
The Secretary of the Interior's Standards for Rehabilitation**

**Subject: Inappropriate Porch Alterations**

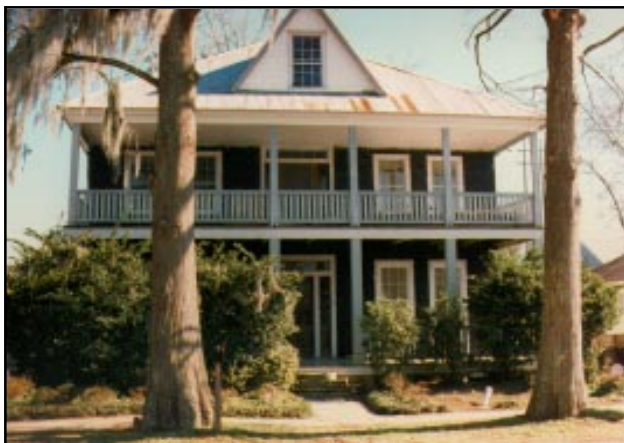
**Application 1** (*Incompatible treatment*): A late-19th century boarding house was rehabilitated for use as a bed and breakfast. Prior to rehabilitation the structure had a very simple porch balustrade with rectangular vertical posts, or balusters. Historic photographs provided documentary evidence that the balustrade had always had this appearance. During rehabilitation the balustrade was replaced with one completely different in design - sawn balusters with ornate cutout shapes. The replacement gives a historically inappropriate look to the building, and an appearance it never had. To meet the Standards the owner replaced the new balustrade with one that matched the simple historic design.

*Before rehabilitation - simple historical balustrade.*

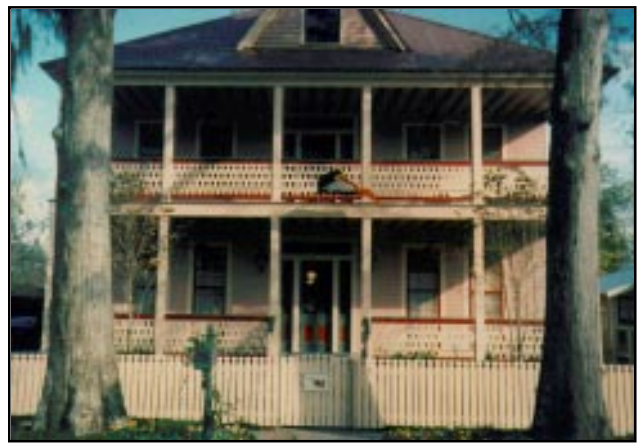
*After rehabilitation - inappropriate replacement balustrade.*

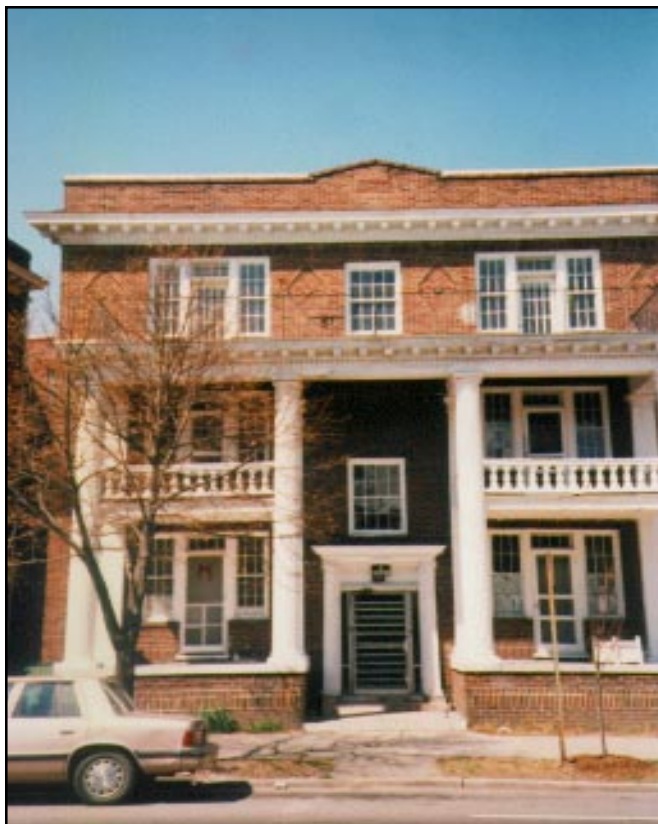
**Application 2** (*Incompatible treatment*): A Colonial Revival-style apartment building, circa 1920, was rehabilitated for continued multifamily use. The front of the building was distinguished by two porches on the second story with low balustrades consisting of decorative, heavy turned balusters. As part of the rehabilitation, these balustrades, along with a non-original metal railing on the third floor level, were removed because their height did not comply with local building code requirements. They were replaced with taller balustrades with straight, narrow, rectangular balusters that did not replicate the visual qualities of the decorative historic balustrade and, therefore, resulted in dramatically altering the character of the building. These new, inappropriate balustrades were also added to the first floor porch.

*Before rehabilitation.*

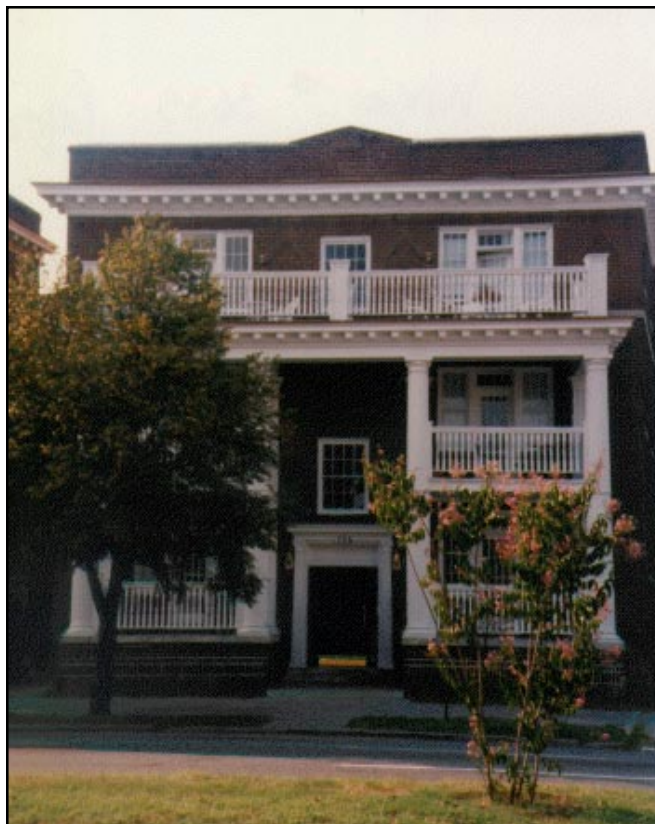
The replacement balustrades are not only incompatible with the historic building itself, but they are also not in keeping with the historic district in which the building is located. Many similar apartment buildings in the district feature such porches which, with their rhythm, harmonious scale, size, and proportion, add a distinctive element to the district. Incompatible changes such as these new balustrades can cumulatively and negatively impact the overall character of a historic district.

*After rehabilitation.*

A more appropriate solution for meeting the safety requirements might have been to raise the existing second story balustrade, and modify the bottom of the railing to reduce the size of the opening. Another approach might have been to add a simple and inconspicuous pipe rail above the historic balustrade to meet the height requirements. From a distance this would not have been visible, and would have preserved the historic character.

There was no documentary evidence that there had ever been balustrades at the first and third floor levels. To satisfy both the Standards and code requirements it would have been preferable had the owner retained the modern metal railing that already existed on the third floor, and added a similarly simple railing on the first floor that was compatible with the building's historic character.
