**Subject:** Retaining Distinctive Corridor Features

- Applicable Standards:**
2. Retention of Historic Character
  5. Preservation of Distinctive Features, Finishes and Craftsmanship
  6. Repair/Replacement of Deteriorated or Missing Features

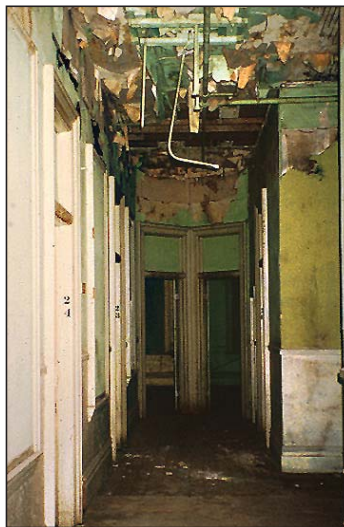
*Left: Before the rehabilitation, the historic office building was in poor condition and many of the historic transoms had been sealed. (Before and after views are of different areas).*

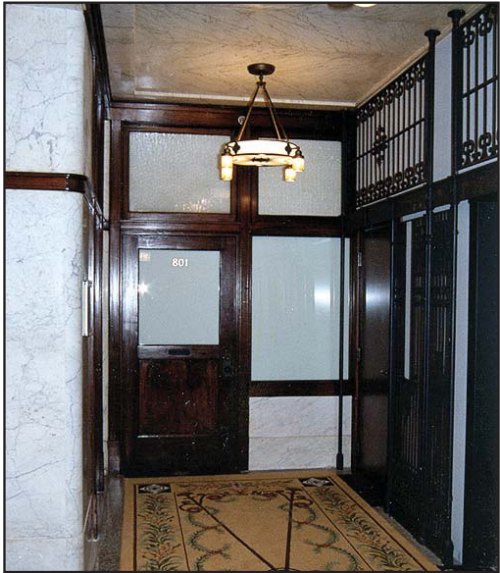
*The historic corridors in this office building had reflective surfaces that were character-defining, including glazing, marble wainscoting, and high-gloss varnish on the mahogany trim.*

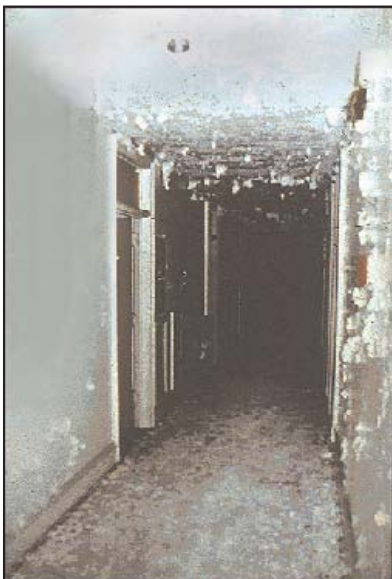
*Left: The previous owner had blocked the transoms in this hotel with plywood – a treatment that did not meet the fire rating requirements. The building had been vacant for some time and the finishes were in poor condition.*
