Five-Year Review Report

First Five-Year Review Report for the Oklahoma Refining Company Superfund Site Cyril, Caddo County, Oklahoma

July 2002

United States Environmental Protection Agency Region 6 Dallas, Texas

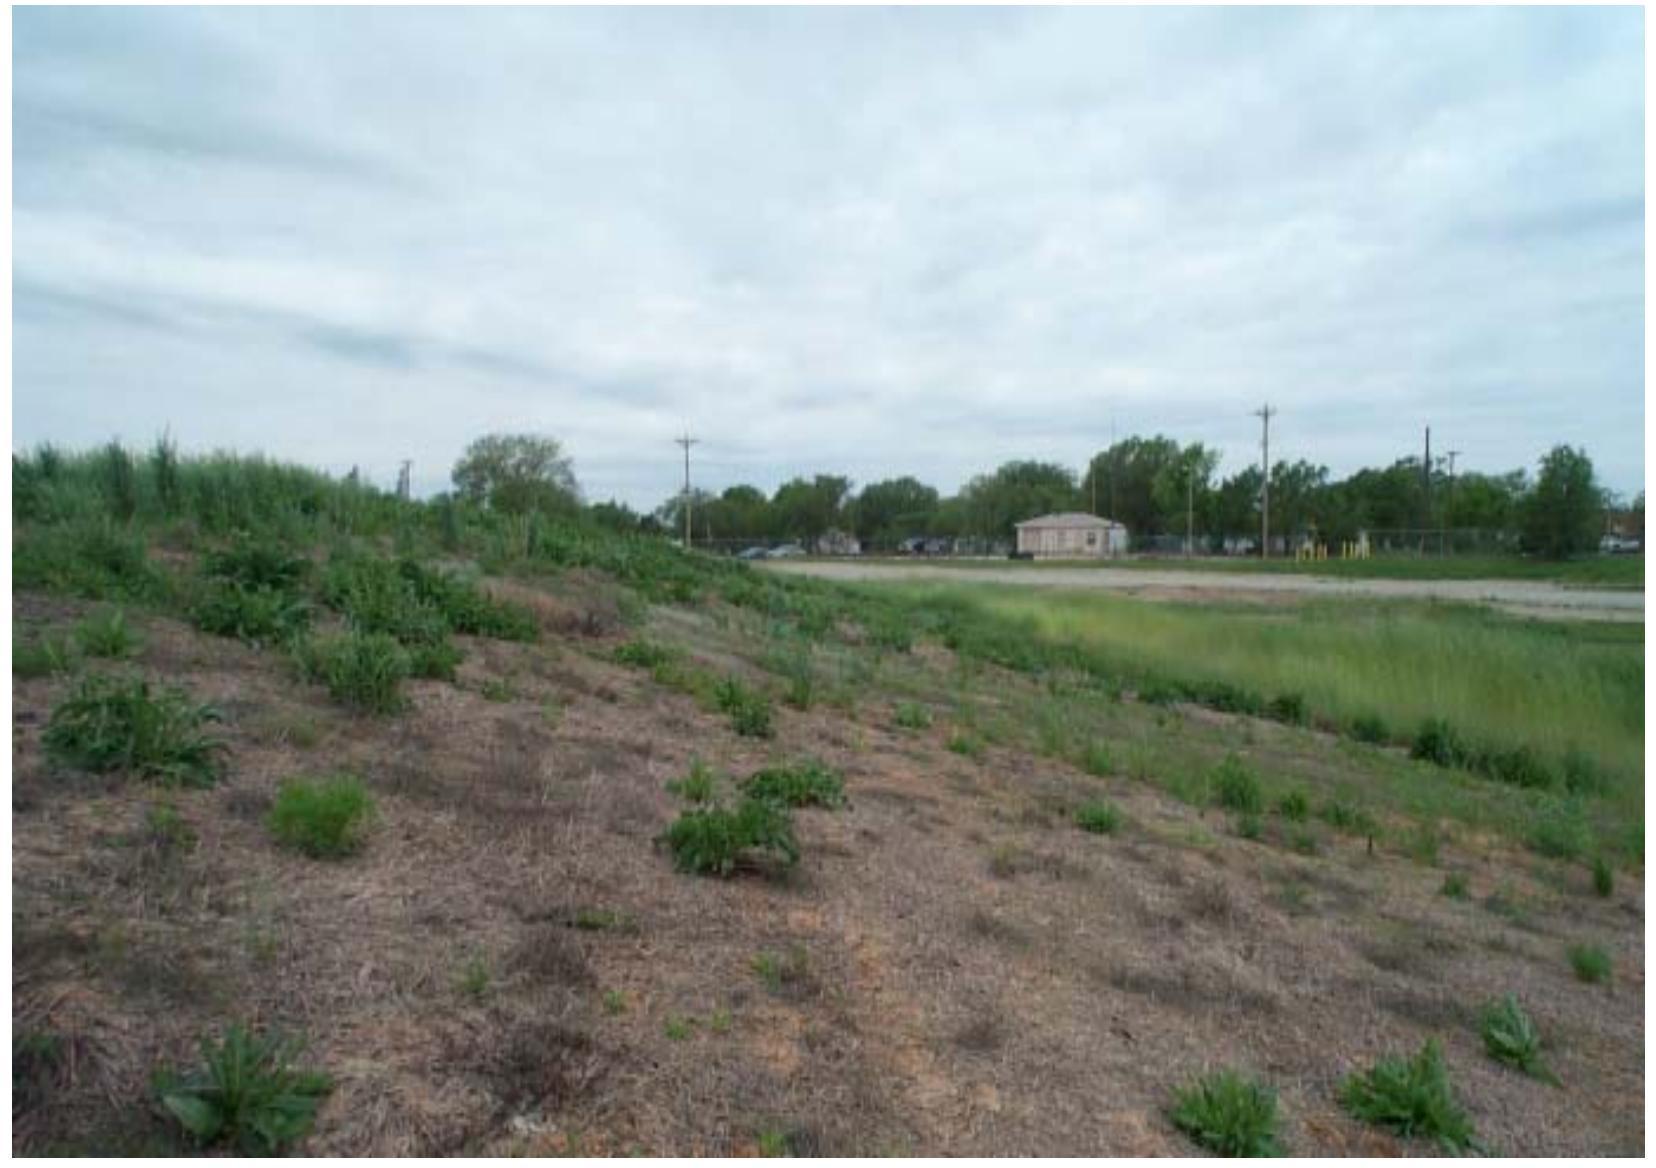
Photograph 1 of 46

Photograph 1: Sparse vegetative cover visible on embankment of non-hazardous waste landfill.

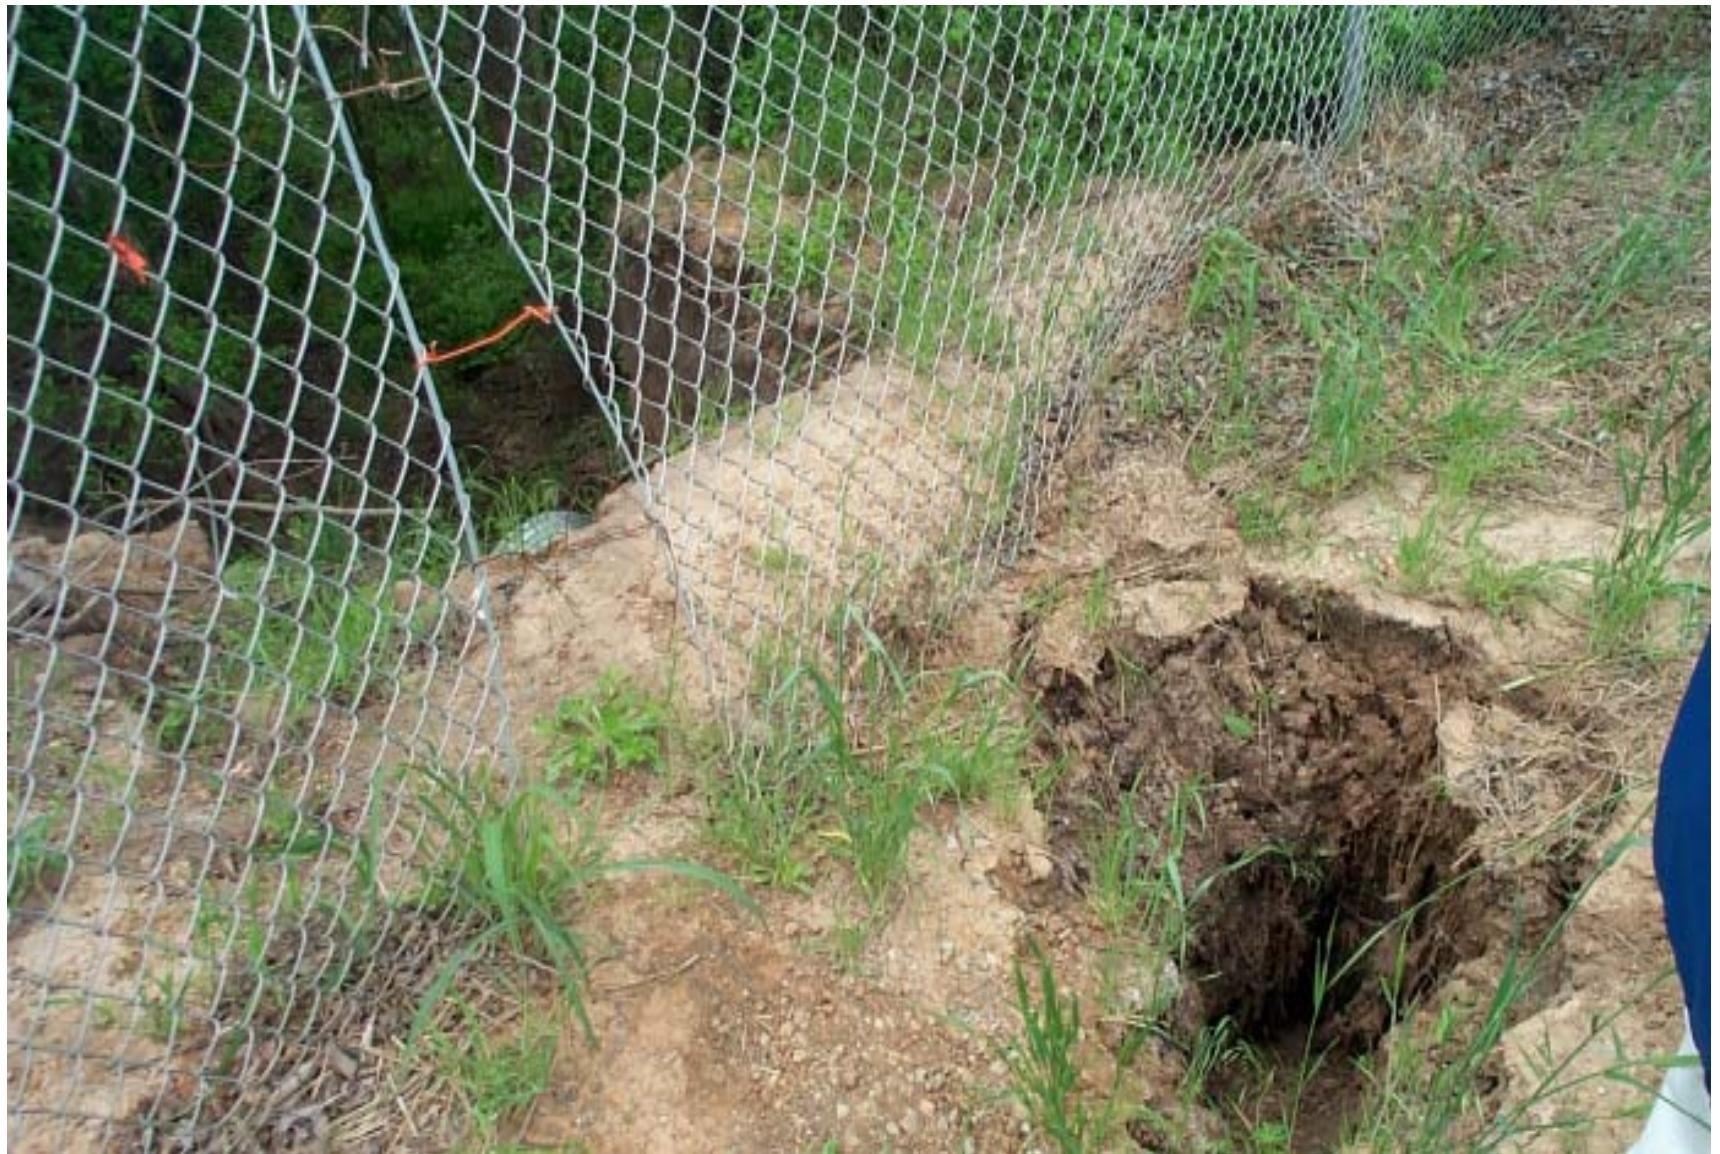
Photograph 15 of 46

<u>Site Access.</u> The perimeter fence has been damaged at a location on the east side of the Site, south of groundwater monitoring well SBB-11, and the perimeter fence along the south boundary, east of groundwater monitoring well SBB-7, has been undercut by erosion. At each of these locations, access to the Site is no longer restricted.

hole (two feet diameter by one foot deep) was observed on the east perimeter fence line at a discharge pipe (**Photograph No. 15**). The ODEQ representatives indicated that repairs to these areas will be made. Also, damage to the perimeter fence was observed at two locations. Temporary repairs had been made.

Photograph 15: Damaged fence along east perimeter and hole caused by erosion, approximately 250' south of monitoring well SBB-11.

The remedial action construction completion report must be submitted. Review of this document should be included in the next five-year review. The monitoring plan for long term groundwater and surface water monitoring should be prepared and implemented. This monitoring plan should include sampling of discharge from observed seeps and the surface water of Gladys Creek, as well as procedures to address maintenance of both on and offsite monitoring wells, and at a minimum, annual review of the monitoring results. Also, the plan should define monitoring criteria that will indicate the need for additional monitoring and/or further action, if necessary. Protective monitoring well casing for wells located offsite north of Highway 277 have been damaged by corrosion and need to be repaired to restrict trespasser access to these wells, or alternatives for restricting trespasser access should be pursued (such as fencing around individual wells).

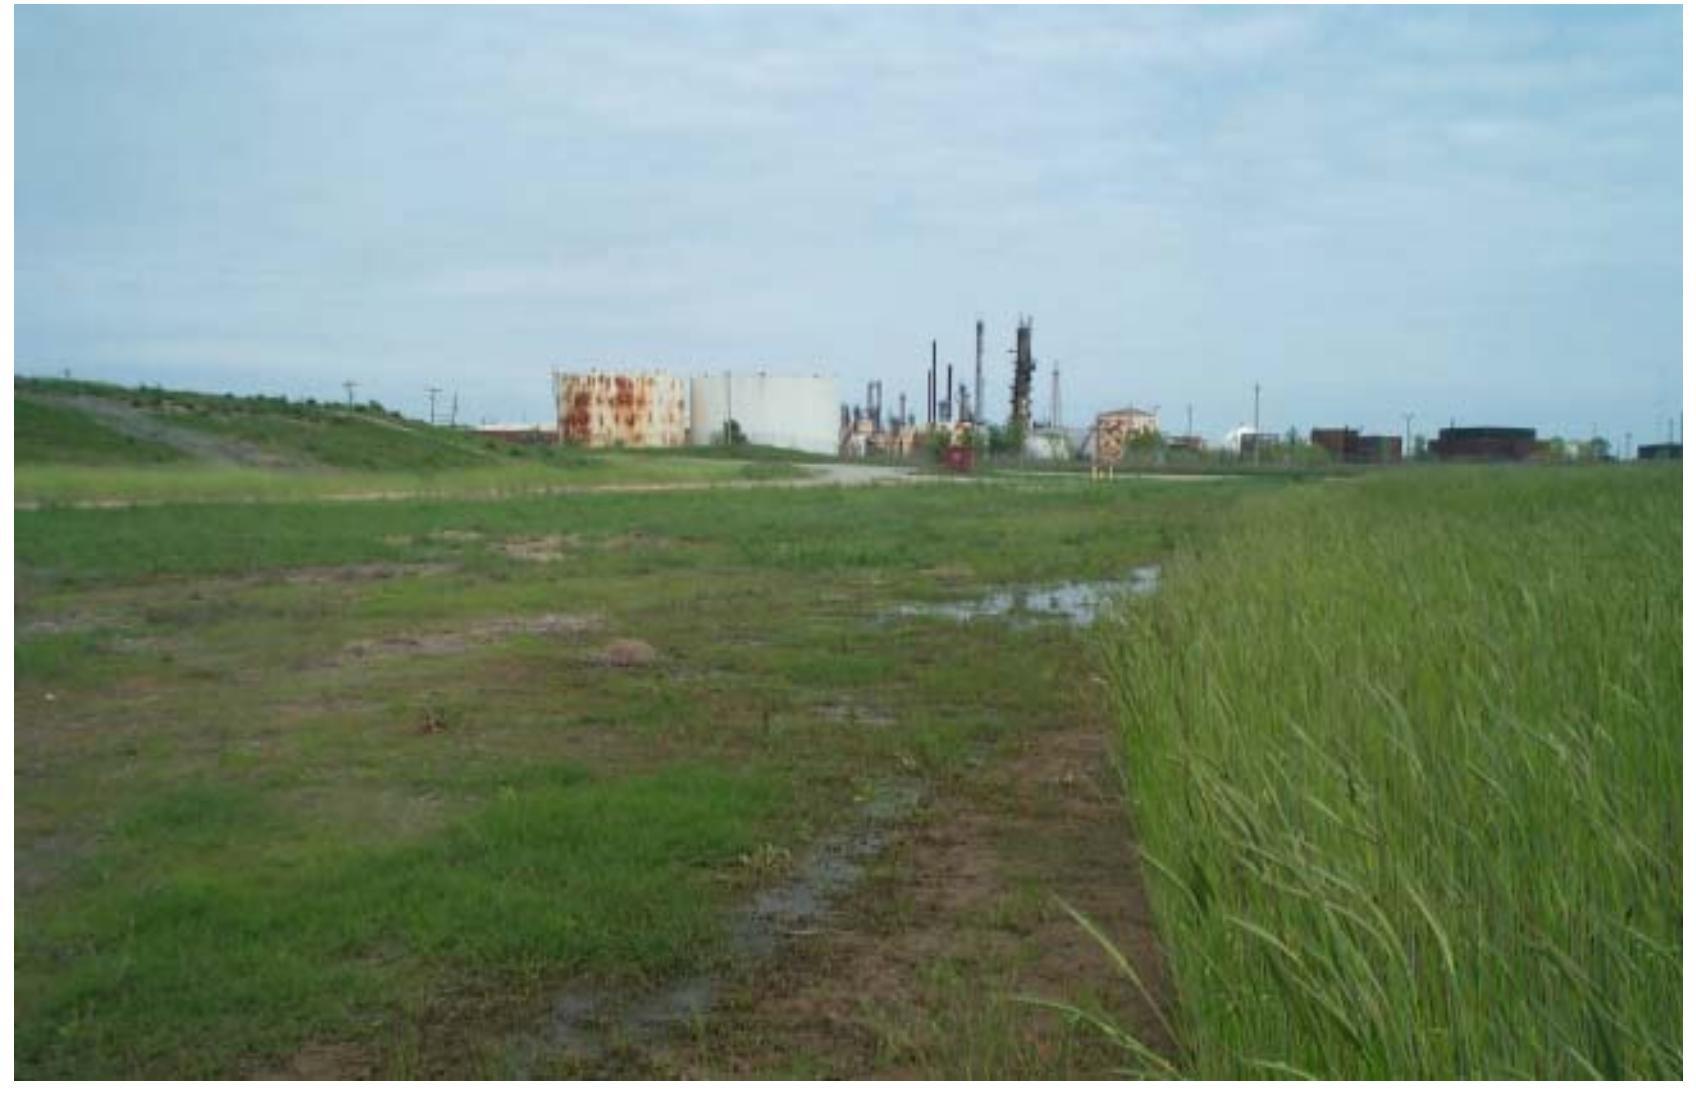
Photograph 32 of 46

Photograph 32: Wet area between non-hazardous waste landfill and hazardous waste landfill, looking north to CPC property.

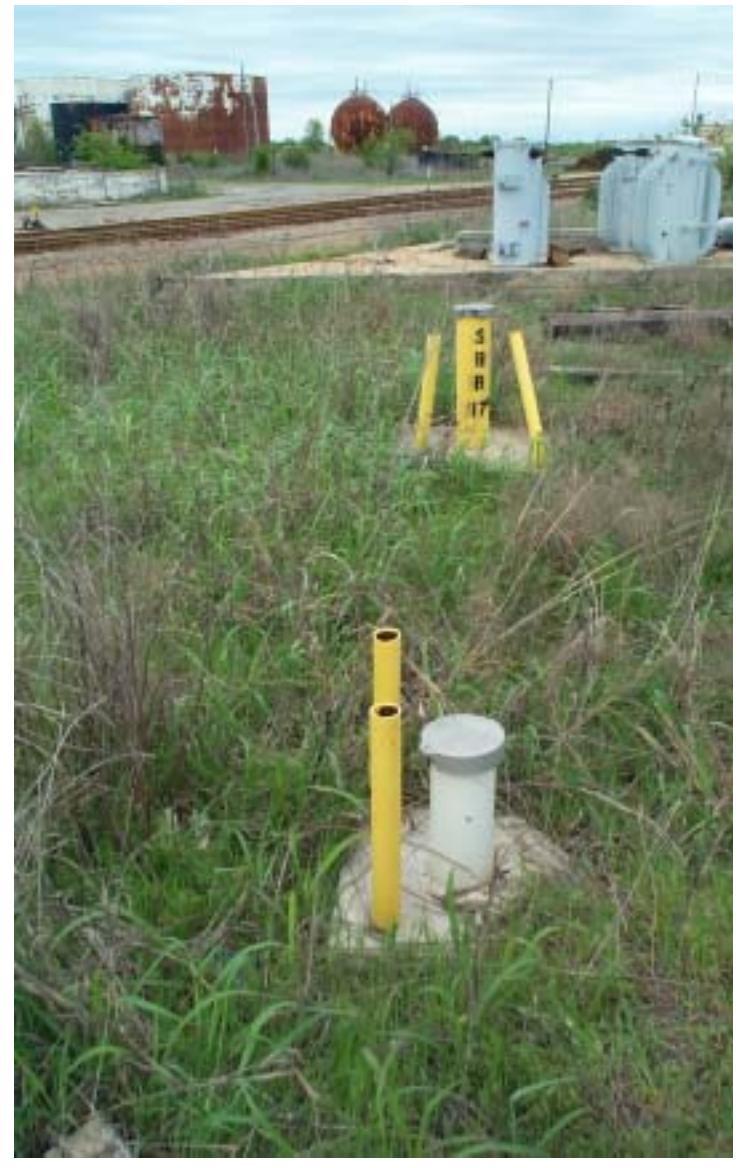
Photograph 39: Monitoring wells on CPC property. Damaged RCRA well in foreground.

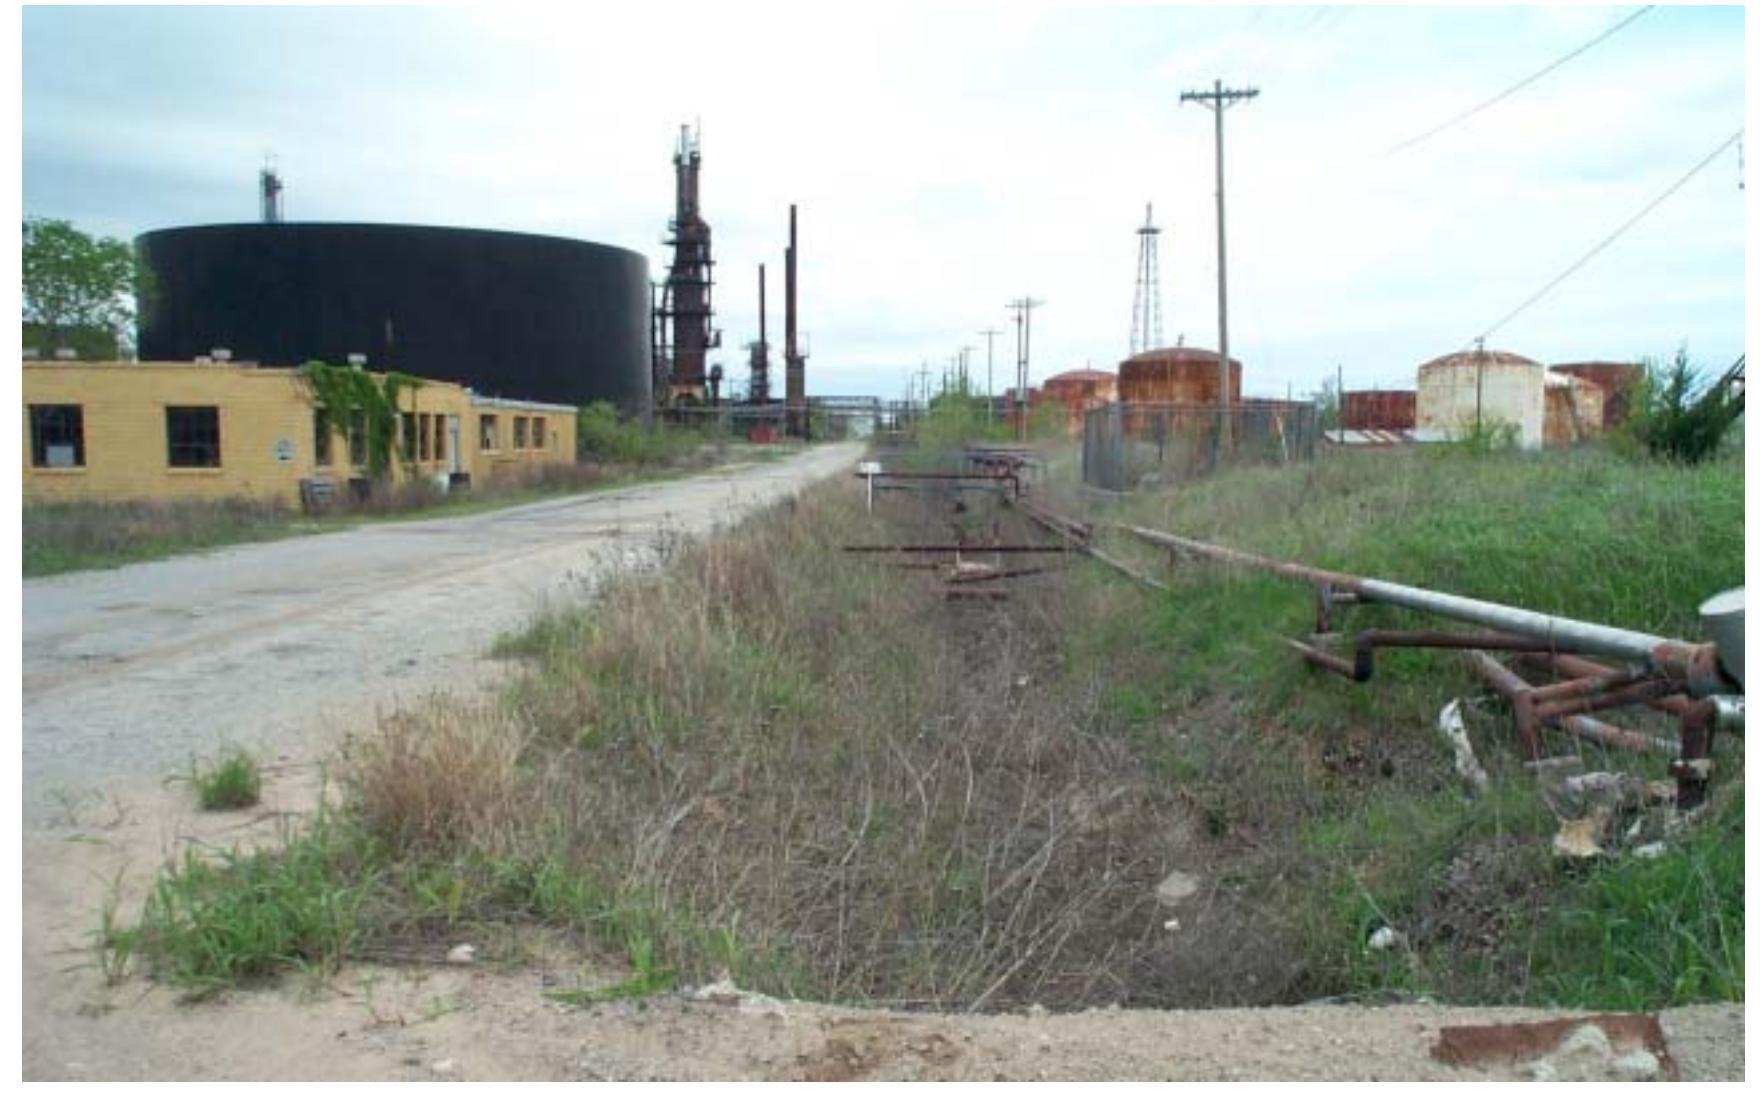
Photograph 40 of 46

Photograph 40: Looking west along surface water runoff ditch on CPC property, clogged by vegetation and debris.

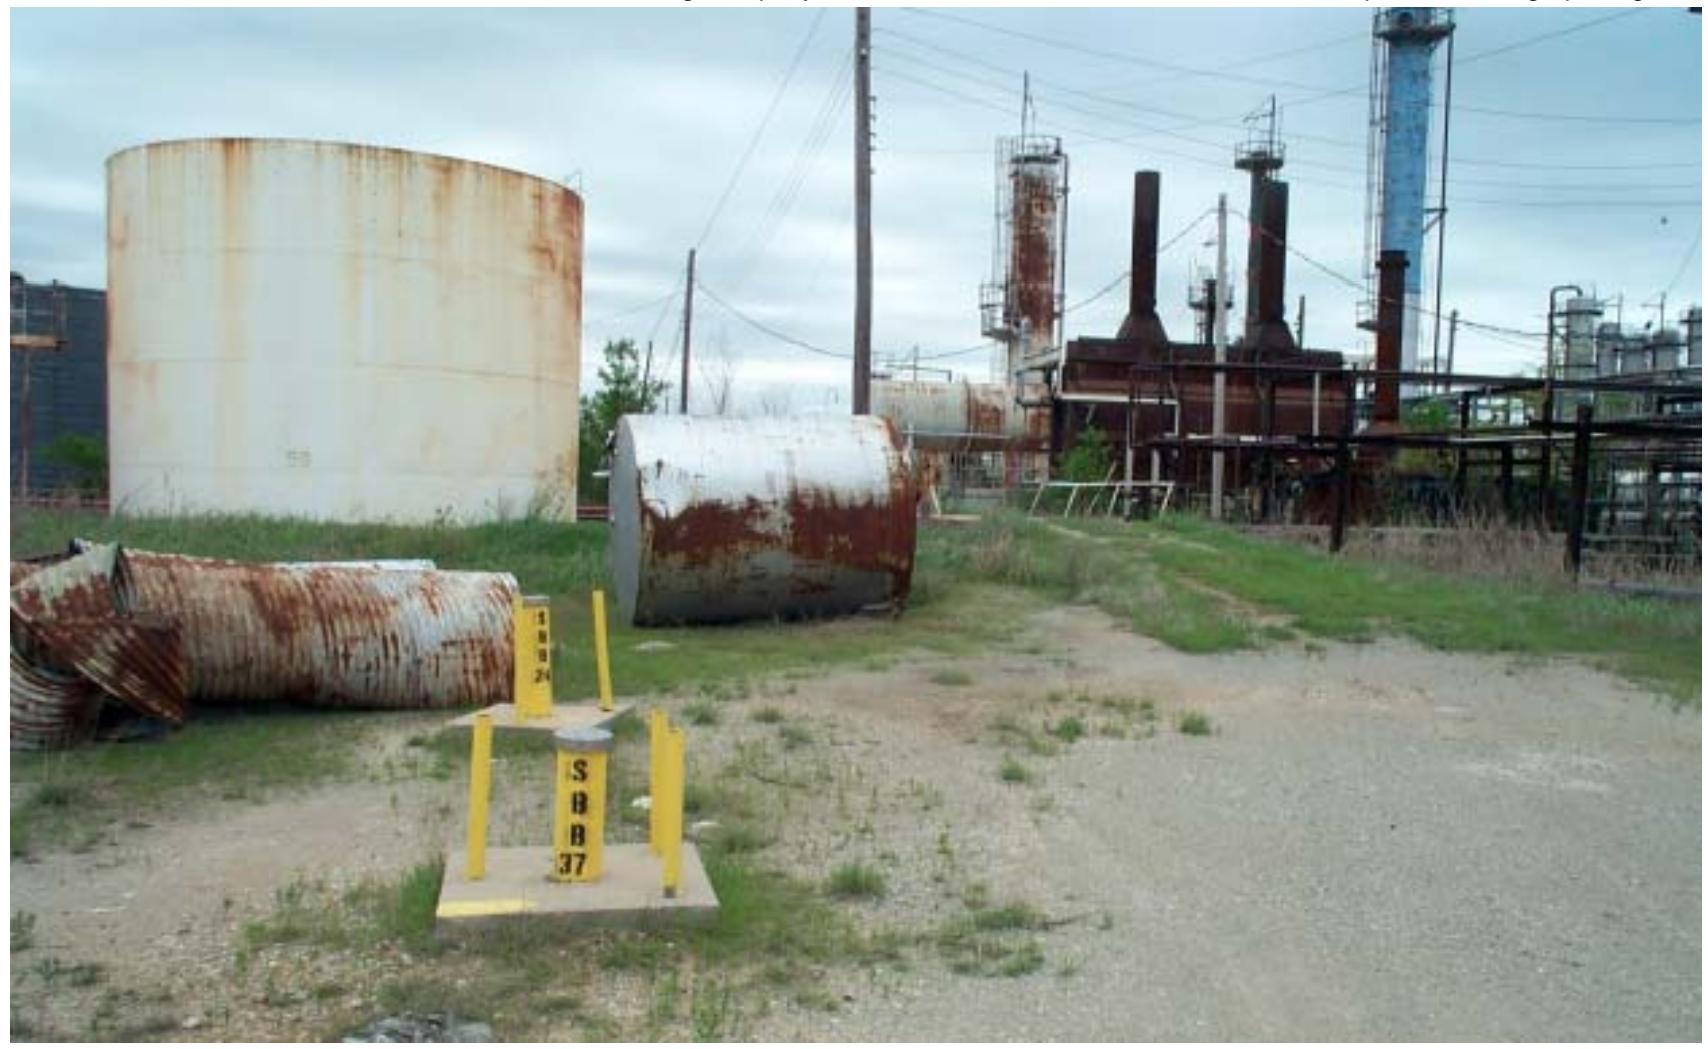
Photograph 41 of 46

Photograph 41: Groundwater monitoring wells on CPC property. Approximately 20 feet LNAPL measured in SBB37 (3-27-2002).

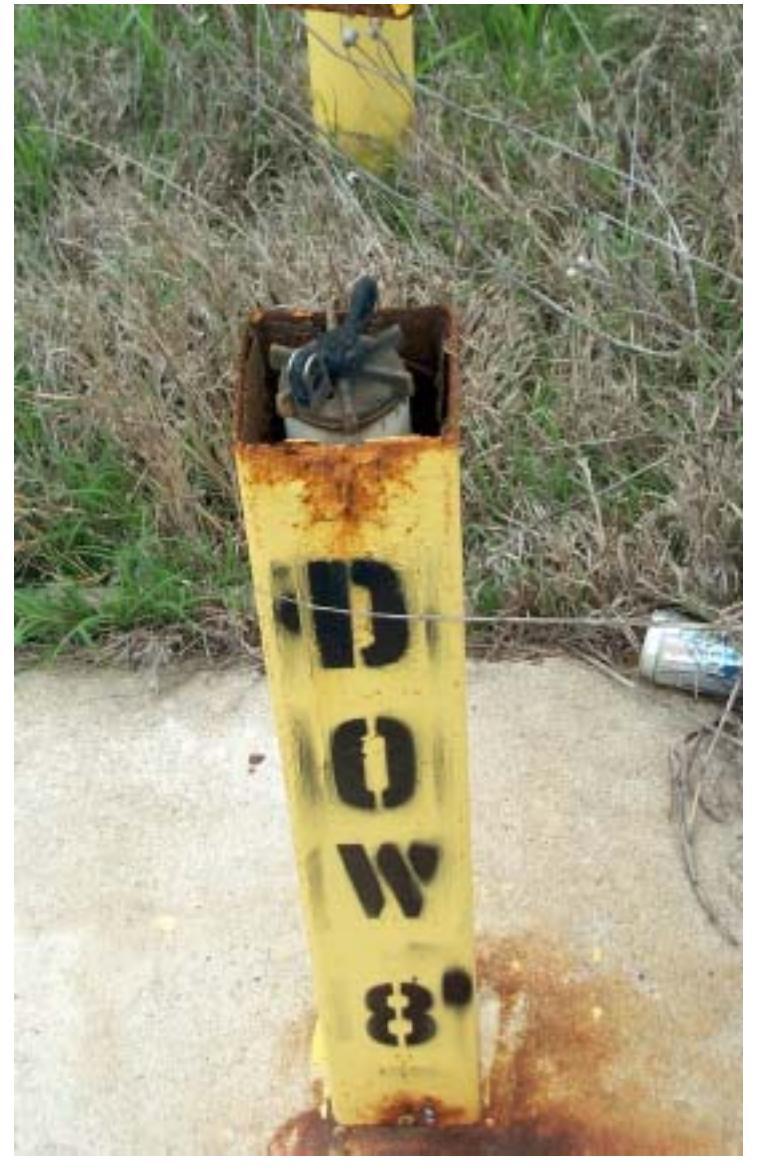
Photograph 42 of 46

<u>Groundwater</u>. LNAPL recovery and the groundwater remedy for the Site have been postponed until negotiations between Region 6 EPA and CPC or others regarding existing environmental problems under RCRA have been completed, or until groundwater monitoring results indicate that contaminated groundwater threatens Gladys Creek. The monitoring plan is in preparation by ODEQ. When submitted, this monitoring plan should include, at a minimum, in addition to groundwater monitoring parameters and procedures, sampling of discharge from observed seeps and the surface water of Gladys Creek, as well as procedures to address maintenance of both on and offsite monitoring wells. Also included should be delineation of the criteria that would necessitate an increase in monitoring or further action. Protective monitoring well casing for wells located offsite north of Highway 277 have been damaged by corrosion and need to be repaired to restrict trespasser access to these wells.

All existing onsite ground water monitoring wells were located during the ORC site visit. All surface completions were secure and in good condition (**Photograph Nos. 6, 25, 27, 36, 41, 45**) except for three wells located north of Highway 277. The locking covers for these wells, identified as DGR-03, DOW-07 and DOW-08, have been damaged by corrosion (**Photograph Nos. 42, 43**). The ODEQ representatives indicated that the corrosion was most likely due to the presence of hydrogen sulfide gas present in these wells.

Photograph 42: Ground water monitoring well located north of Highway 277. Protective casing damaged by corrosion (possibly hydrogen sulfide).

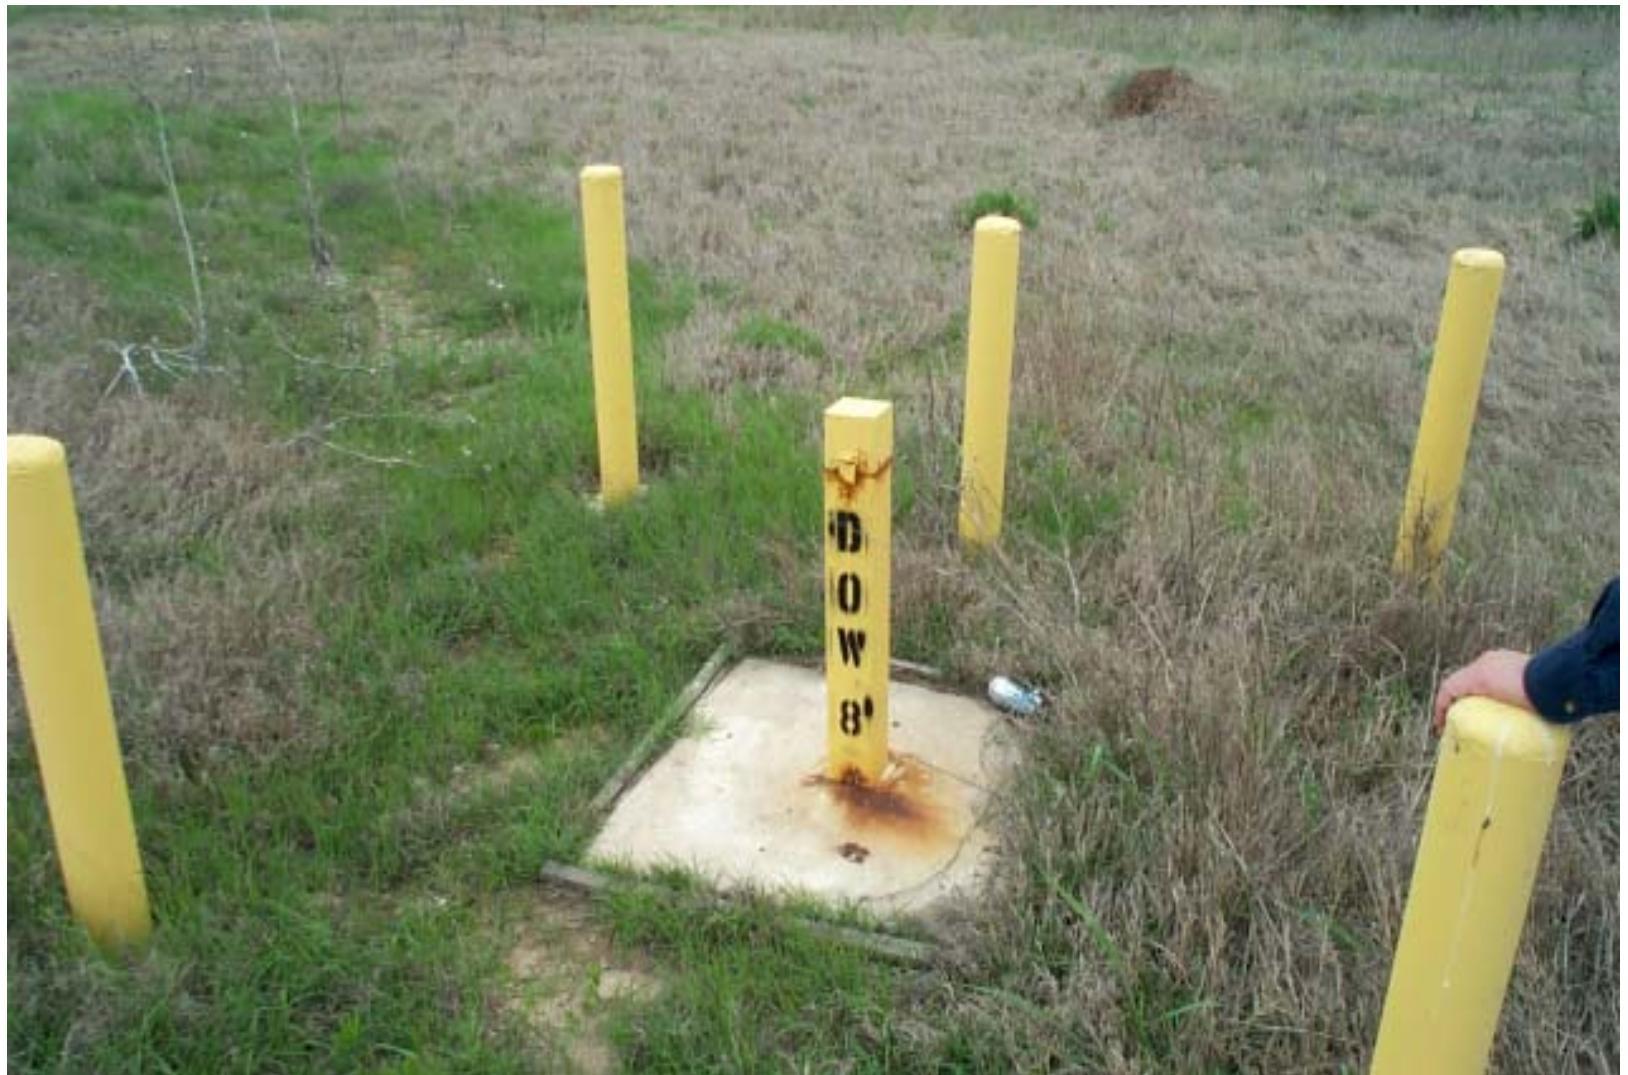
Photograph 43: Ground water monitoring well located north of Highway 277. Protective casing damaged by corrosion (possibly hydrogen sulfide). Photograph 43 of 46
