Third Five-Year Review Report for the Geneva Industries Superfund Site Houston, Harris County, Texas

September 2008

THIRD FIVE-YEAR REVIEW GENEVA INDUSTRIES SUPERFUND SITE EPA ID# TXD980748453 Houston, Harris County, Texas

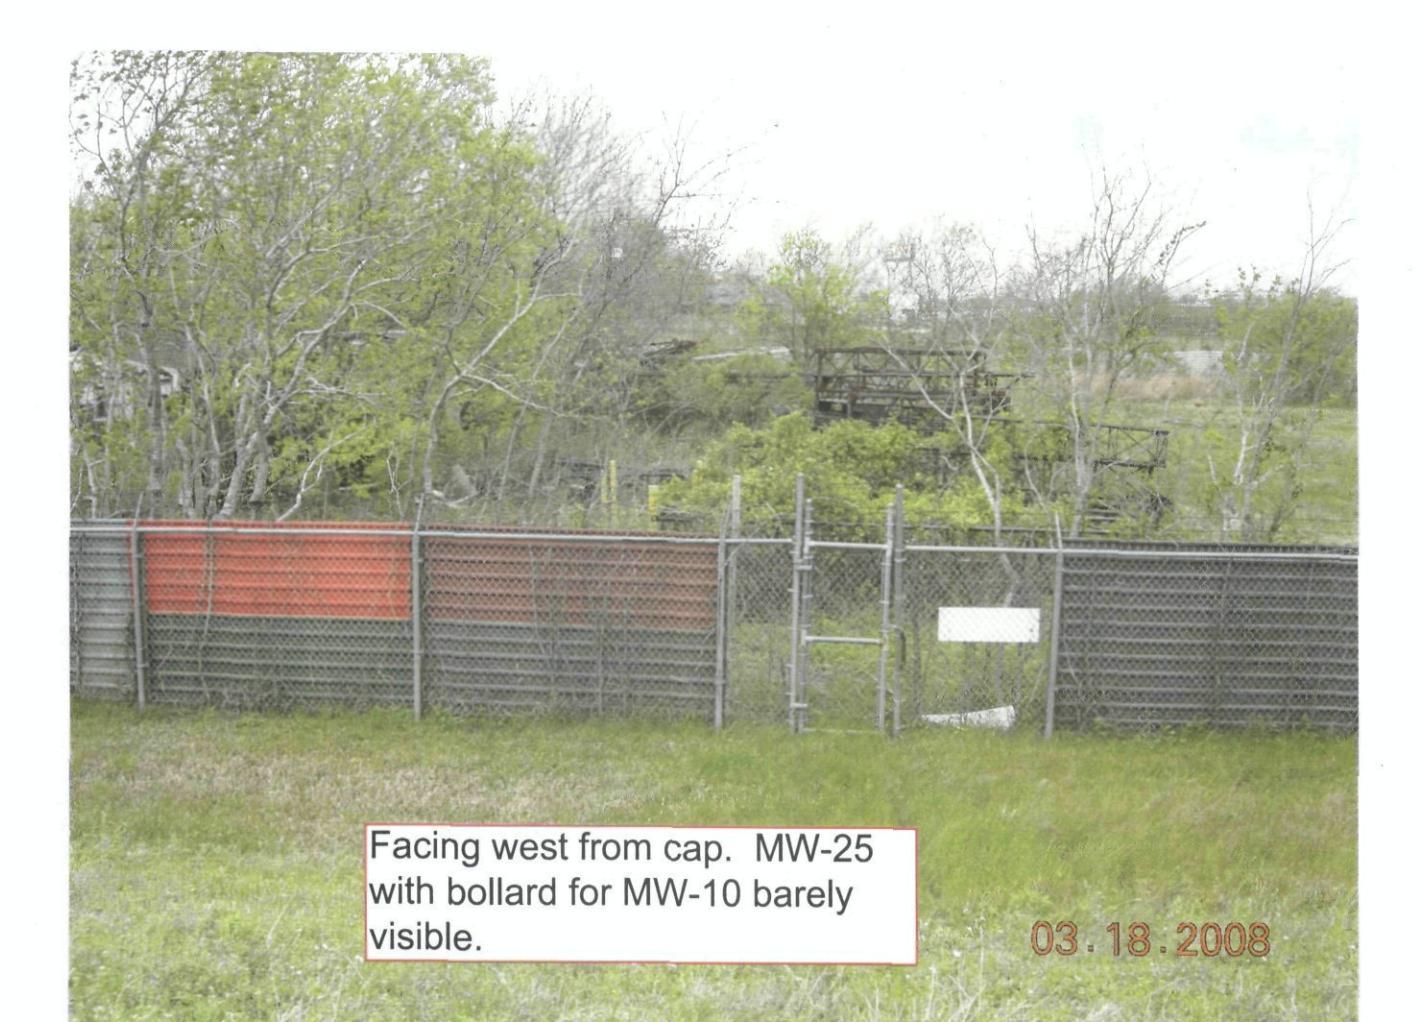
Facing west southwest from cap. Bollards for MW-25 with bollard for MW-10 barely visible.
