[Docket No. FAA-2006-25084; Directorate Identifier 2005-SW-38-AD]

Airworthiness Directives; Bell Helicopter Textron Canada Model 206L Series Helicopters

ACTION: Notice of proposed rulemaking (NPRM).

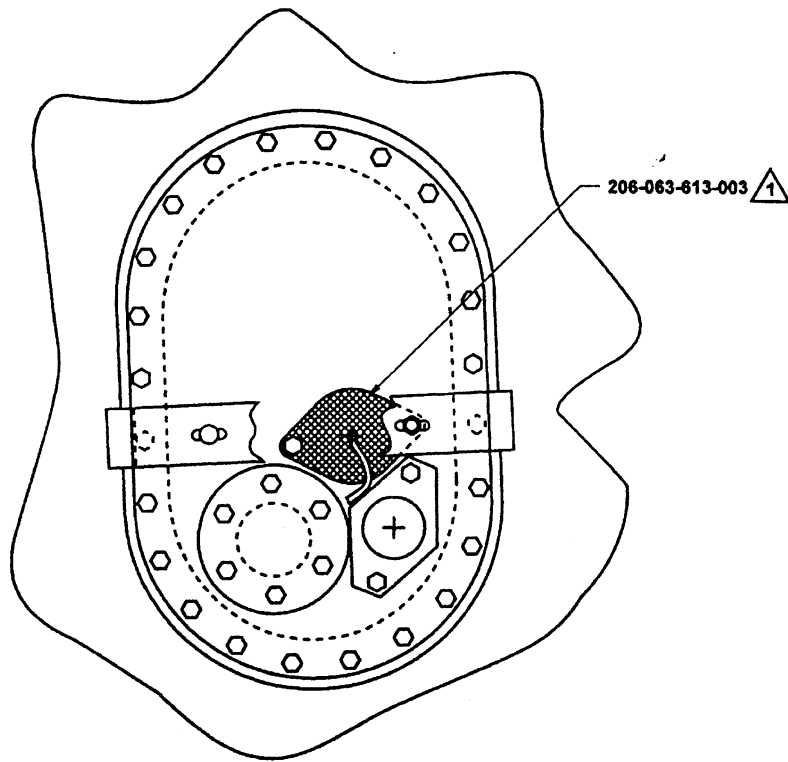
NOTE
1 Part number and serial number are located in the cross hatched area.

- (a) On or before the next 100-hour time-in-service inspection, determine whether the installed switch unit has a serial number listed in the applicability section of this AD. If the installed switch unit is one of the listed switch units, before further flight, replace it with an airworthy switch unit that has a serial number other than those listed in the applicability section of this AD. See Figure 1 of this AD for the location of the serial number.
