National Park Service  
U.S. Department of the Interior

**CULTURAL LANDSCAPE REPORT  
FOR  
SAUGUS IRON WORKS  
NATIONAL HISTORIC SITE:  
TWENTIETH-CENTURY PEDESTRIAN CIRCULATION**

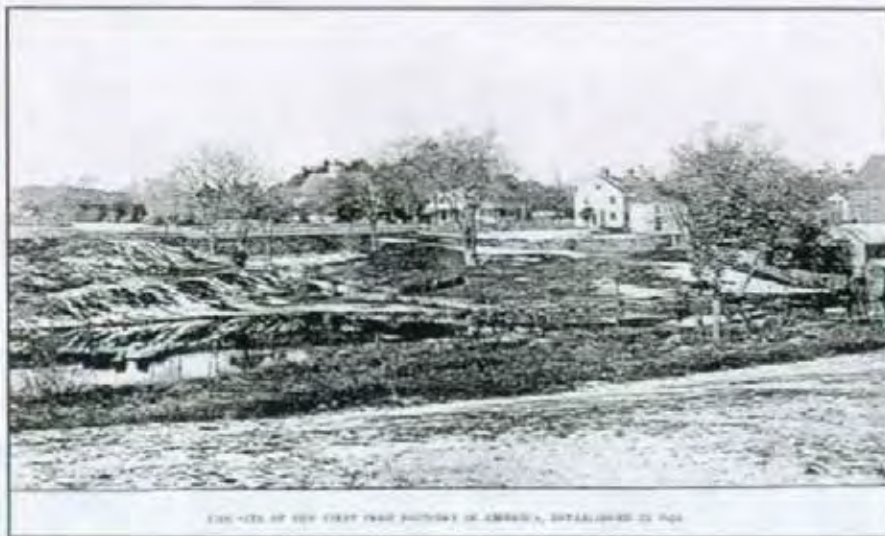
Figure 2.7. This early twentieth-century view looks northwest from the east bank of the river. Taken prior to archeological field work, it shows the slag pile and the Central Street retaining wall. The site's openness suggests its use as a pasture, although surrounding suburbanization had probably diminished this type of activity by this point. A conspicuous ell-shaped stone structure is visible on the opposite bank in the center of the photograph, possibly a foundation, well, or perhaps a sluice outfall from the iron works plant. (SAIR #186)

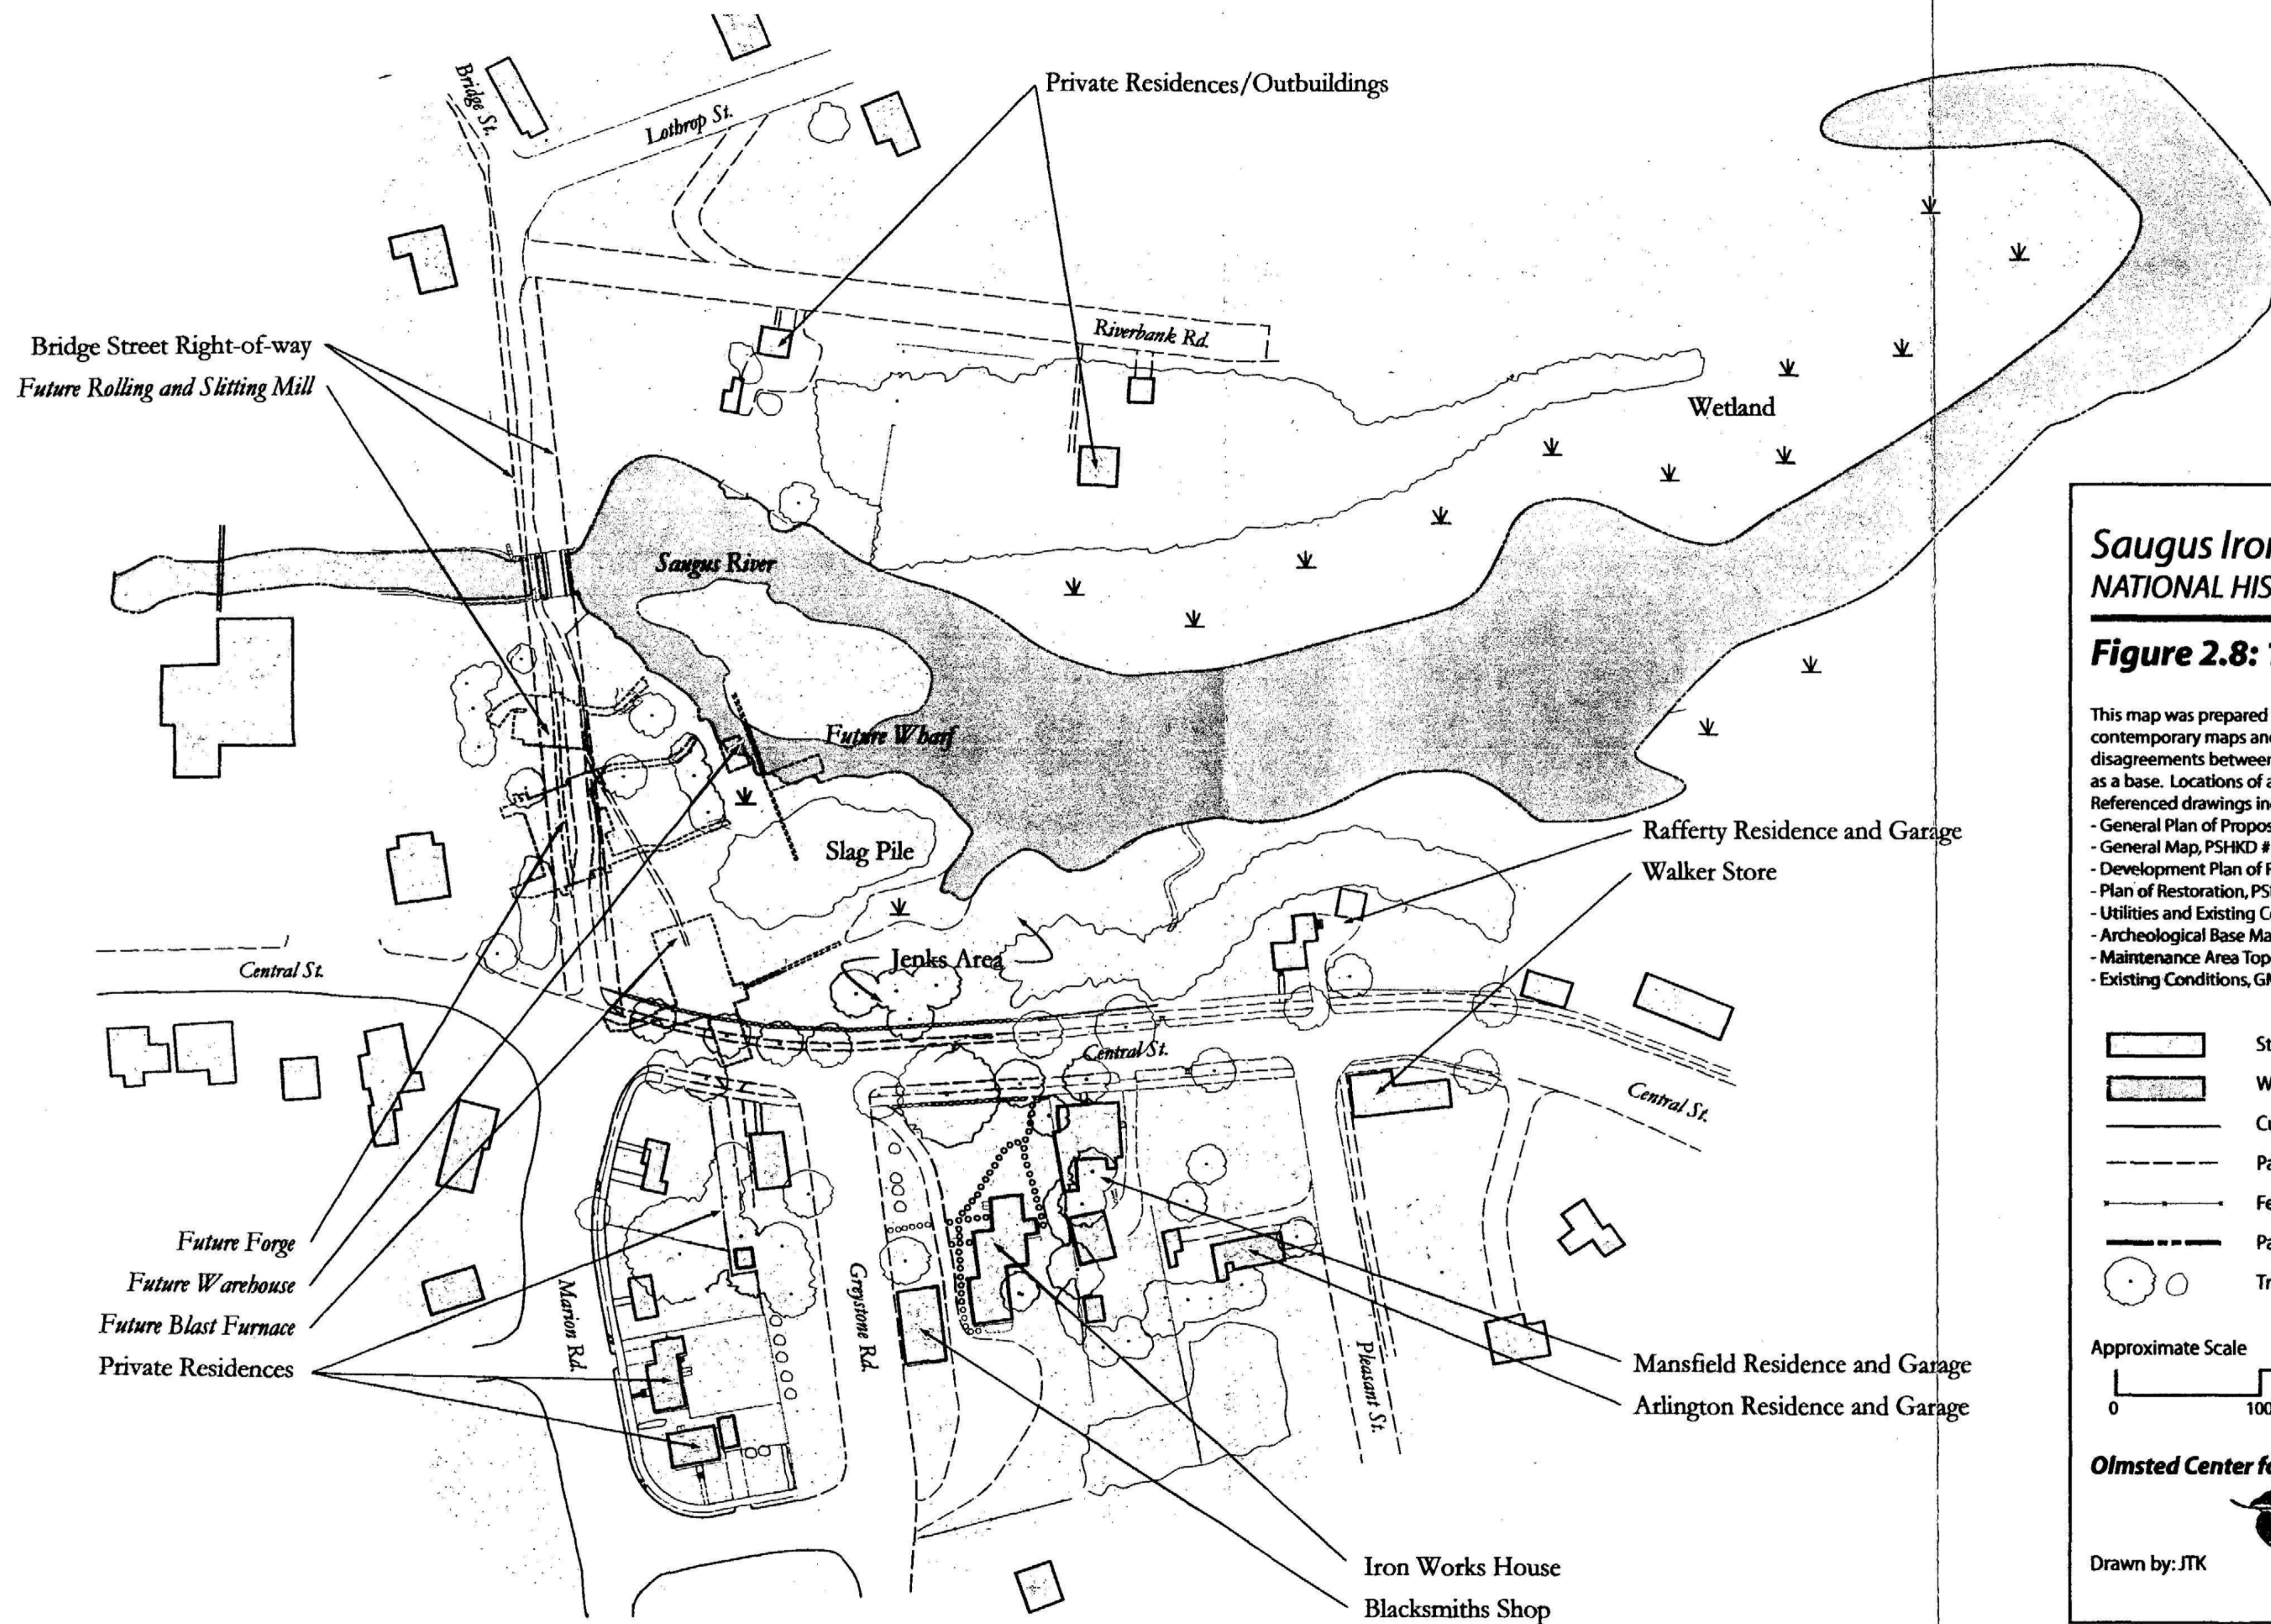
**Saugus Iron Works  
NATIONAL HISTORIC SITE**

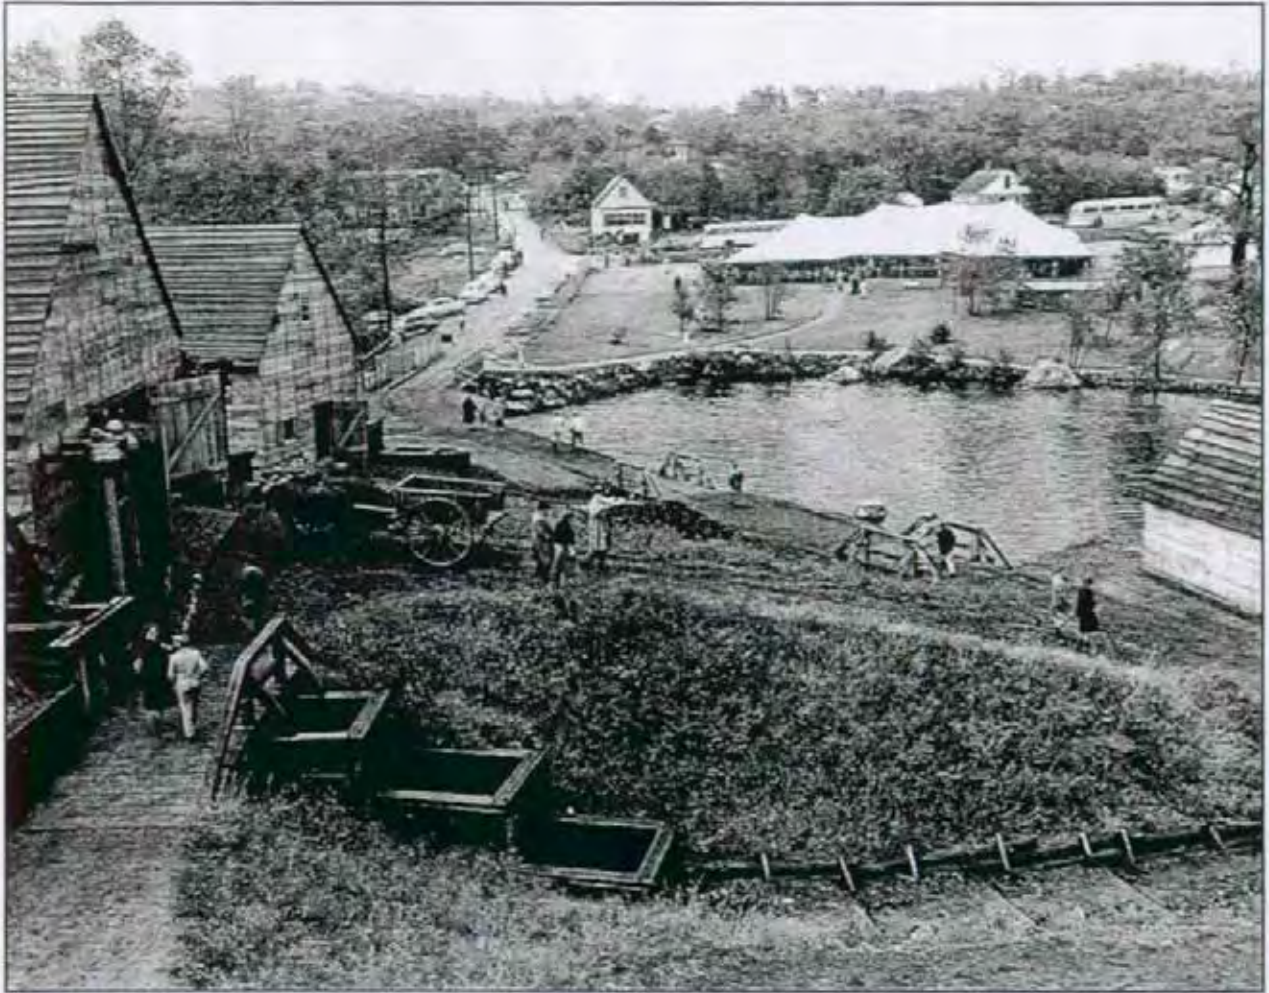
Figure 3.19. View looking east from the blast furnace at the First Iron Works, on dedication day in 1954. The east bank was a suitable location for the tent because of its ample space and uncluttered views toward the reconstructed iron works plant; extant shade trees would likely have prevented the setup of such a large tent in the upper terrace. On the east bank, the two paths extending from the riverside path to the tent are no longer extant, and the stone foundation of a demolished house is visible on the right side of the main tent. Note that along the water's edge and between the two visible footbridges there is no corduroy road; it was installed by FTWA at a later date. (SAIR #1269)

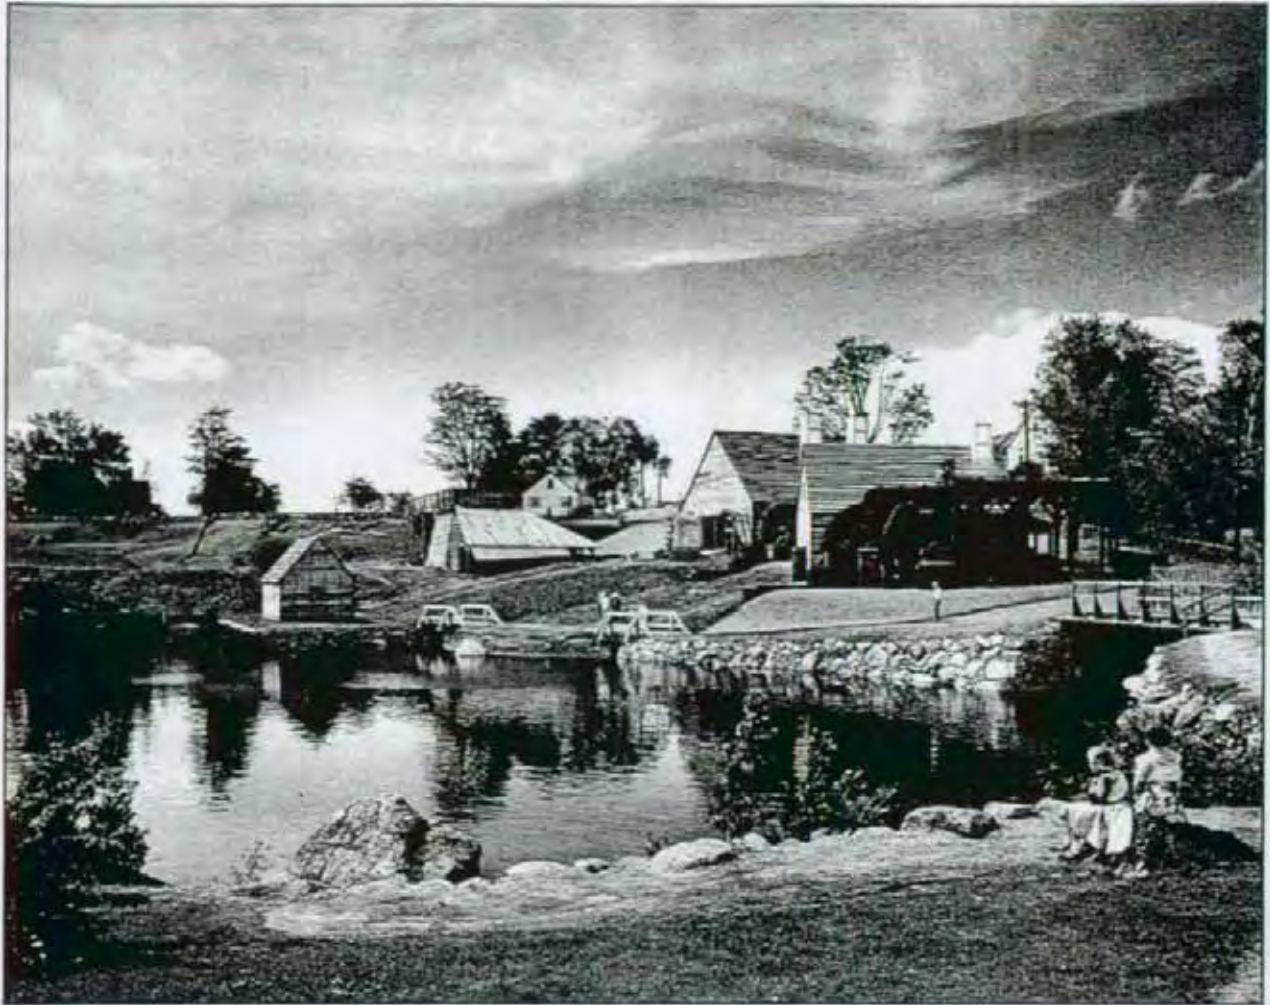
Figure 3.20. Picturesque view west toward the reconstructed iron works taken in 1954 or 1955. A dam breach a few years later would dramatically change this scene. (SAIR #1281)

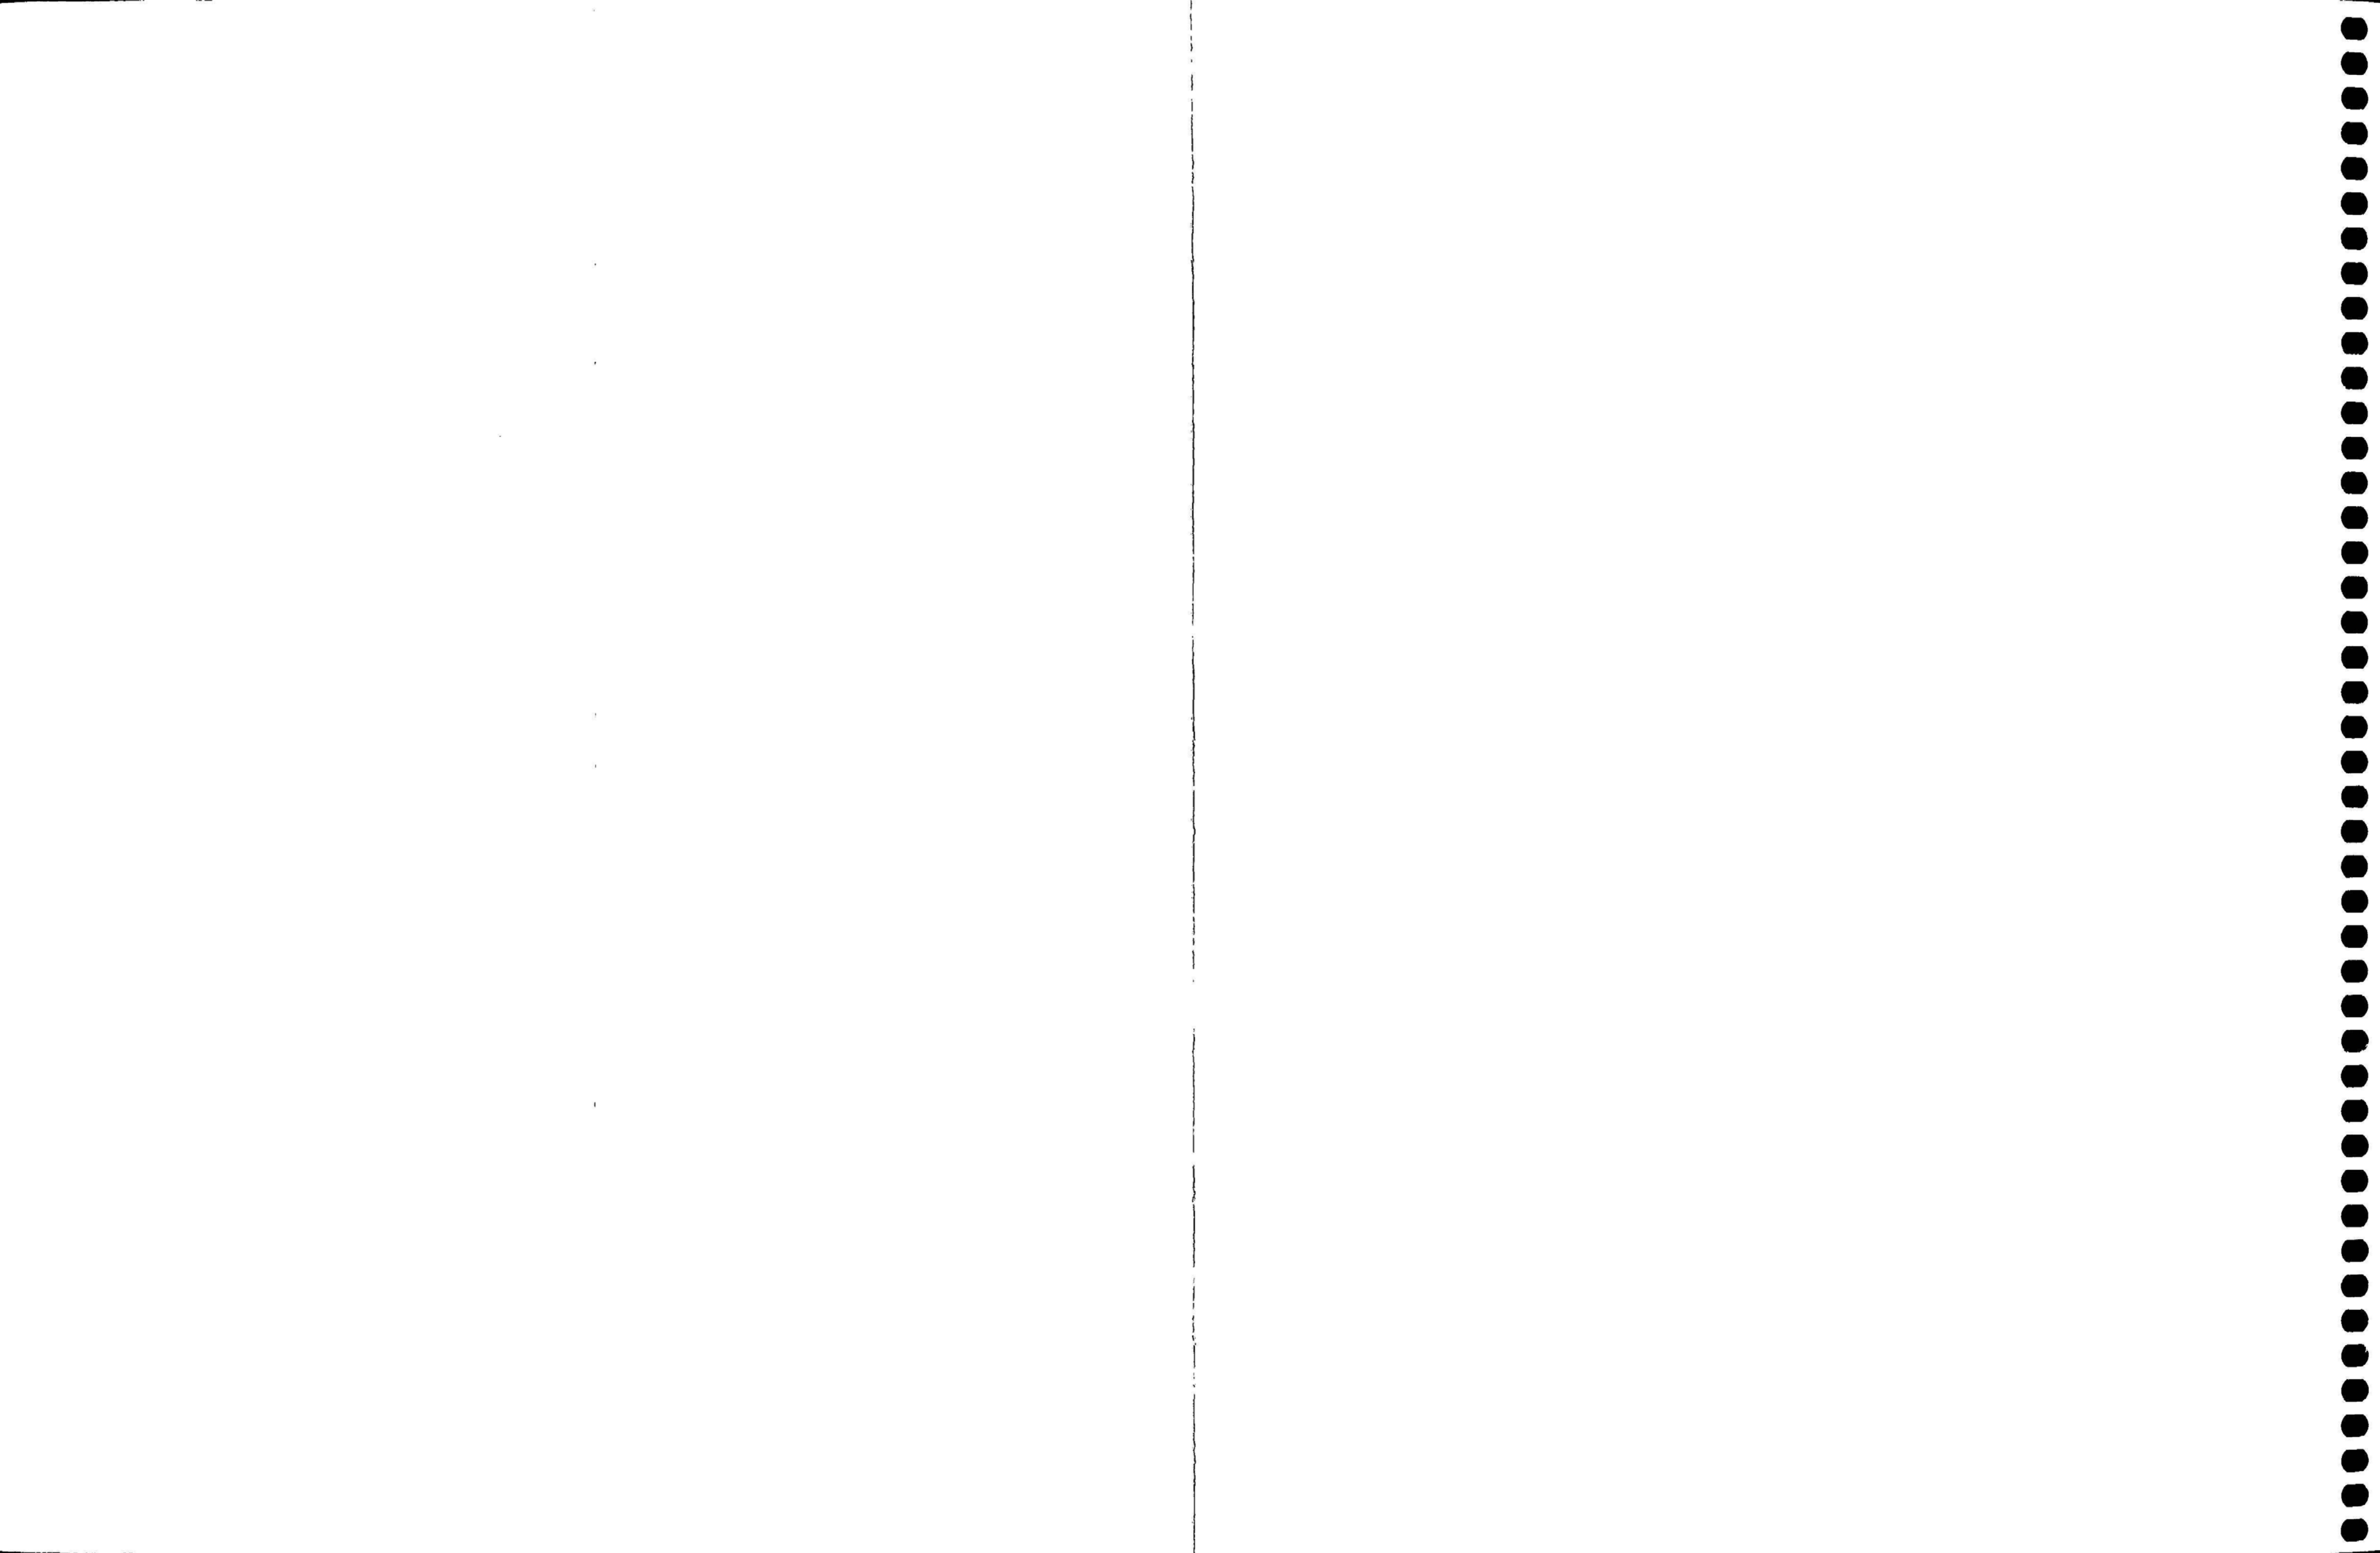
Drawn by: JTK   Date: 4-30-03

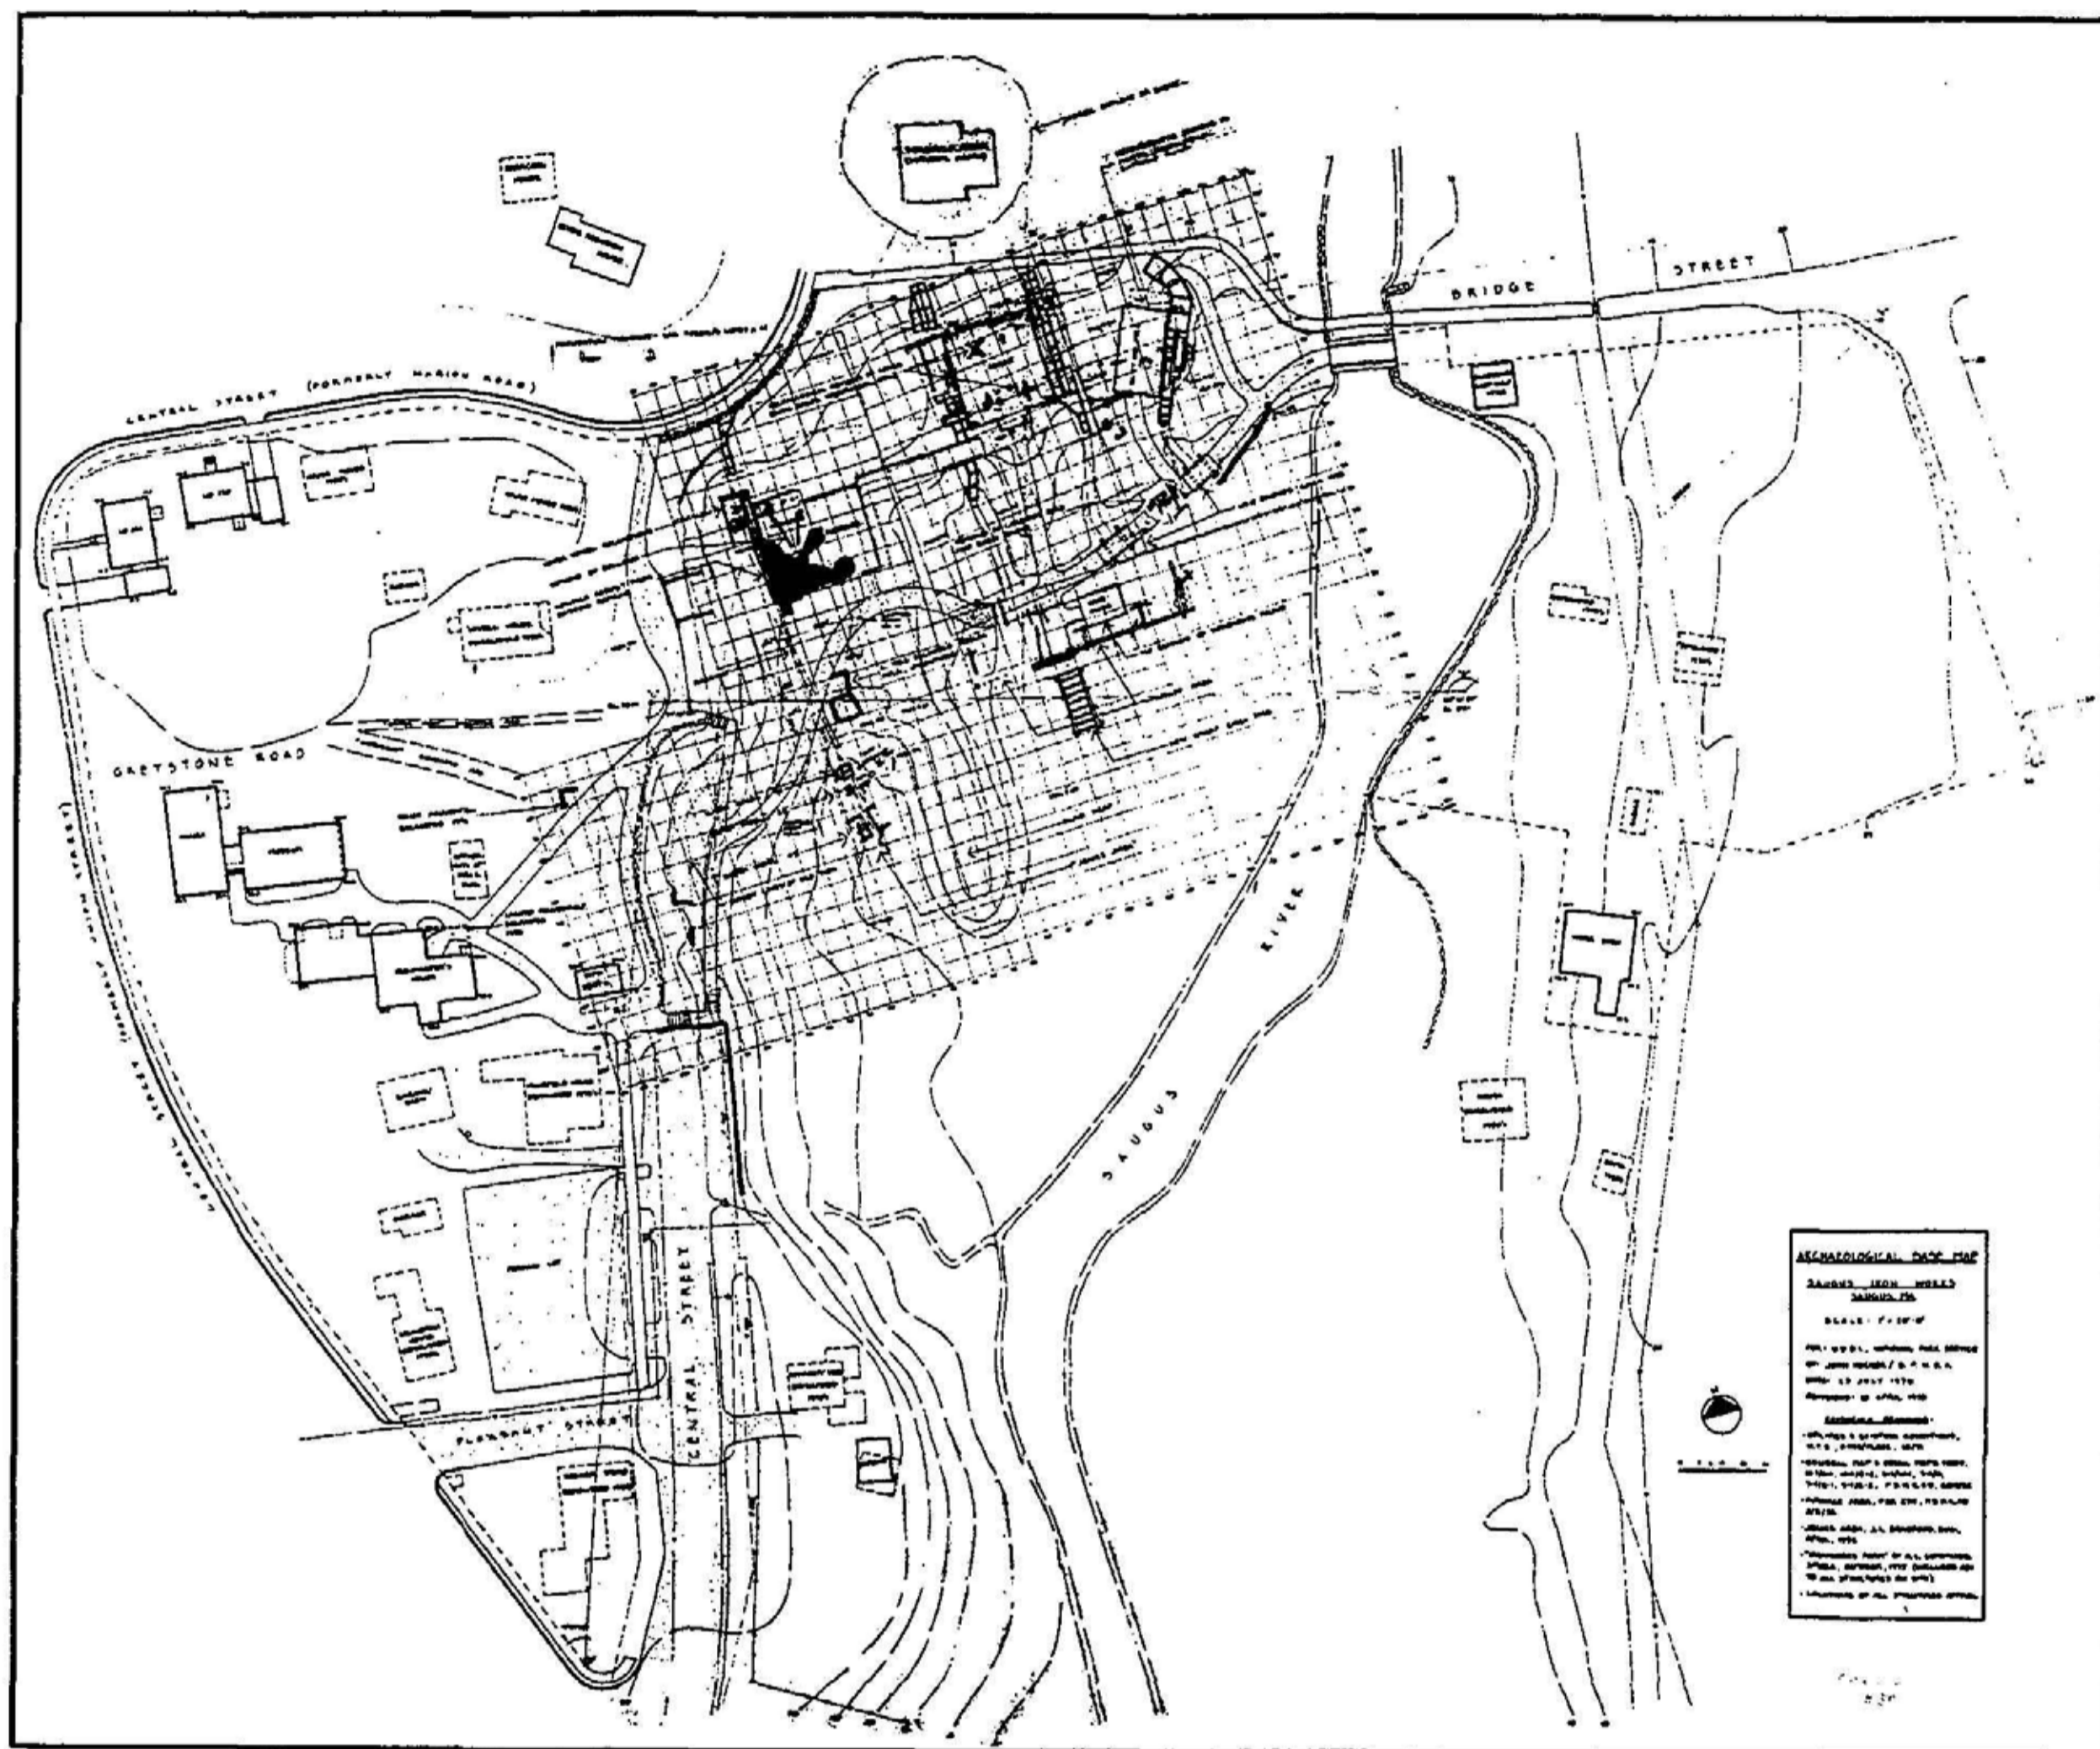
Figure 3.23. Produced in the mid-1970s, this base map shows many of the park's archeological features, including a waterway that possibly led to the Jenks area, a nineteenth-century barn next to the Iron Works House, and off-site locales of the holding basin, charcoal house, and other foundation remains. (BOSO: SPNEA/NPS, 1976/78)

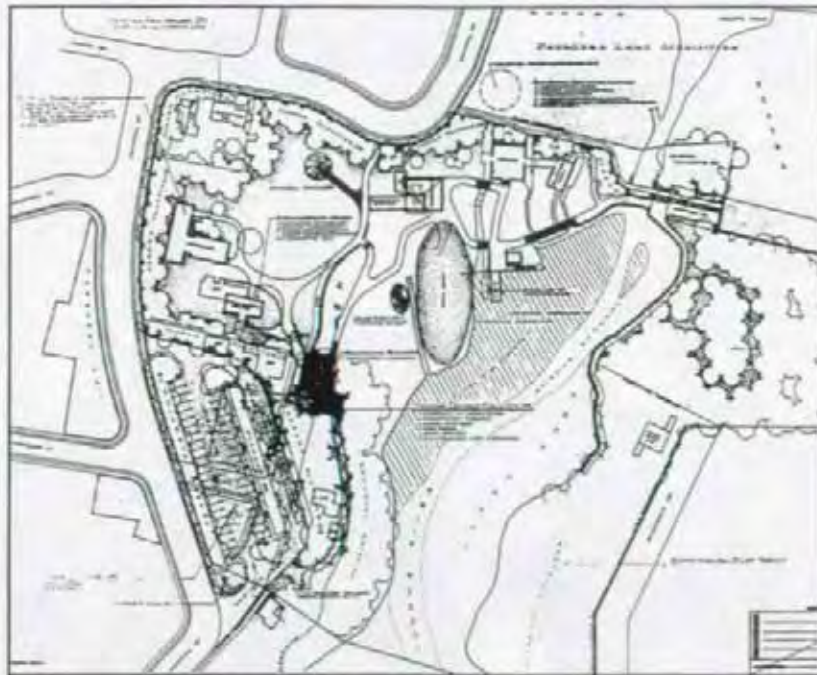
**Figure 3.24.** This plan, from the 1970s, proposed major reconfiguration of FIWA's circulation system. The expanded parking area features spaces for busses, one-way traffic flow with separate entrance and exit, and a drop-off area. The visitor contact station is replaced by an overlook visitor center, from which walkways arc to the Iron Works House, museum, and outdoor exhibits. Also note the hillside maintenance road, new land acquisition, and screen plantings. The plan was never implemented. (BOSO: Drawing #444/40002)

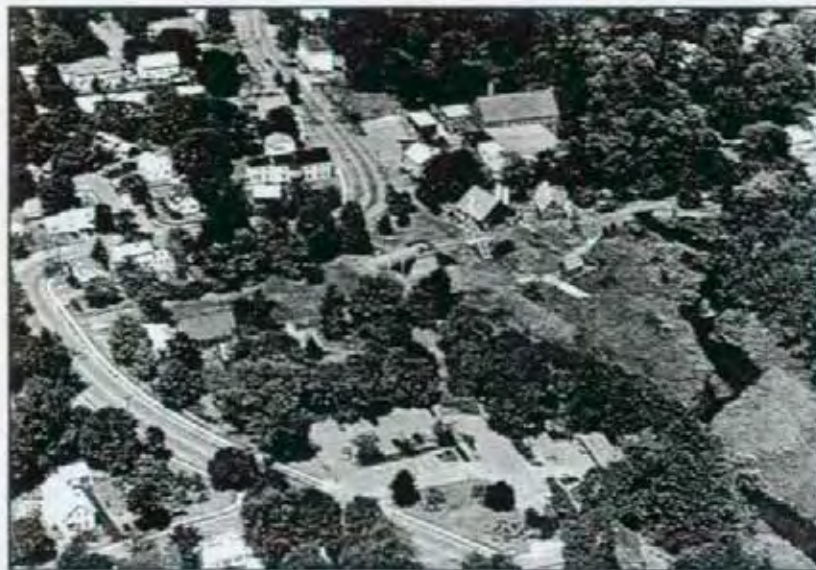
**Figure 3.25.** 1995 aerial view of the Saugus Iron Works NHS shows the vehicular entrance into the parking lot from Central Street, bus parking area, and maintenance garage. The clear view of the maintenance garage from the parking lot has caused some visitors to mistake it for the visitors center. Note the width of the river channel compared to the view in 1951/52, in Figure 3.6. (SAIR #2-5580)

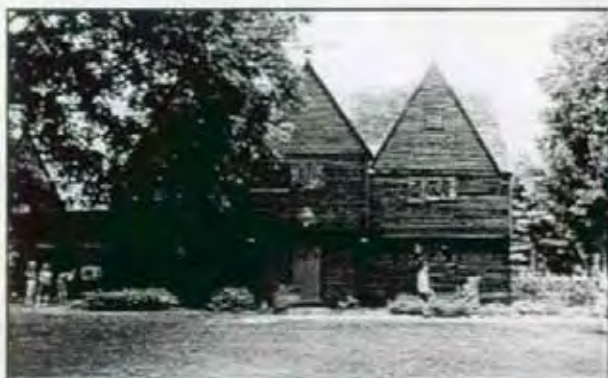
Figure 4.6. View looking north of the existing path in front of the Iron Works House. As recommended by the GMP, a new entrance gate and path is proposed from the parking lot to the front door, at which point it will turn left to a proposed visitor center in the Iron Works House Annex. (OCLP 2002)

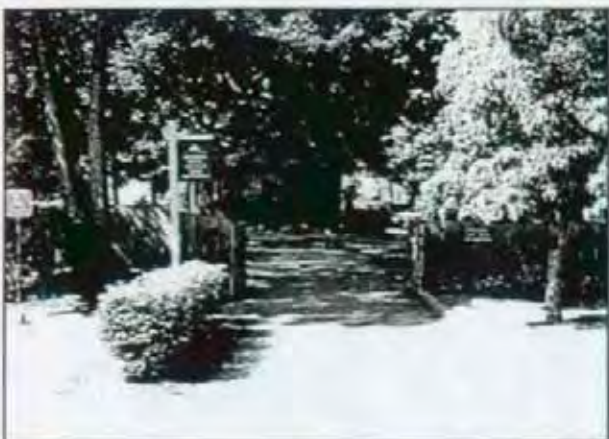
Figure 4.4. View looking north at the park's entrance gate and path leading to the visitor contact station. (OCLP 2002)

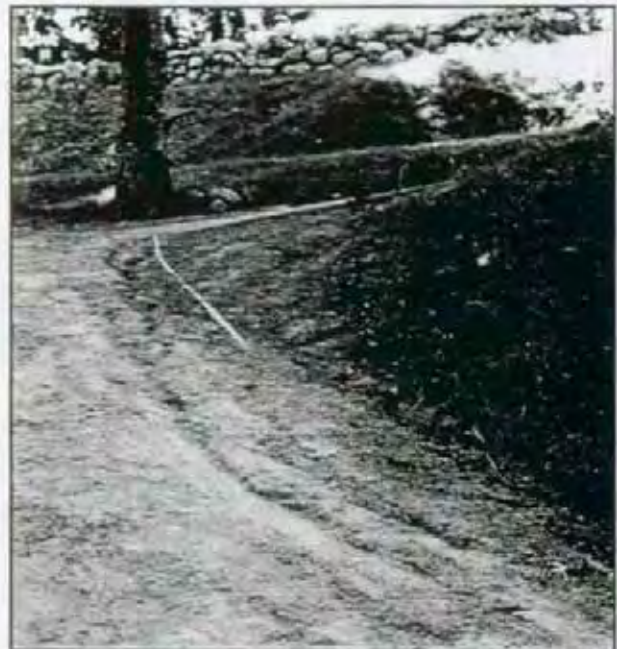
Figure 4.13. Close up view of the path on the slope showing runnels caused by heavy rainfall and their effect on the flexible trex border. (OCLP 2002)

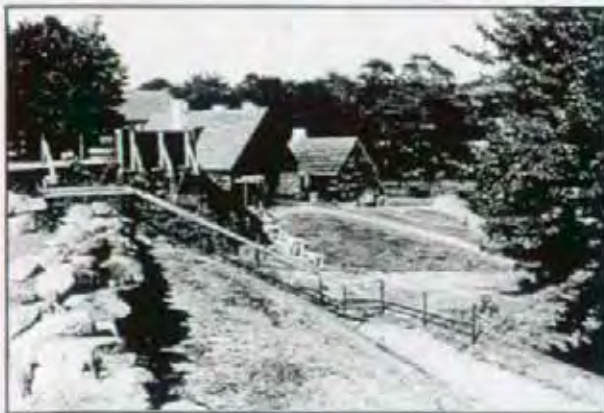
Figure 4.12. The north stairway marks the beginning of the park's National Recreation Trail. (OCLP 2002)

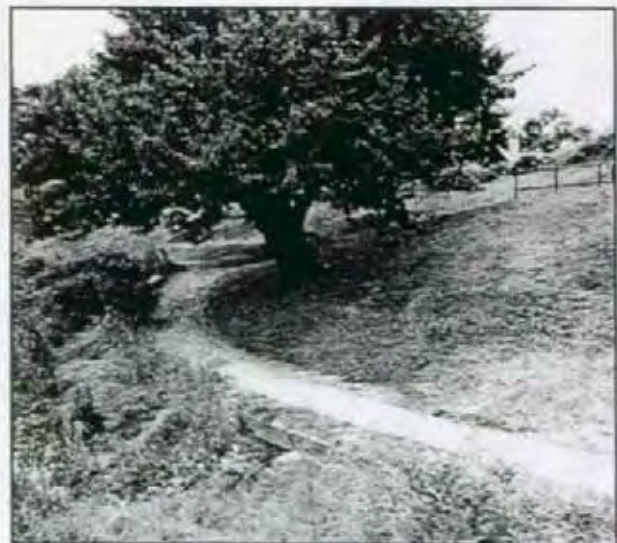
Figure 4.14. This segment of the path leading from the upper terrace to the industrial complex does not meet American with Disabilities Act requirements. Steep portions such as this, and in other areas of the industrial area, are chronically plagued with erosion problems that make for hazardous walking surfaces. (OCLP 2002)

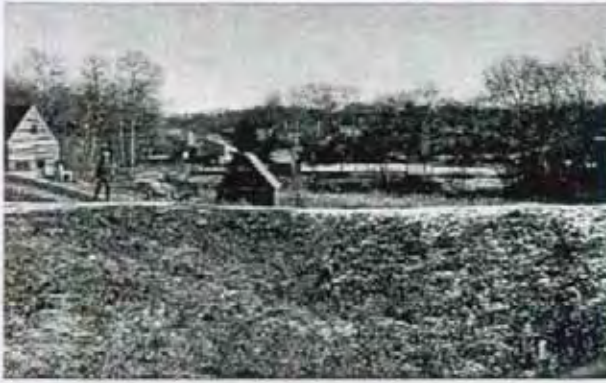
**Figure 4.15.** Without the benefit of a wayside or path, the slag heap appears to be just another hill. (OCLP 2002)

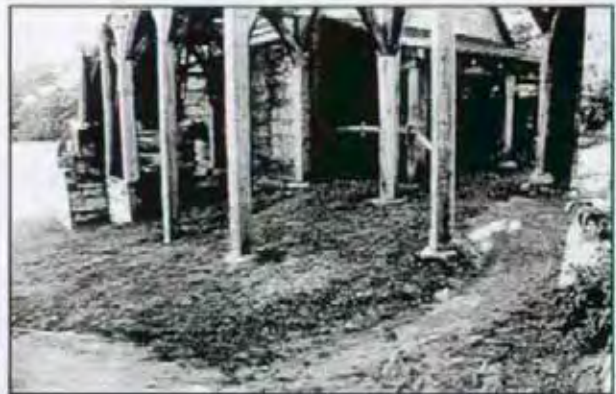
**Figure 4.18.** Upon exiting the rolling and slitting mill, visitors encounter an eroded switchback characterized by steep grades and loose gravel, creating dangerous walking conditions. (OCLP 2002)

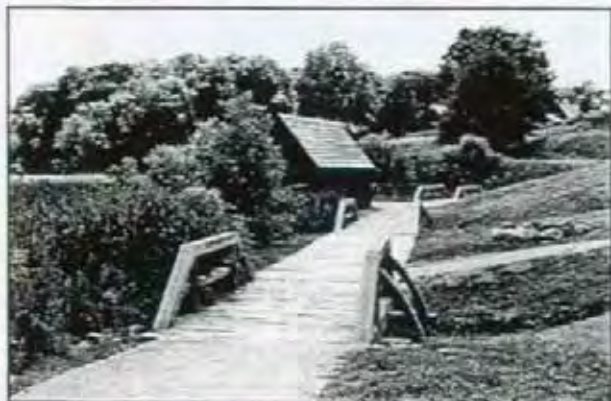
Figure 4.19. The three wood footbridges shown here are part of the park's National Recreation Trail and are in good condition. The corduroy road, between the first and second bridges in this view, was rehabilitated in 2001. Note the masses of invasive vegetation on the left; this would have been open water as late as 1957. (OCLP 2002)

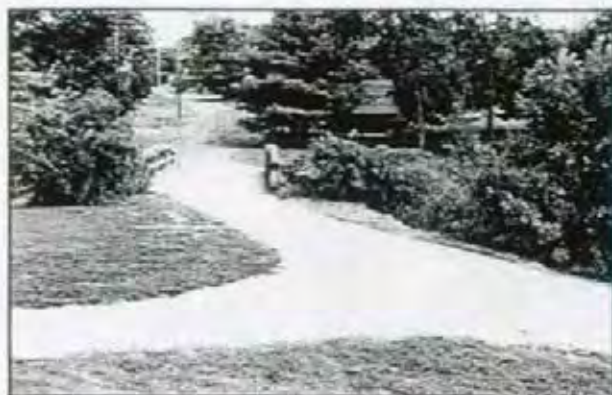
Figure 4.20. Compared to paths on the hillside and between the reconstructed buildings, the walkways alongside the river and on the east bank assume a more level grade. Portions of the deck and railing on the bridge crossing the Saugus River, shown here, are showing signs of deterioration. (OCLP 2002)

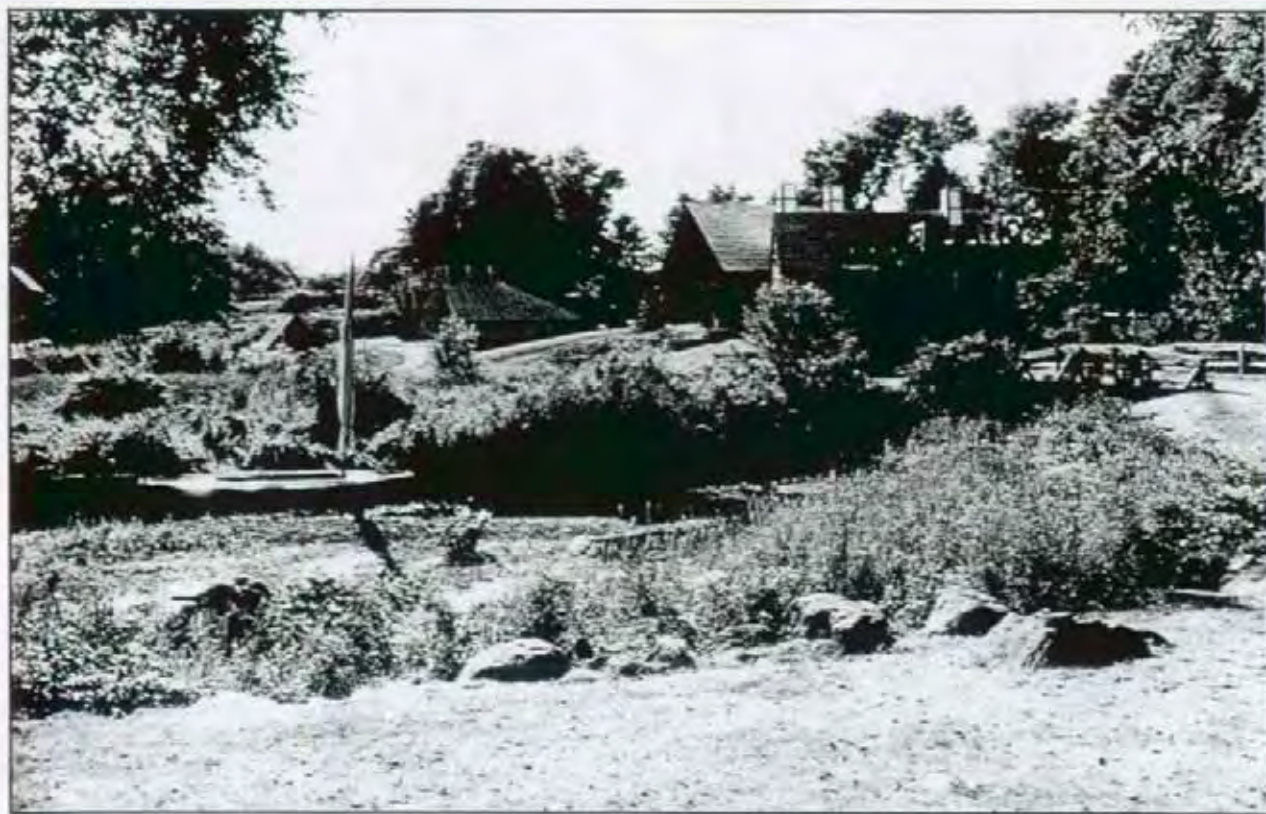
Figure 4.21. The park's National Recreation Trail parallels the shoreline of the Saugus as a grass path. Compare this contemporary view of the river with Figure 3.20 taken almost fifty years ago. (OCLP 2002)

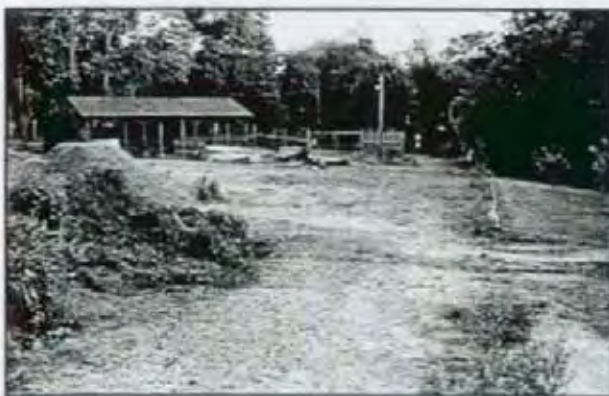
**Figure 4.24.** In this view of the maintenance yard looking south, erosion from stockpiles of organic materials have encroached into the lawn area. The maintenance yard is within clear view of visitors using the adjacent picnic area and should be screened with vegetation. (OCLP 2002)
