CULTURAL LANDSCAPE REPORT FOR PARK HEADQUARTERS

DENALI NATIONAL PARK & PRESERVE

SITE HISTORY, EXISTING CONDITIONS, ANALYSIS & TREATMENT

NATIONAL PARK SERVICE, BOSTON, MASSACHUSETTS, 2008

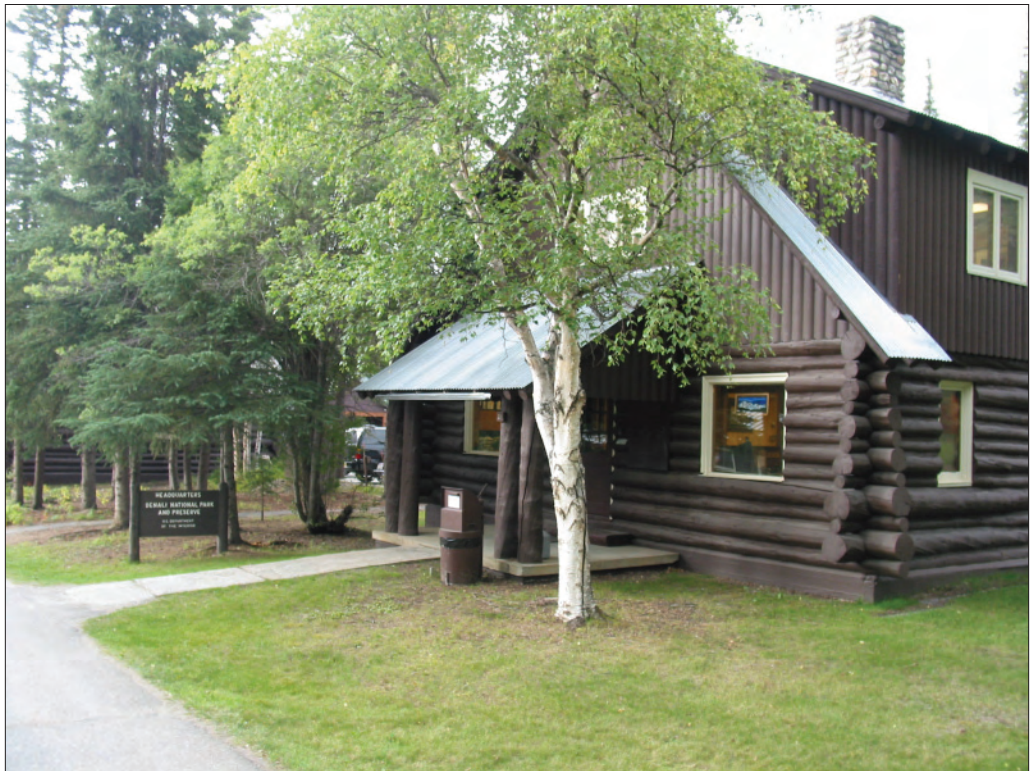
Figure 3.23. View southwest of the administration building (Building 21, original rangers' dorm), August 2005. Note building changes including the replacement windows and roofing material. Also note Building 101 (original warehouse, far left behind the grove of evergreen trees), the lawn around the building, and the asphalt main headquarters road at the left of the image (OCLP).

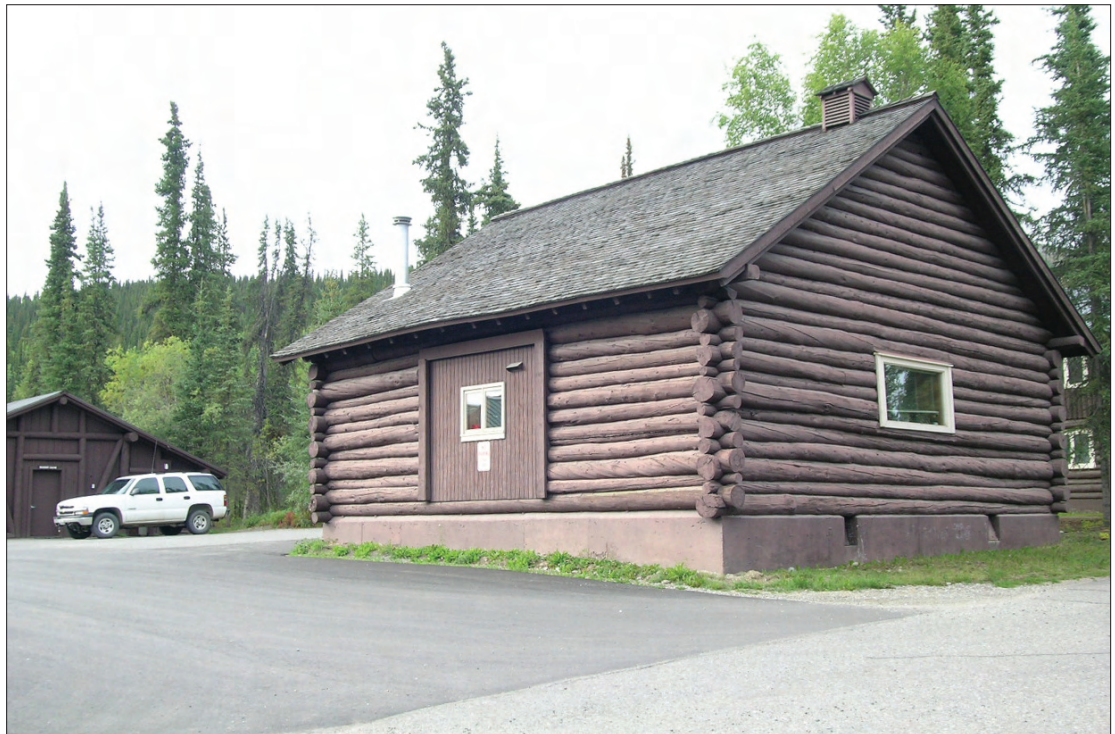
Figure 3.36. View looking northwest of Building 101 (original warehouse), August 2005. Note building changes including the in filled double doors, roof surface, concrete foundation, and absence of the loading dock. Also note the garage (Building 103) at left and the asphalt service road foreground and main headquarters road at right (OCLP).

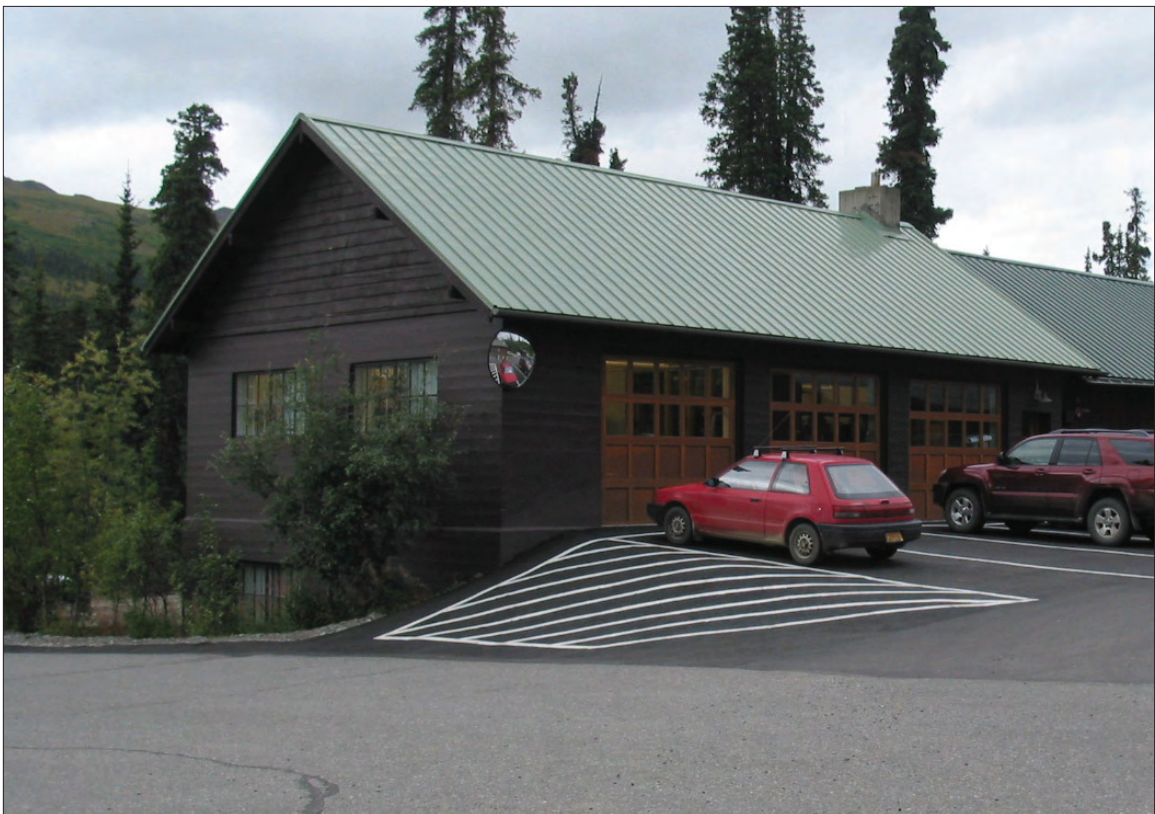
Figure 3.38. View looking southwest toward Building 102 (original garage and repair shop), August 2006. Note building changes including the painted concrete exterior and the roof surface. Also note the asphalt pavement leading to faux garage doors (parking spaces), service court at right, and the north-south headquarters road at left in the foreground (OCLP).

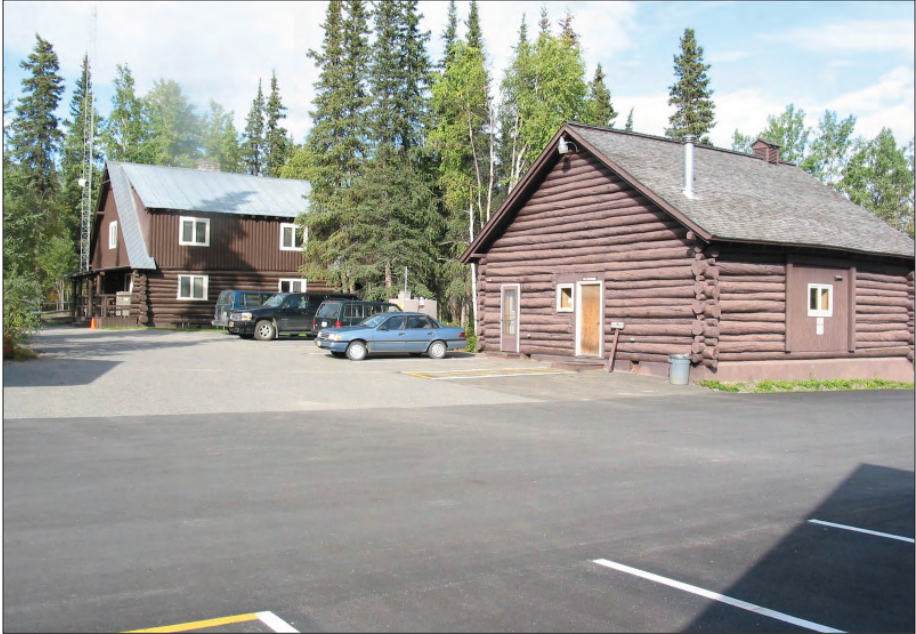
Figure 4.9. Circulation and Parking - Eliminate central parking and through-traffic - Treatment Tasks 1.A and 1.C - Remove bituminous pavement proliferating at the center of the district after WWII. Existing conditions shown above detract greatly from the historic character of the property (OCLP, 2006).

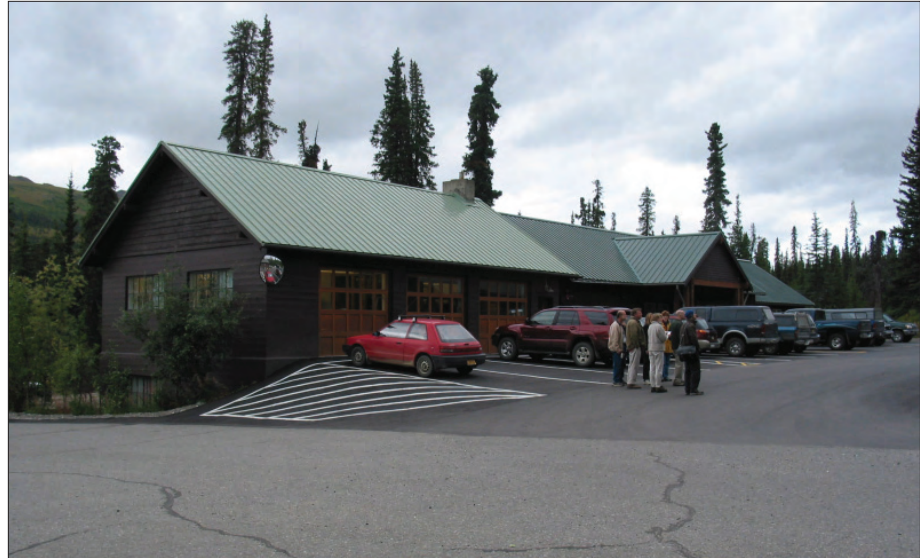
Figure 4.15. Circulation and Parking - Eliminate central parking and through-traffic. Treatment Tasks 1.A and 1.C - Eliminate parking and through-traffic from the center of the historic district; install traffic control measures. Existing conditions shown above include an abundance of bituminous concrete installed after 1945 to facilitate staff parking. These conditions detract greatly from the historic character of the property (OCLP, 2006).

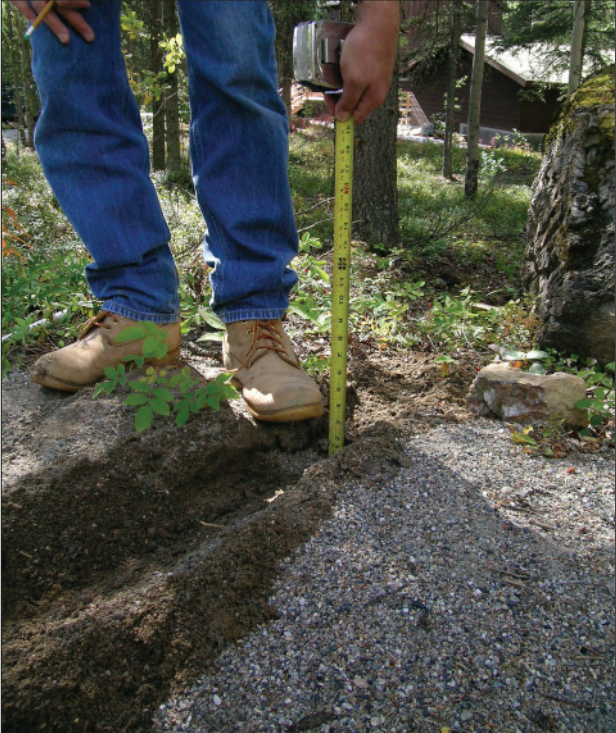
Figure 4.17. Circulation and Parking - Enhance Roadside Character and Vegetation - Treatment Task 2.A - Remove windrows of sand found developing at road shoulders. Accumulations of sand develop into windrows at the shoulder of Denali Park Headquarters roadways impeding the flow of surface drainage from the roadway, and destroys roadside vegetation (OCLP, 2006).

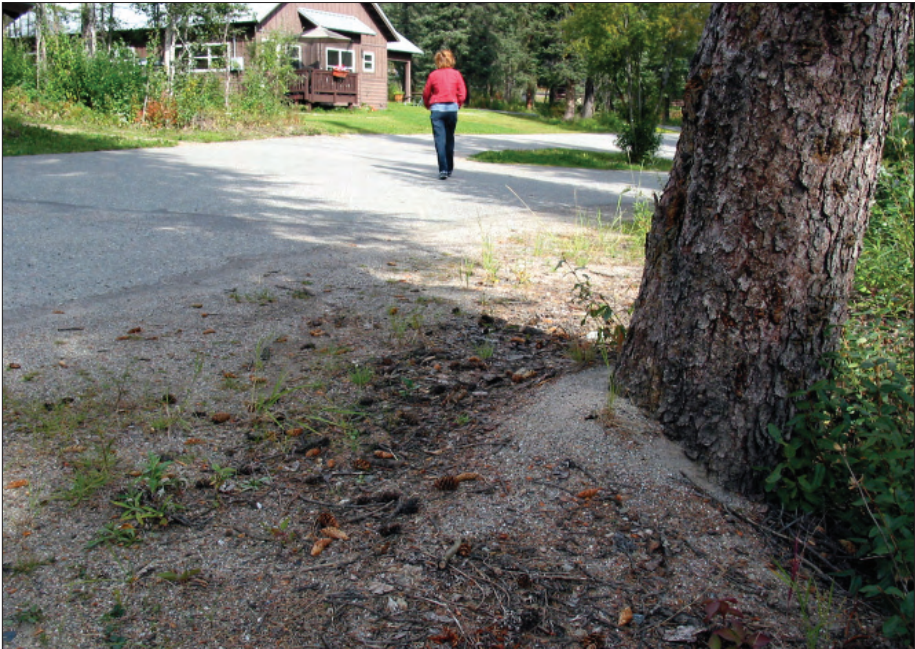
Figure 4.18. Circulation and Parking - Enhance Roadside Character and Vegetation - Treatment Task 2.A - Remove windrows of sand found developing at road shoulders. Over time, accumulation of roadside sand, has the visual effect of widening the roadway, promoting roadside parking that further damages vegetation (OCLP, 2007).

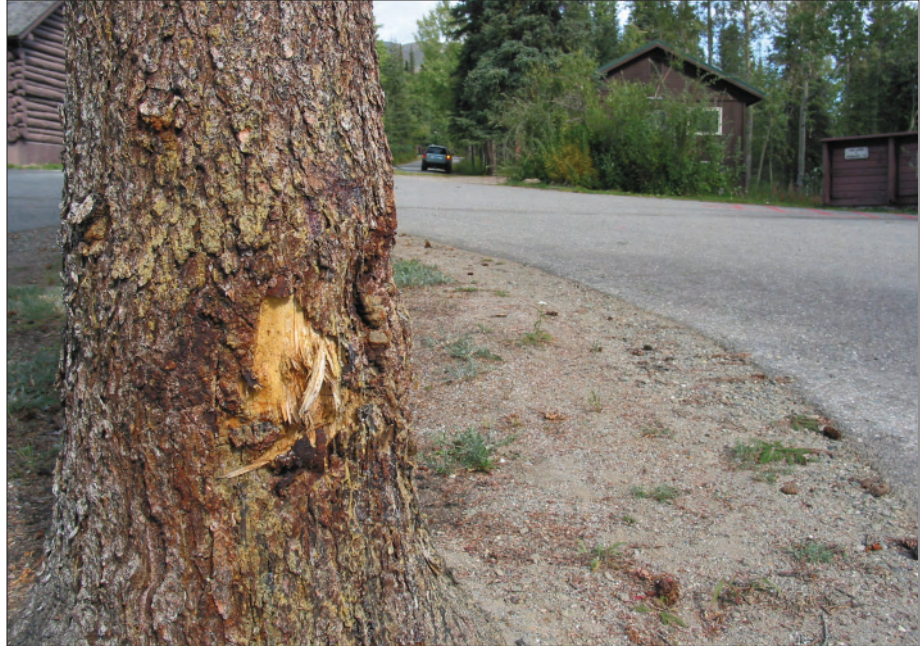
Figure 4.19. Circulation and Parking - Enhance Roadside Character and Vegetation - Treatment Task 2B - Protect roadside trees and vegetation by installing limited numbers of non-historic boulder barriers. Unrestricted roadside parking within the Denali Park Headquarters District is the cause of soil compaction and mechanical damage to roadside vegetation (OCLP, 2006).

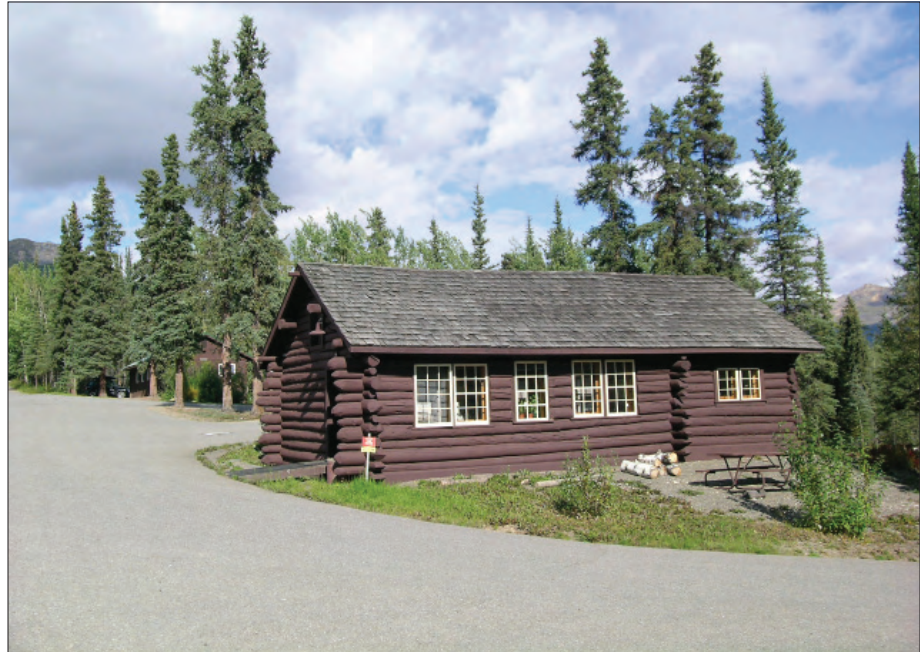
Figure 4.22. Circulation and Parking - Enhance Roadside Character and Vegetation - Treatment Tasks 2.B, 2.C and 2.D - The piecemeal widening of roadways and paved surfaces as illustrated by this photograph, have encroached on the setting of historic log buildings and compromises the historic character of the Denali Park Headquarters District (OCLP, 2006).

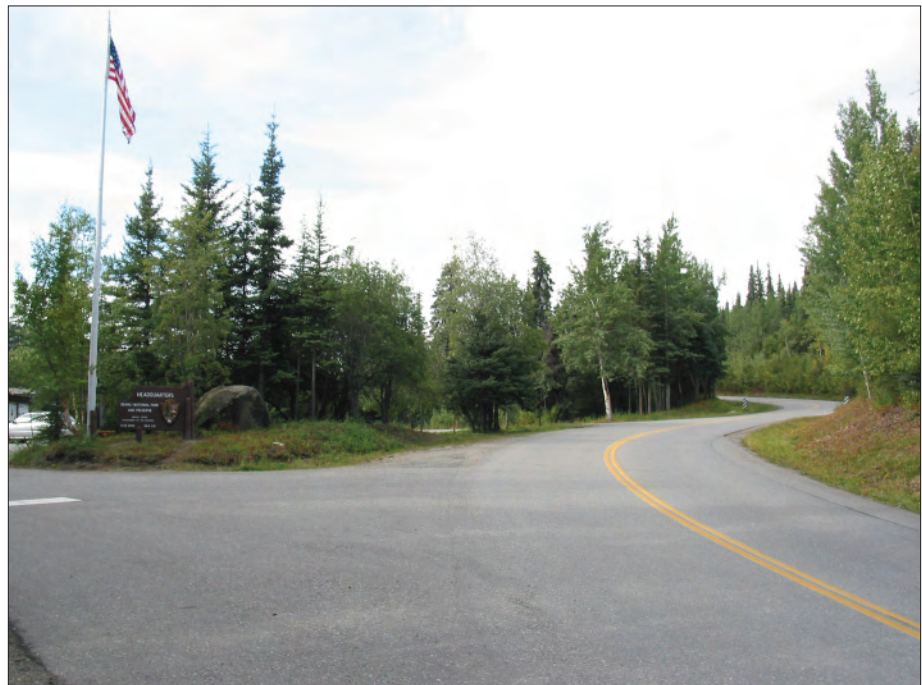
Figure 4.27. Circulation and Parking - Improve Sight-Distances at Park Road - Treatment Task 3.B - As seen in this photograph of existing conditions, the clearance of brush, understory and trees from the inside of the adjacent curve on the Denali Park Road would greatly improve sight-distances at the Headquarters entrance without impacting the historic landscape (OCLP, 2006).
