National Weather Service

Storm Data and Unusual Weather Phenomena

October 2005

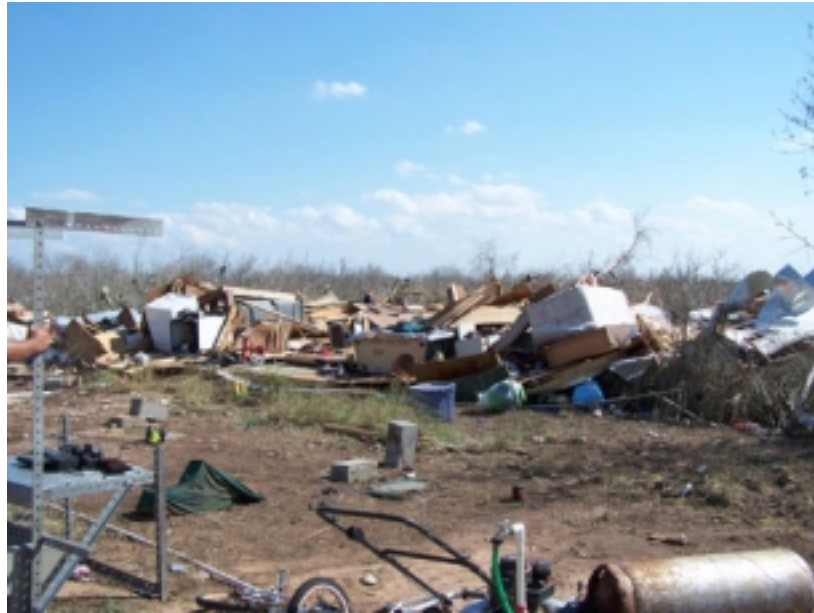
Pictured above is what was left of a mobile home after being destroyed by straight line winds. Three residents inside the home survived, with one receiving minor injuries.

An NWS storm survey concluded straight line winds severely damaged roughly 15 homes, a community center and church. Nearly all the damage was observed on the northwest sides of the structures with debris scattered to the southeast. Two mobile home were completely destroyed, with one man injured that was inside one of the mobile homes. The two mobile homes that were completely destroyed were oriented north-northeast to south-southwest, perpendicular to the northwest to southeast straight-line winds observed on radar. The damage from the two mobile homes was thrown to the southeast roughly 20 yards. In addition numerous large trees and power poles were uprooted and broken, all lying to the southeast direction. Several vehicles were also damaged by the uprooted trees and debris from homes. Winds were estimated between 80 and 100 mph.
