DOT/FAA/CT-94/119

Evaluation of Alternative Pavement Marking Materials

Final Report

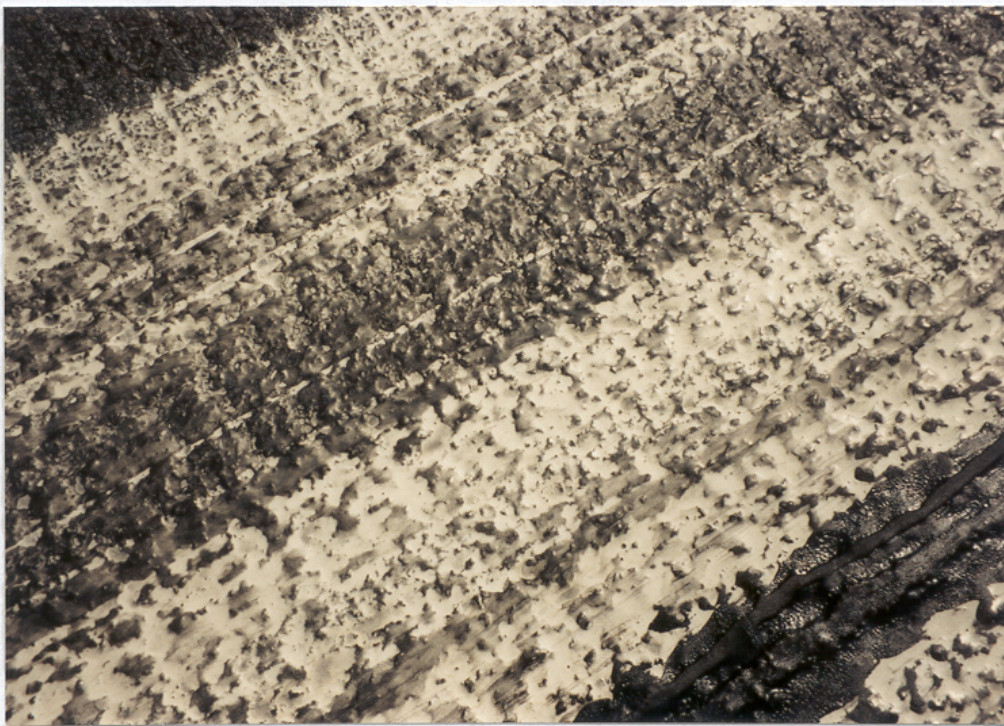
Resistance to rubber buildup is an important factor on those materials which have been installed in an area subjected to the impact of aircraft landing gear. At the Atlantic City location, the water-borne material no. 1 was almost totally covered with rubber within a short time after application. Each of the other materials had significantly less rubber coverage at this site. Certain materials offered greater rubber resistance than others. Resistance to rubber buildup was better when silica and/or bead additives were applied to the material, as opposed to the heavier buildup noted with similar materials not having silica or beads applied.

FIGURE A-19. RUBBER BUILDUP ON RUNWAY TEST STRIPE

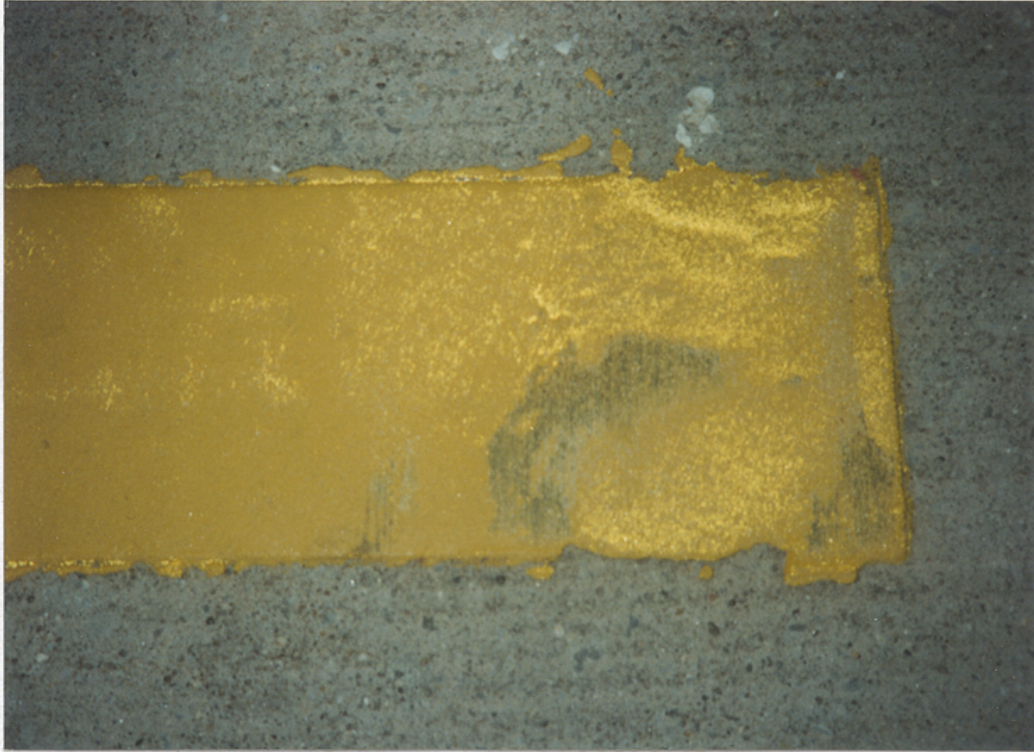
A harsh winter environment caused significant damage to all but the most durable materials. A number of snowfalls were experienced at the Pittsburgh and Atlantic City airports exposing the materials to snow removal operations. In Pittsburgh a significant amount of damage from snow plowing was experienced on the materials applied to the concrete taxiway surfaces. The use

FIGURE A-20. SNOWPLOW STRIKE ON METHACRYLIC RESIN

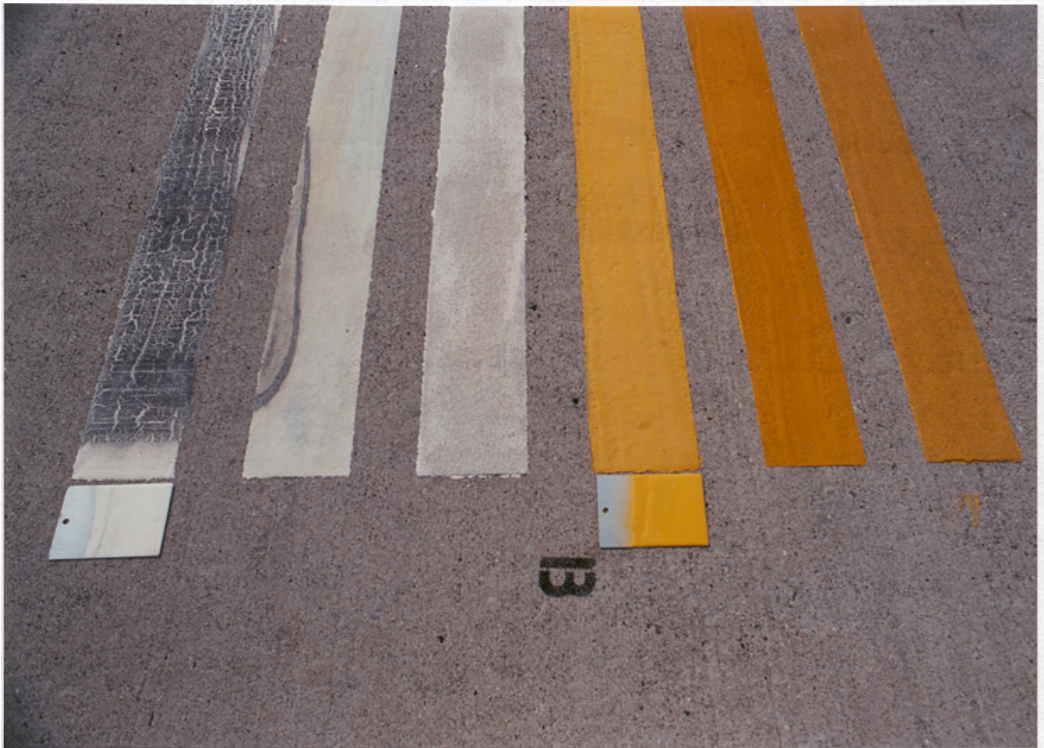
The taxiways Bravo and Hotel test stripes were each inspected on a monthly basis. One stripe of epoxy material (Epoxy no. 2, white, non-beaded) was noted to have not completely cured and assumed a blackened appearance. The blackened appearance was a result of the partially cured epoxy collecting the dirt from the main gear of the aircraft and vehicle tires as they passed over the test stripe. One benefit to be mentioned is that the material remained in place even though only partially cured. The test stripe did not delaminate from the concrete surface therefore eliminating the potential for foreign object damage (FOD).

FIGURE A-21. EPOXY NO. 2 - INCOMPLETE HARDENING

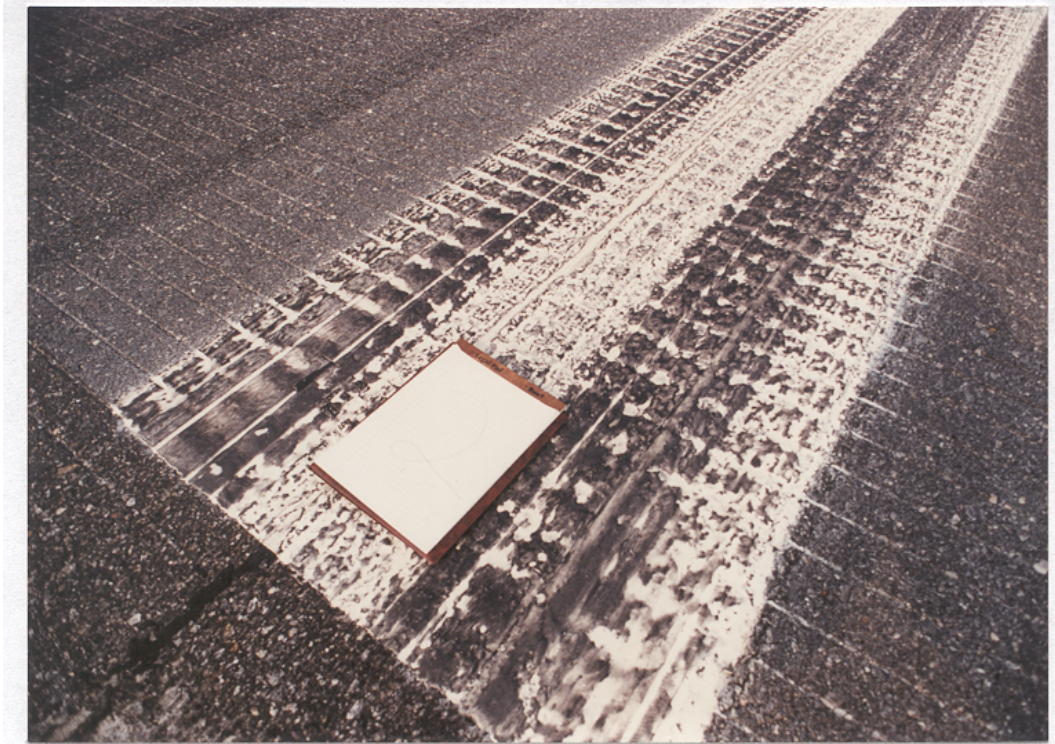
The silica appeared to cause the rubber to "flake" away and not smear onto the paint as was the case with the test stripes that did not have silica. There was a significant difference in rubber adherence between the epoxy runway test stripe with silica and the epoxy without silica along with the water-borne runway stripes with and without silica. In both cases the materials with silica retained their white color and did not get obscured by rubber. The addition of the silica to the test stripes was at the discretion of each of the manufacturers involved in the study.

FIGURE A-22. RUBBER ACCUMULATION ON RUNWAY TEST STRIPE

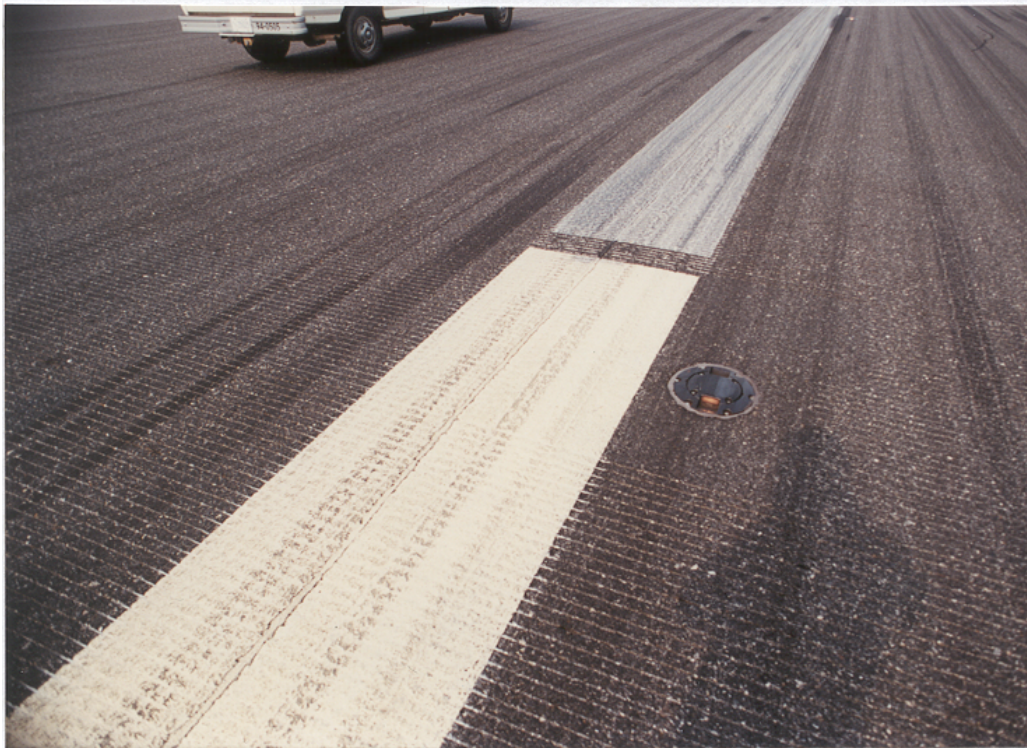
FIGURE A-23. COLOR VARIANCE - ATLANTIC CITY

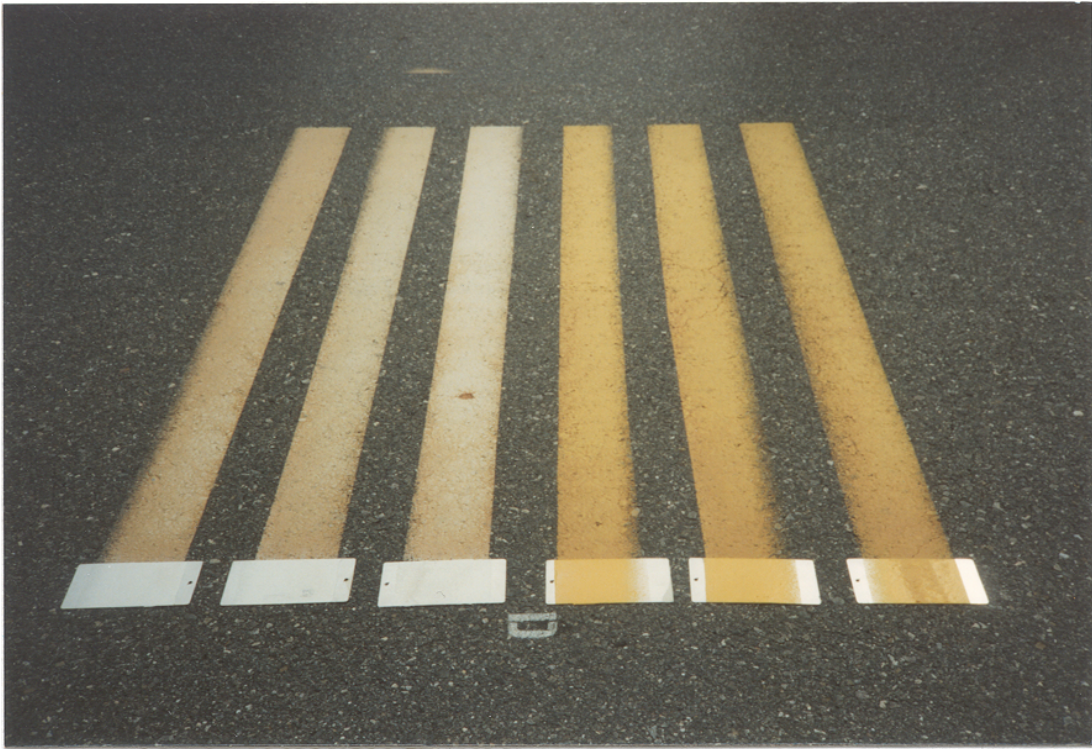
At Atlantic City airport the water-borne material no. 2 was found to have developed a rust-colored cast on the runway threshold stripes and on the asphalt taxiway stripes. Since this occurred only on the asphalt pavement surfaces, it was believed that a component in the asphalt mix was interacting with the materials. Use of drawdowns and comparative photographs illustrated the color transformations that occurred. Refer to the appendix for individual comparisons. Overall, the test materials displayed a constancy in color characteristics with the exceptions already noted.

FIGURE A-24. WATER-BORNE DISCOLORATION - ASPHALT SURFACE

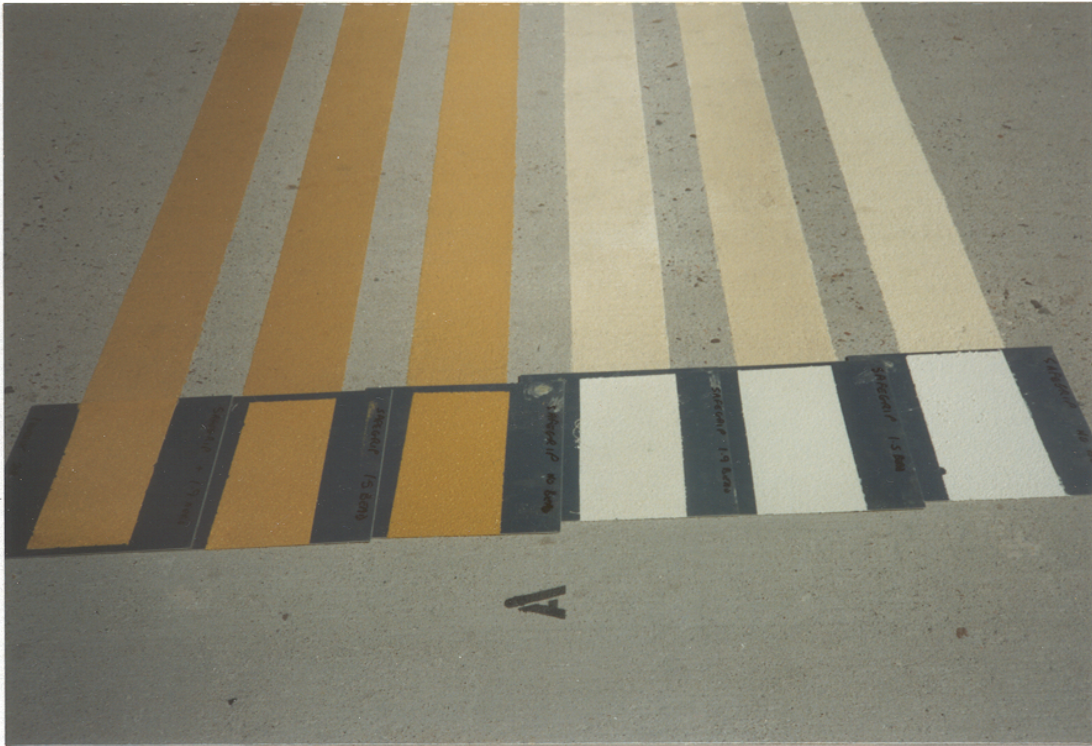
FIGURE A-25. EPOXY NO. 1 DISCOLORATION - CONCRETE SURFACE

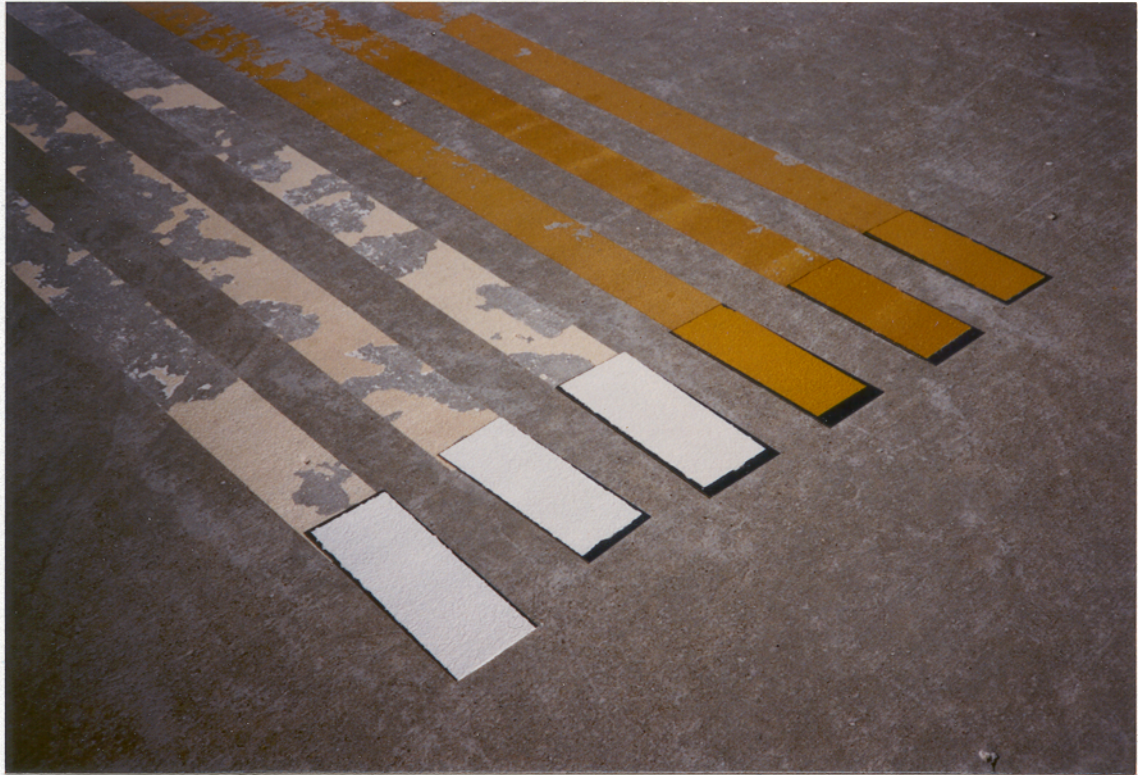
FIGURE A-28. EPOXY NO. 1 TAXIWAY TEST STRIPE AFTER 1 YEAR - PITTSBURGH

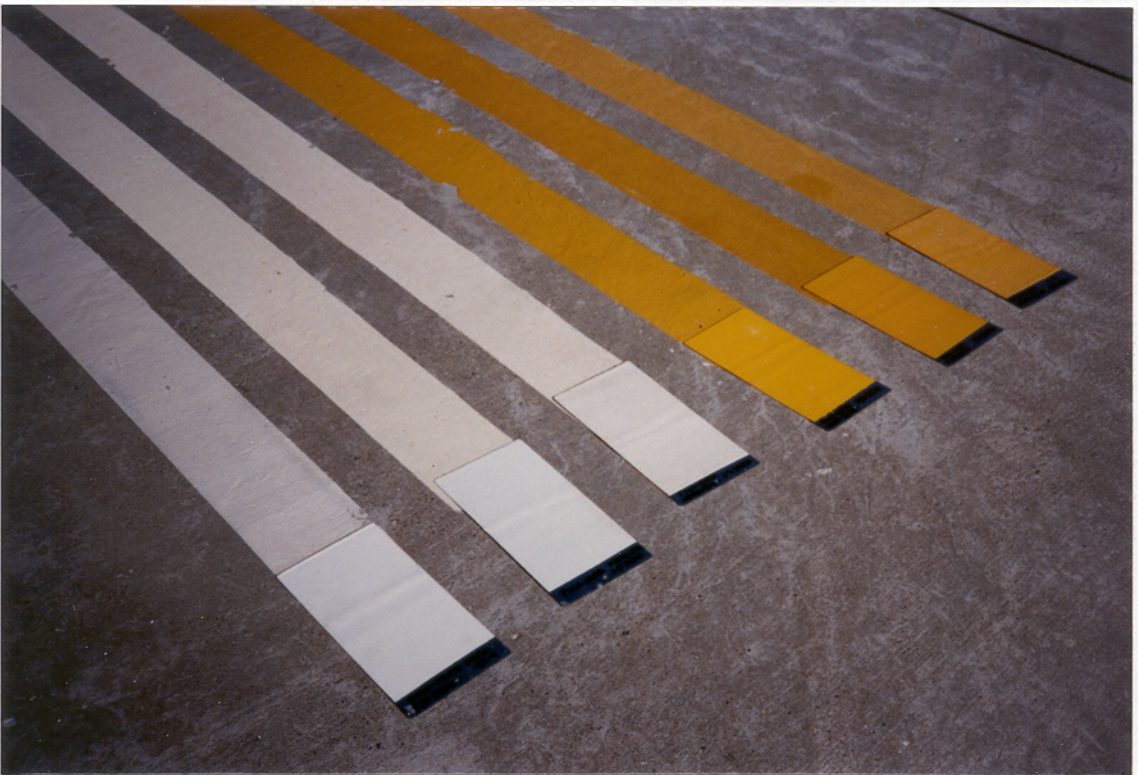
FIGURE A-29. EPOXY NO. 2 TAXIWAY TEST STRIPE AFTER 1 YEAR - PITTSBURGH

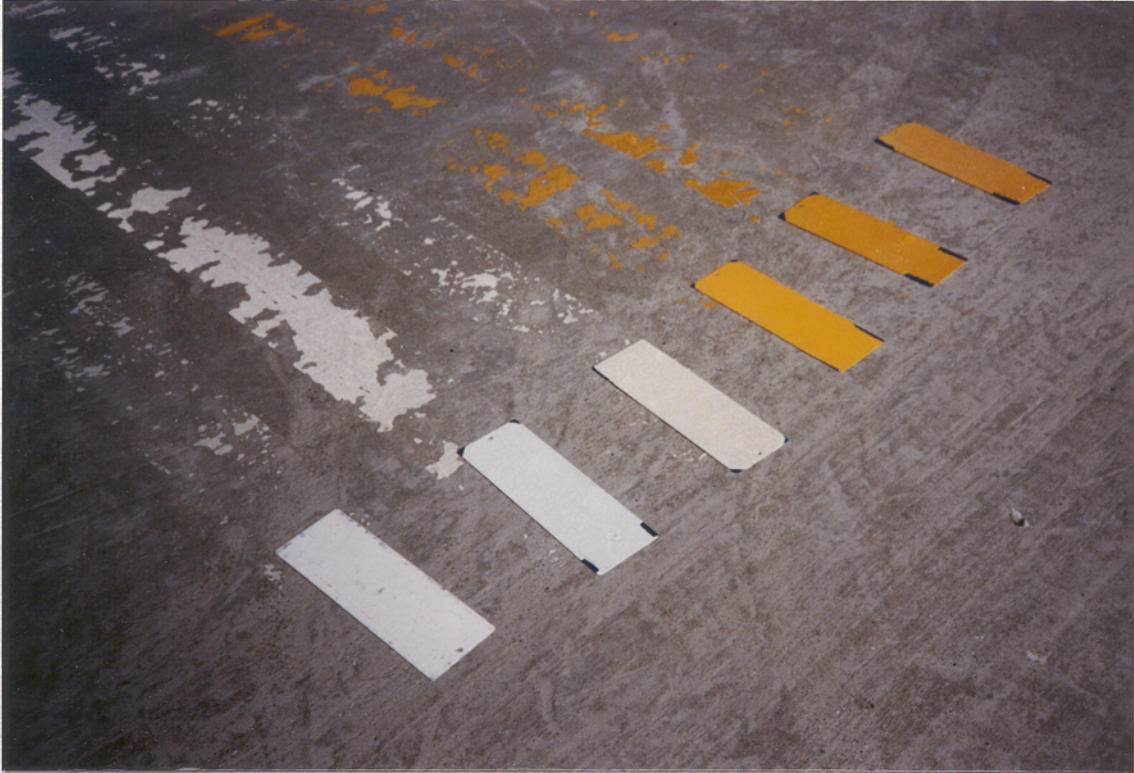
FIGURE A-30. WATER-BORNE NO. 1 TAXIWAY TEST STRIPE AFTER 1 YEAR - PITTSBURGH

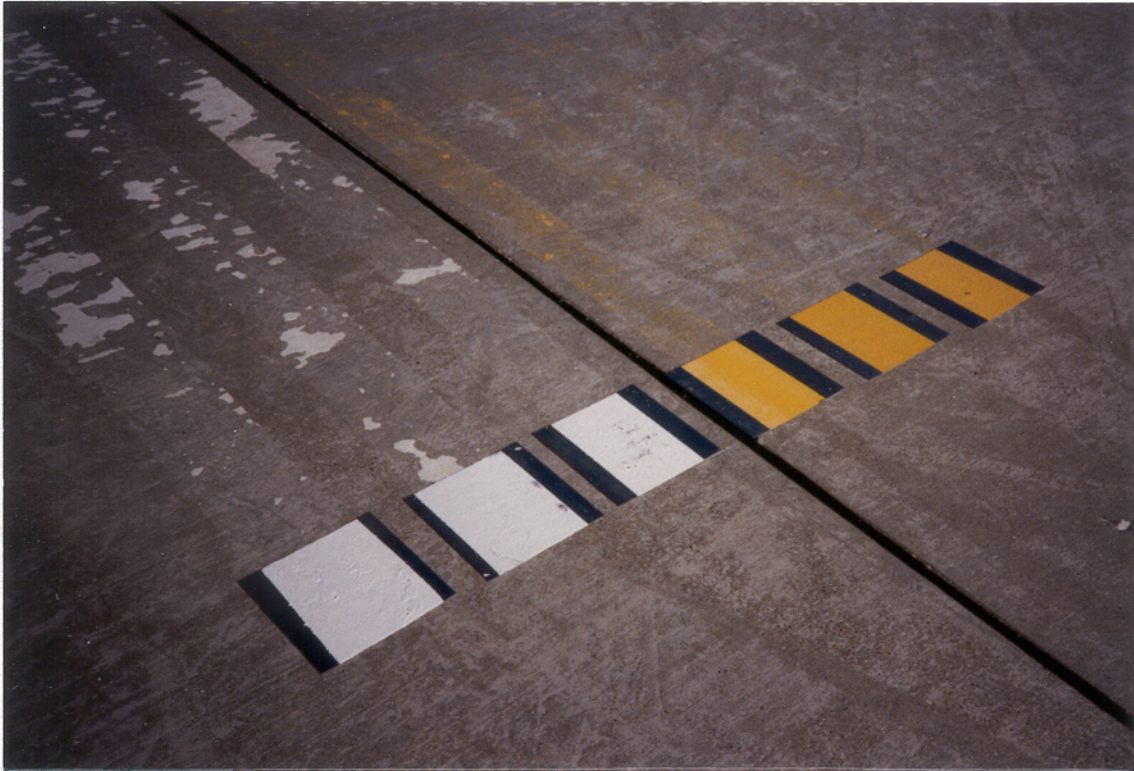
FIGURE A-31. WATER-BORNE NO. 2 TAXIWAY TEST STRIPE AFTER 1 YEAR - PITTSBURGH

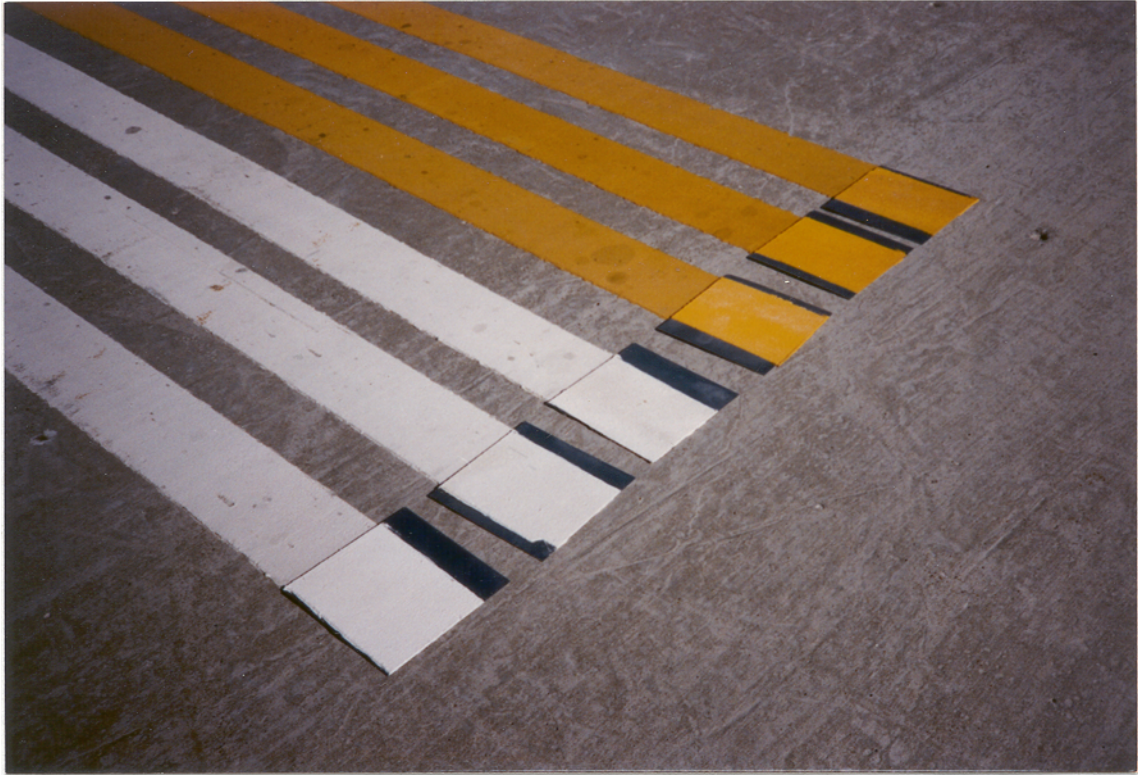
FIGURE A-32. METHACRYLIC RESIN TAXIWAY TEST STRIPE AFTER 1 YEAR - PITTSBURGH

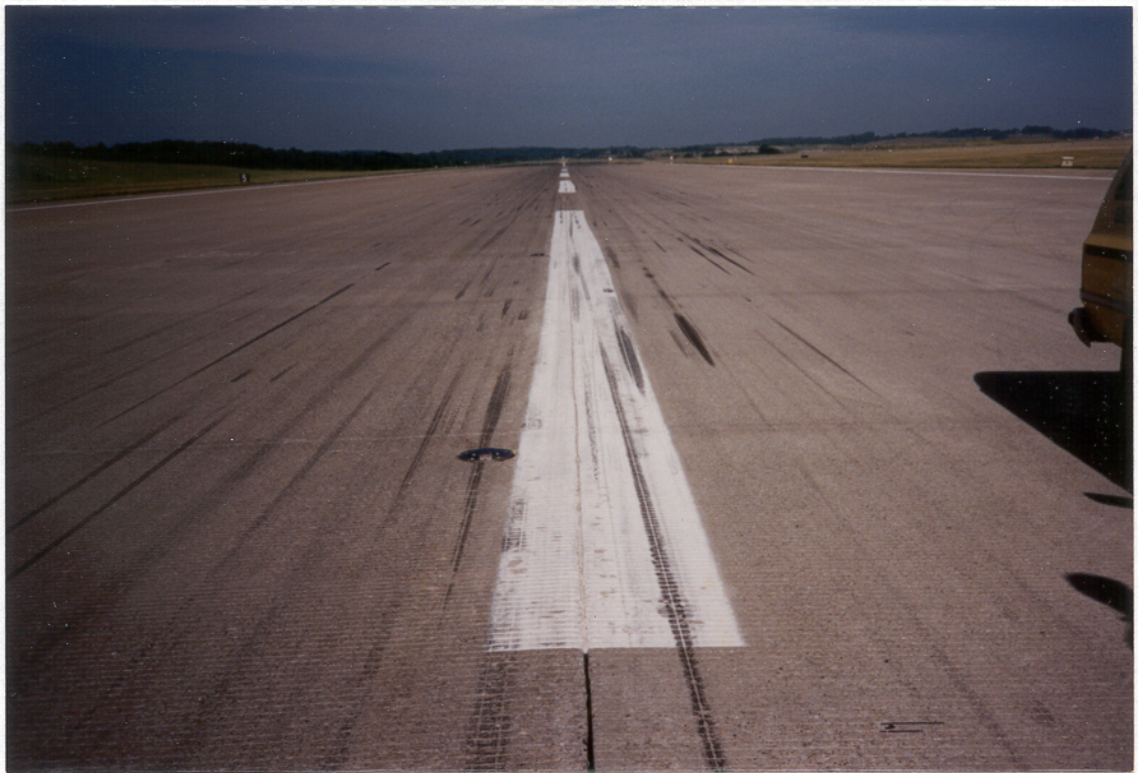
The overall condition of the test materials at the various locations at Pittsburgh airport varied considerably. At the completion of testing in June 1994, runway markings were in generally good condition. Very little rubber adhesion had occurred on the runway centerline test stripes. Significant yellowing was noted on the epoxy no. 1 material. The taxiway test stripes were significantly damaged, particularly the water-borne materials which suffered delamination from snow plow activity. Refer to figures A-26 through A-32 for photographs of the of the damaged test stripes. One of the epoxies also suffered delamination prior to completion of the test period at the Pittsburgh airport site. The methacrylic resin provided excellent performance in all criteria throughout the test period. The epoxy no. 2 performed very well also, with the exception of friction readings.

FIGURE A-33. RUNWAY TEST STRIPE AFTER 1 YEAR - PITTSBURGH
