Executive Summary Systems Safety – Re-defining a Core Value

We invite you to study the FY 2004 Accident Review and to benefit from the lessons learned. For more about the USDA Forest Service Aviation Safety program, visit the NASC website at <u>www.fs.fed.us/fire/aviation_safety</u>.

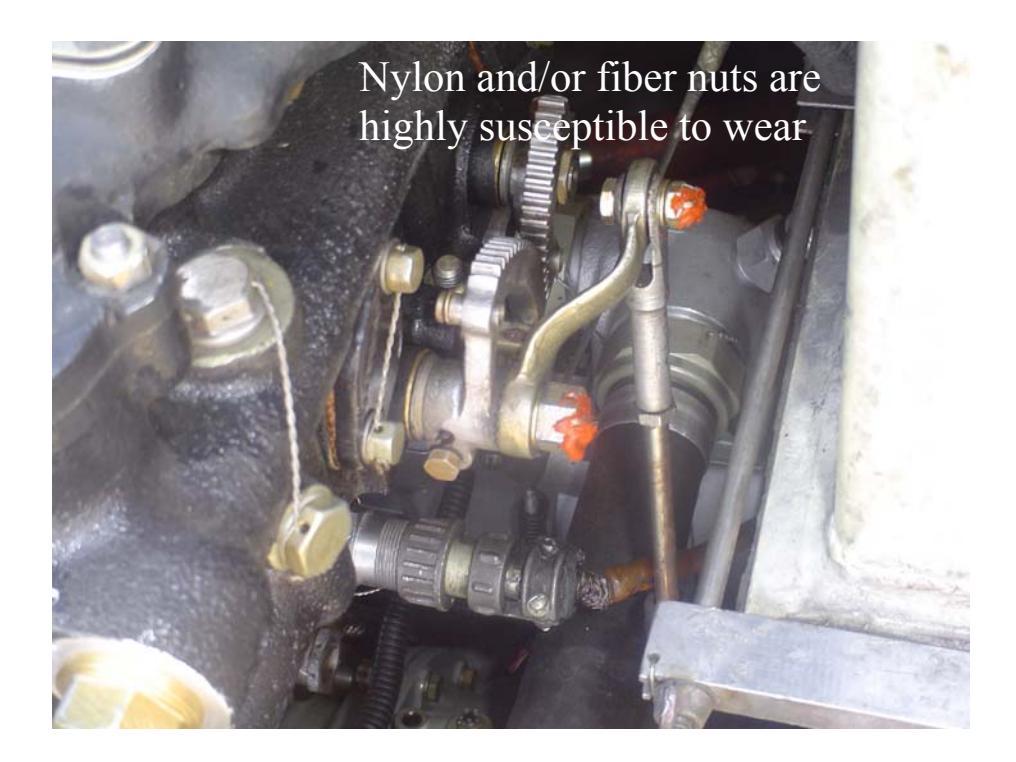
In order to land the airplane, the pilot turned the fuel selector to the off position. During the landing roll, the left wing impacted a fence pole bending ribs and wrinkling the aileron. Post accident examination revealed that the bolt normally connecting the throttle linkage clevis to the throttle arm was missing.

The investigating team examined a sister aircraft from the same provider. They found that a nylon lock nut had been installed on the clevis bolt, and it was loose enough to be removed without the aid of any tools.

The industry standard, found in FAA Advisory Circular AC43.13-1B, chapter 7, section 4, paragraph 7-64, states that nylon locking nuts should not be used with rotating components or assemblies. It further states that nylon and/or fiber nuts are highly susceptible to wear from repetitive use and from high heat applications.

NTSB Probable Cause: The improper installation of the throttle linkage clevis to the throttle control arm by unknown maintenance personnel. Contributing factors were the nylon lock nut separating from its' bolt, which permitted the throttle cable to disconnect from the throttle control arm, and the fence post.

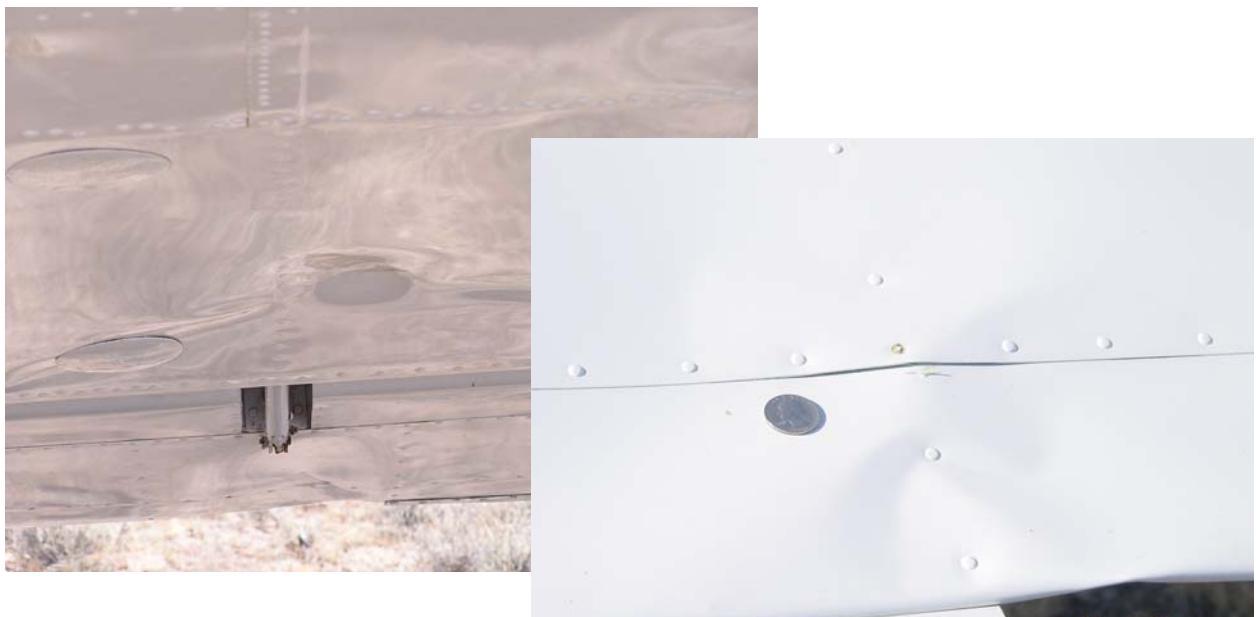
Bent ribs and wrinkled aileron

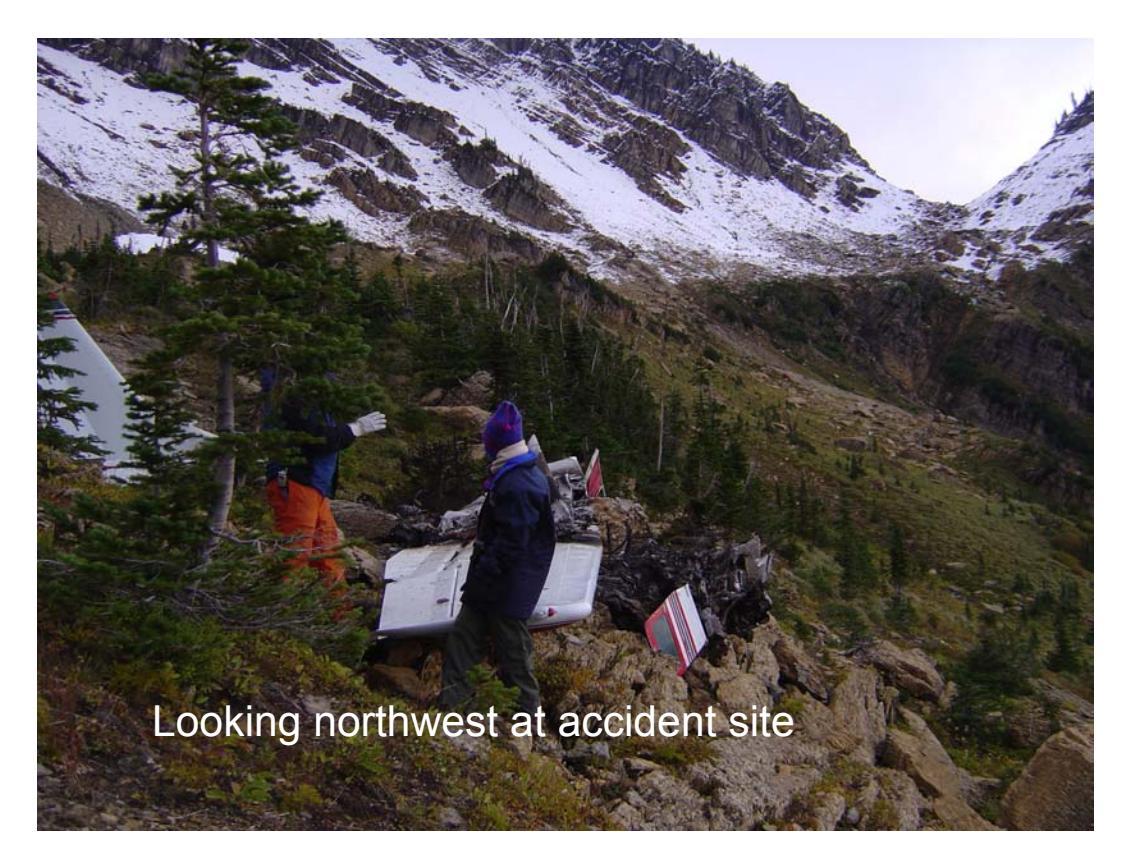
The right cargo door located on left side of wreckage

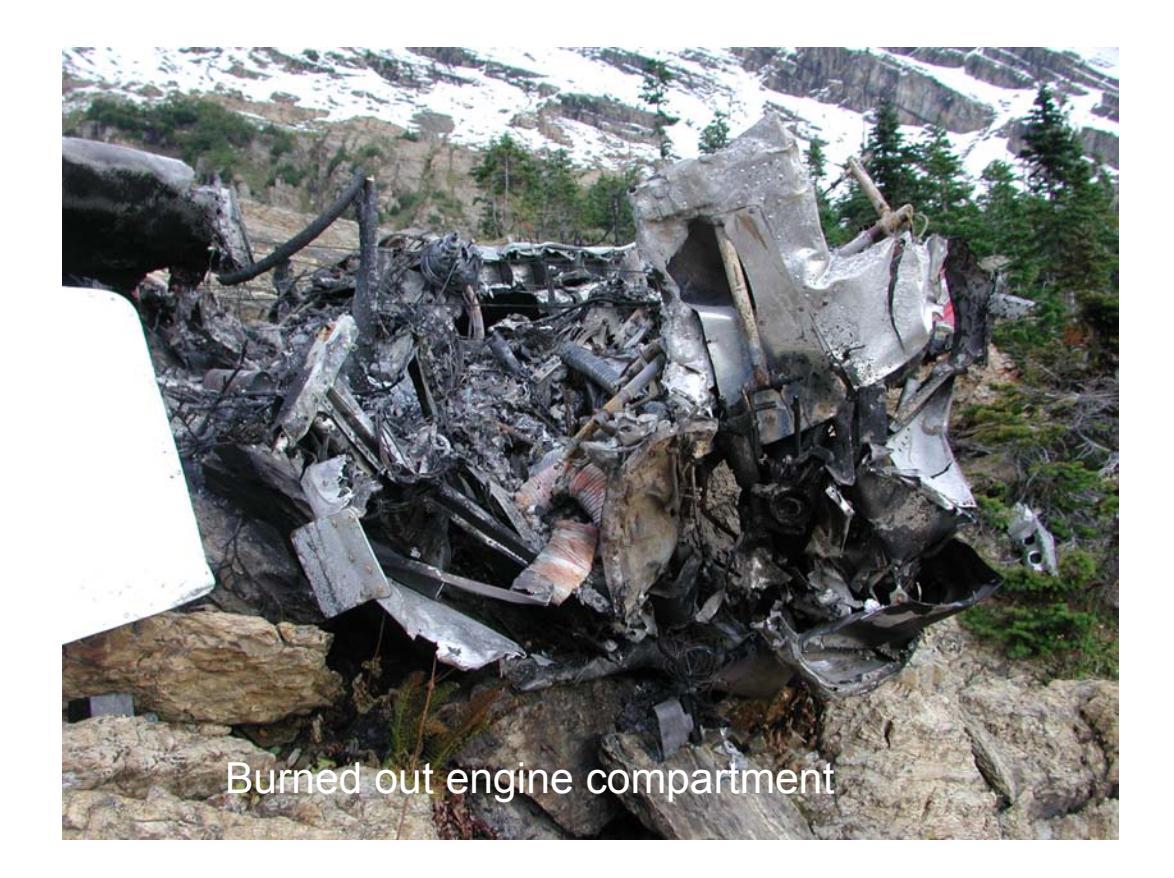
The fuselage with both wings attached came to rest inverted, and the empennage, which remained attached to the fuselage by control cables came to rest upright. The engine had separated from the firewall, and the propeller had separated from the engine crankshaft. All flight controls remained attached to their respective attach points, and control continuity was verified from the control surfaces to the cockpit controls. The cockpit, cabin and the inboard sections of both wings were destroyed by fire. All three propeller blades were bent and twisted, the blade tips were broken off, and the blade leading edges were gouged and scraped.
