developed aerial photographic techniques to help identify and document septic system performance.

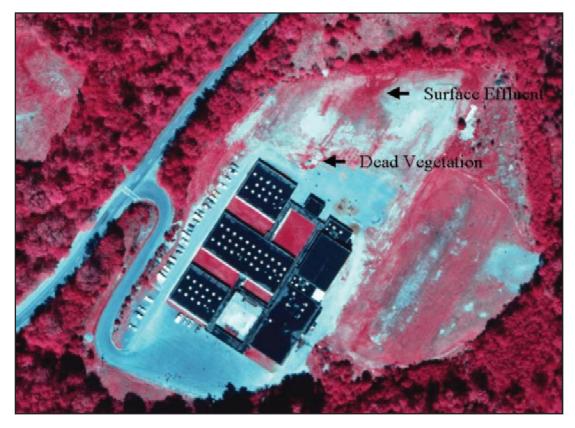
Figure 1. Surface failure. False color infrared (CIR) aerial photographs are very valuable for showing vegetation in shades of red and pink, and any stresses associated with the vegetation which result in a change in their photographic "signature". False color infrared is also useful for showing differences in soil moisture content and the presence of standing water on the ground surface. Surface failure of a septic system in this image is characterized by dead vegetation and the presence of surface effluent. CIR records near or reflective infrared energy, not thermal emissions or temperature and should not be confused with thermal infrared

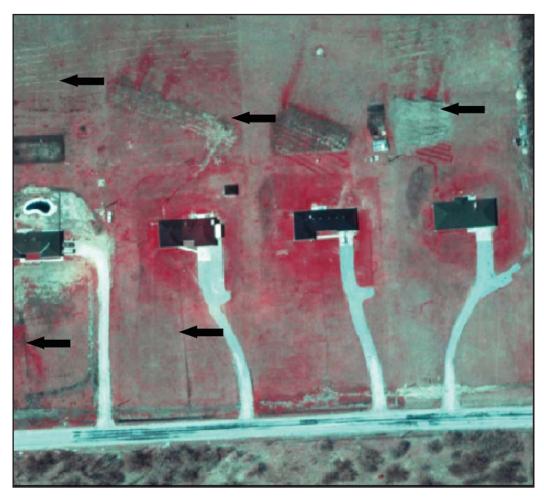
Figure 2. Secondary signatures. This false color infrared photo shows the common practice of covering a failing absorption field and rerouting wash water through small ditches.

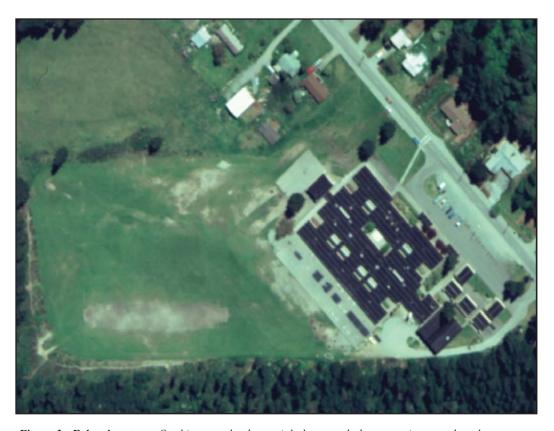
Figure 3. False signature. On this natural color aerial photograph the vegetative growth and stress pattern behind this building appears to be a large, seasonally failing septic system. It is actually vegetation stress caused by athletic activity.
