**Final Report**

**February 1998**

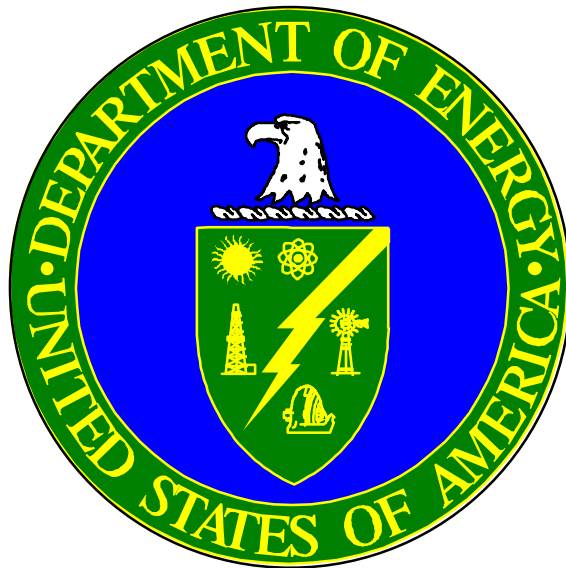
**Type B Accident  
Investigation Board Report  
Chiller Line Rupture  
at  
Technical Area 35,  
Building 27  
Los Alamos National Laboratory**

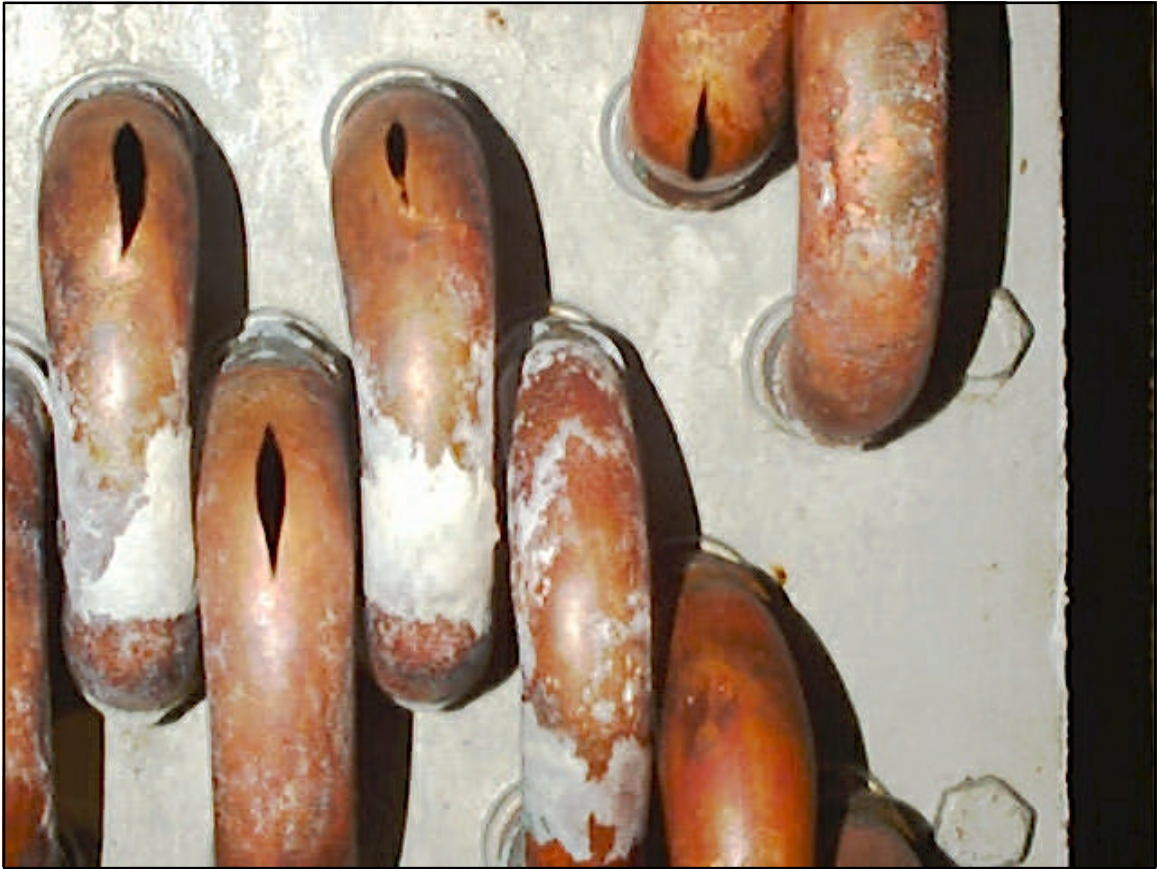
Figure 4: Ruptured Coils of CWE-1

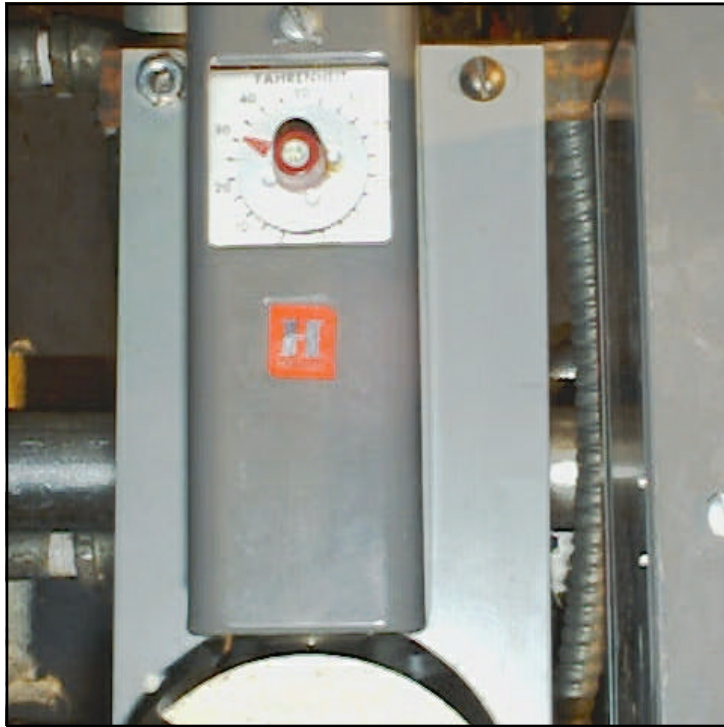
Figure 5: Thermostat Set at 32 Degrees Fahrenheit

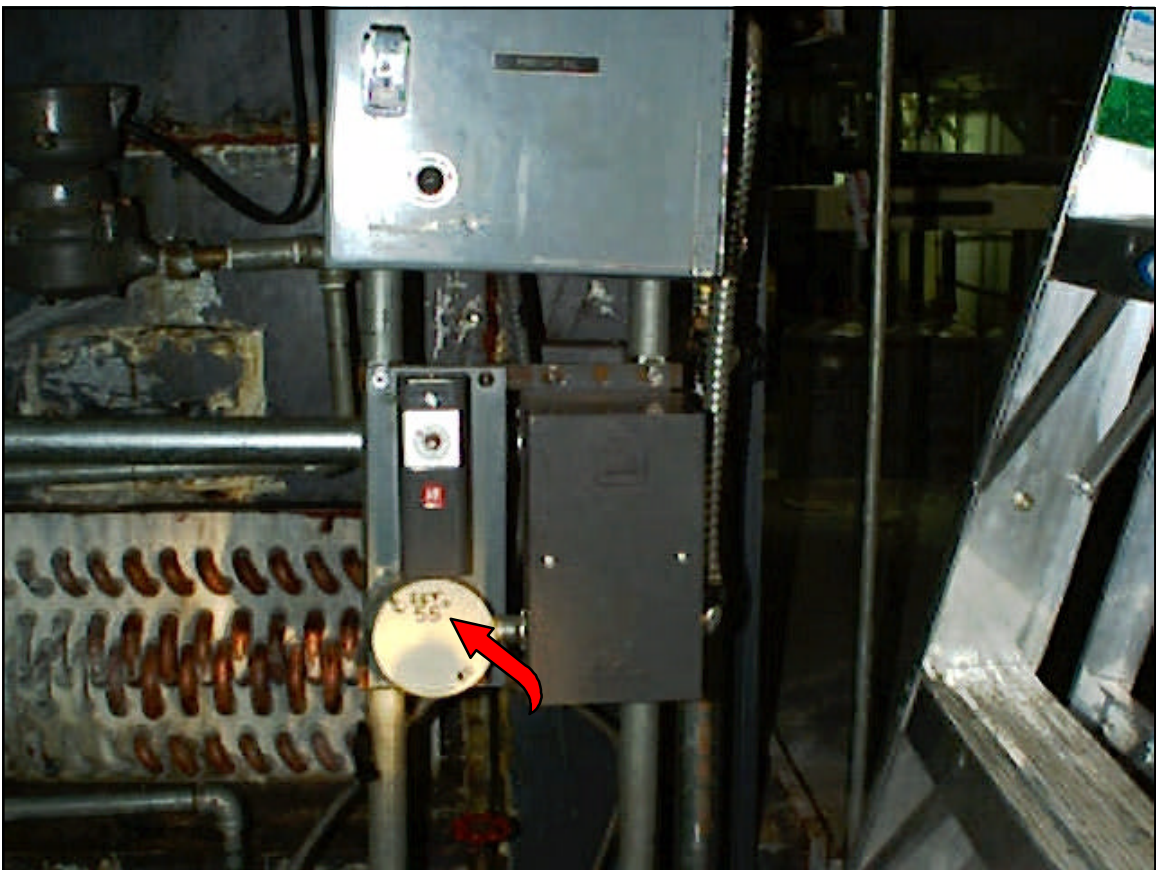
Figure 6: Thermostat with note set at 55 degrees Fahrenheit

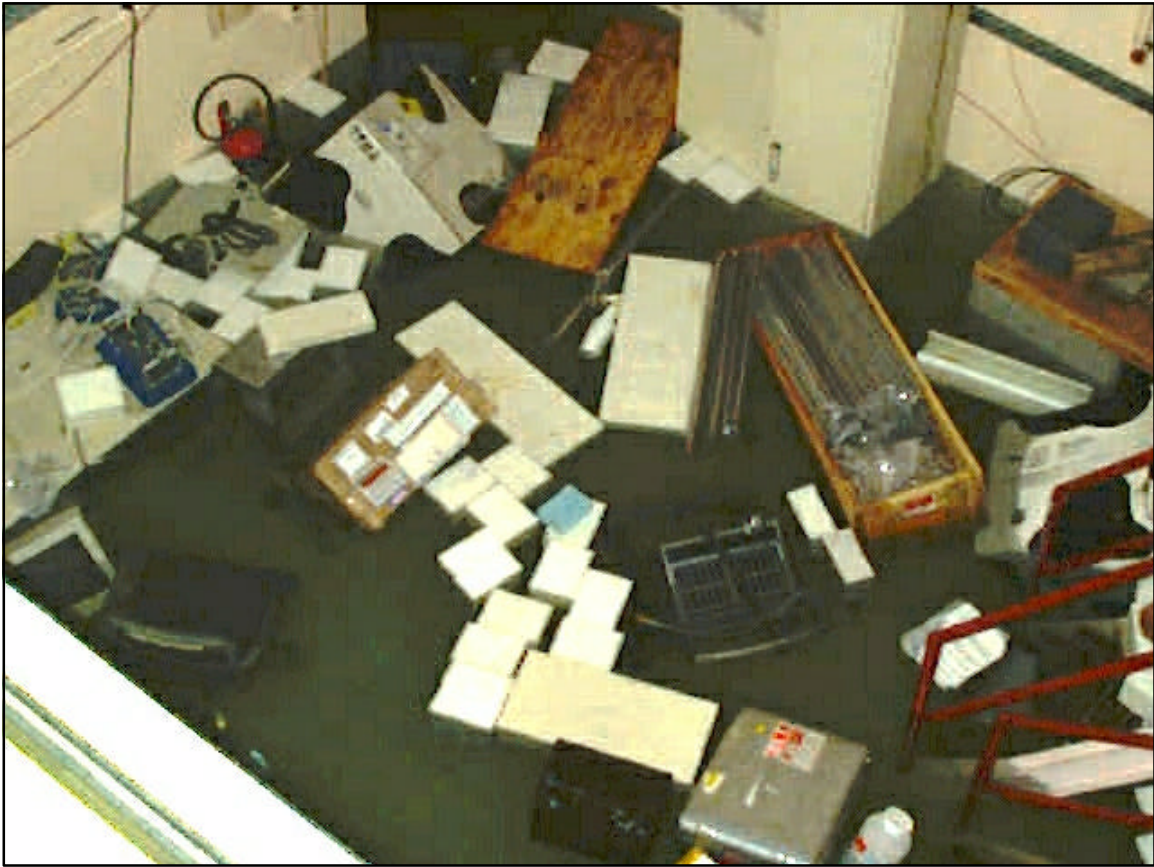
Figure 7: Debris floating in water in sub-basement

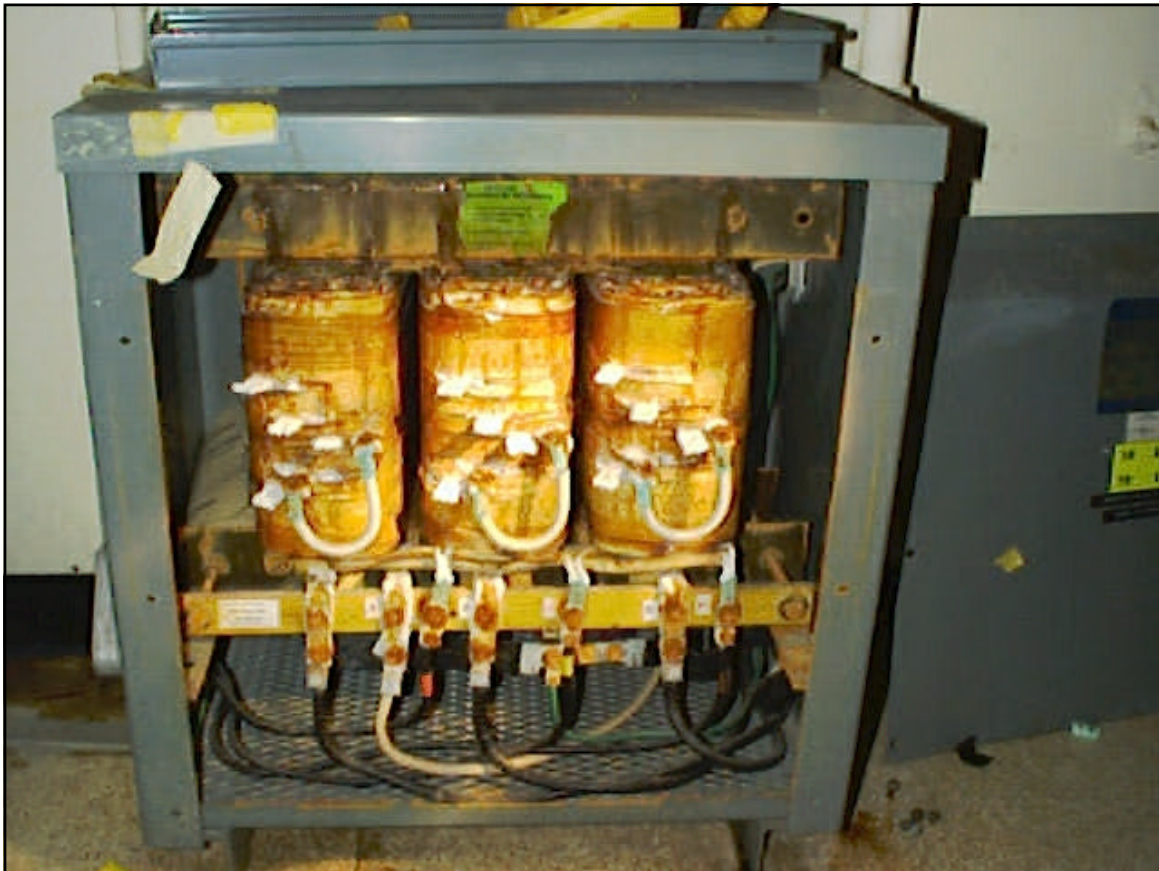
Figure 10: Damaged transformer in sub-basement

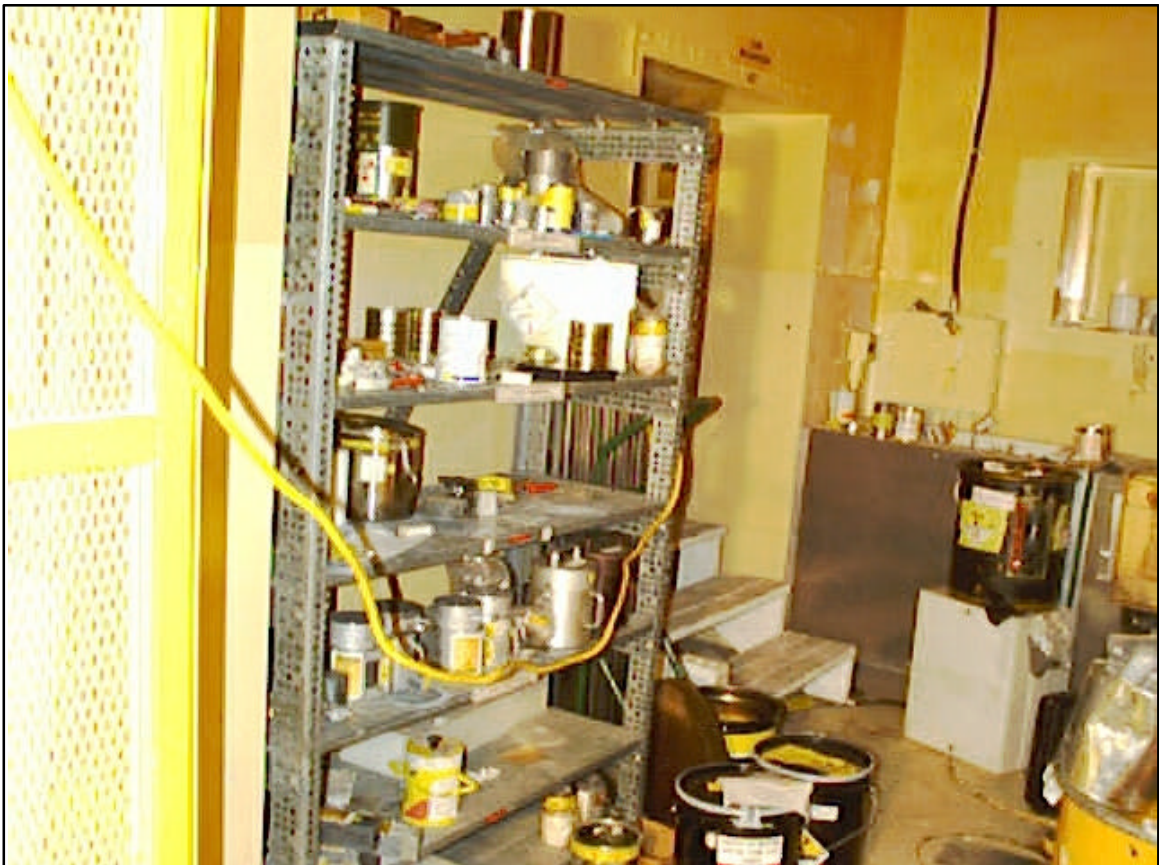
Figure 11: Radiological source storage

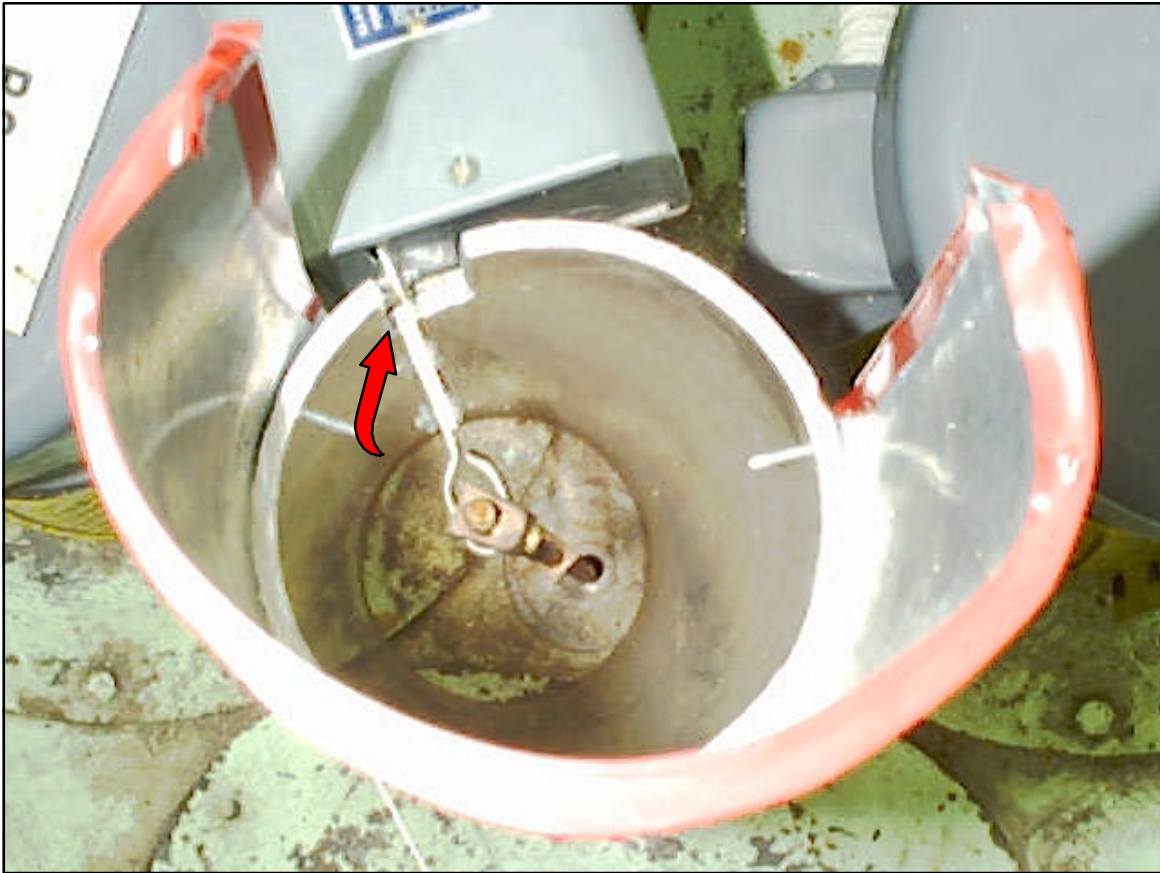
Figure 12: Actuator arm for sump pumps

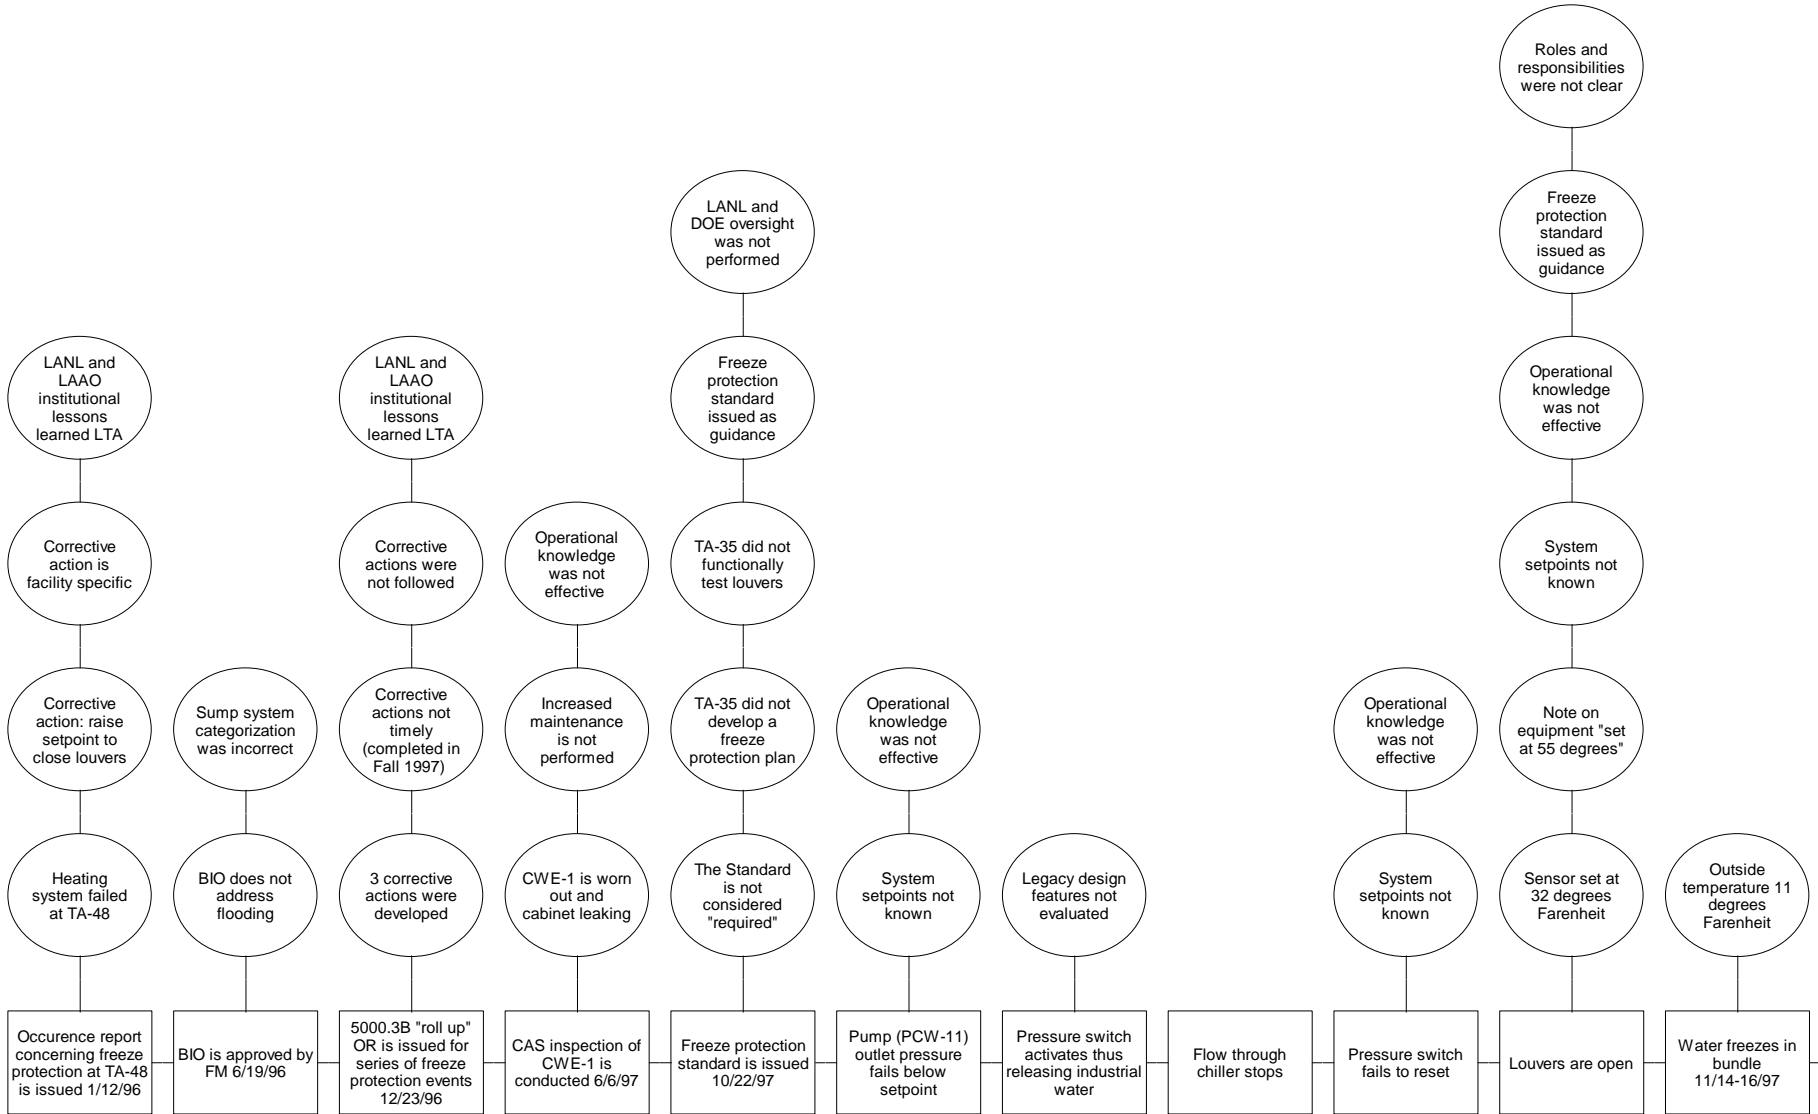
- Maintenance categorization of the equipment was incorrect.
- Maintenance was not conducted on a more frequent basis.
- Legacy design features were not evaluated after the facility and mission changed.
- Oversight by DOE was not performed.
- Radiological source control program was not completely developed and implemented. It's recognized that the source control program is not a contributing

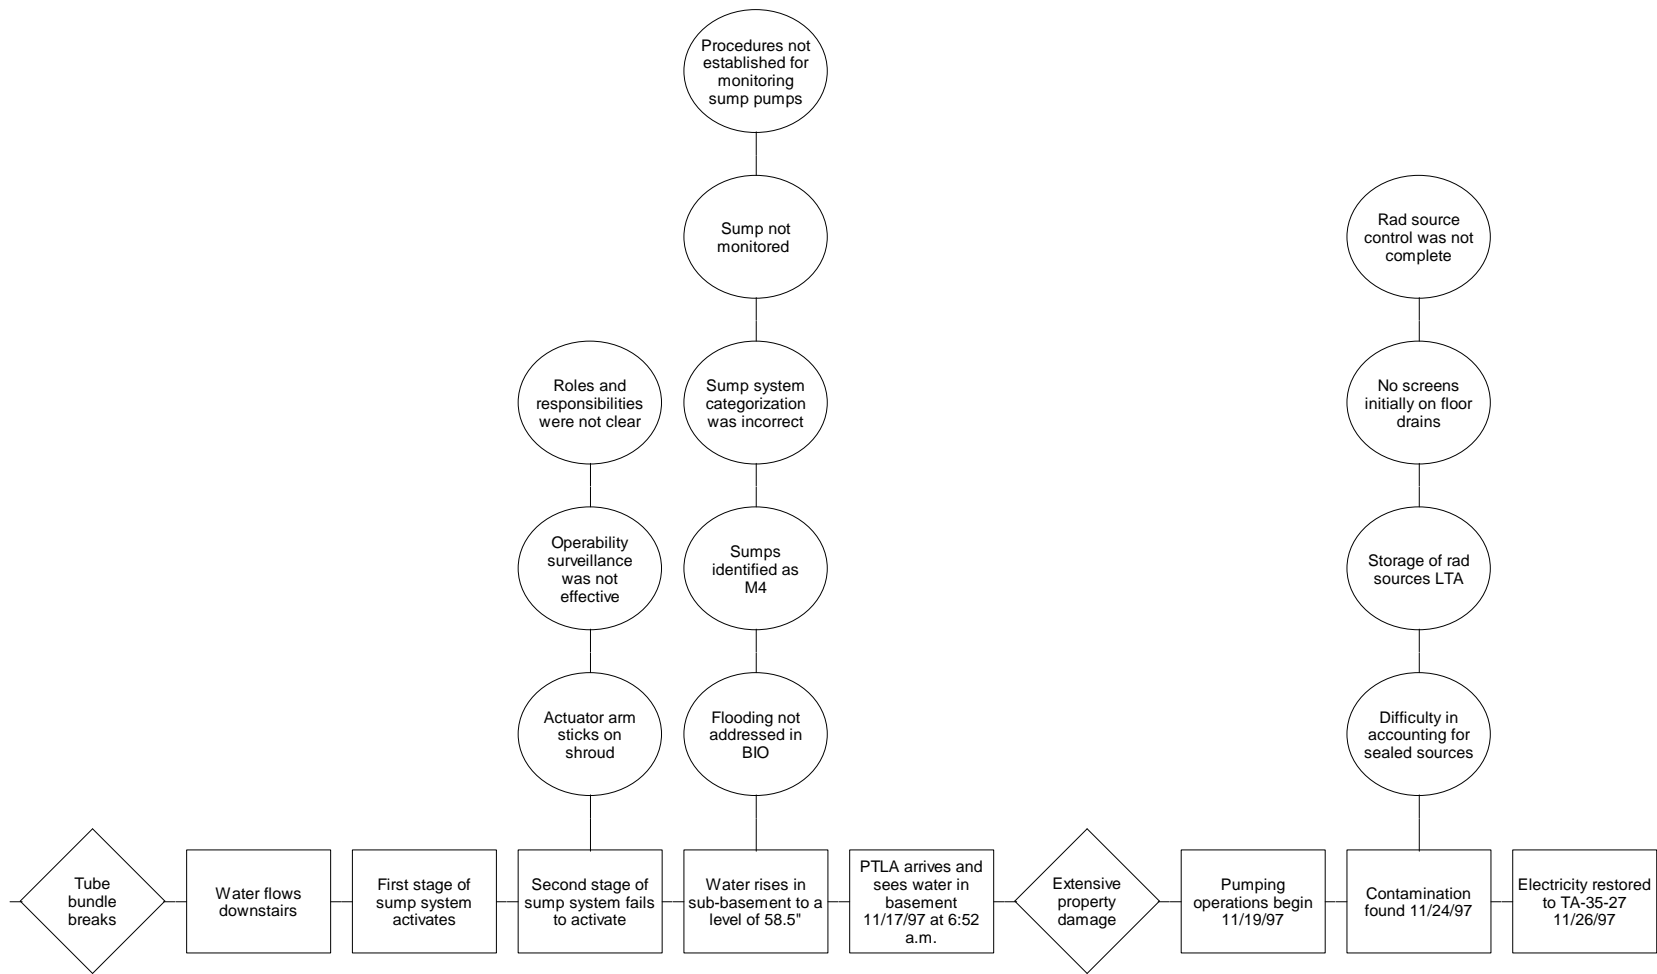
cause to the rupture of the coils in CWE-1, however, this impacted the ability to respond to this incident.
