- 28. Phase I Environmental Baseline Reports
 - Phase I. Environmental Baseline Report and Analysis (May 24, 2005)

May 24, 2005

Environmental Baseline Report

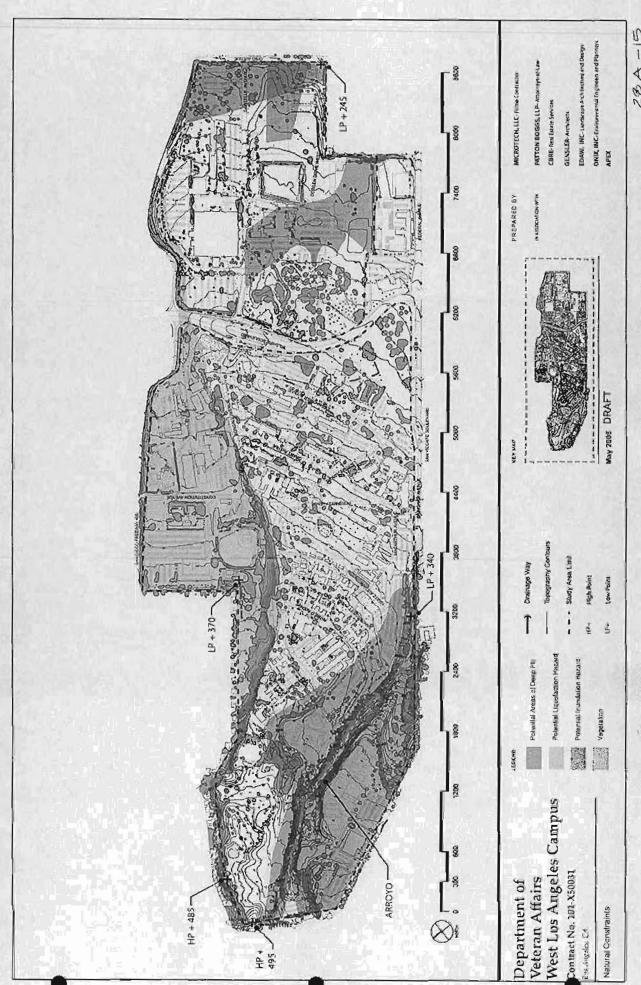
FIGURE 4-1, NATURAL CONSTRAINTS

The site is within an undifferentiated shallow superficial landslide area and contains liquefiable areas. The southern portion of the site is within a fault rupture study area and contains an area of potential inundation. Slopes along the arroyo and the escarpment within the site have the potential for localized slope instability. Potential geologic hazards within the site are shown in Figure 4-1, Natural Constraints, provided at the end of this section. See Section 6.0 Environmental Issues and Hazards, items 8-11, and Section 7.0 Recommendations below for additional discussion of the geologic hazards.

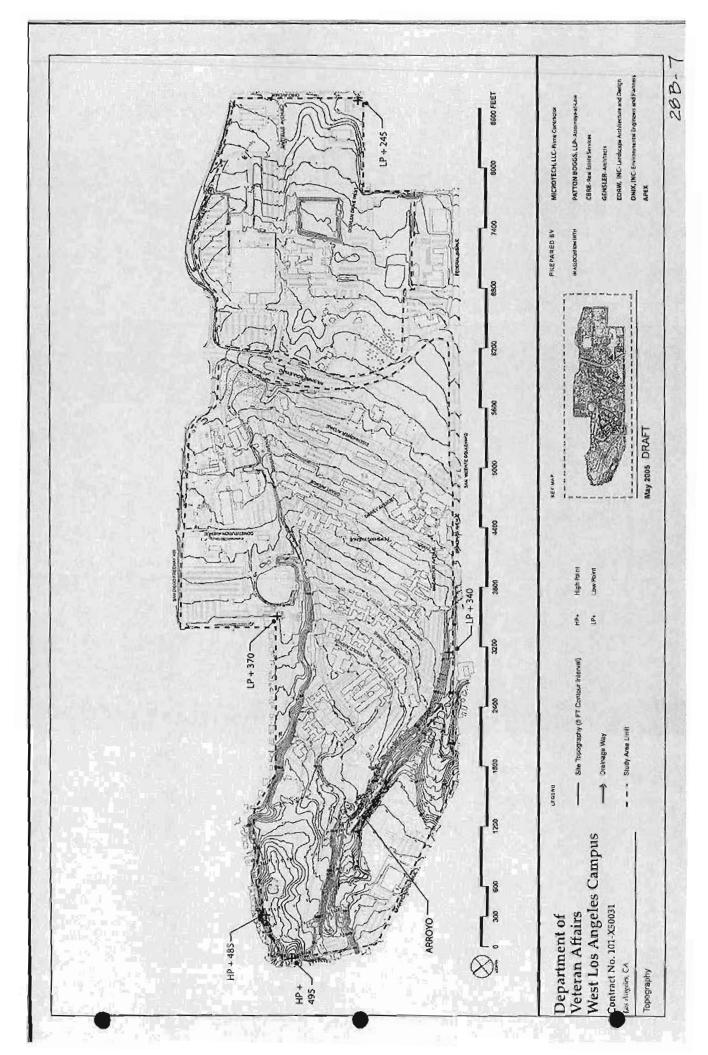
FIGURE 2-1, TOPOGRAPHY AND HYDROLOGY

The arroyo is a well-defined natural watercourse within the site. There is a small area of wetland within the arroyo. State and federal regulations allow development of a wetland elsewhere to compensate for removal of an existing wetland. Please see Item 7 of the section titled: 6.0 Environmental Issues and Hazards, and Section 8.0 Conclusions below for additional discussion of the wetland area.

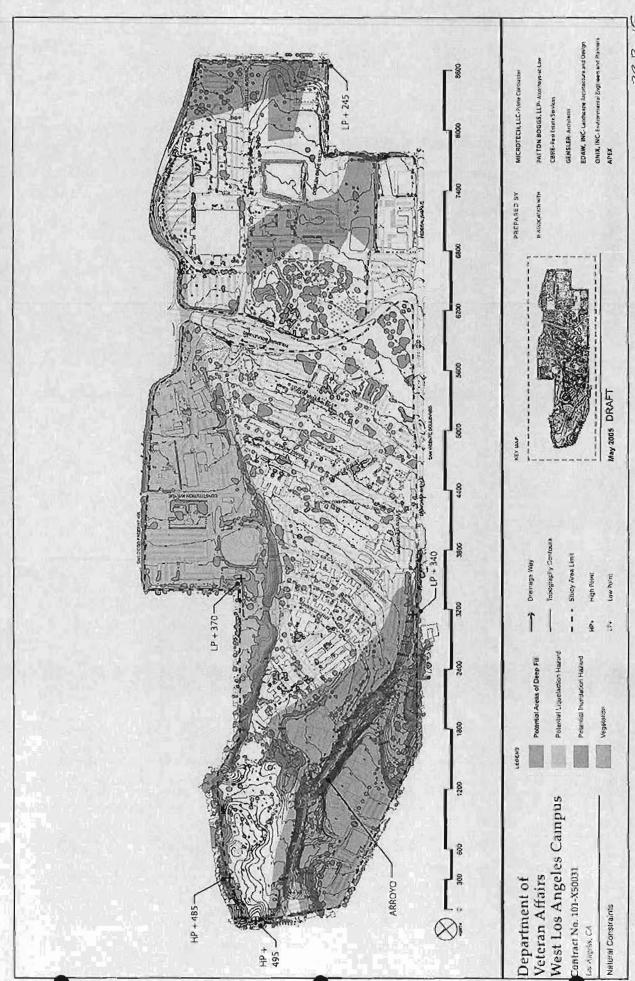
FIGURE 4-1, NATURAL CONSTRAINTS

The site is within an undifferentiated shallow superficial landslide area and contains liquefiable areas. The southern portion of the site is within a fault rupture study area and contains an area of potential inundation. Slopes along the arroyo and the escarpment within the site have the potential for localized slope instability. Potential geologic hazards within the site are shown in Figure 4-1, Natural Constraints, provided at the end of this section. See Section 6.0 Environmental Issues and Hazards, items 8-11, and Section 7.0 Recommendations below for additional discussion of the geologic hazards.
