Title **Final Progress Report on Los Alamos National Laboratory
Cerro Grande Fire Rehabilitation Activities**

Prepared by **Kevin J. Buckley and Jeffrey C. Walterscheid,
Water Quality and Hydrology Group
Samuel R. Loftin, Ecology Group
Gregory A. Kuyumjian, USDA Forest Service**

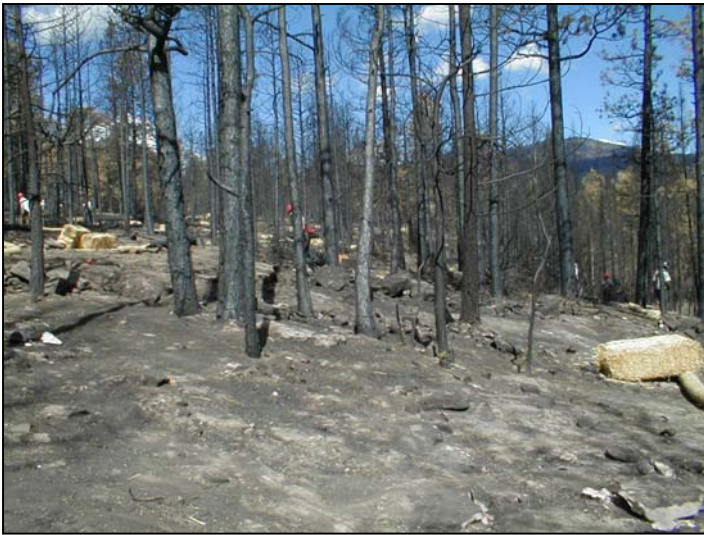
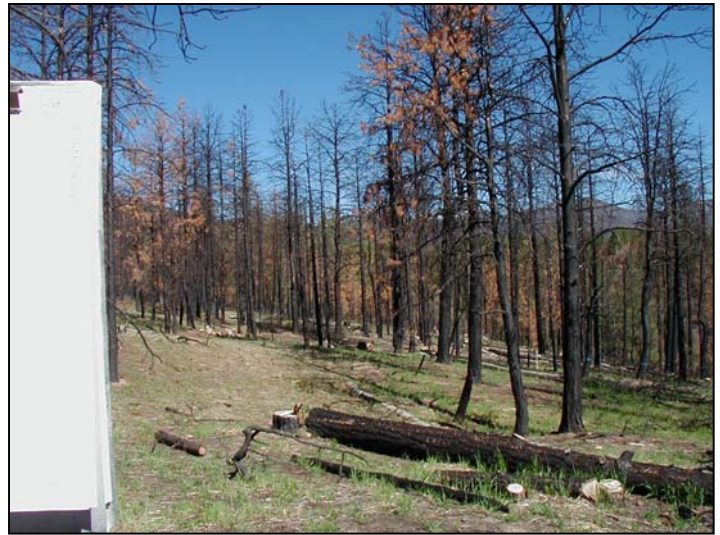
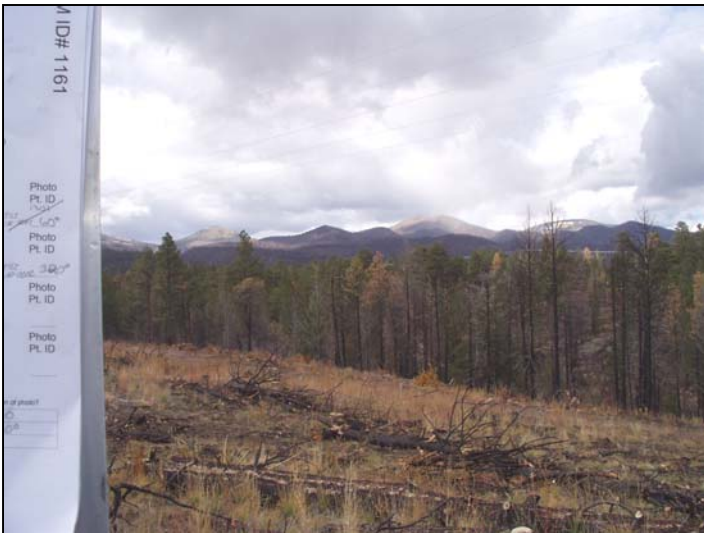
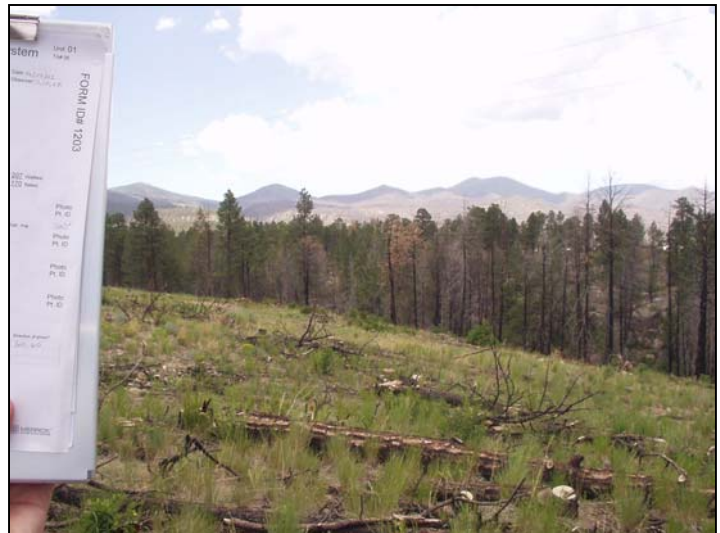
Changes in Vegetation Over Three Years on BART Unit 1, LANL TA-06

The following pages illustrate some of the post-fire changes in vegetation on BART units over the past three years. BART units 1, 2, 22, and 33 were chosen as a representative sample of the rehab units. Changes in vegetation are apparent in the photos. Units 1, 22, and 33 were located in areas that the CGRP thinned for fire protection. The figures on each page show results of BART vegetation and total cover sampling. There are no cover data for the summer 2000 photos. Because most BART units are in high-burn severity, it is assumed that vegetative and ground cover were near zero in 2000.
