# Section Four

## ALARA Activities at DOE

### 4.1 ALARA Activities at Fermi National Accelerator Laboratory (Fermilab)

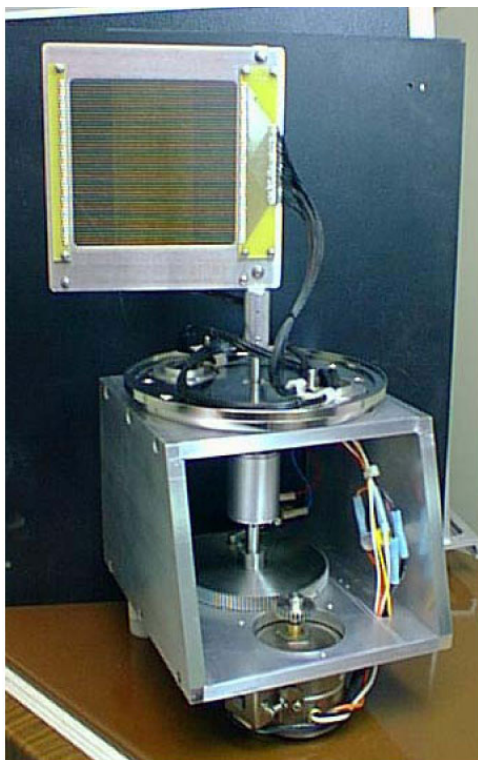
**Exhibit 4-1:**  
**Main Injector Multiwire Paddle**

Replacement of the weak LEP corrector magnets and repair of the 851 multiwire proportional chamber improved the performance of the Main Injector 8 GeV collimator system (see *Exhibit 4-1*). The small aperture LEP dipole magnets were replaced with rebuilt LEP corrector magnets that can run more

current than the previously installed LEP magnets. This improvement will help to reduce losses in the Main Injector. The multiwire at 851 measures the transverse beam prior to injection into the Main Injector. The mechanical system that moved the multiwire into and out of the beam was repaired. This job required radiological control technician (RCT) coverage, and radiation surveys were conducted as needed to monitor exposure rates during the work. There were five persons assigned to this job in addition to the RCT. The job went as planned, so the estimated collective dose of 64 person-mrem matched extremely well with the actual collective dose received of 61 person-mrem. This LEP magnet replacement and multiwire repair is estimated to reduce future doses by 300 person-mrem annually.

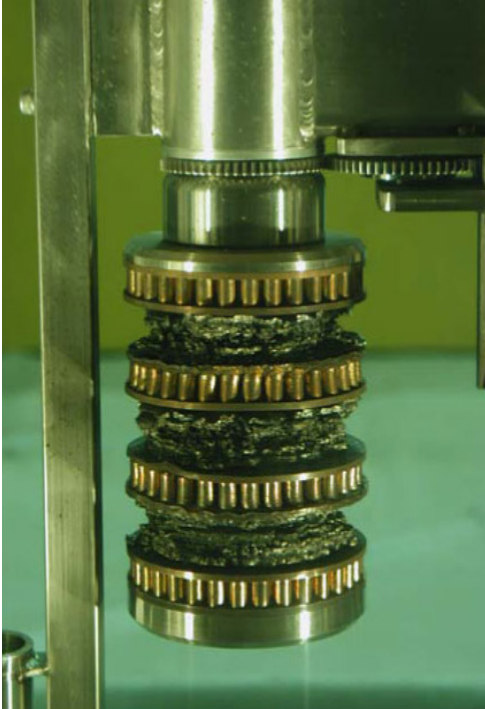
**Exhibit 4-4:**  
**Used Nickel Antiproton Target**

Fermilab creates antiprotons by striking a nickel target with protons. It takes 100,000 to a million protons to make an antiproton. Over time, these nickel targets become damaged by the proton beam and must be replaced (see *Exhibit 4-4*). In May of 2007, work was performed to replace a target and also replace a drive shaft. Before the work began, the Accelerator Division ordered beam to be shut off from the area approximately 4 hours to allow for cool down. Plastic was placed on the floor and the alcove before the target module was moved. When the used target was removed and placed into the alcove, it measured approximately 300 R/hr at 1 foot from the upstream side of the target. It is interesting to note that several pieces of the target were observed on the antiproton target stand frame. When the target was placed into the coffin, it measured about 150 mR/hr at 1 foot. The coffin was wrapped in plastic to contain any highly activated material fragments. Once the work was completed, the plastic on the floor between the alcove and the lower vault was placed into a bag. The bag measured approximately 700 mR/hr on contact from highly activated particles. Next, the drive shaft on the target module was replaced (see *Exhibit 4-5*). Plastic was placed over the old shaft and the shaft was transferred to the storage vault. The drive shaft measured about 600 mR/hr at 1 foot. All areas were carefully surveyed to ensure that there were no highly activated material fragments present. During this work, pictures of the lithium lens and the pulsed magnet were also taken. Unexpected difficulties in obtaining photos of these items added 16 person-mrem to the overall collective dose. The collective dose estimate for the target and drive shaft replacement was 285 person-mrem and the actual collective dose was 290 person-mrem. This actual dose was well within the contingency estimate of 340 person-mrem. This job was carefully planned, well-executed, and workers diligently followed ALARA. The time estimated for this work was 12 hours, but it was completed in 10 hours.

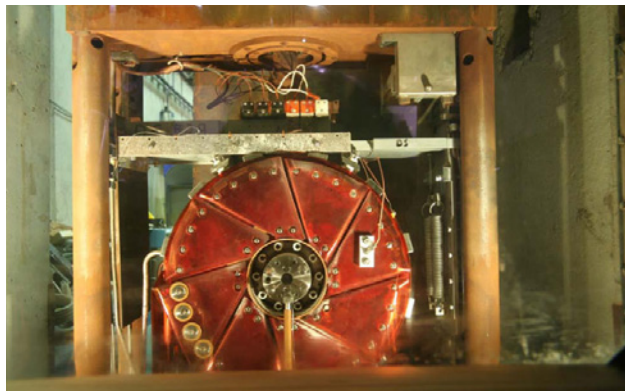
**Exhibit 4-7:**  
**Lens Module Replacement with New Pre-Attached Lithium Lens**

A spare lithium lens module was refurbished complete with a replacement lens already attached (see *Exhibit 4-7*). In the past, when a lithium lens failed, the lens was replaced with a new lens on the same highly radioactive lens module. In this case, a new lens was attached to a previously used spare lens module. In the future, when a lens failure does occur, the entire lens module will be switched out by remote crane operations and replaced with another less radioactive lens module. In this ALARA job, the highly radioactive lens module was placed directly in the storage vault for cool down. The exposure rate at the downstream side of the lithium lens was about 200 R/hr at 1 foot. The estimate for this job was 257 person-mrem and the actual collective dose received was 234 person-mrem. Another unique ALARA feature of this job was fabrication of a screwdriver with long extension to reduce exposure. Additionally, there was effective use of temporary shielding in the APO alcove. Another feature of this work was careful pre-planning and use of a mock-up to practice the job before it was performed. The mock-up work was performed on a radioactive spare module with a much lower exposure rate than the lens module being replaced. The highest dose rate on the spare mock-up lens module was about 4 R/hr at 1 foot. The use of a spare lithium lens module will save both time and dose in future lens replacements. It is anticipated that the refurbishment of a spare replacement lens module will require about 50 person-mrem. A typical lithium lens replacement job results in a collective dose of approximately 300 person-mrem. Therefore, a spare lens module with a new lens will save an estimated dose of about 250 person-mrem.

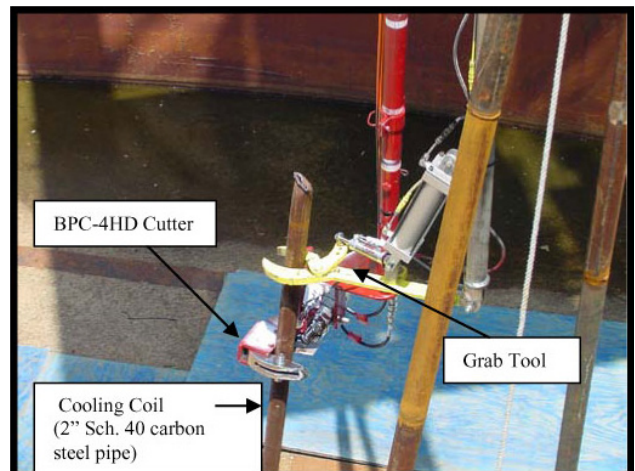
**Exhibit 4-8:**  
**Mock-up of Mega-Tech Blade Plunging**

Recently, construction was tasked to install two submersible pumps at Tank 5 in F Tank Farm (FTF). To ensure no obstructions were present in the Tank risers that would restrict the installation of two submersible pumps, cameras were inserted into access ports at Risers 3 and 8. A review of the videos revealed that cooling coils in both risers had moved and would hinder the installation of the pumps. Knowing this and keeping ALARA and Safety foremost, the construction team, led by engineer Tom France, consulted with the Savannah River Site (SRS) ALARA Center and selected the Mega-Tech Blade Plunging Cutter (BPC-4HD) as the cooling coil cutting tool (see *Exhibit 4-8*). The BPC-4HD was modified to add a deployment system for positioning the cutter on the coil. A pneumatic grab tool was designed by construction to grab the coils as they were cut to control where they landed in the tank. A special riser shield plate was also designed to reduce occupational radiation exposure. These tools would enable the workers to cut the cooling coils remotely through the open tank risers.

Operation of the cutting and grab tools was successfully demonstrated at T Area, also known as TNX, prior to use in FTF. Below is a picture taken during the mock-up.

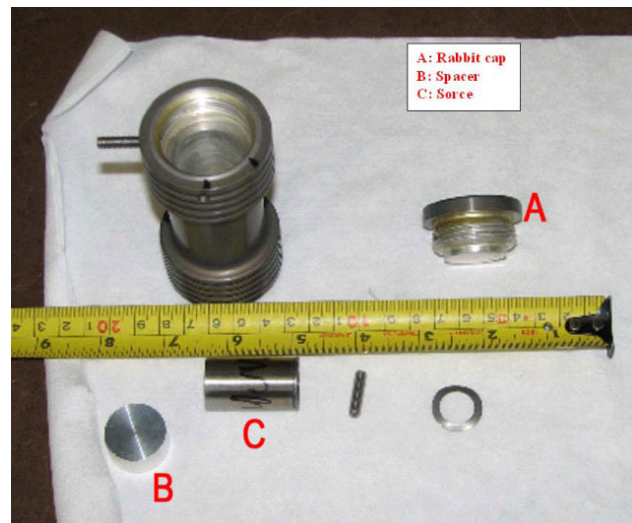
**Exhibit 4-10:**  
**Rabbit, spacer, source, washer and set**

In July 2007, the vendor returned to remove the source and rabbit from the GBI. The vendor used the appropriate tools and removed the source and failed rabbit from the GBI. All rabbit internal parts (2 washers and spacer) were accounted for.

The rabbit and associated internal parts smeared <20 dpm  $\alpha$ /100 cm<sup>2</sup>, <200 dpm  $\beta\gamma$ /100 cm<sup>2</sup> and probed no detectable. A visual inspection of the sealed source via boroscope indicated the source was not compromised. The source is currently inside an engineered shipping cask, temporarily stored in the GBI Room.

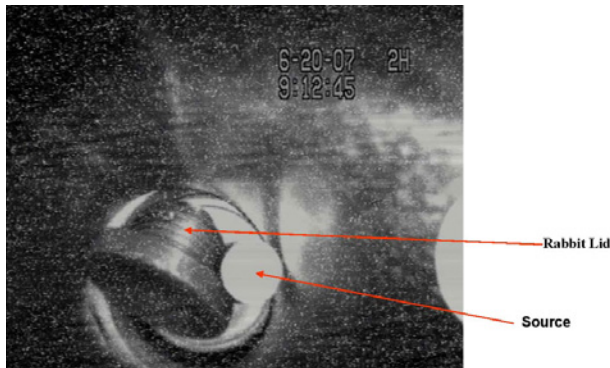
**Exhibit 4-11:**  
**Boroscope view of rabbit lid and source.**

The HPS Technical Director decided to insert a boroscope into the source transfer tube to determine the cause of the obstruction. The boroscope revealed the rabbit's lid containing the 1 Ci Co-60 source had become unscrewed causing the obstruction (see *Exhibit 4-11*). The HPS Technical Director notified the vendor and scheduled an appointment to come out to resolve the jam.

All other sources in the GBI had a second, longer set screw added to ensure that their rabbit's lid would remain intact during operation of the GBI.

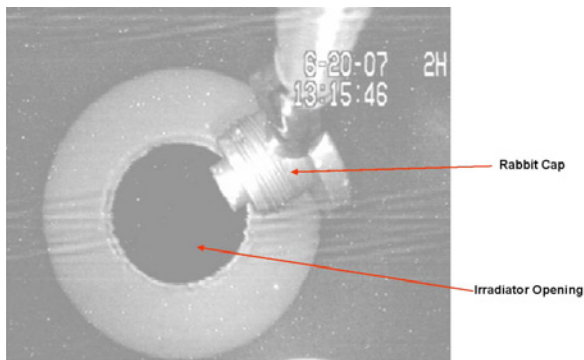
**Exhibit 4-12:**  
**The Rabbit Lid being removed from the**

During the vendor's visit, the rabbit lid was removed (see *Exhibit 4-12*) from the GBI and the source was returned to the rabbit until the vendor, HPS Director, and Radiation Controls Operation (RCO) could determine a path forward for removing the rabbit and source from the GBI.

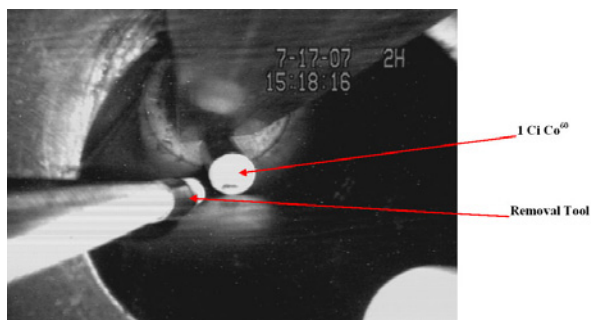
**Exhibit 4-13:**  
**Source removed from the GBI.**

Radiological conditions of the GBI were determined before the rabbit and source were removed. Dose rate calculations were performed based on decay of the source (0.254 Ci). It was determined that at 5 cm the unshielded dose would be 150 R/hr and at 30 cm this rate would be 3.6 R/hr. Based on these dose rates, RCO determined that an extension tool had to be used to remove the 1 Ci Co-60 source and place it into a storage carousel (see *Exhibit 4-13*).

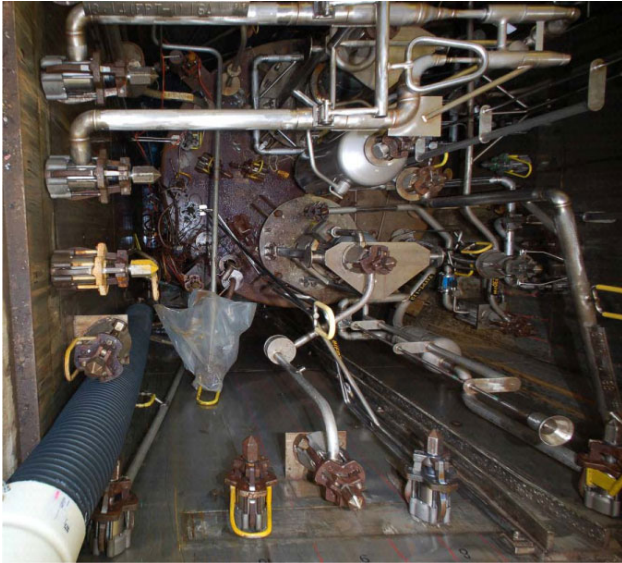
**Exhibit 4-14:**  
**Pump pit with jumpers and valves.**

Due to tank closure missions to re-direct waste transfers, a plan was developed to re-configure the jumper alignment, which would include repairing and replacing several jumpers. A total of 13 jumpers had to be removed from the highly contaminated 15' x 15' x 25' deep pit cell. The size of the cell opening created a very prohibitive maintenance of negative airflow.

Historical data has shown a Price-Anderson Amendments Act (PAAA) investigation was performed, due to contamination being detected outside the containment (e.g., windbreak), which resulted in a personnel contamination case. During the past, the pump pit collected spent equipment (e.g., sump pumps, cords, jumpers, ventilation duct, etc), making it very difficult to remove any jumper from the pit area. Recent waste transfers from the F Canyon included Am/Cm (americium/curium). These isotopes increased the risk of spreading contamination, once the jumpers were disconnected.

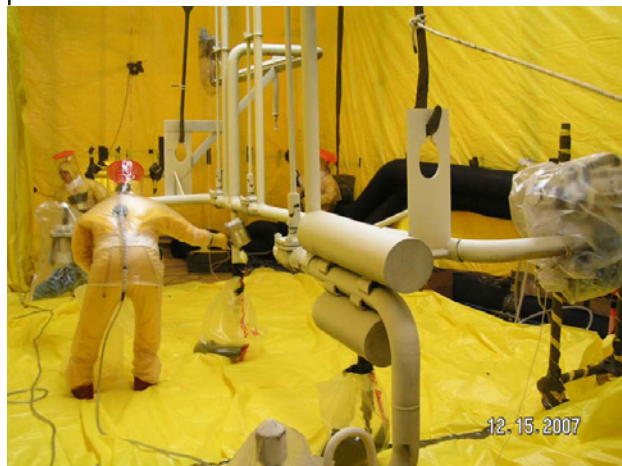
**Exhibit 4-26:**  
**Removed jumper**

- ◆ Eleven cell covers were removed, 12 jumpers were removed and disposed (see *Exhibit 4-26*), 3 new jumpers were installed (see *Exhibit 4-27*), and the 11 cell covers were replaced.
