Mech

Spring 2009

**The Navy & Marine Corps
Aviation Maintenance Safety Magazine**
Spring 2009, Volume 48 No. 2

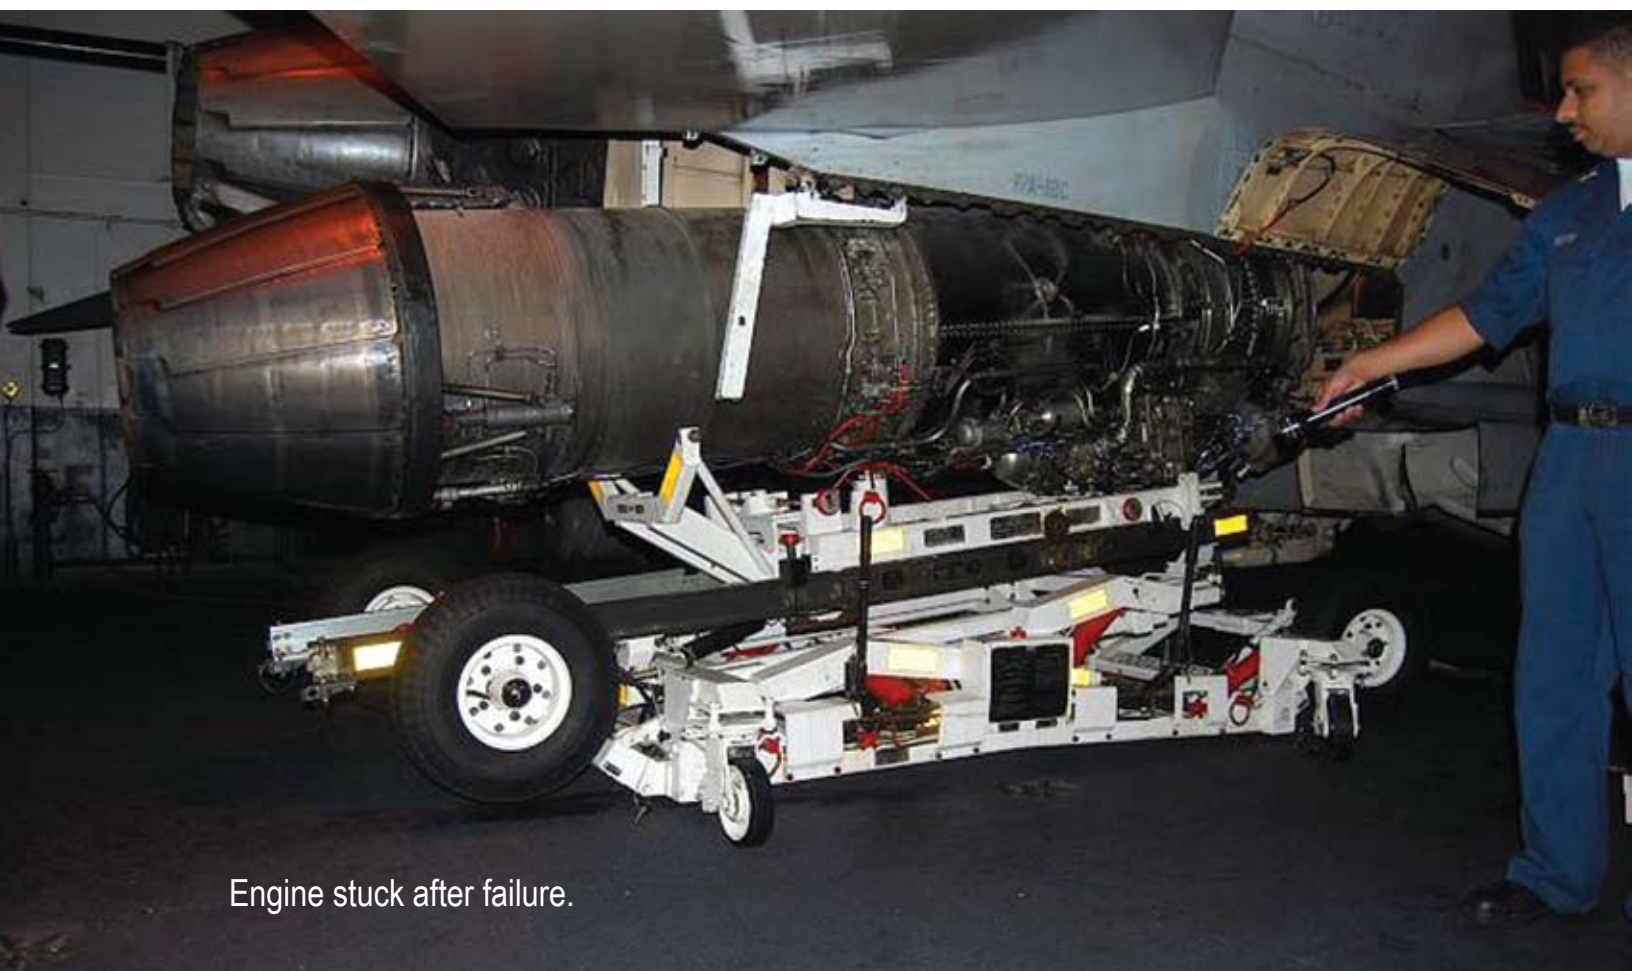
We pumped the aft section back up, simultaneously lowering the front enough to clear the manifold. Suddenly, one of the hydraulic lines on the stand ruptured.

Engine stuck after failure.

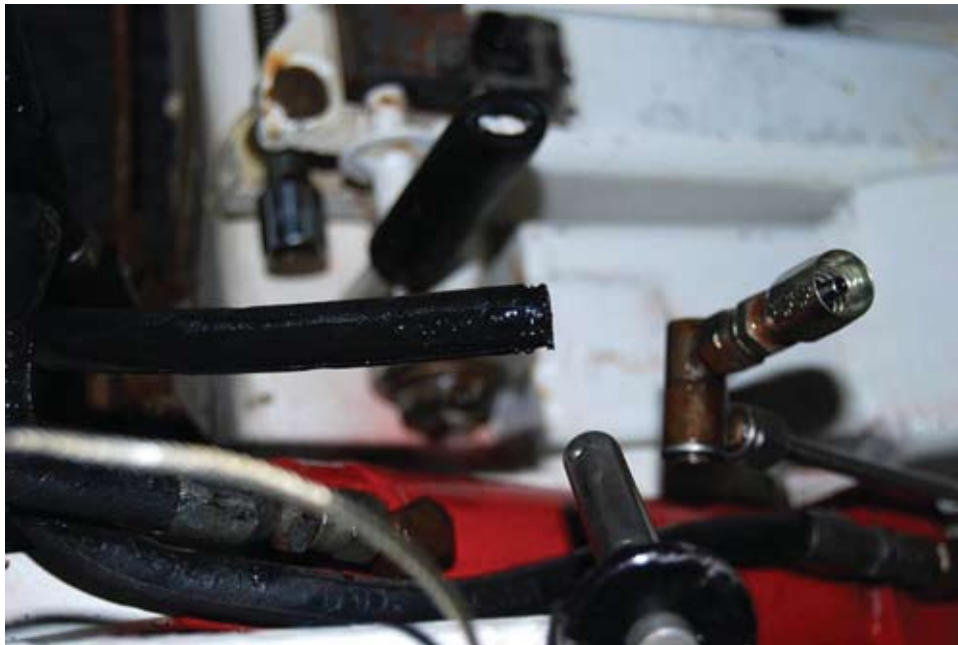
Aft hydraulic line on ETU-110 failure (above).

All the pressure in the aft section of the stand immediately was released, causing the stand and the 3,000-pound engine to free-fall to the deck. I had been holding a flashlight between the engine and the wall of the engine cavity in order to have a clear view of the fuel manifold. The engine hit my shoulder on its way down.

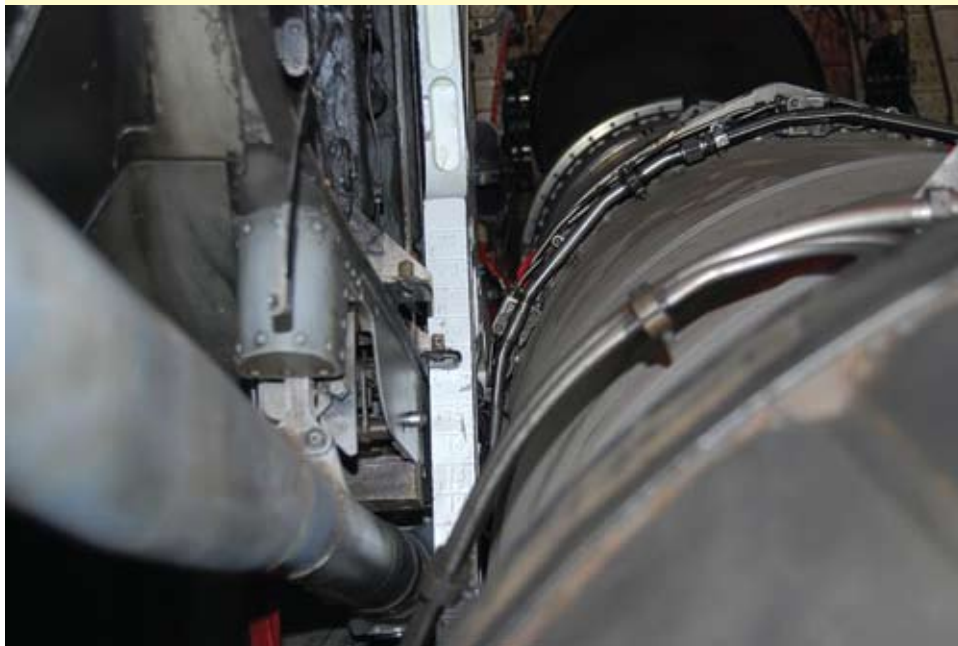
Engine shift inboard area between tailhook and engine is where the author had been standing (below).

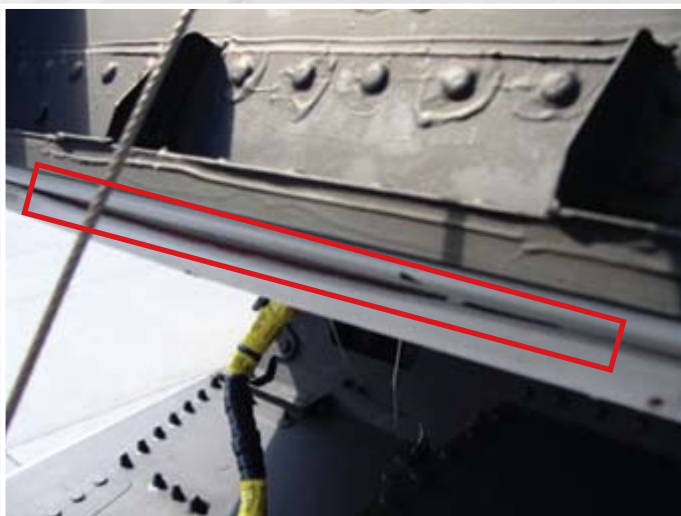
In three other incidents, a weather seal on the aft portion of the canopy became worn and eventually tore, exposing an orange inner seal that laid over the canopy rail. This failure was unsettling because the weather seals showed wear at less than 20 hours of flight time. Once these seals split, the AMEs had to replace them.

The seals were tearing along the very aft portion of the canopy. Unless aircrew or maintenance personnel knew to check this location during preflight, they easily could overlook a torn seal.

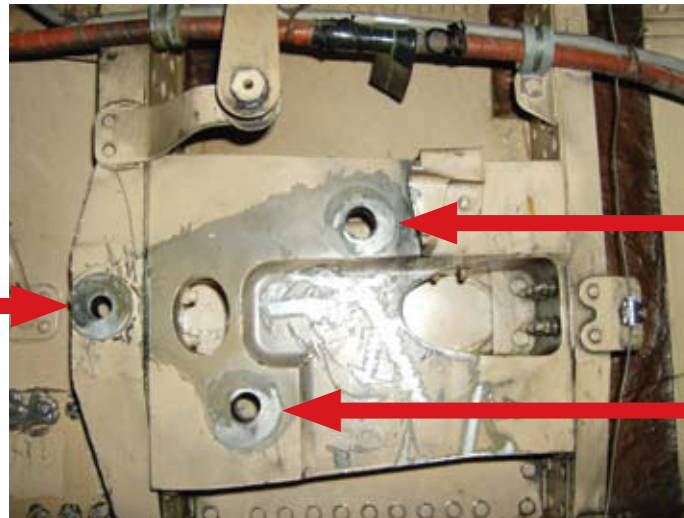
This is how the mount bolt hole is supposed to look...

...but this is what the other bolt holes looked like.

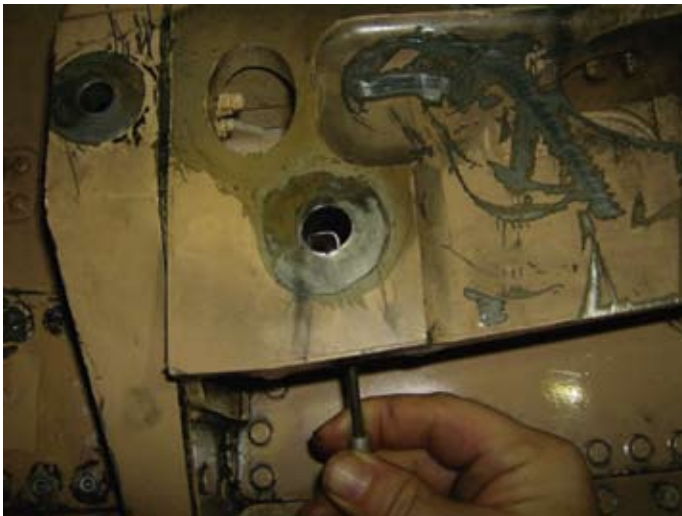
This bolt hole also was rounded out.

The scribe points out how worn the lower bolt hole was, as opposed to the upper hole.

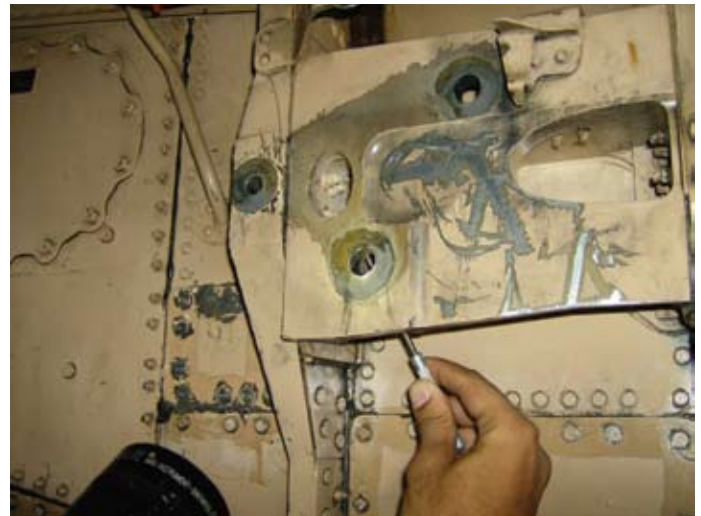
Another close-up of these bolt holes. Those worn bolt holes are the reason that the engine was shifting mid-flight.

of the nuts connecting the mount to the airframe didn't have a torque seal and was sitting loosely on the bolt. When we had removed the mount, we found that two of the three mount bolts were warped and cracked. This discovery explained the shifting of the engine, as well as the issue we had been having with the FIT rubbing on the bell crank.

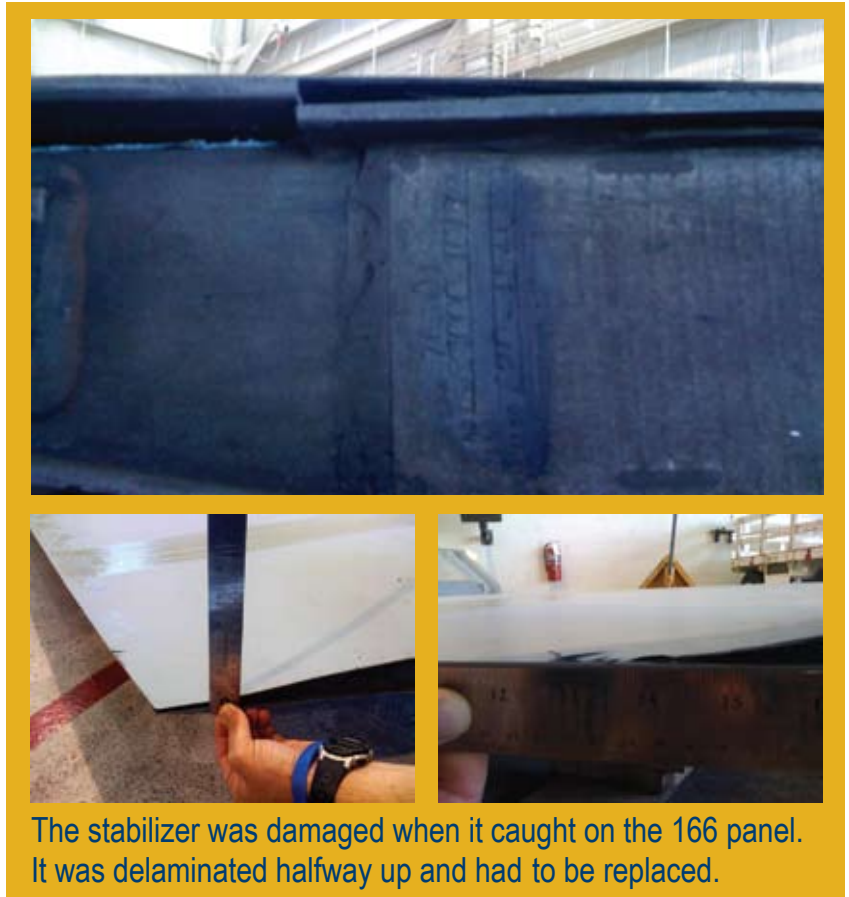
The stabilizer was damaged when it caught on the 166 panel. It was delaminated halfway up and had to be replaced.

The horizontal stabilizer still had hydraulic pressure in the system. It had jumped and rapidly was coming down on top of my hands. Thanks to the careful eye of my fellow mechanic, I was able to move my hands before losing a finger, but the stabilizer was damaged when it caught on the 166 panel. It was delaminated halfway up and had to be replaced.

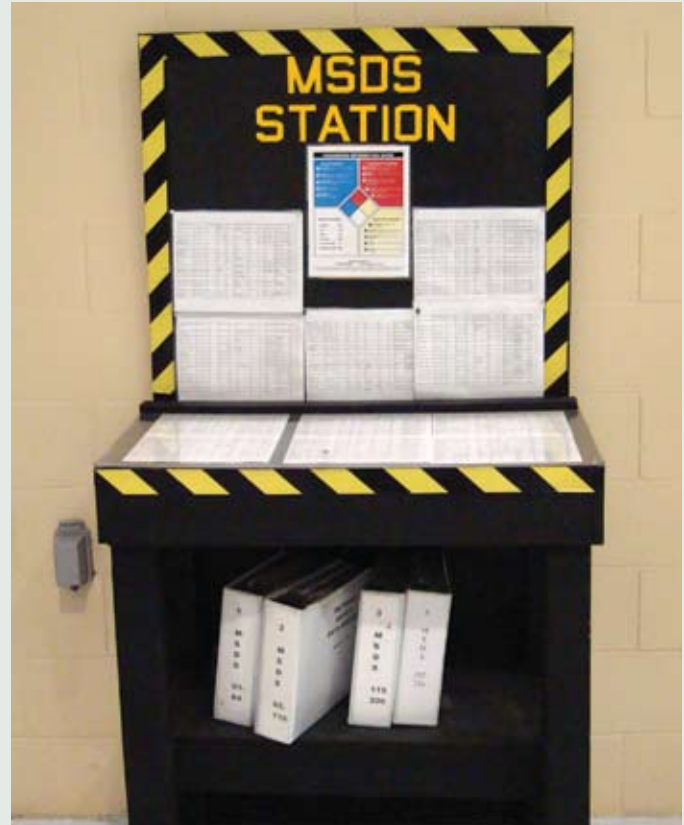
Good

MSDS station central location—it's all about simplicity and awareness.

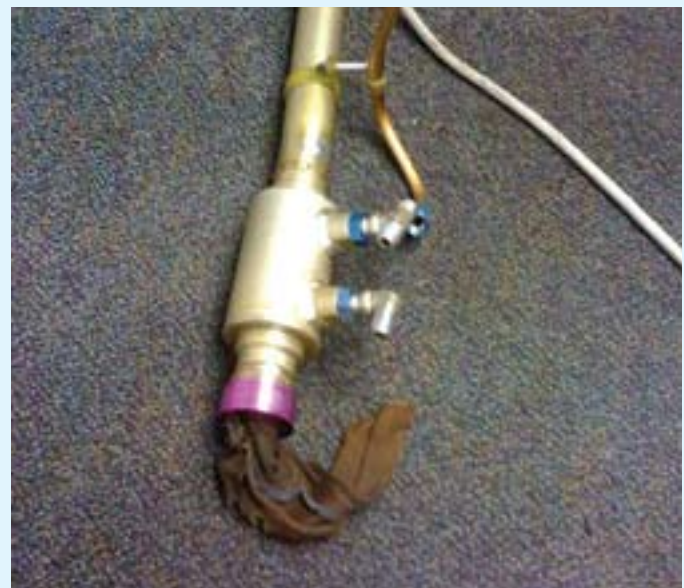
Bad

Rag was not accounted for during a fuel-maintenance procedure and ended up clogging up the fuel system—could have caused a mishap.
