Methodology for Estimating Fabrication Flaw Density and Distribution – Reactor Pressure Vessel Welds

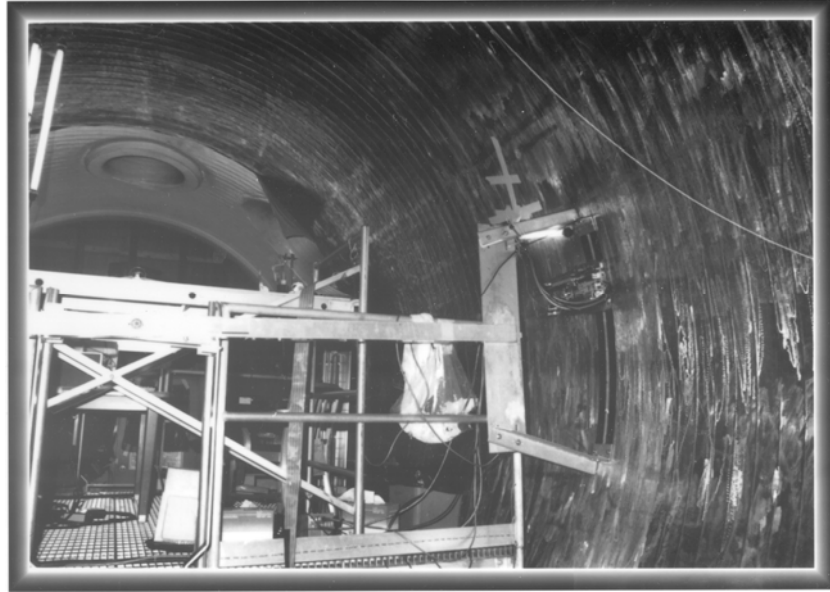
Figure 2.1 Inside View of the PVRUF Vessel during SAFT-UT Inspections

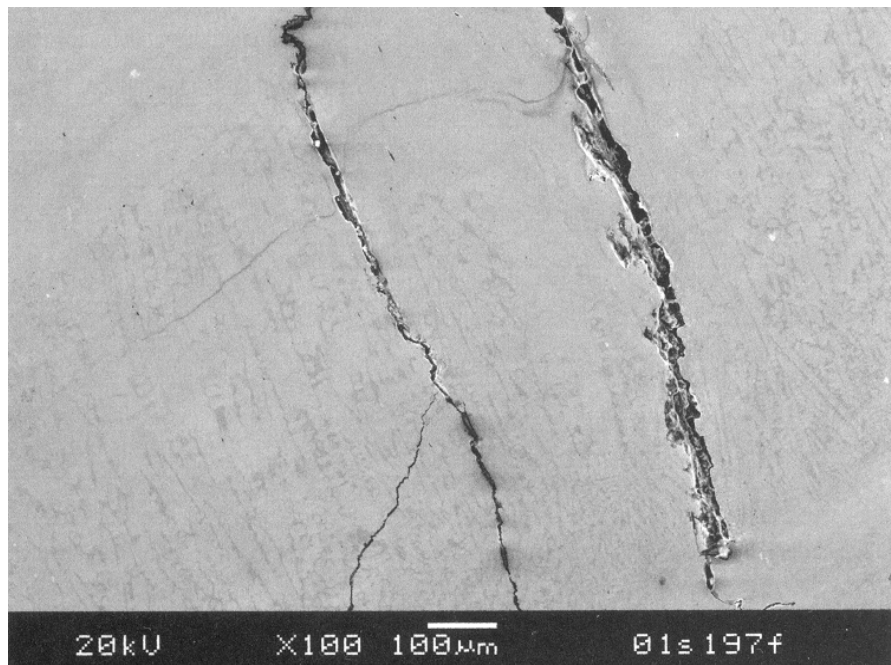
Figure 2.16 Electron Microscope Image of Cracked Weld Bead in PVRUF Vessel

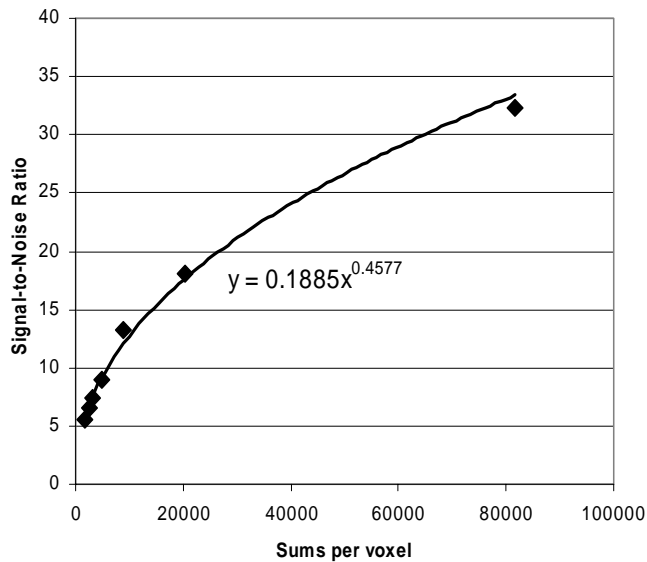
Figure 3.2 Signal-to-Noise and Sizing Performance for Lens Sampling
