**Collision Between a Ford Dump Truck
and Four Passenger Cars
Glen Rock, Pennsylvania
April 11, 2003**

Highway Accident Report

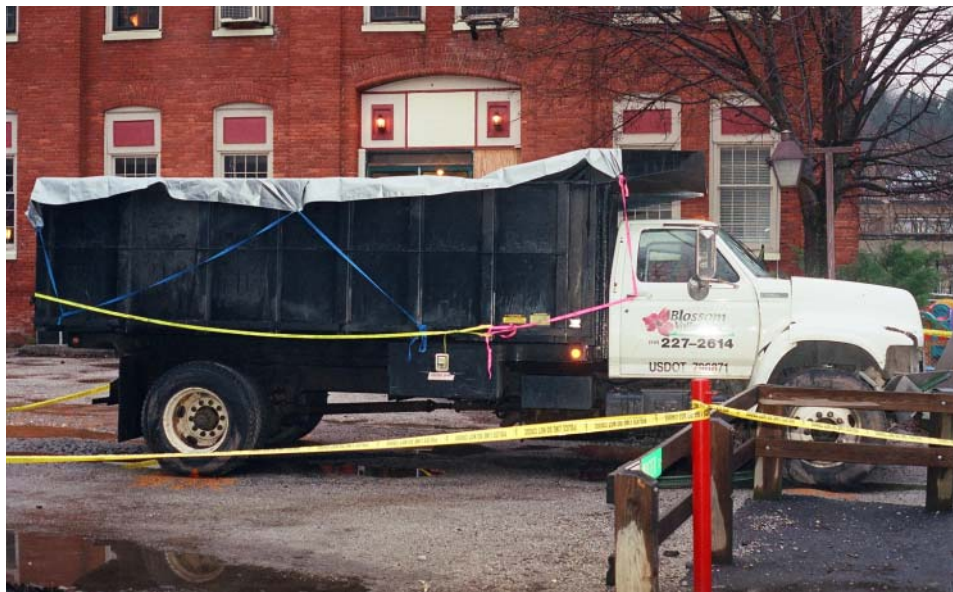
Figure 1. Accident truck. (Source: Southern Regional Police Department)

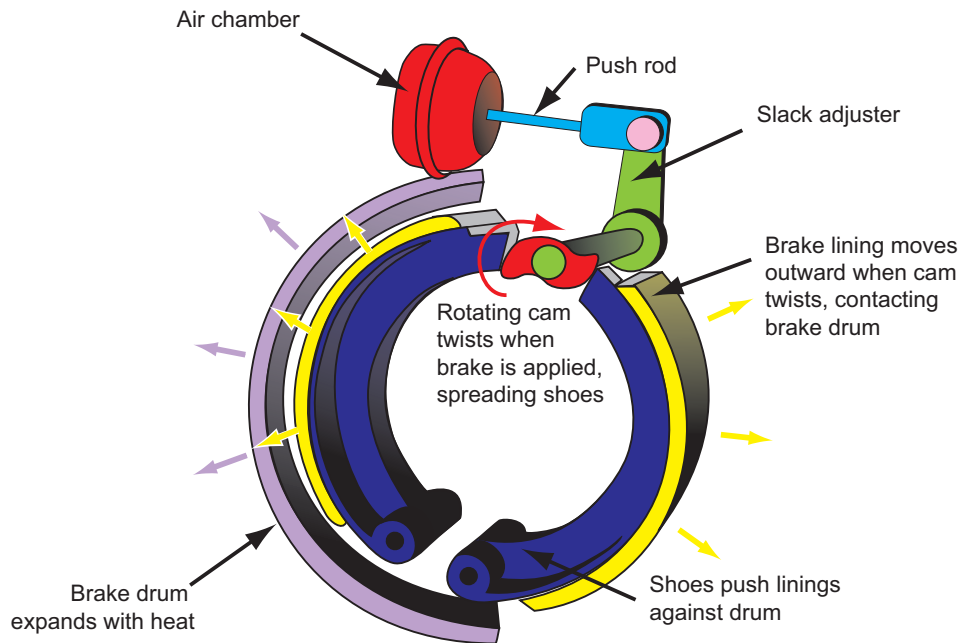
Figure 9. Brake schematic.

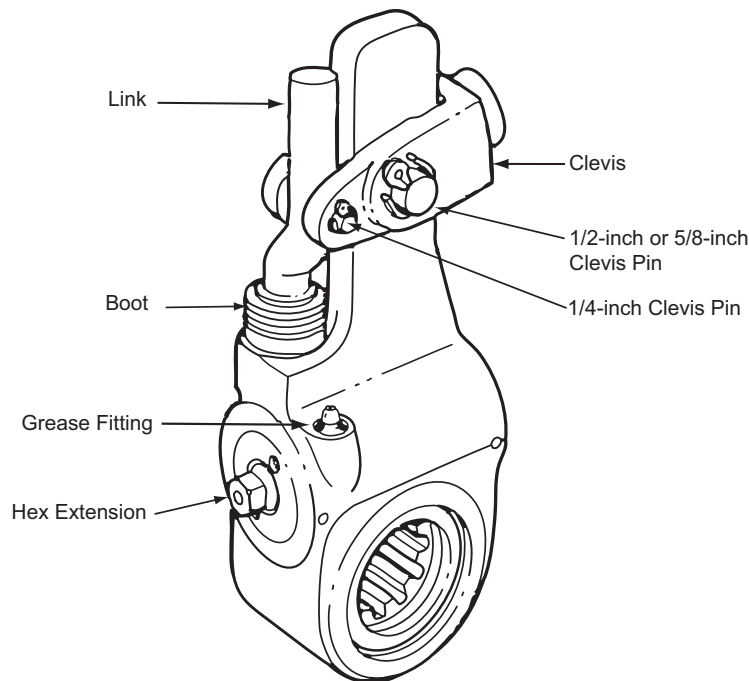
Figure 10. Schematic of a Gunite automatic slack adjuster. (Adapted from a figure that appears in the *Gunite Corporation Automatic Slack Adjuster Service Manual*, June 1994 edition.)

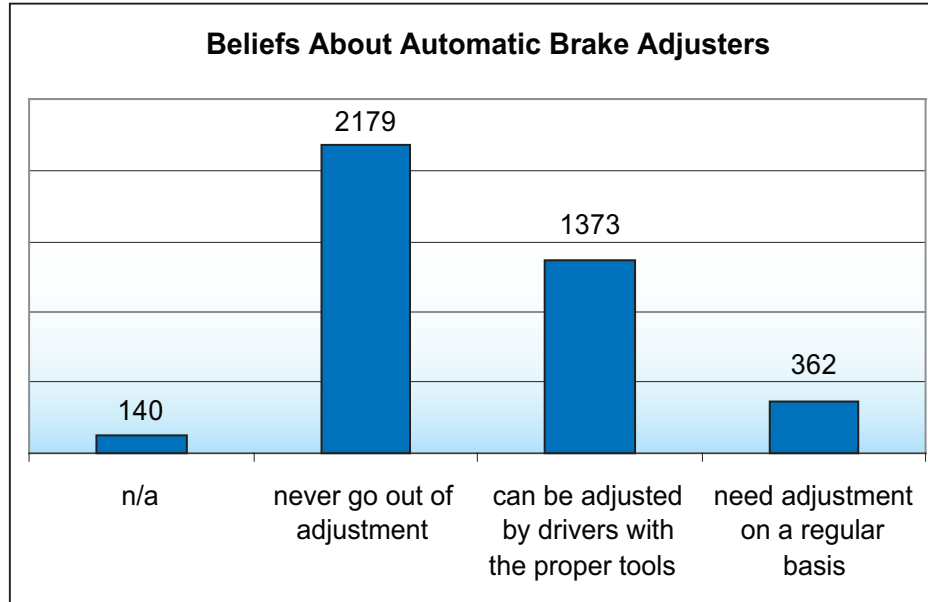
Figure 11. Responses to 2003 Operation Air Brake driver survey question about automatic slack adjusters. (Source: Commercial Vehicle Safety Alliance)

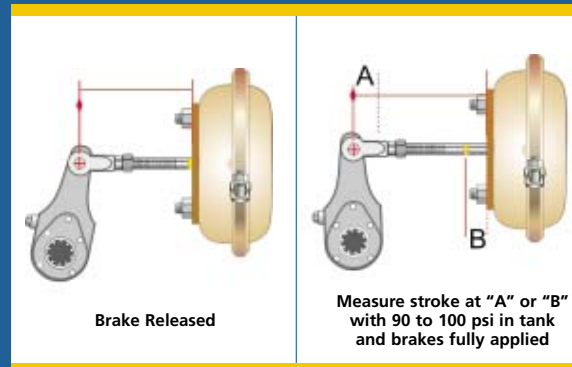
If this distance is also longer than normal, a readjustment may temporarily correct the problem.

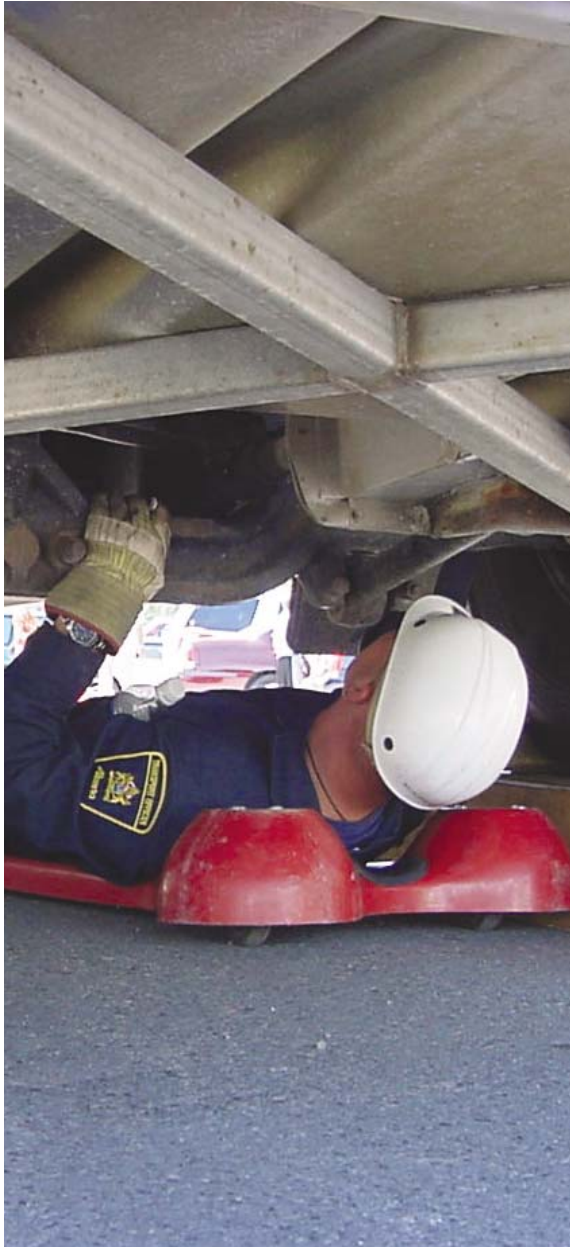
*Why It's So
Important To Keep Your Brakes
Properly Adjusted*
