DOCUMENT RELEASE FORM

(5) Release Type <input checked="" type="checkbox"/> New <input type="checkbox"/> Cancel		<input type="checkbox"/> Page Change		<input type="checkbox"/> Complete Revision

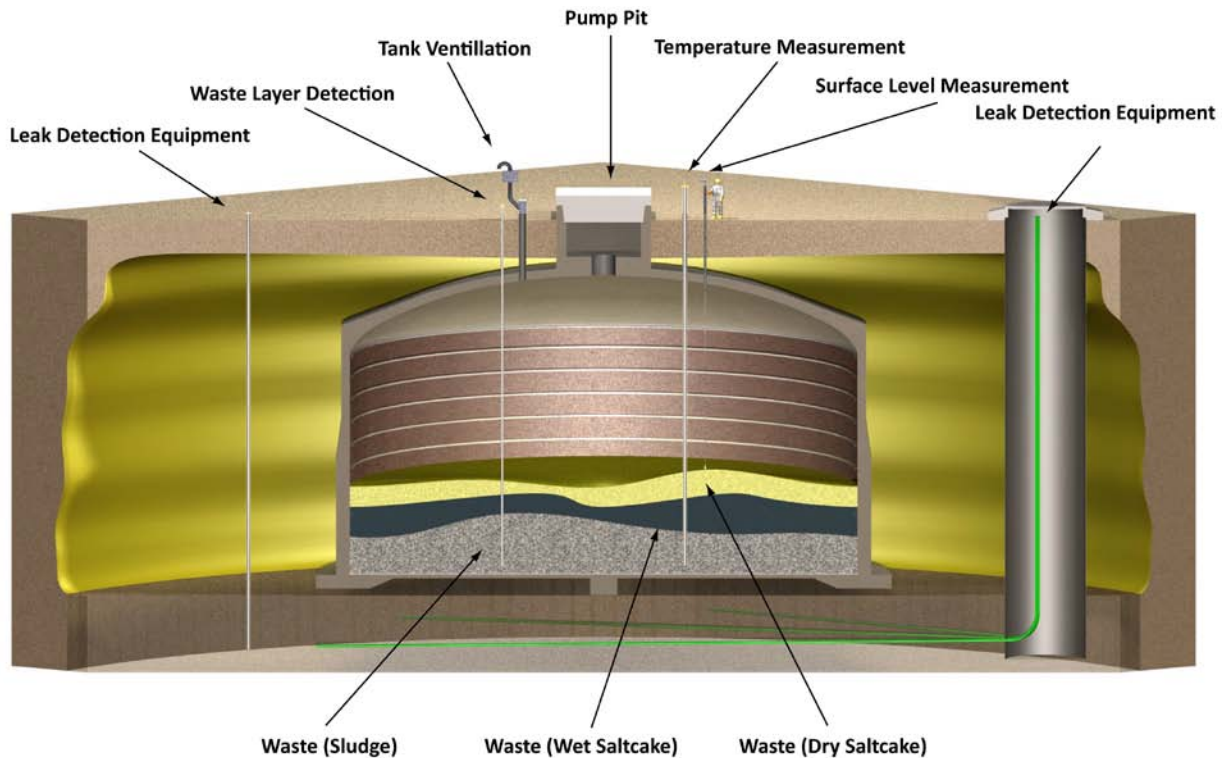
SST_Rendering-4_09022009

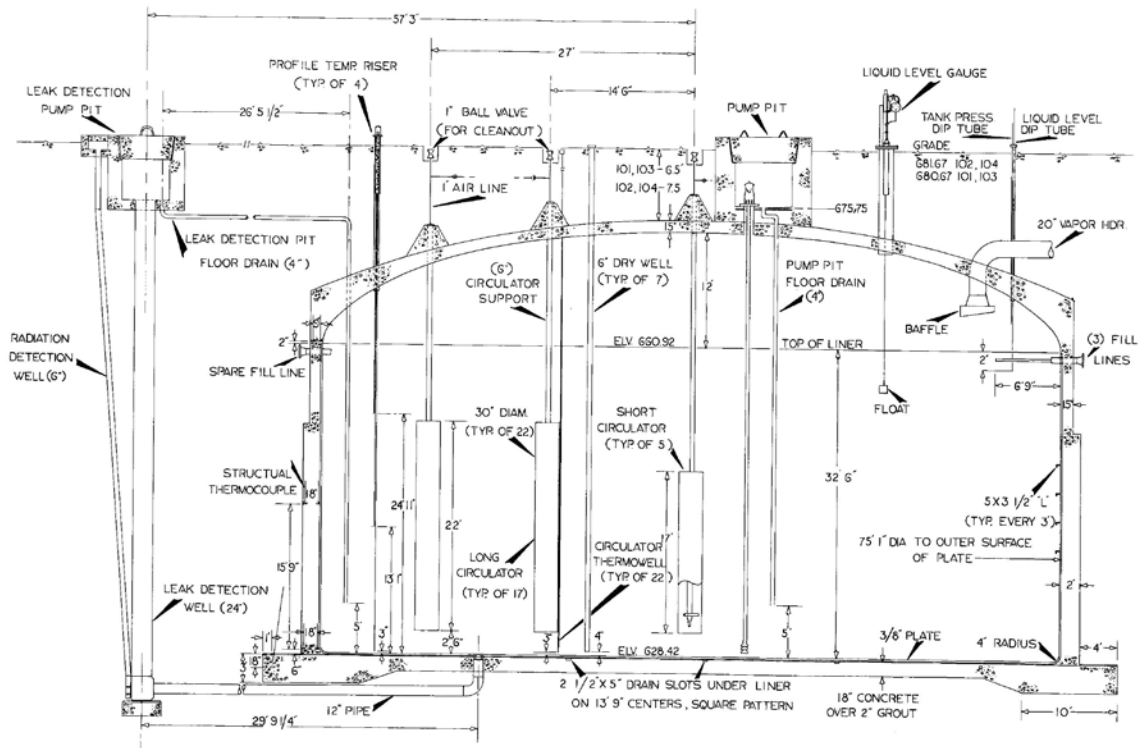
3.0 HANFORD VISUAL INSPECTIONS

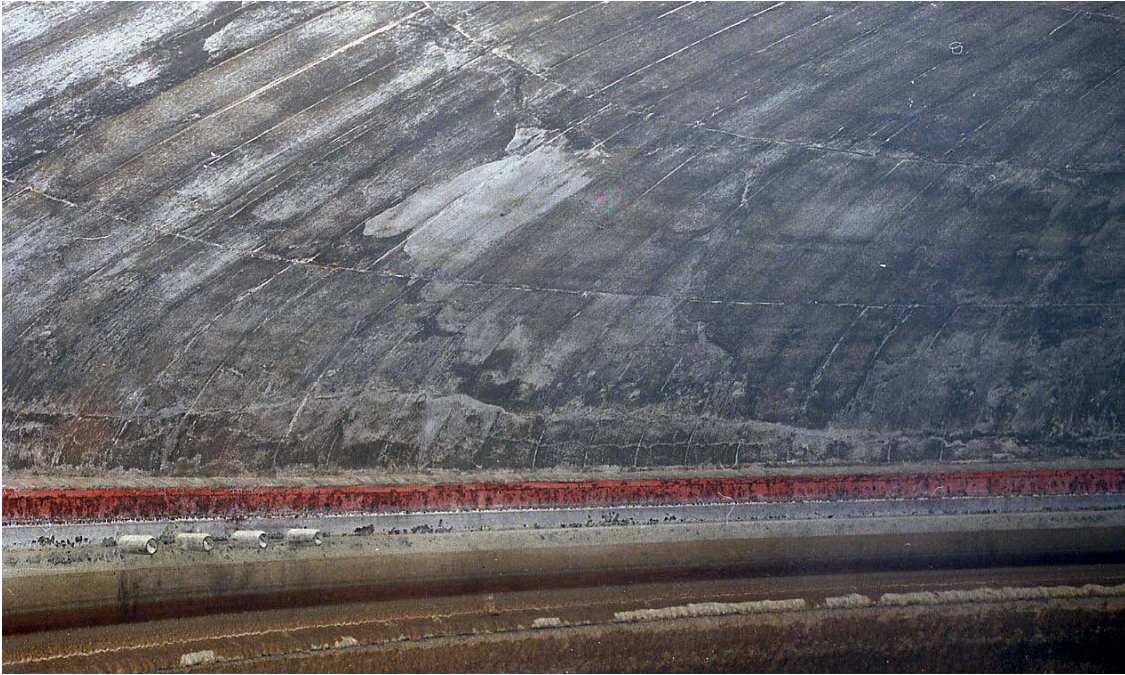
Figure 3-3. SST Headspace Remote Video.

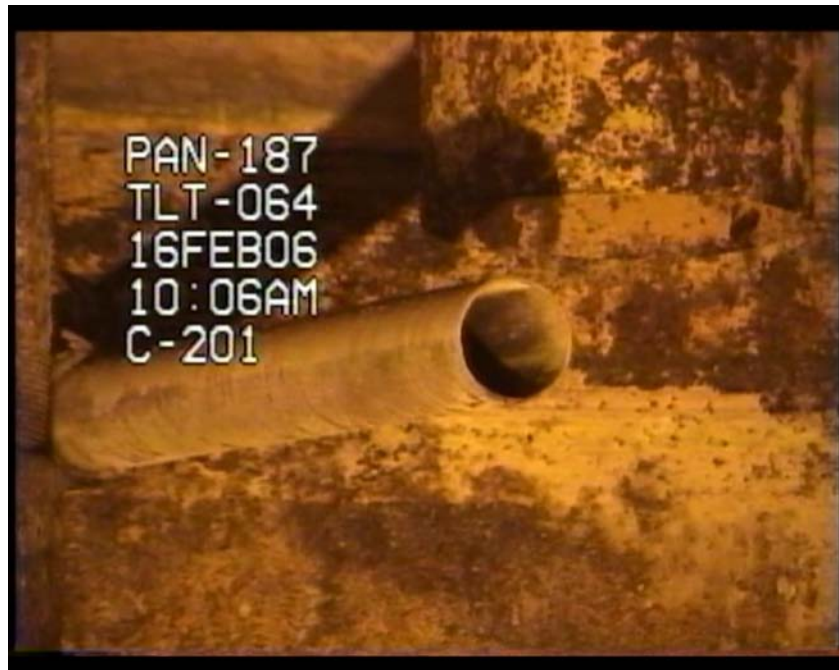
3.2 DOUBLE-SHELL TANK VISUAL INSPECTIONS

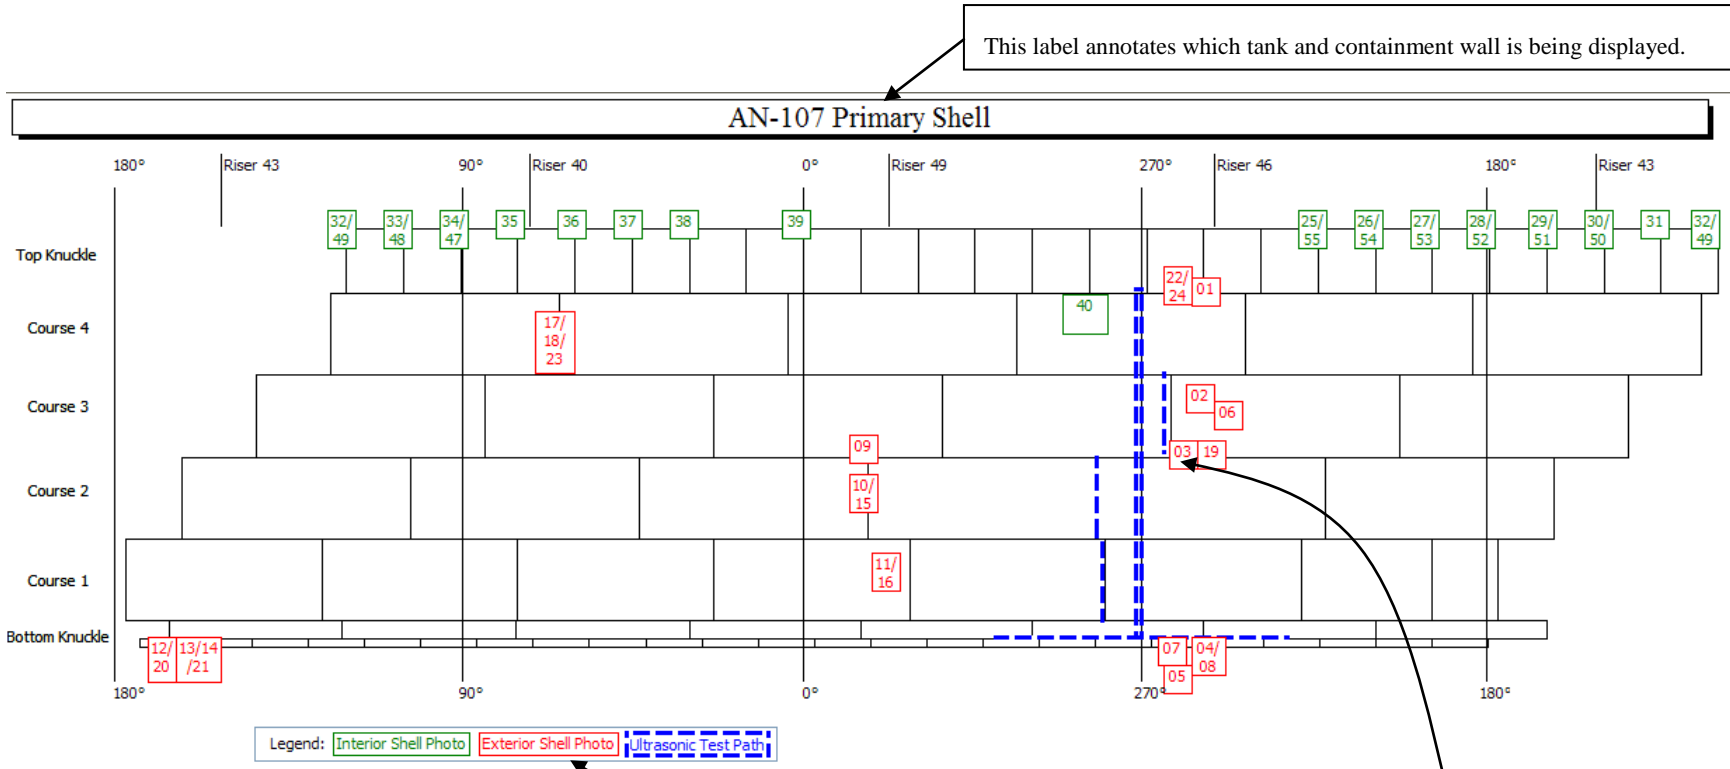
Figure 3-4. AN Tank Integrity Inspection Map Example.

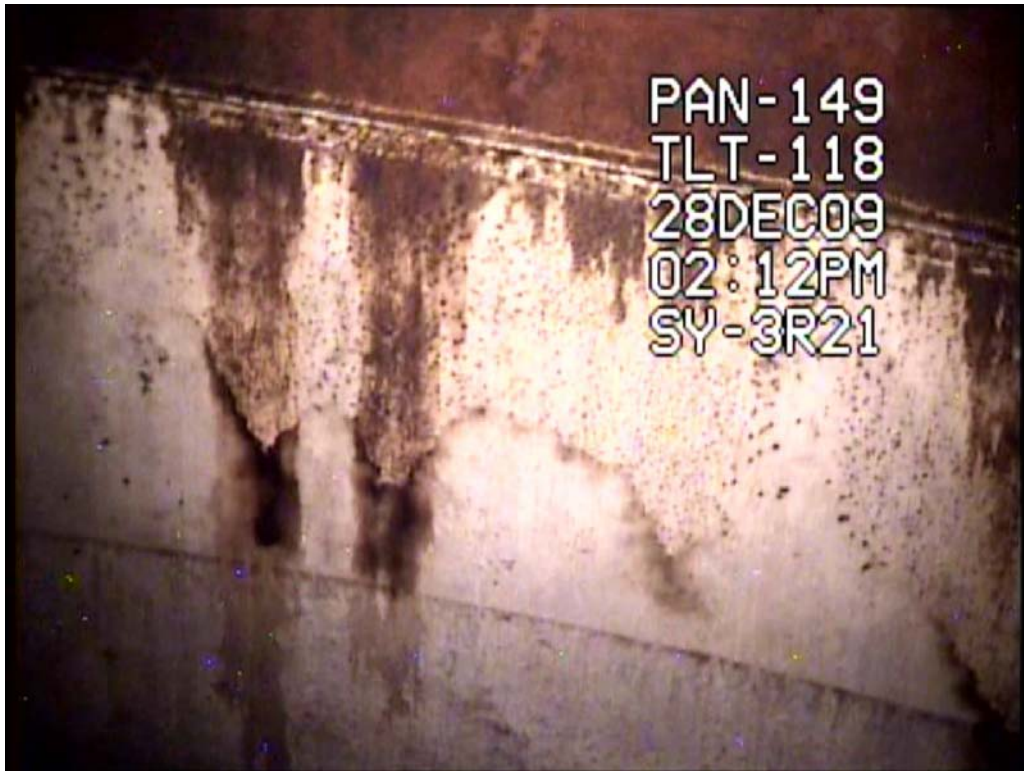
Figure 3-7. Close-Up of Potential Pitting in Tank 241-SY-103 Liquid-Air-Interface Region.

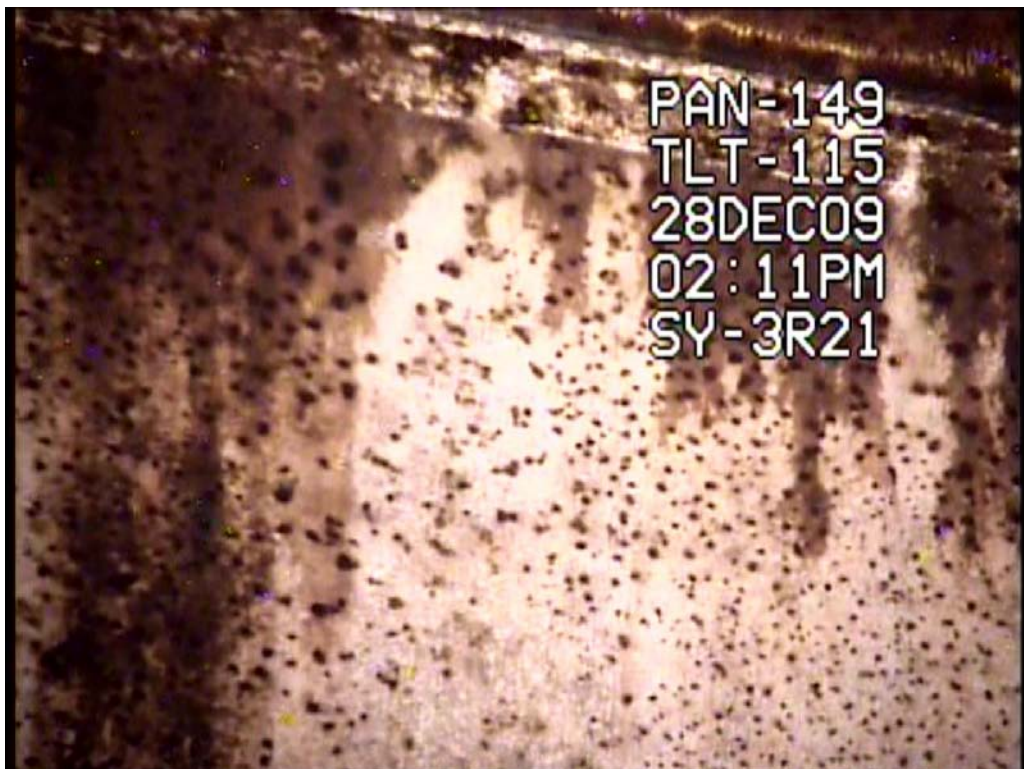
Primary Tank Cracks:

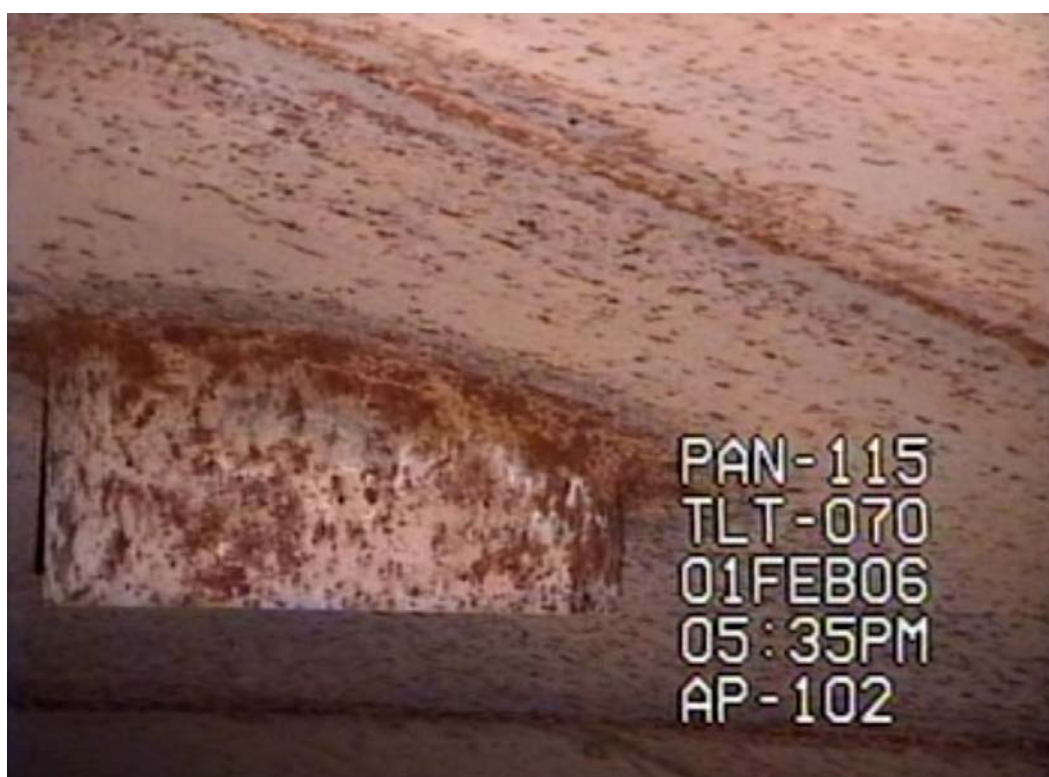
3.3.2 ANNULUS INSPECTION EVALUATION FACTORS

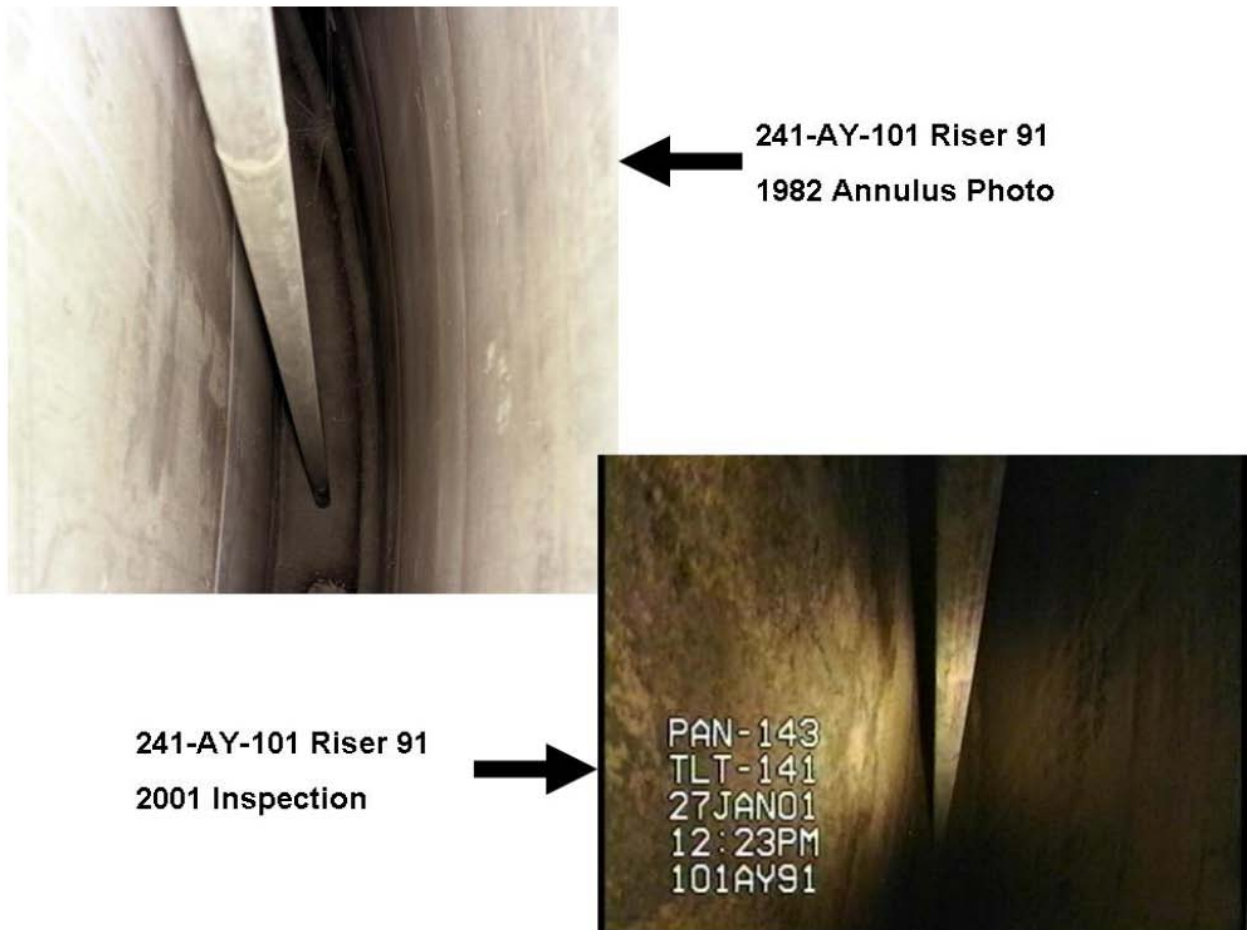
Primary Tank Cracks:

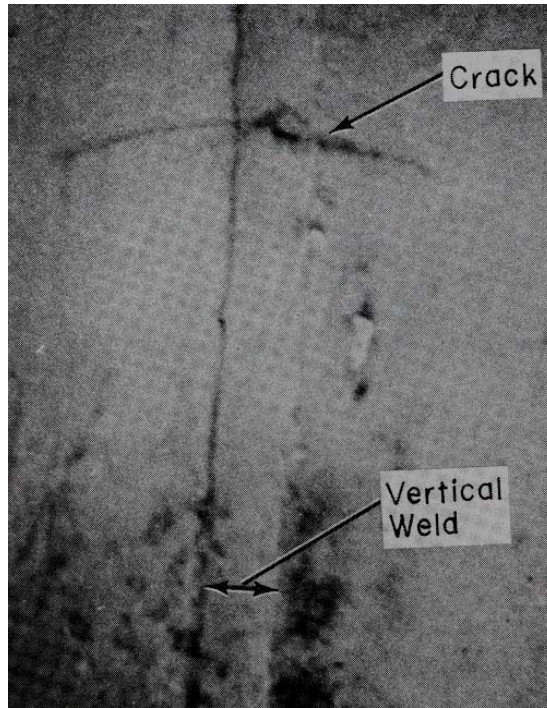
Figure 3-11. Savannah River Site Tank 15 Vapor Space Crack.

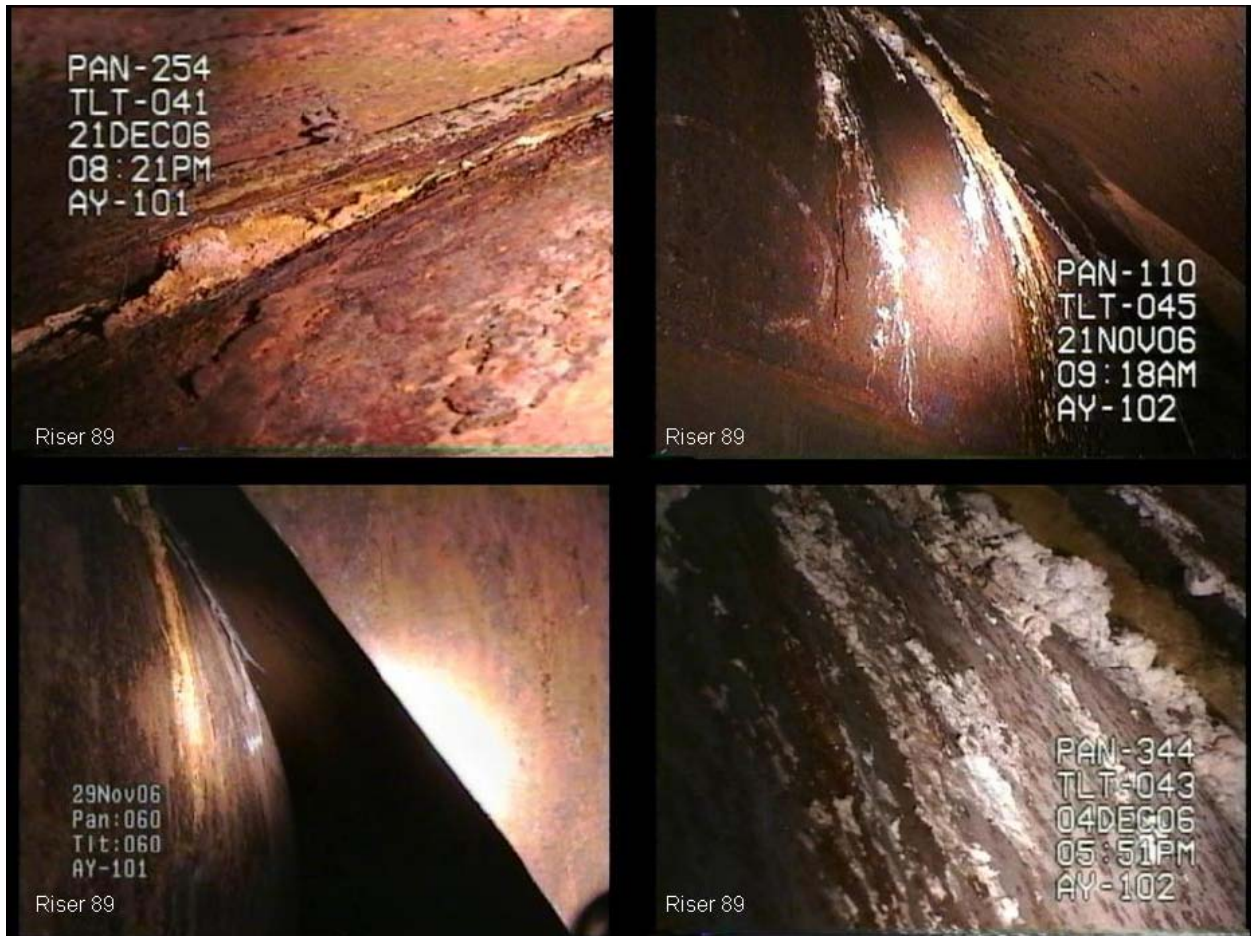
3.4 SINGLE-SHELL TANK VISUAL INSPECTIONS

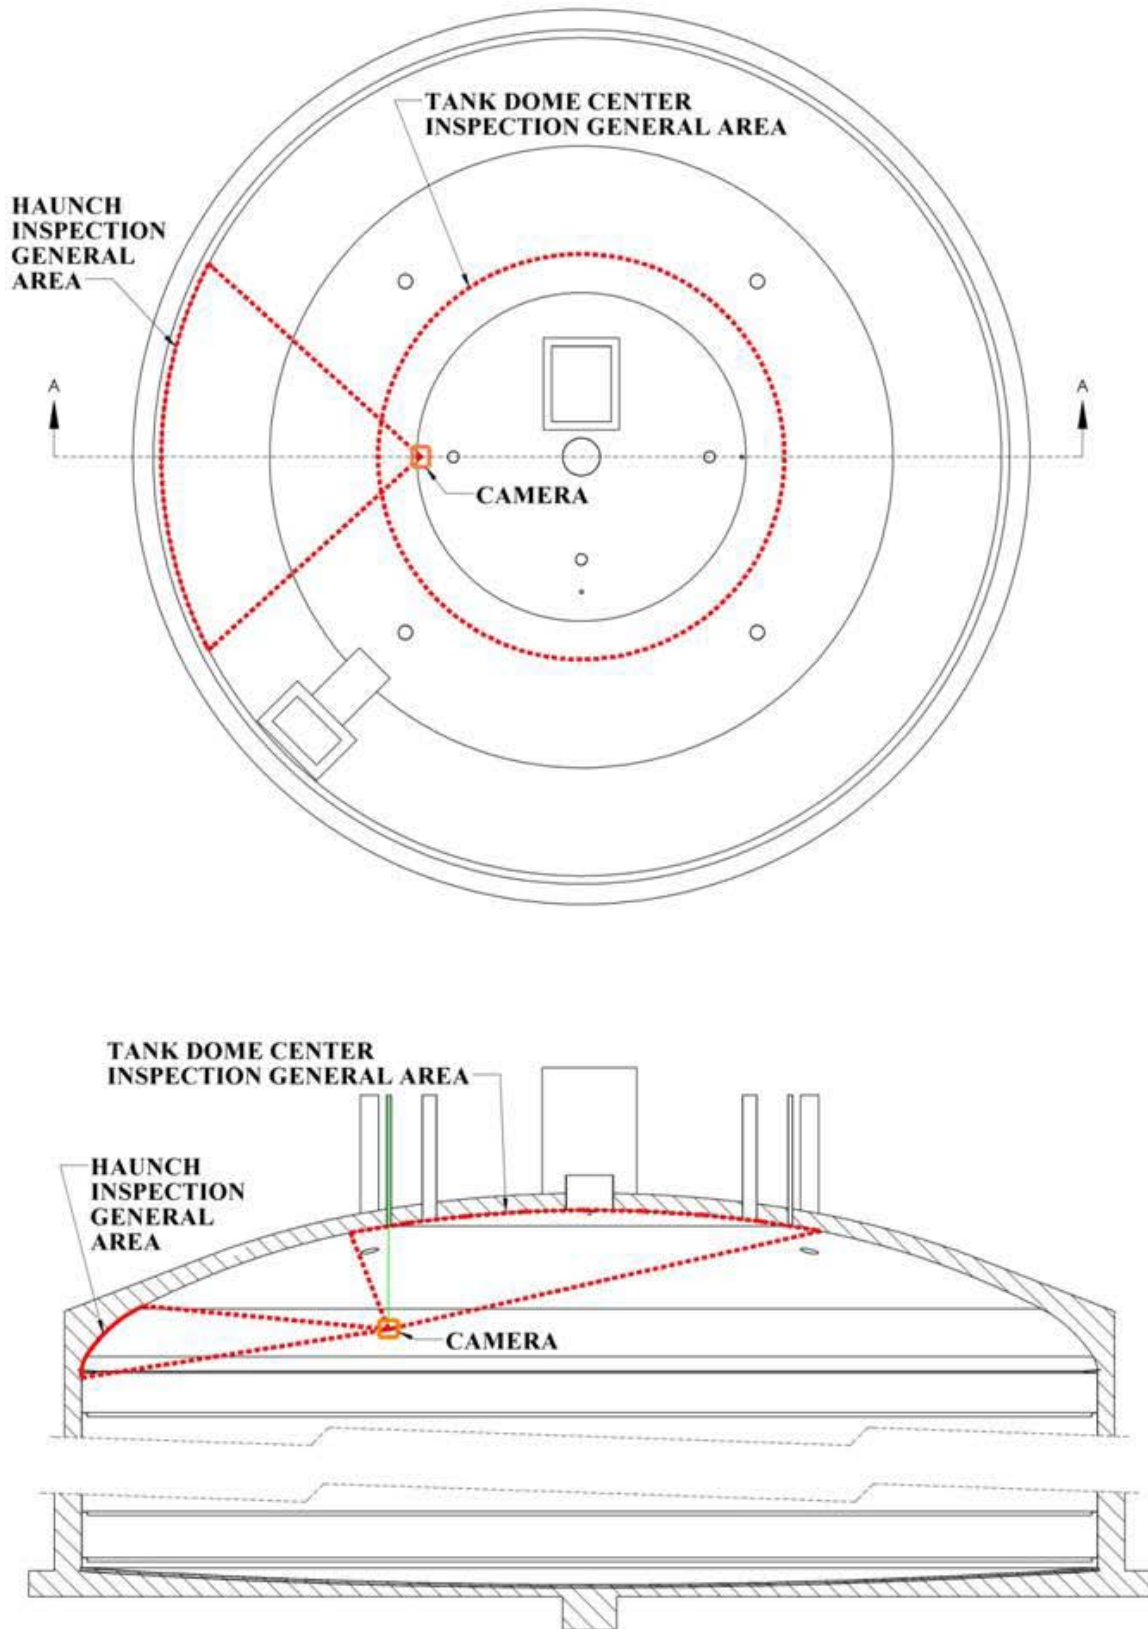
3.5 SINGLE SHELL TANK EVALUATION FACTORS

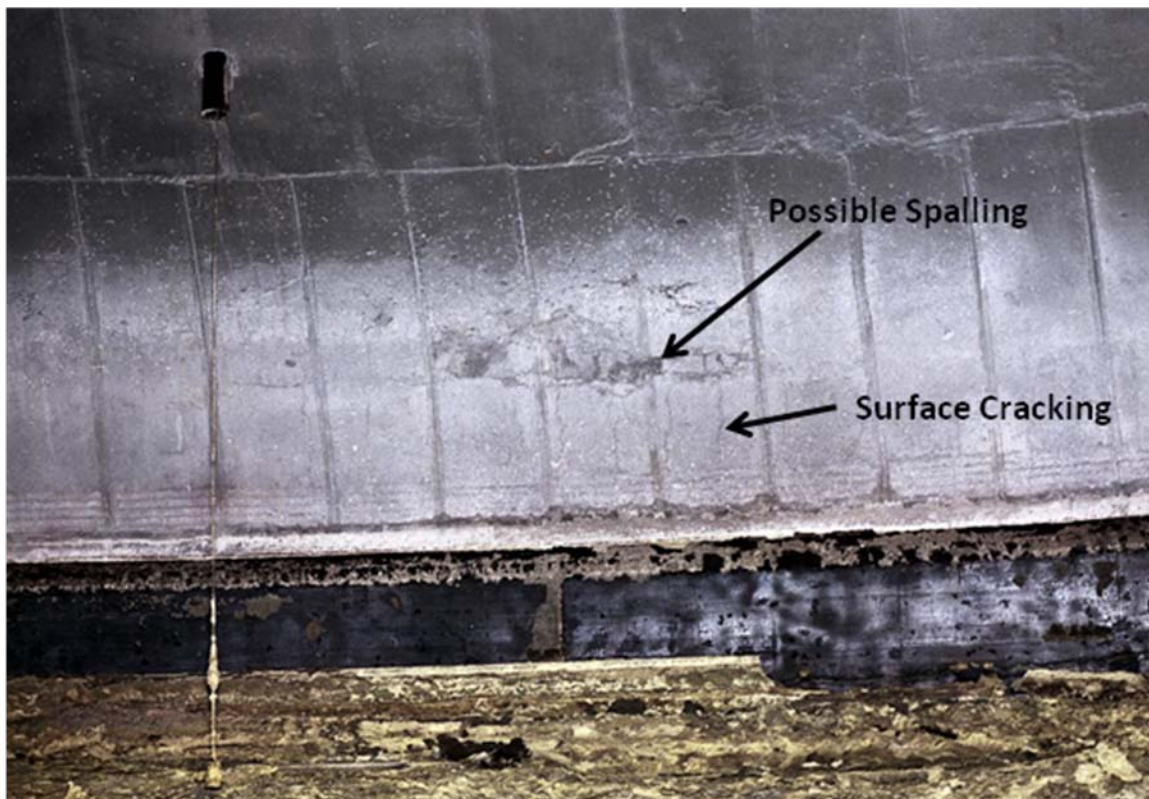
Figure 3-14. Possible Concrete Cracking and Spalling (241-S-112).

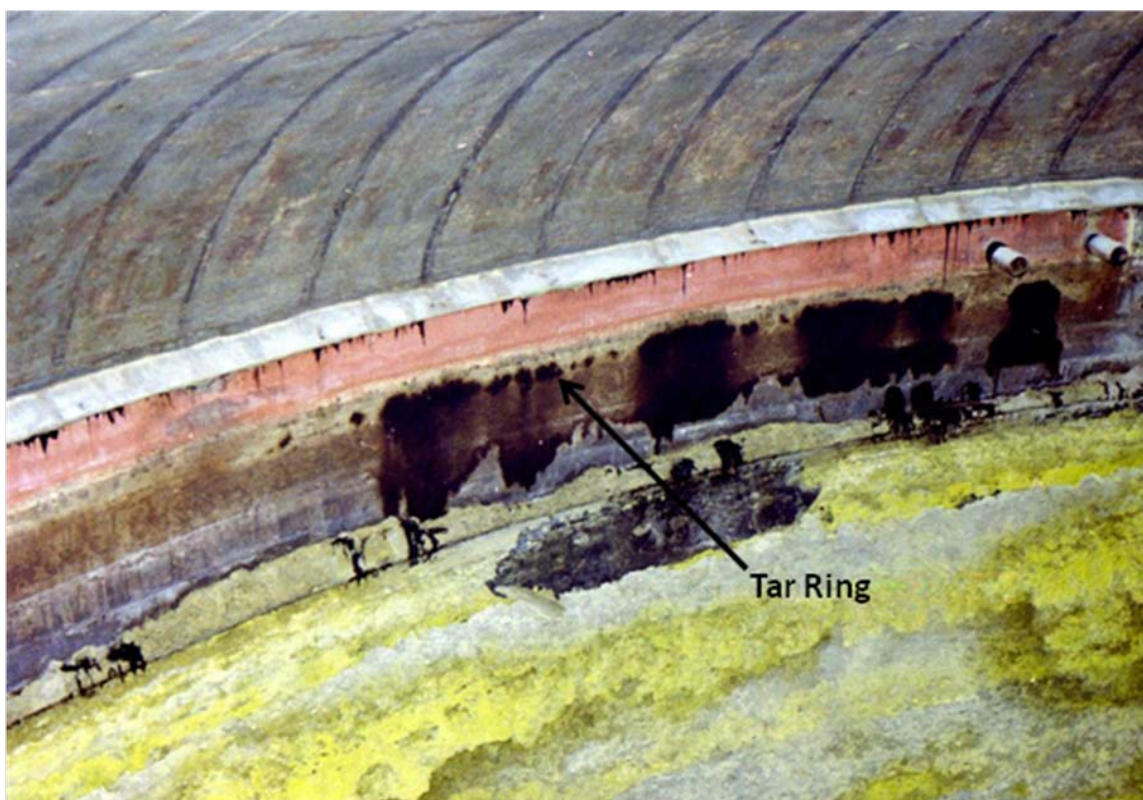
Figure 3-16. Tar Deposits (241-BY-110).

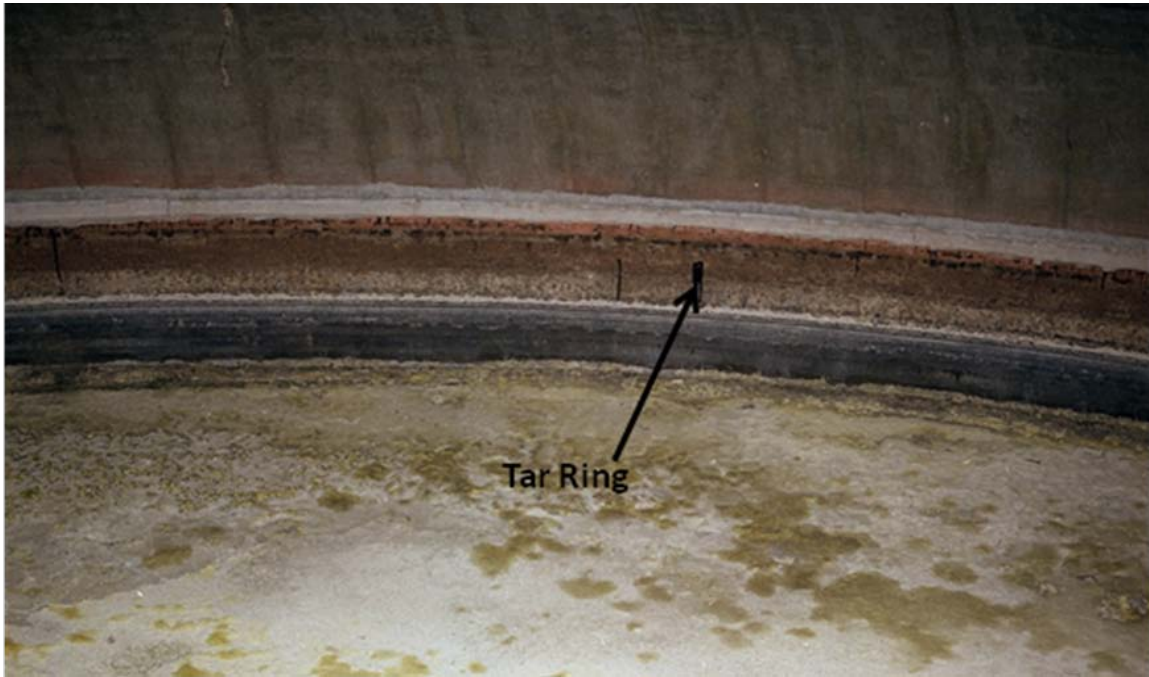
Signs of Liquid Intrusion:

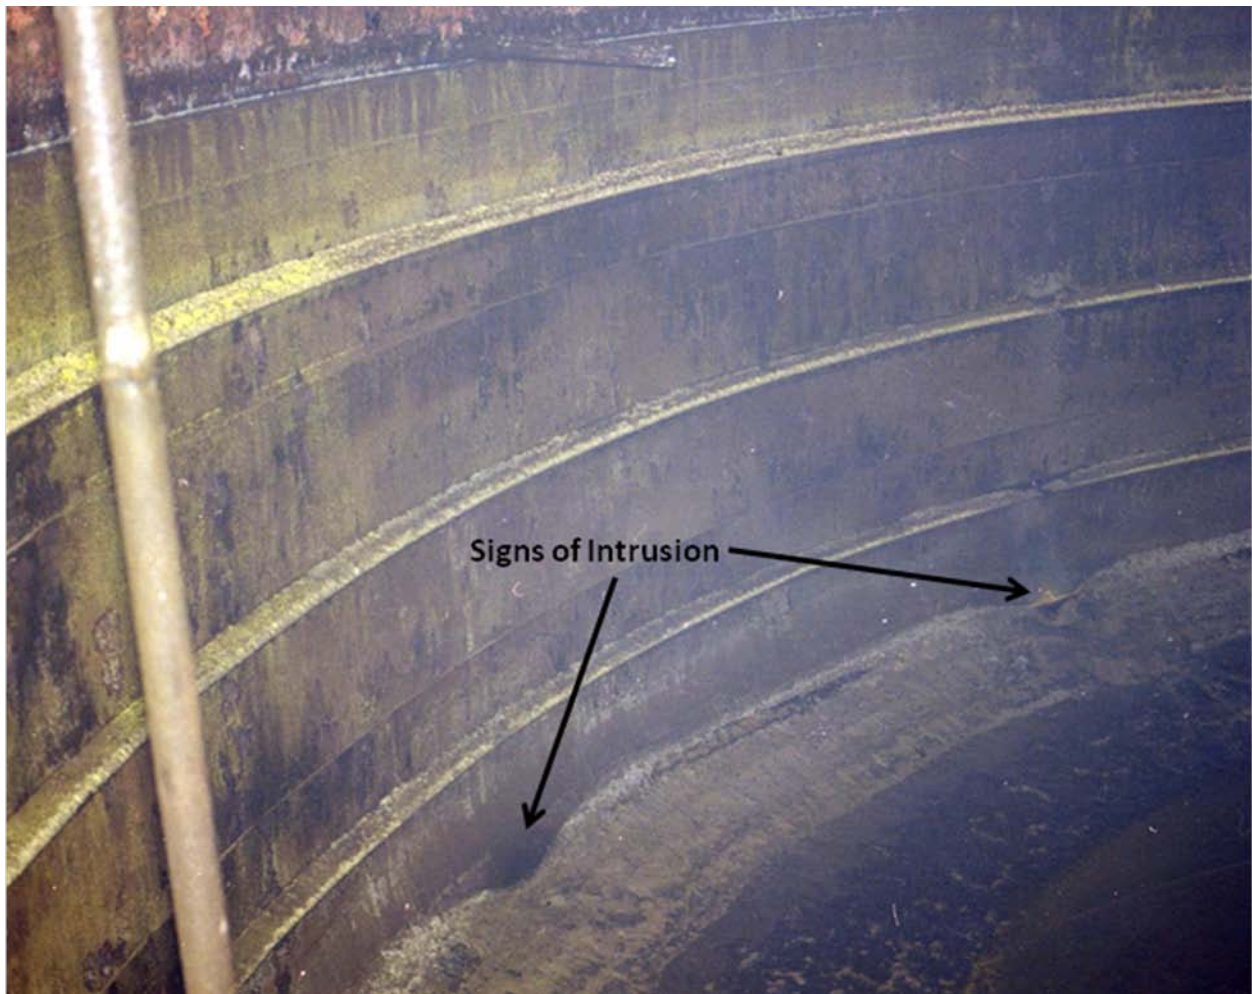
Figure 3-18. Signs of Liquid Intrusion (241-T-102).

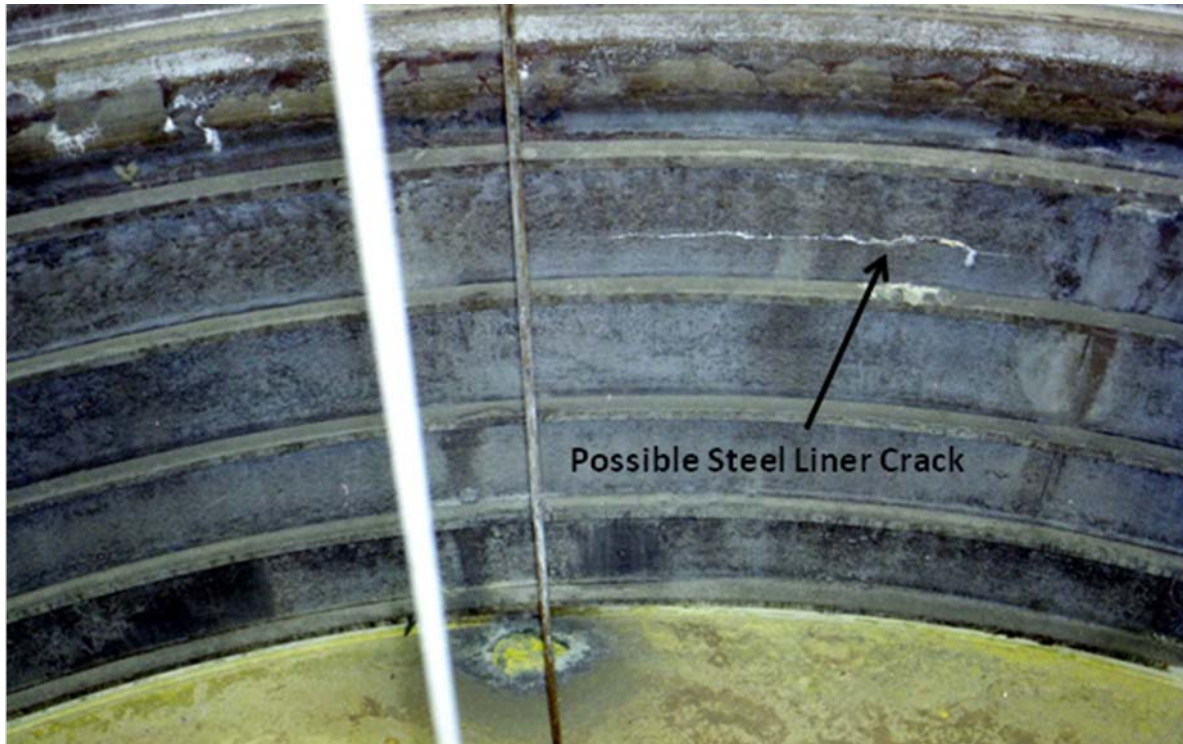
4.0 EQUIPMENT DESCRIPTION
