TALLIL MILITARY BASE  
CAMP UR  
NASIRIYAH, IRAQ

SUSTAINMENT ASSESSMENT

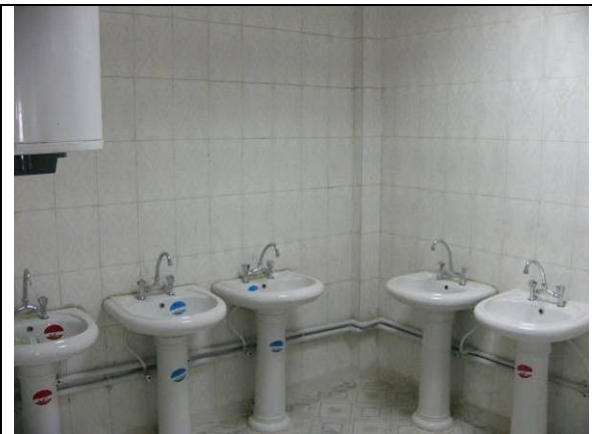
**Site Photo 1. Example of bathroom sinks immediately after construction (From Weston photo log)**
