Rollover of a Truck-Tractor and Cargo Tank Semitrailer
Carrying Liquefied Petroleum Gas and Subsequent Fire
Indianapolis, Indiana
October 22, 2009

Accident Report

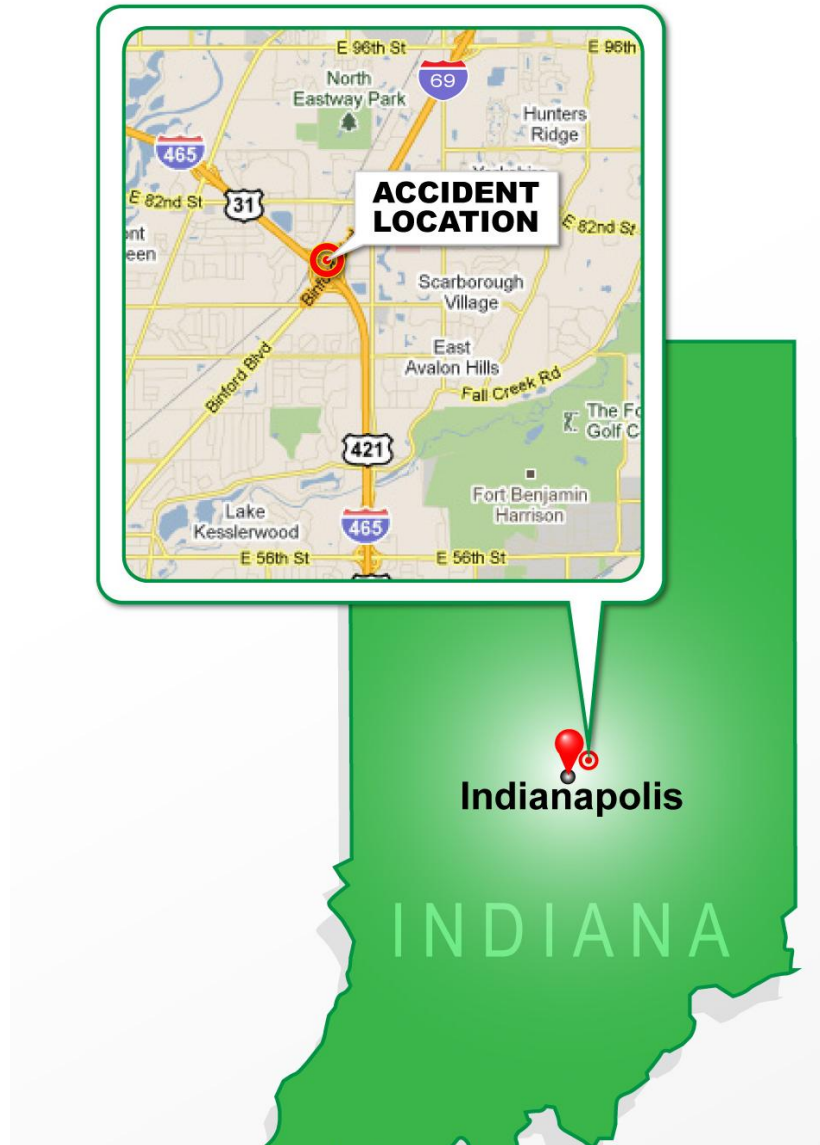
Figure 1. Accident location.

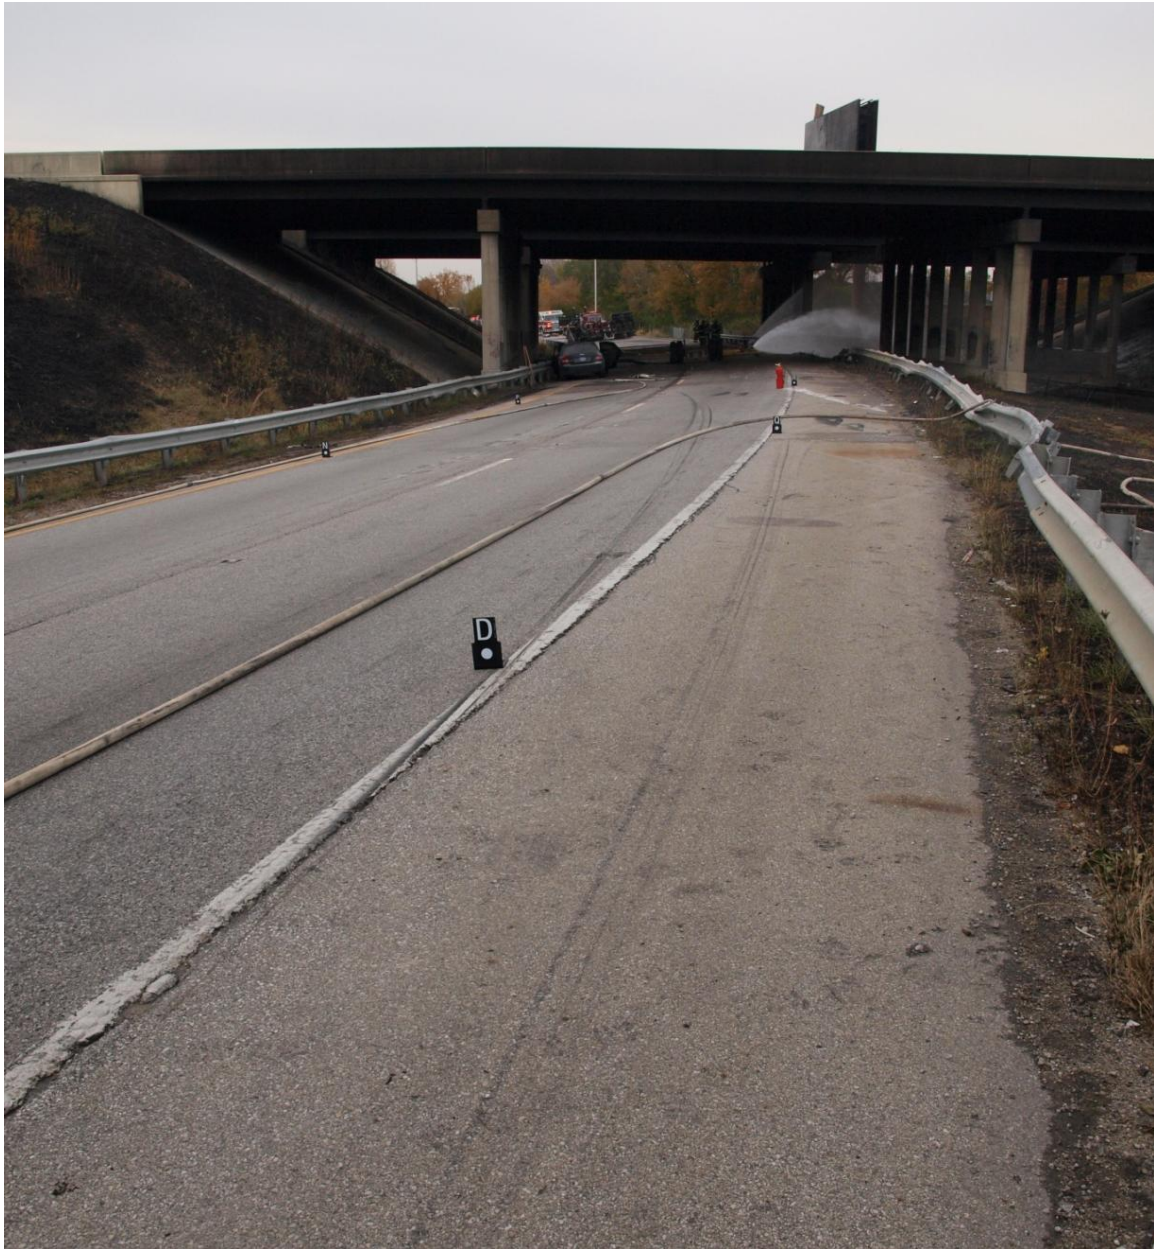
Figure 3. Tire marks indicating redirection of combination unit from the right shoulder to the right lane. (Source: Indiana State Police.)

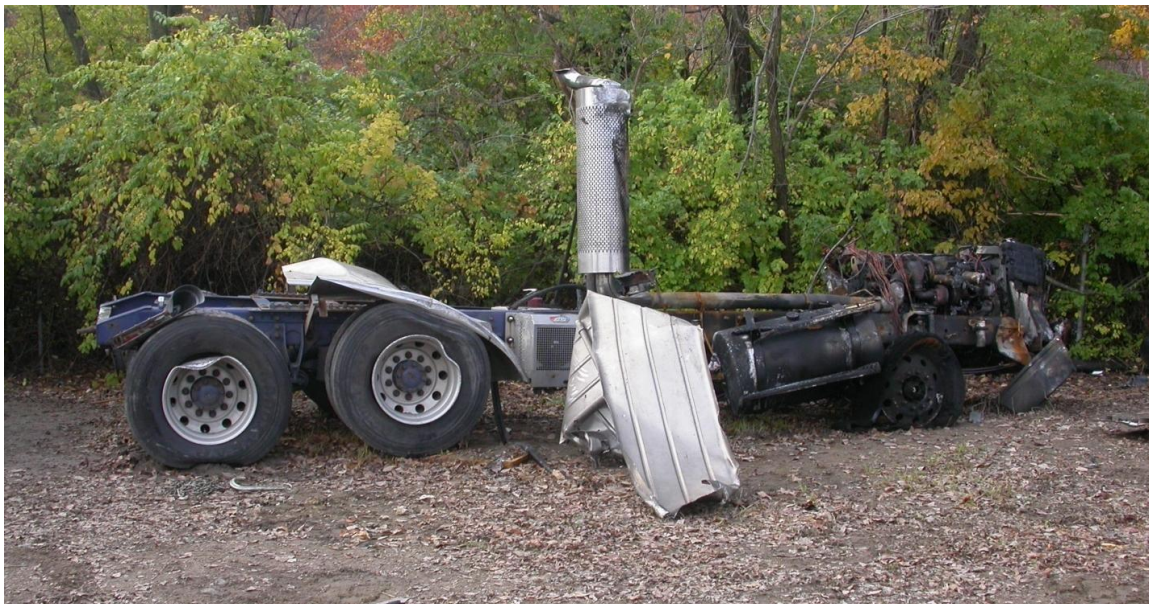
Figure 5. Fire-damaged truck-tractor.

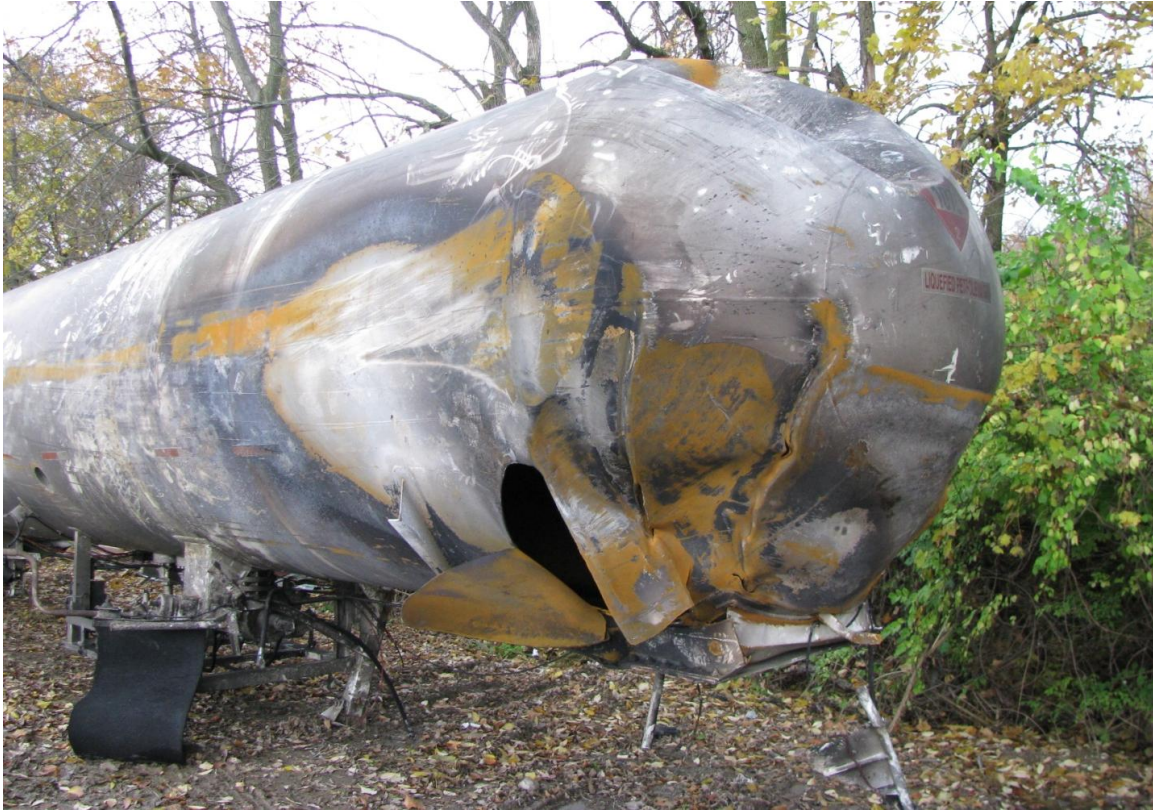
Figure 6. Collision damage and breach at the lower right side of the cargo tank.

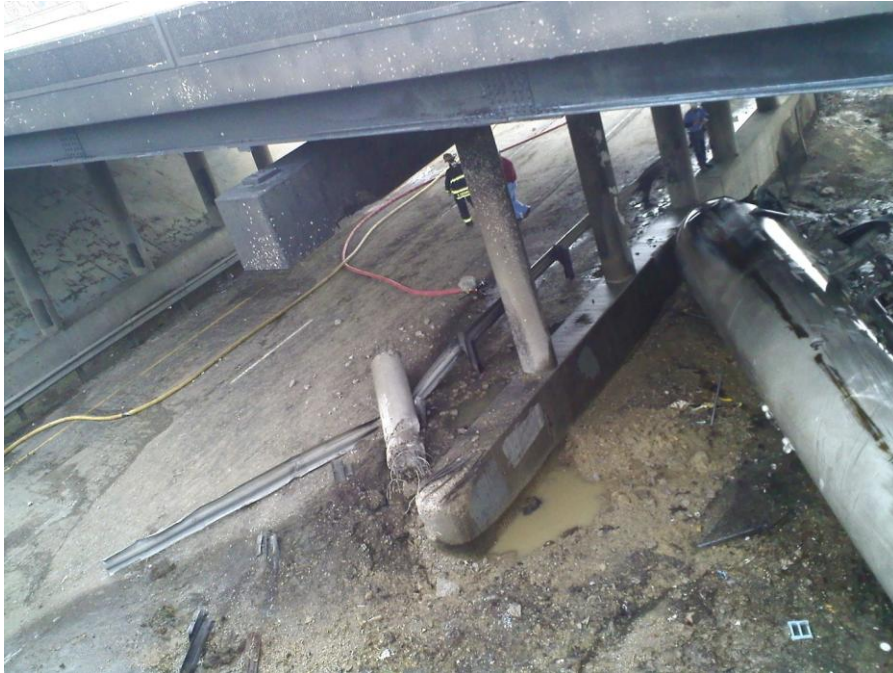
Figure 7. Displaced bridge pier column struck by cargo tank semitrailer. (Source: Indiana State Police.)

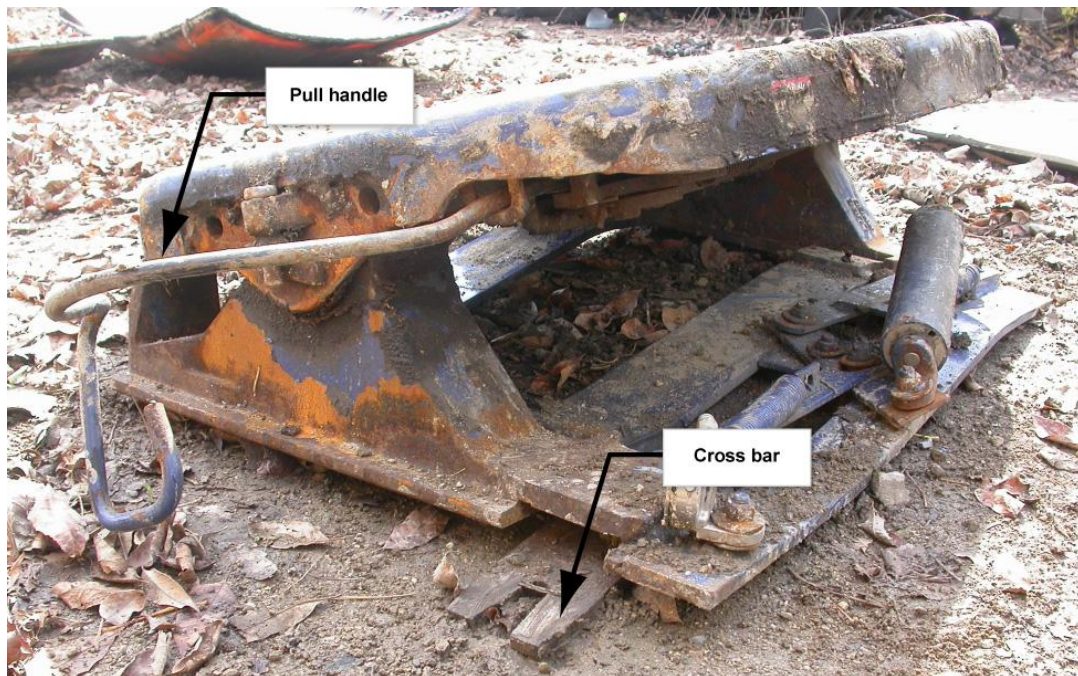
Figure 9. Fifth wheel plate.

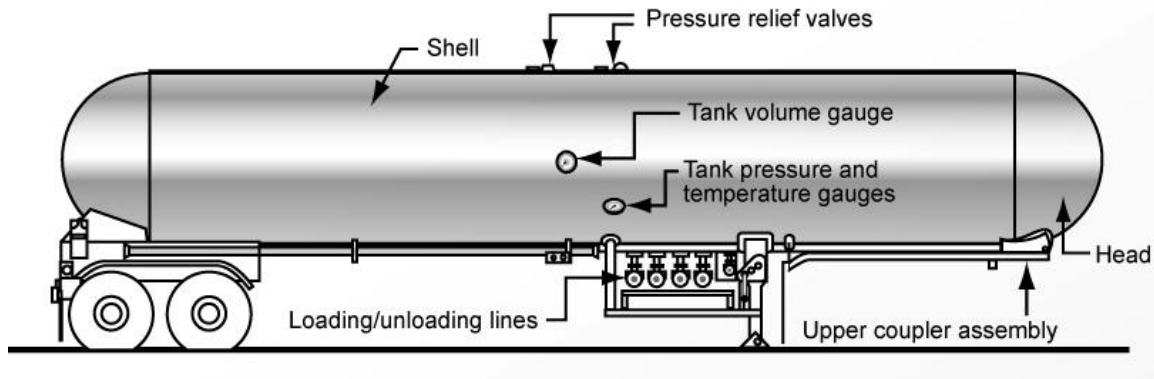
Figure 10. Cargo tank semitrailer (MC331).

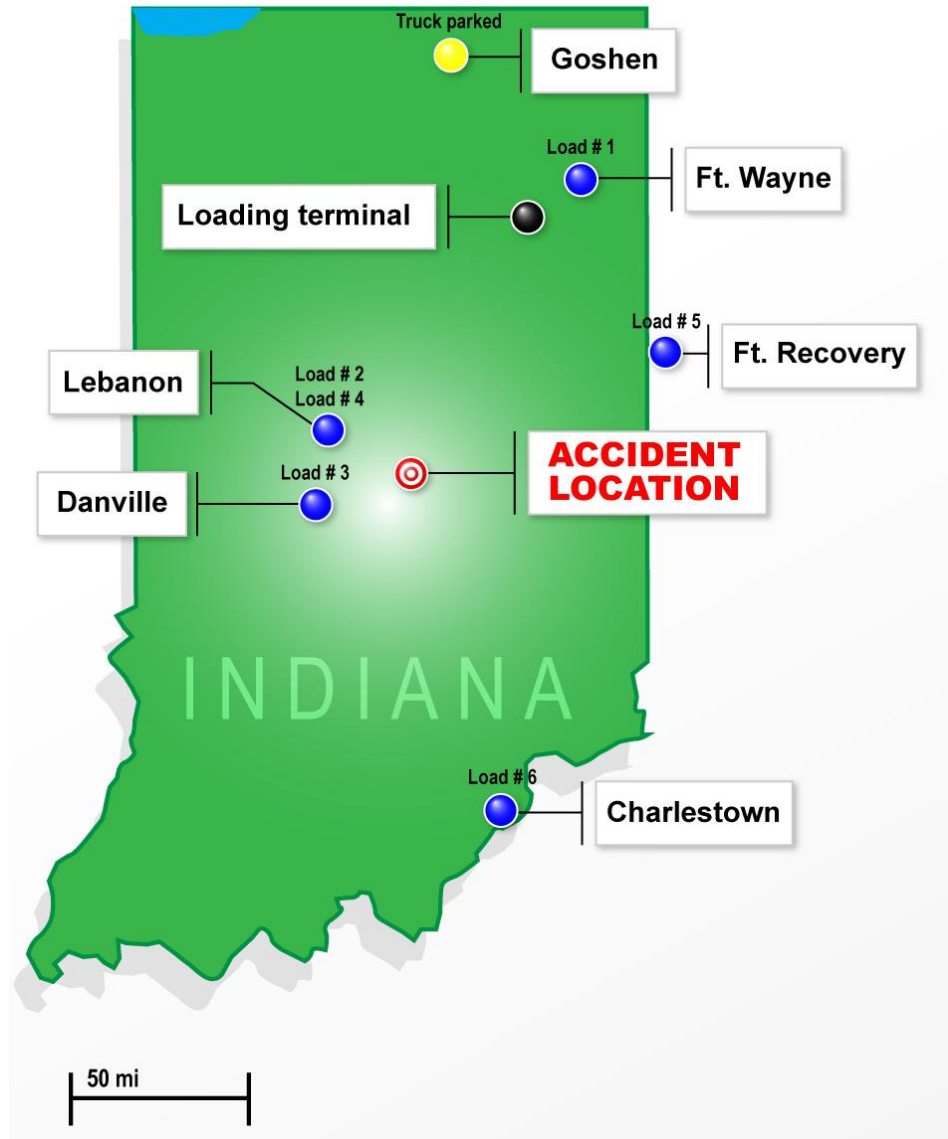
Figure 11. Location of loading terminal in relation to October 19–22 deliveries.

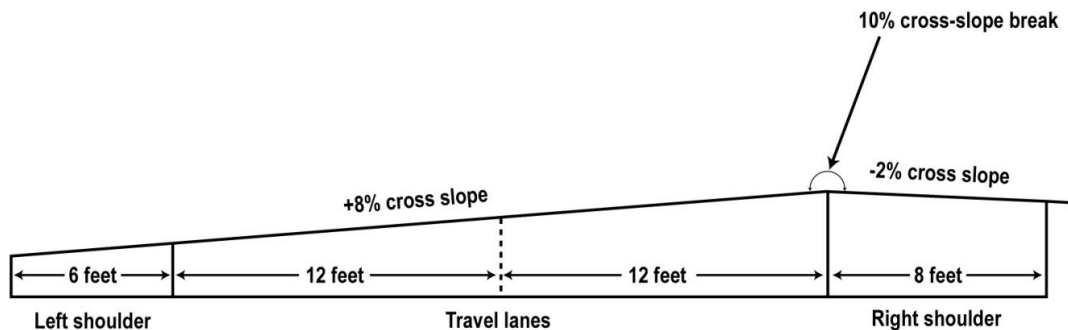
Figure 13. Cross-slope break.

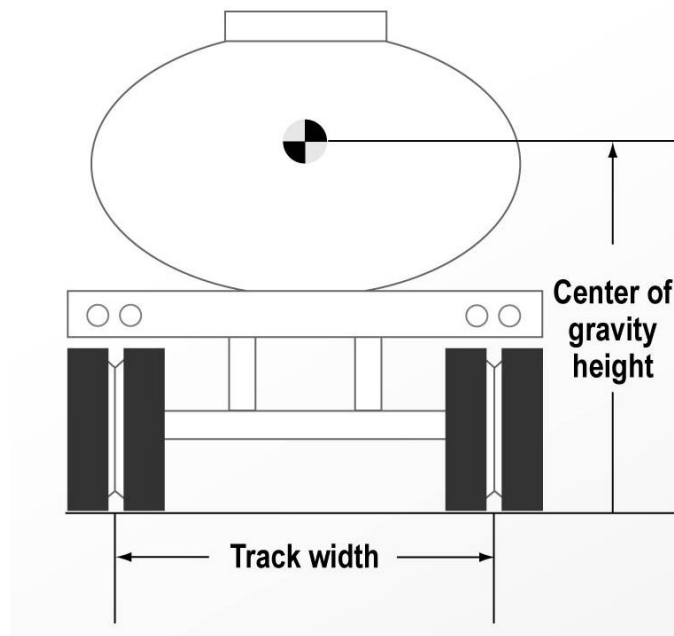
Figure 15. Fundamental design considerations for improving the roll stability of cargo tank motor vehicles.

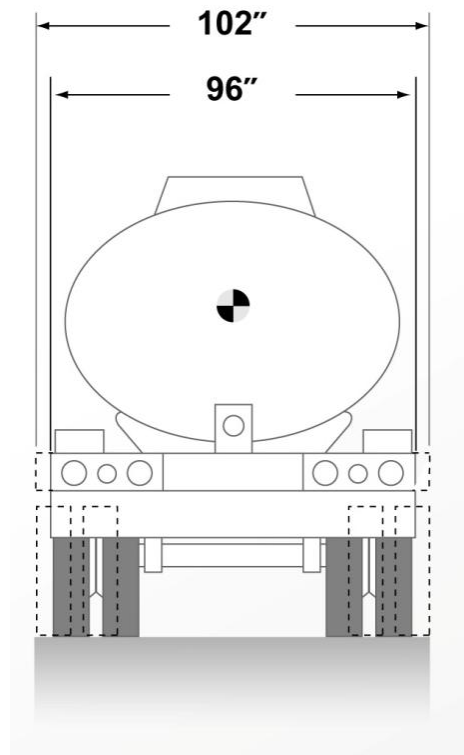
Figure 17. Roll stability improved by increased track width of 102-inch-wide vehicles.

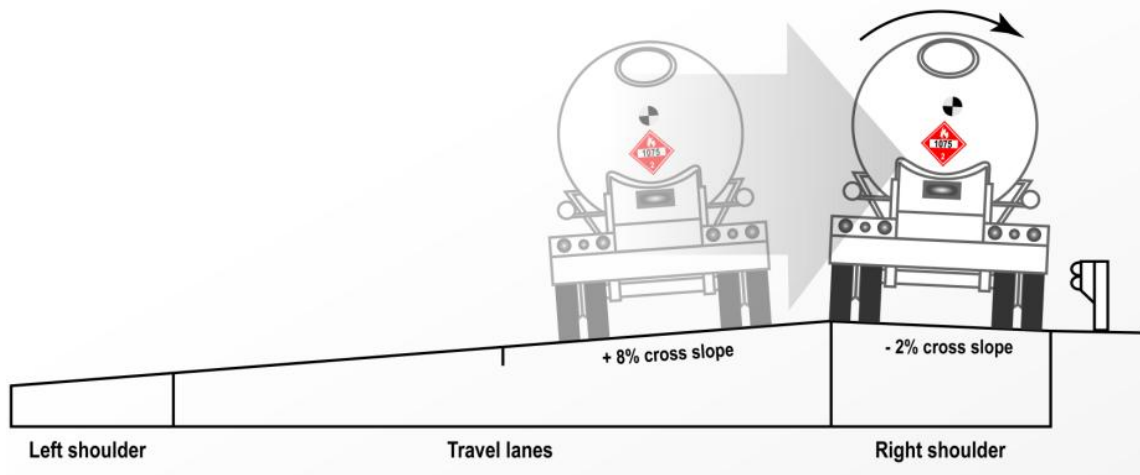
Figure 19. Rollover sequence.

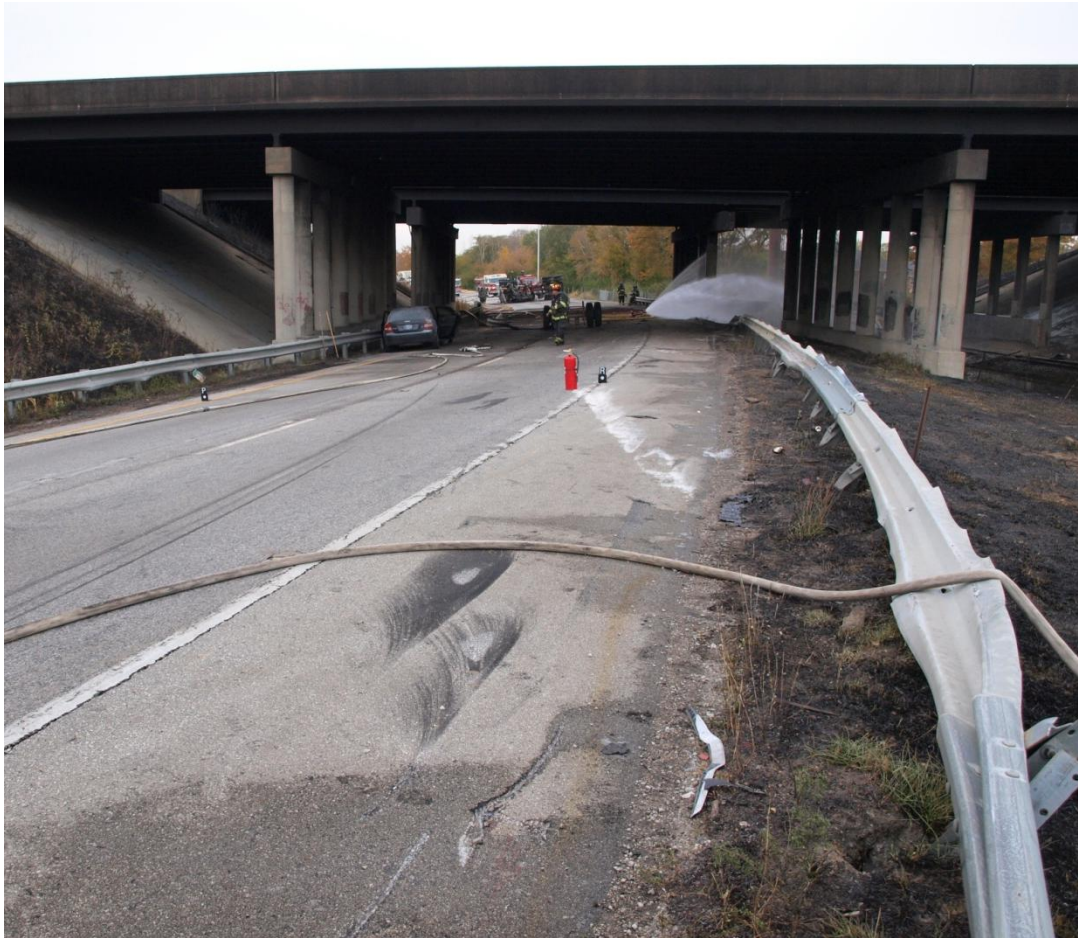
Figure 20. Tire imprints in the right lane and on the shoulder indicating where the combination unit rolled over onto its right side. (Source: Indiana State Police.)

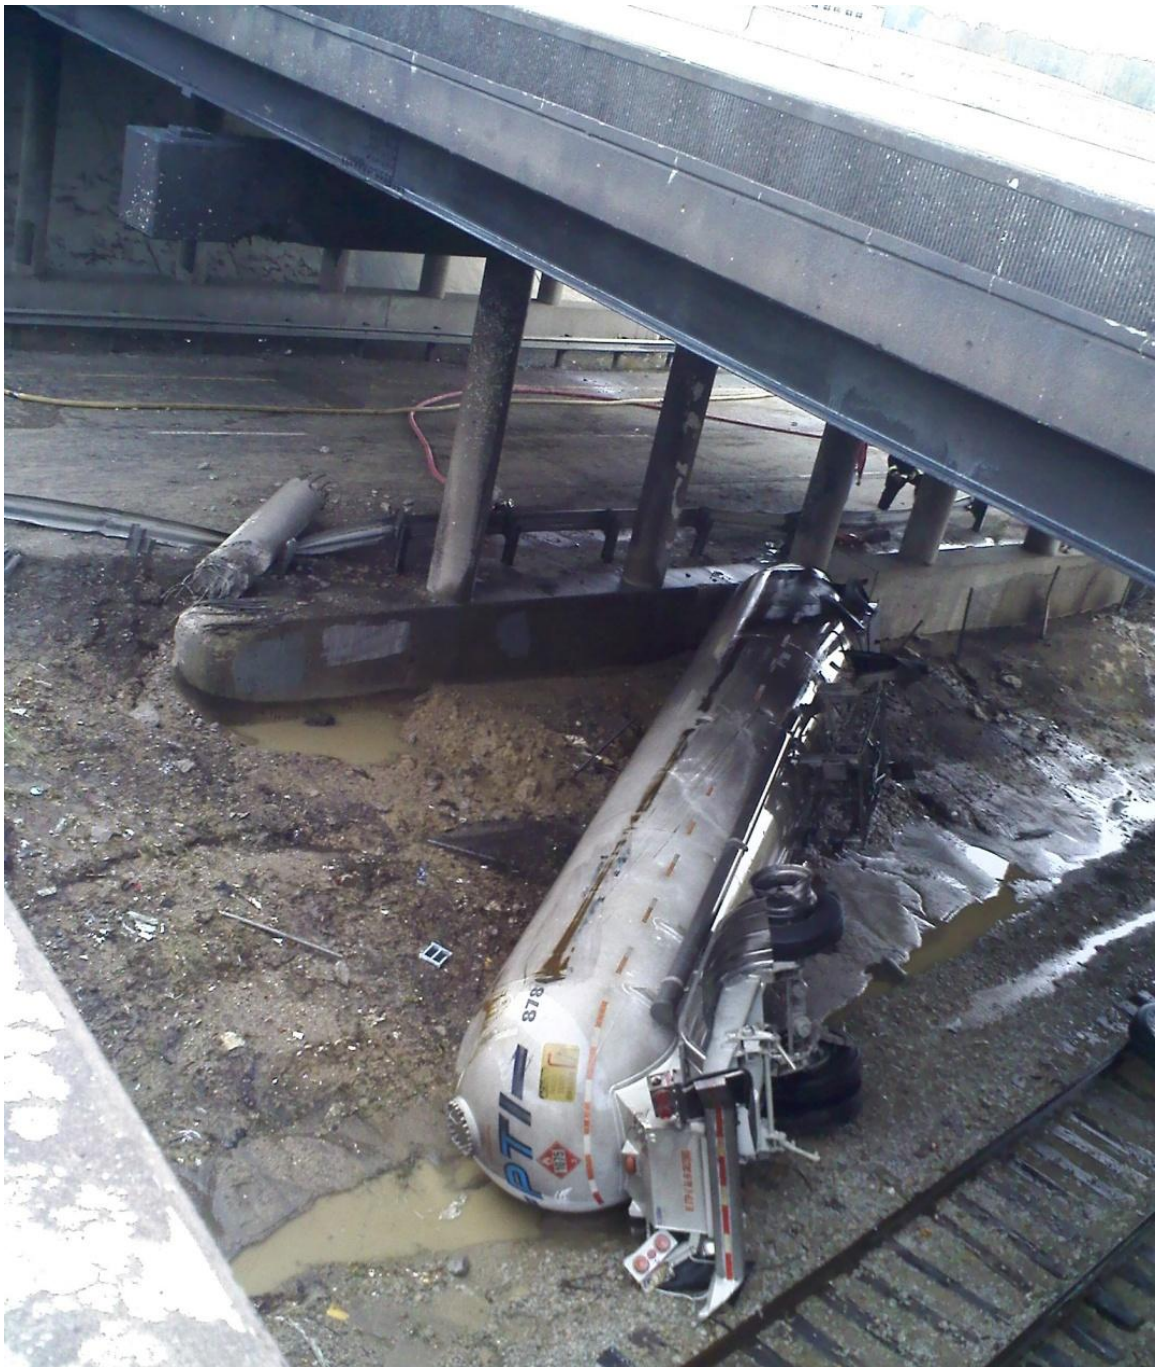
Figure 21. Final rest position of cargo tank semitrailer. (Source: Indiana State Police.)

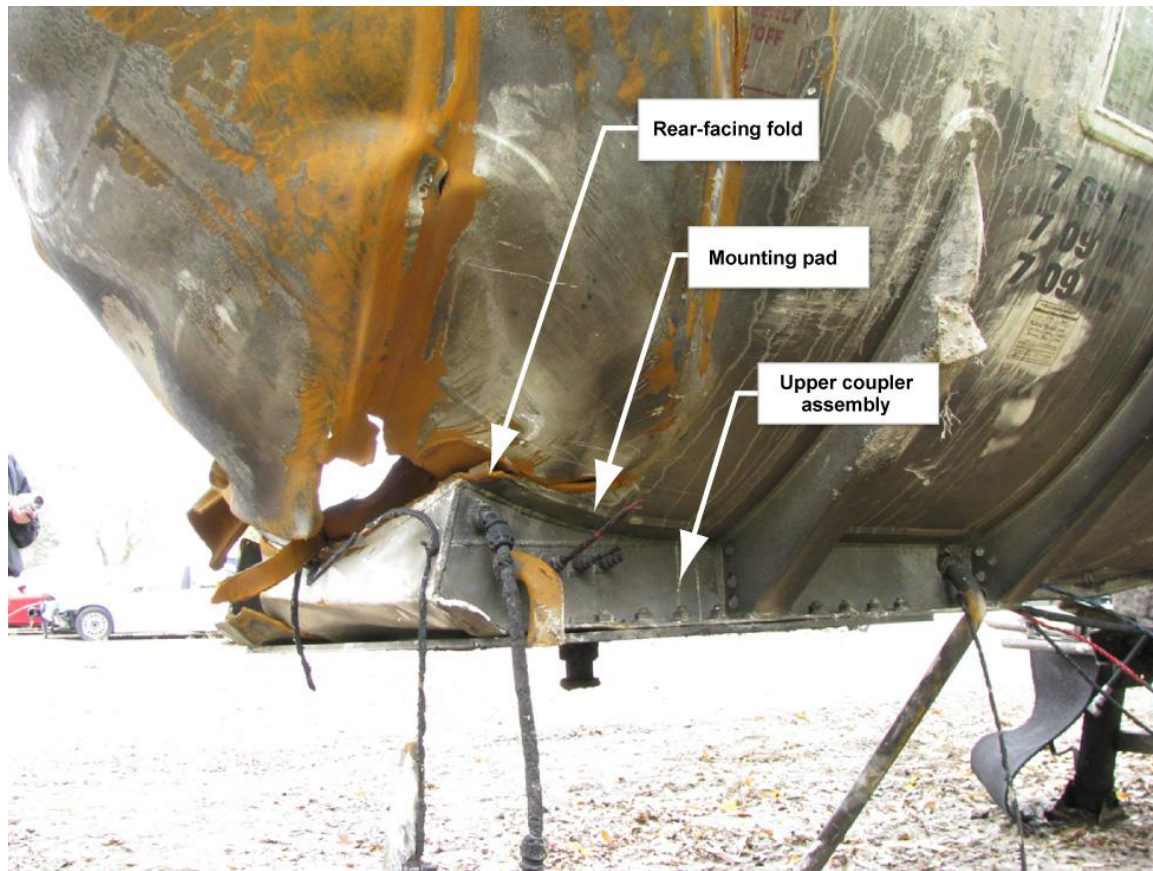
Figure 22. Mounting pad and rear-facing fold above upper coupler assembly.
