Technical Memorandum No. MERL-2012-11

Coatings for Mussel Control — Three Years of Laboratory and Field Testing

U.S. Department of the Interior Bureau of Reclamation Technical Service Center Denver, Colorado

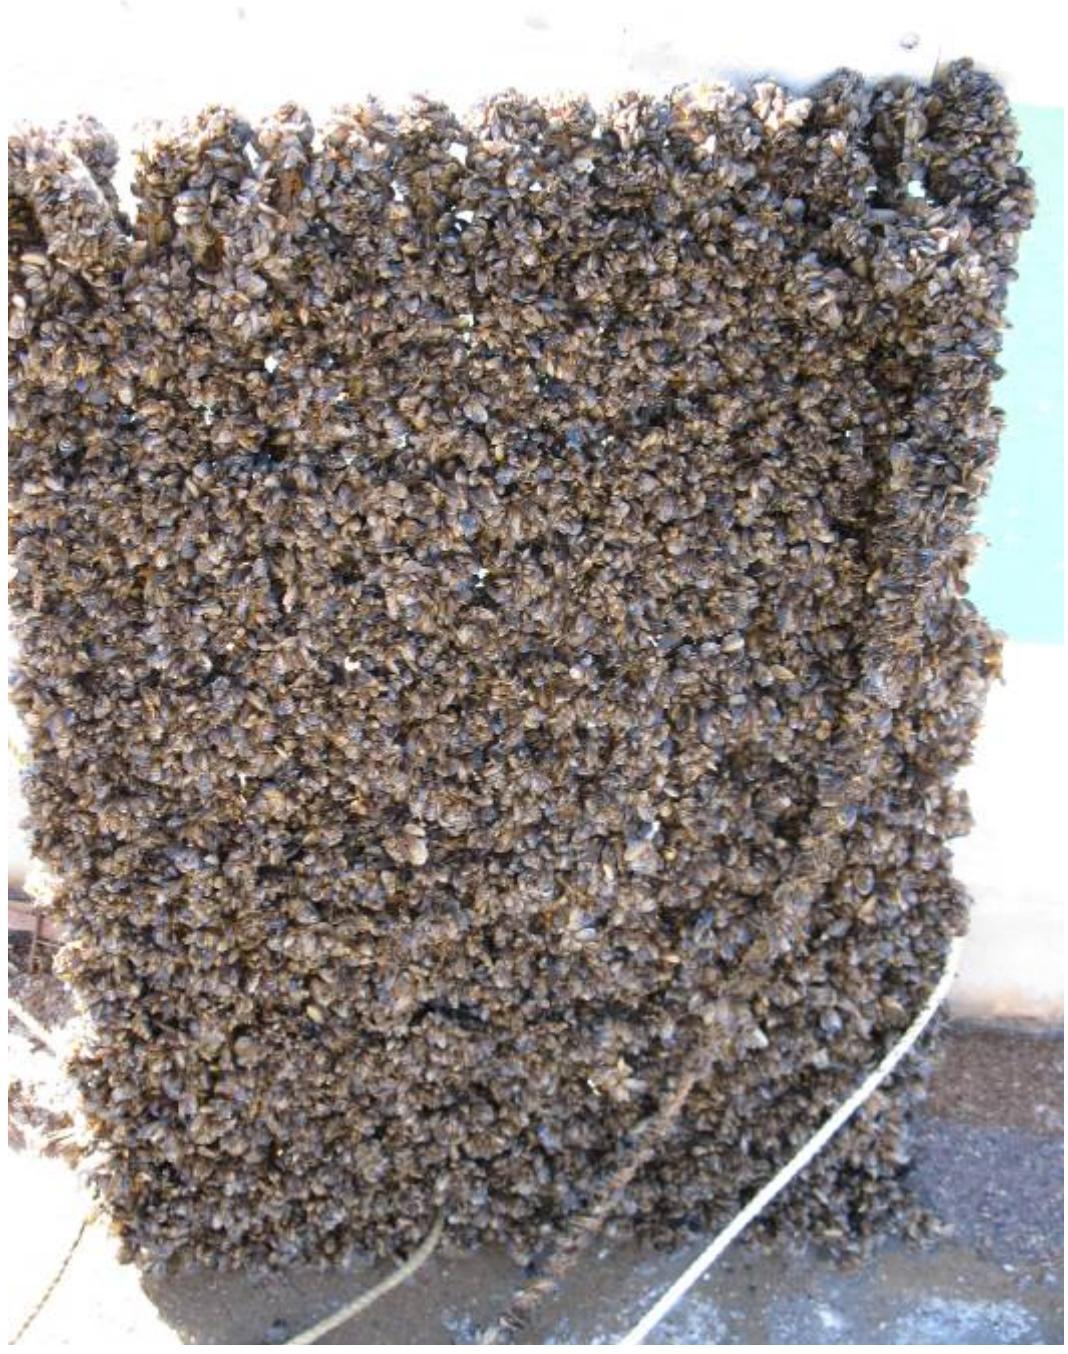
Figure 4.—Uncoated steel after 7 months of exposure in dynamic conditions. Test period May 2008 to December 2008.

ASTM A788 steel and 304 stainless steel were used to verify the presence of mussels and to determine a fouling rate to be compared to coatings.[5] Both steel and stainless steel foul quickly; within a year the mussel completely block the grate so no water was flowing through the 1-inch openings. Over 1.7 pounds of force was needed to remove a single mussel.

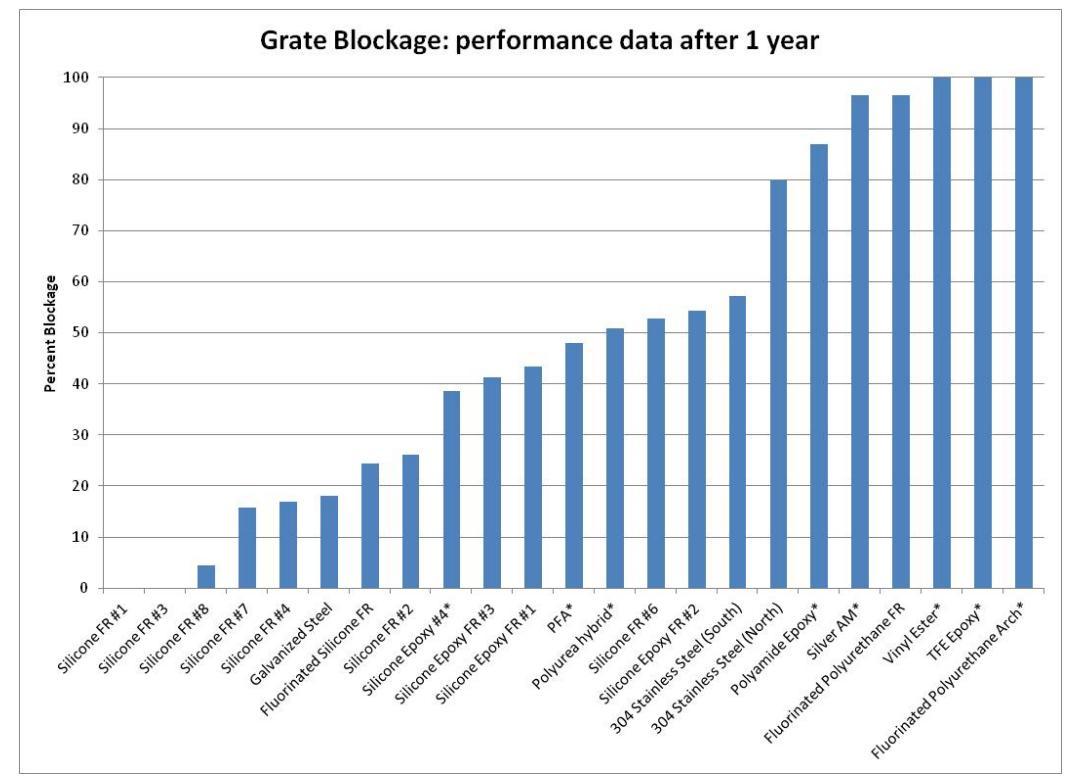
Figure 12.—Performance data for grates after 1 year of exposure.

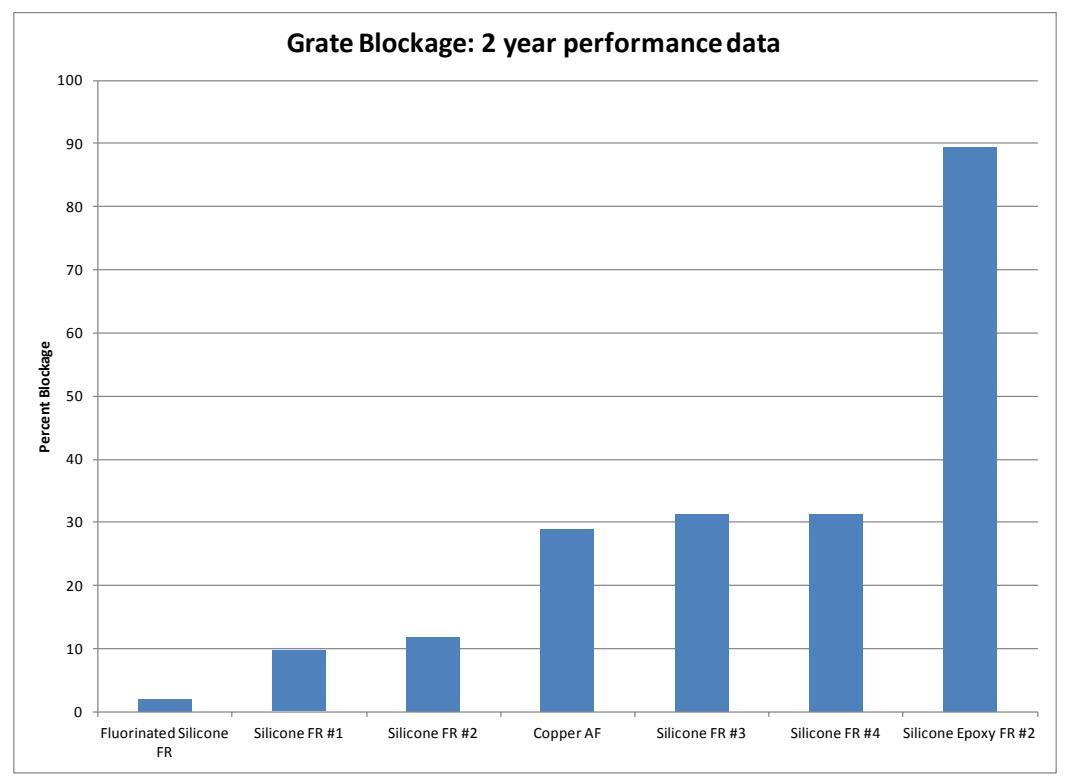
Figure 13.—Performance data for grates after 2 years of exposure.

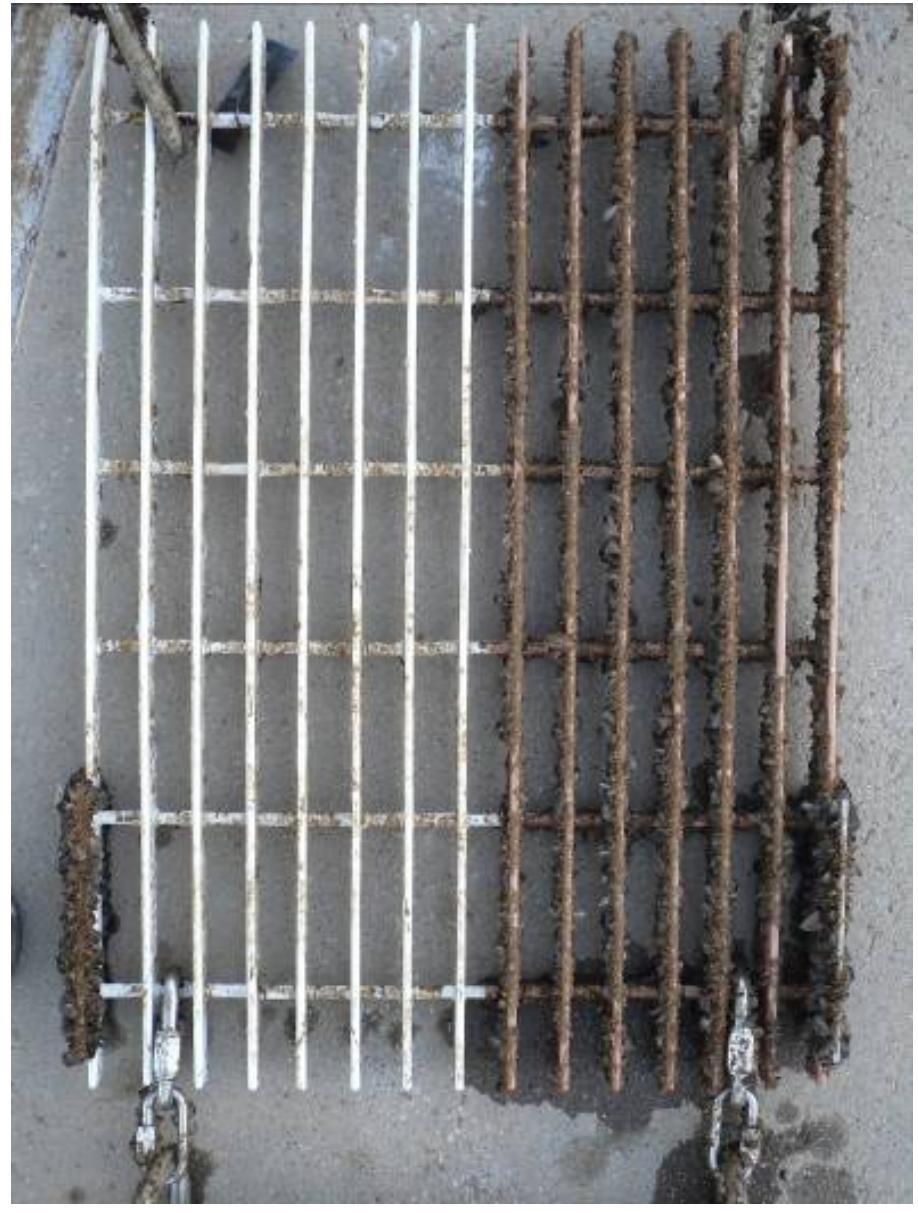
Figure 16.—Silicone FR #6 on the right and Silicone FR #7 on the left after 6 months in dynamic exposure (November 2010).

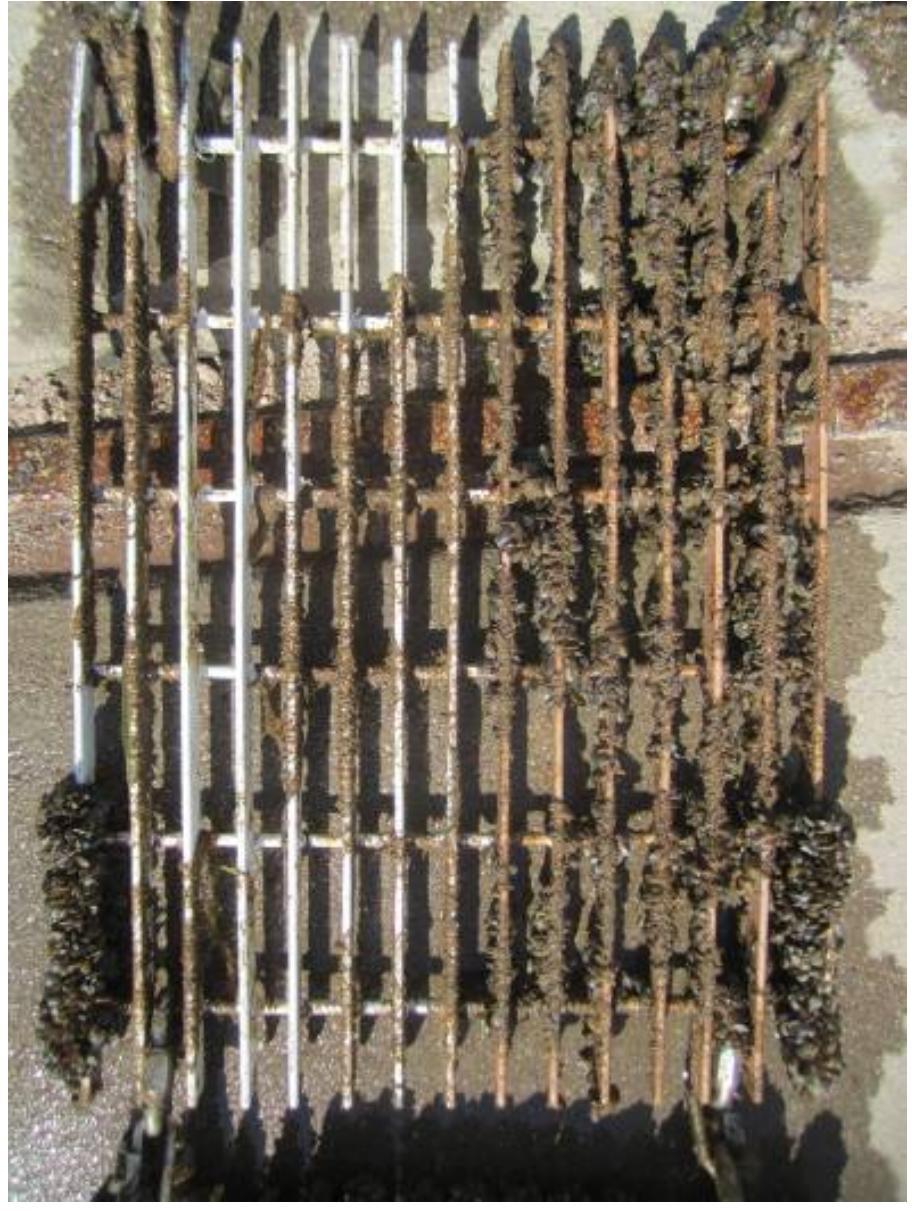
Figure 17.—Silicone FR #6 on the right and Silicone FR #7 on the left after 1 year in dynamic exposure (May 2011).

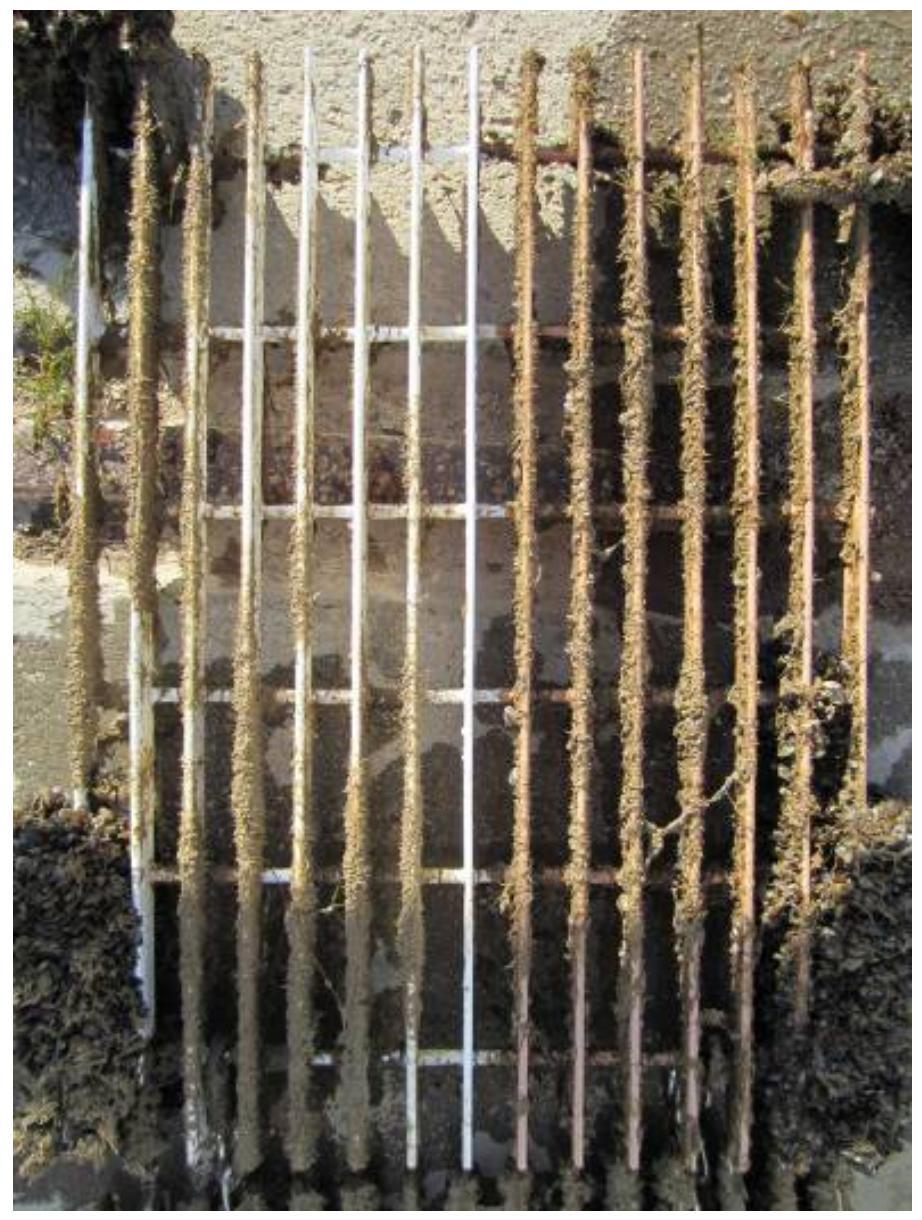
Figure 18.—Silicone FR #6 on the right and Silicone FR #7 on the left after 18 months in dynamic exposure (November 2011).

upon the flow rate and/or drag forces. Either the fouling needs to build up to a certain thickness or the flow rates need to be increased in order to remove the fouling. Silicone FR #6 and FR #7 were used in a waterjetting study in December 2011 and test panels were very easily cleaned.

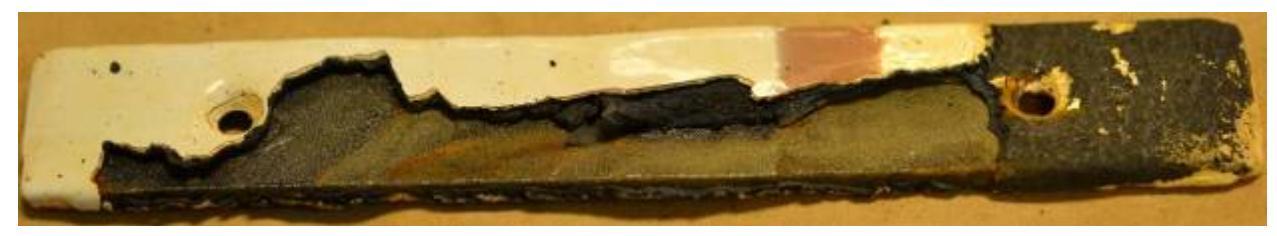
All four coating systems used to overcoat coal tar experienced failures in the high flow test. Typically, the coal tar experienced a disbondment from the metallic substrate on the overcoated portion as shown in figure 23. Neither static immersion in a dilute Harrison solution or in deionized water produced catastrophic failure, but cracking was observed in several samples along the interface between coal tar enamel and the primers. It is believed that internal stresses, perhaps due to expansion/contraction of the primer and subsequent layers, caused the low strength coal tar enamel to fail. It is unlikely this problem is unique to foul release coating systems, but the extra coats that were required may aggravate the effect.

Figure 23.—Failure of overcoated coal tar during a high flow test.

Several foul release coatings outperformed the epoxy controls in erosion testing, but abrasion resistance was much lower. Failure of one of these tests does not automatically eliminate a coating system from consideration, but it is important to recognize each product's limitations when developing performance specifications. Successful deployment of a silicone-based foul release coating will depend strongly on the service environment. Environments where silicone-based foul release coatings have contact with equipment or floating debris is likely should be avoided. Silicone epoxy coatings appear to be more resistant to this type of abrasion damage. None of the coating systems are recommended for application over coal tar enamel.
