Project Information Report PL 84-99 Rehabilitation of Damaged Flood Control Works

NON-FEDERAL PUMP STATIONS FLOOD CONTROL

PLAQUEMINES PARISH, LA

January 2006

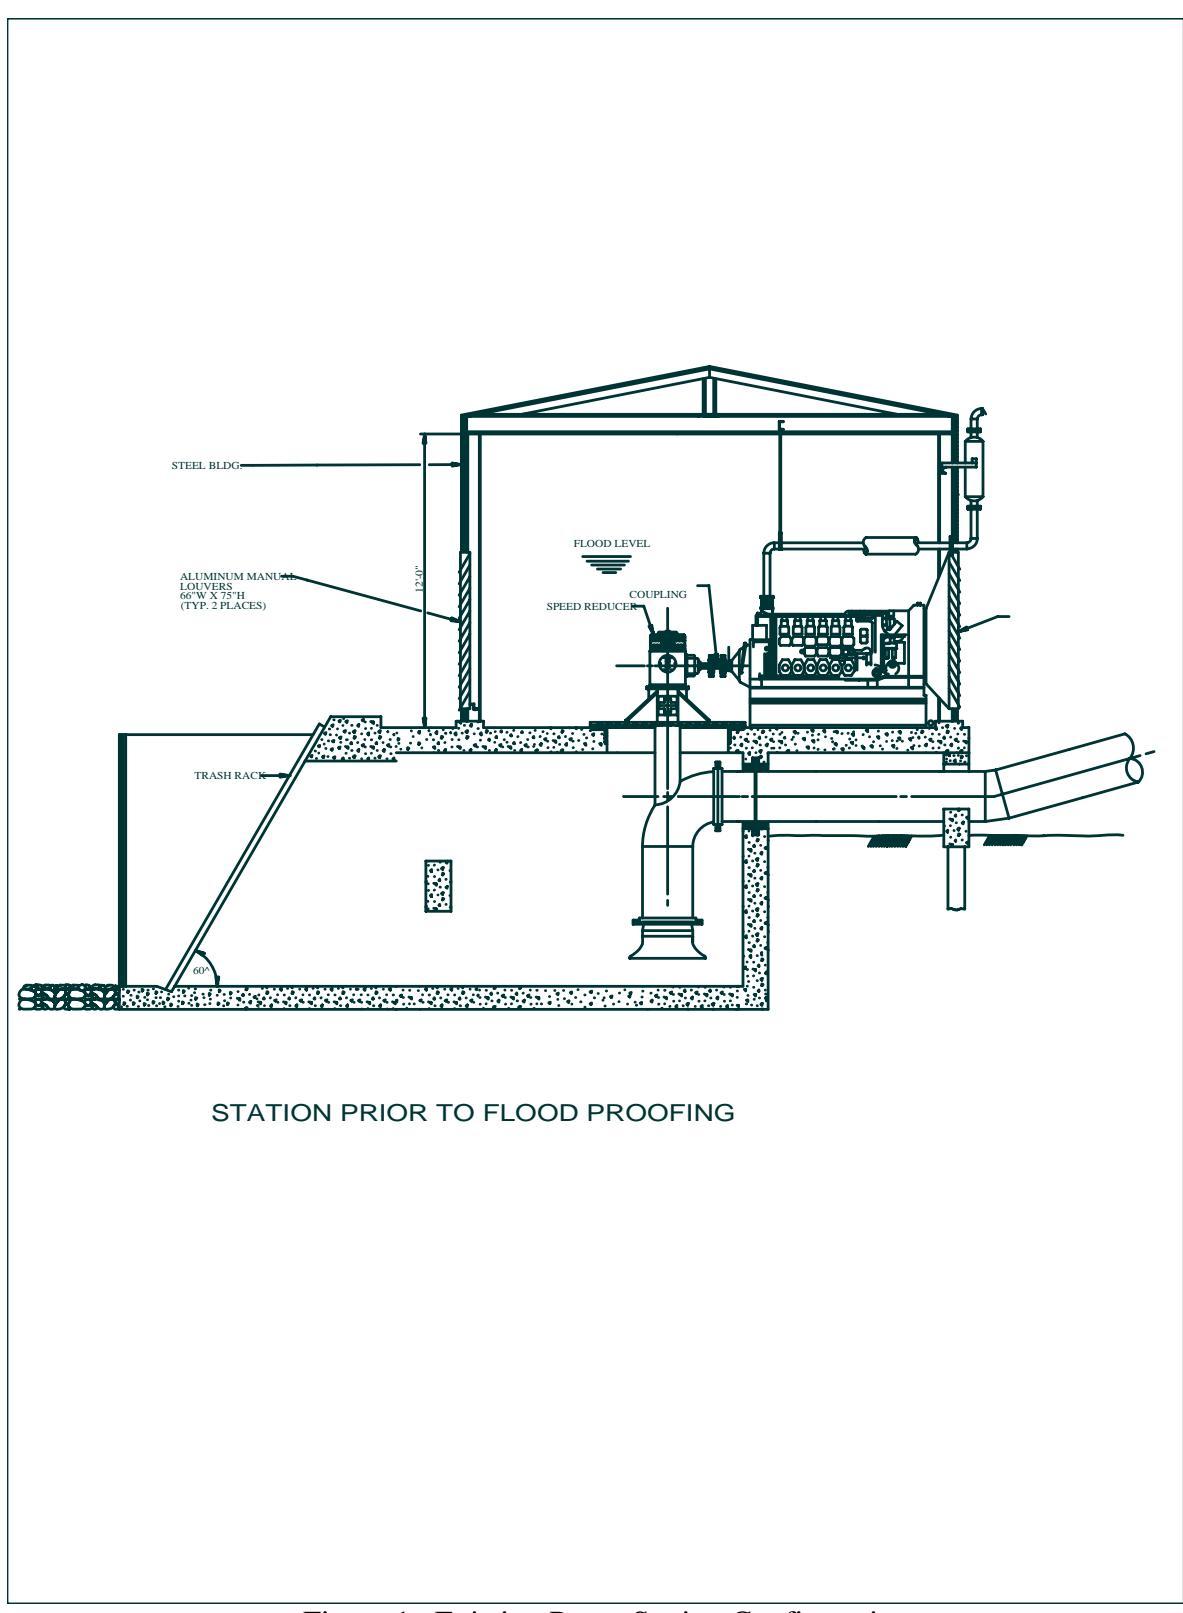
Figure 1. Existing Pump Station Configuration

Figures 1 shows a schematic of an existing pump station. Figure 2 identifies the method used to elevate the diesel engine within the existing building and the addition of the hydraulic drive.
