# L'ENFANT PROMENADE AND BENJAMIN BANNEKER PARK EA

# Environmental Assessment for Improvements to L'Enfant Promenade and Benjamin Banneker Park

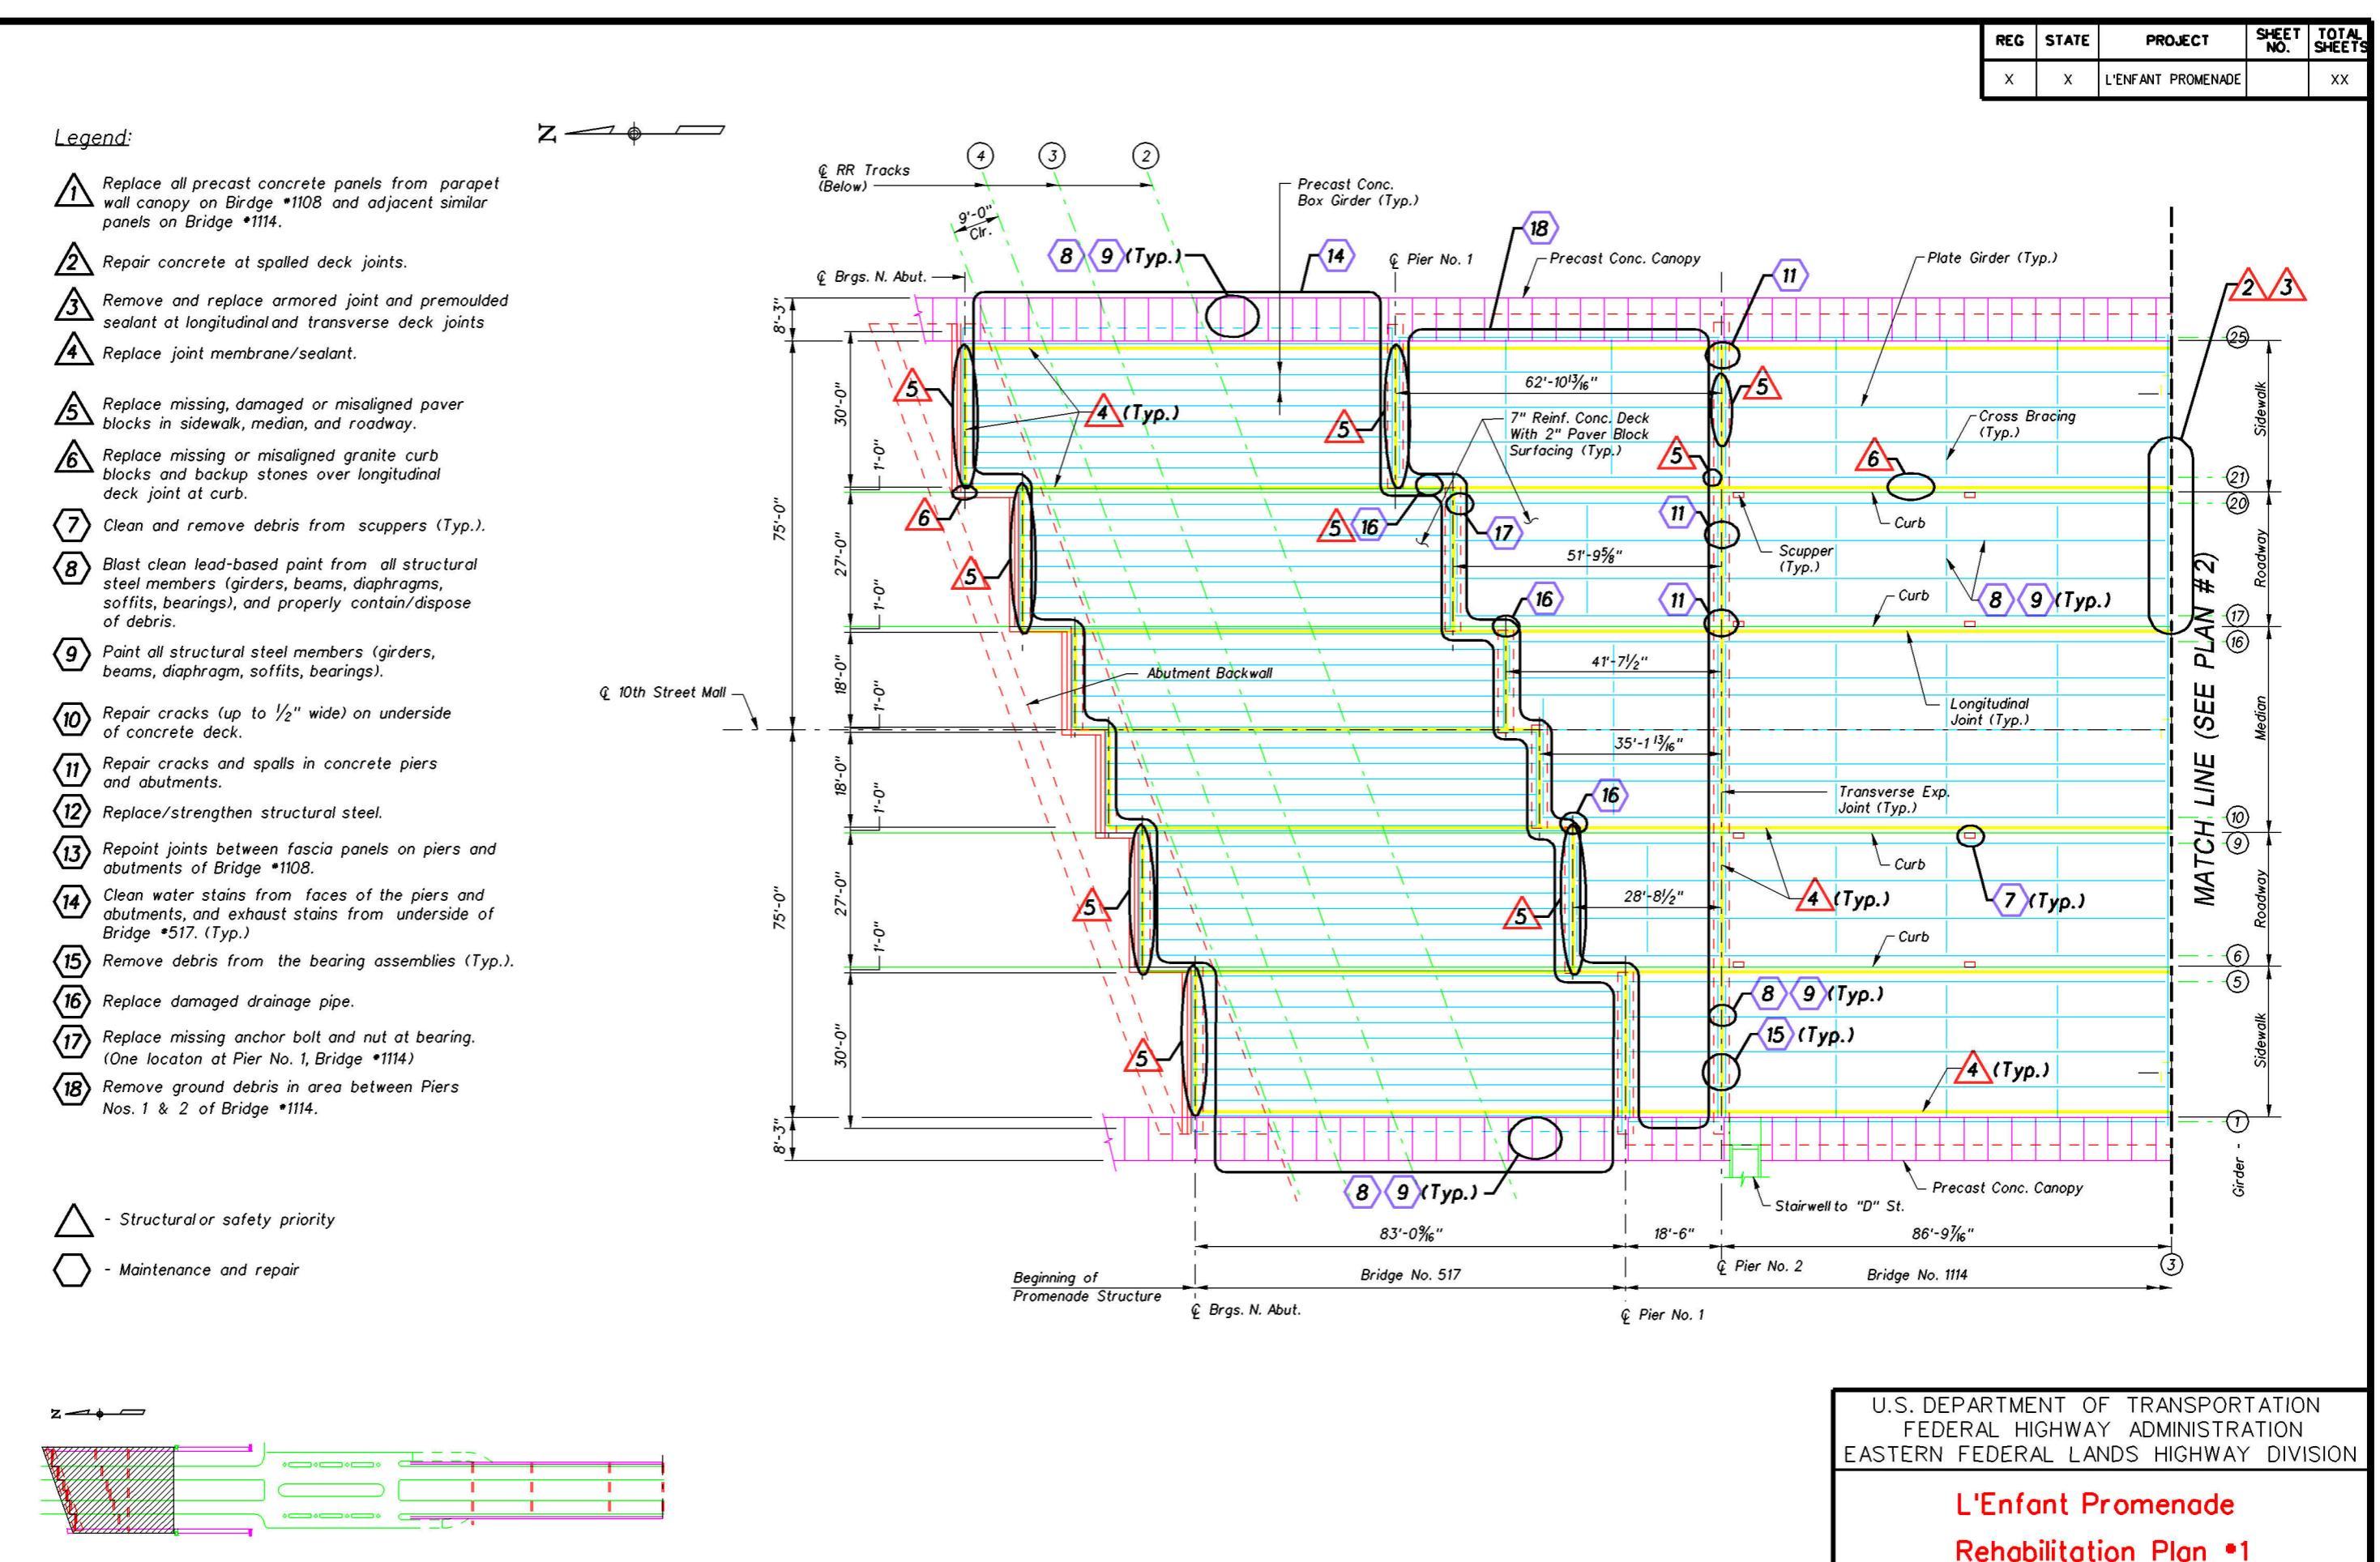
Plans depicting the deficiencies discussed in this report are found on the following pages.

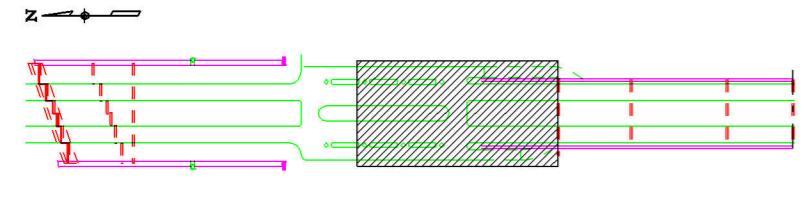
<u>Note:</u> For repair items, see legend on Sheet No. 1.

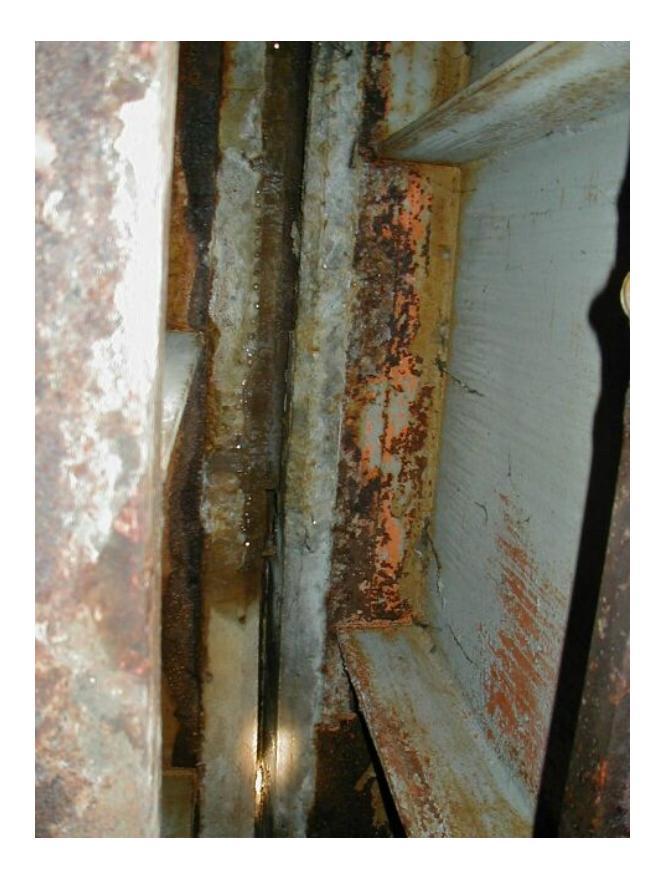
Photo 1: Active drops of water, and corroded top flanges of girders at deteriorated deck joint.

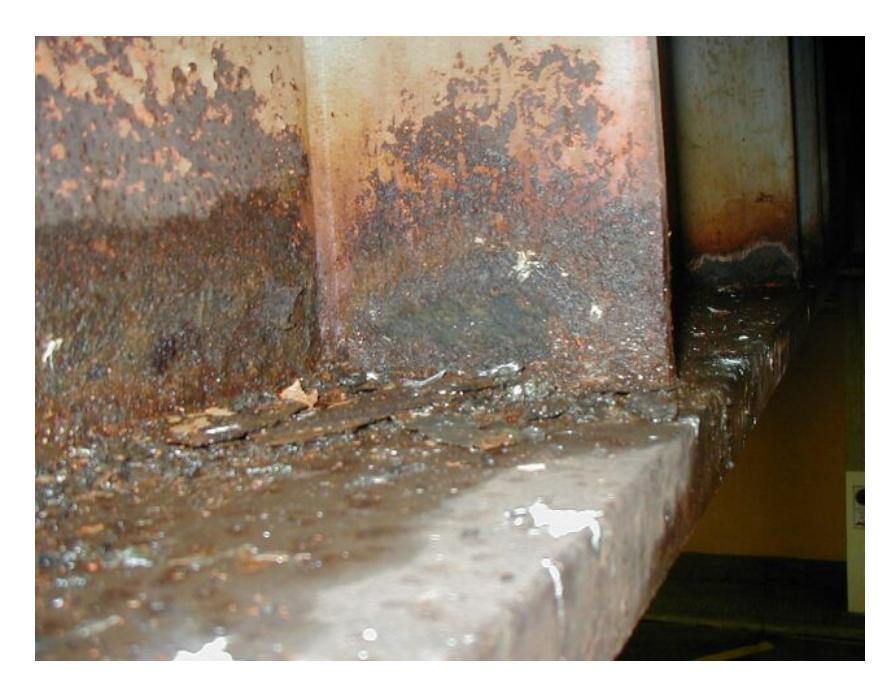
Photo 2: Moisture and corrosion found on top of bottom flange and lower areas of web and stiffeners on a girder near a failed joint.

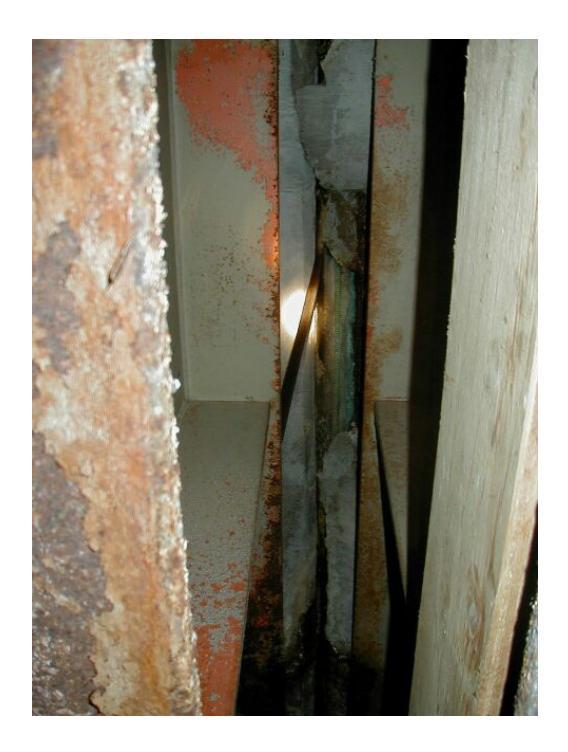
Photo 3: Attempted repair on slab and hanging joint filler material at deck joint.

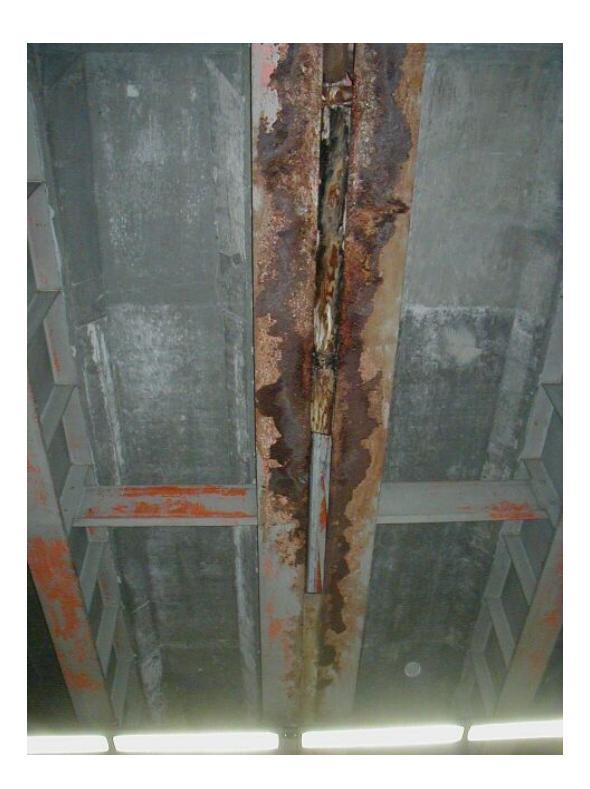
Photo 4: Typical corrosion found on bottom flanges of girders, and wood shoring located between them, at a failed deck joint.

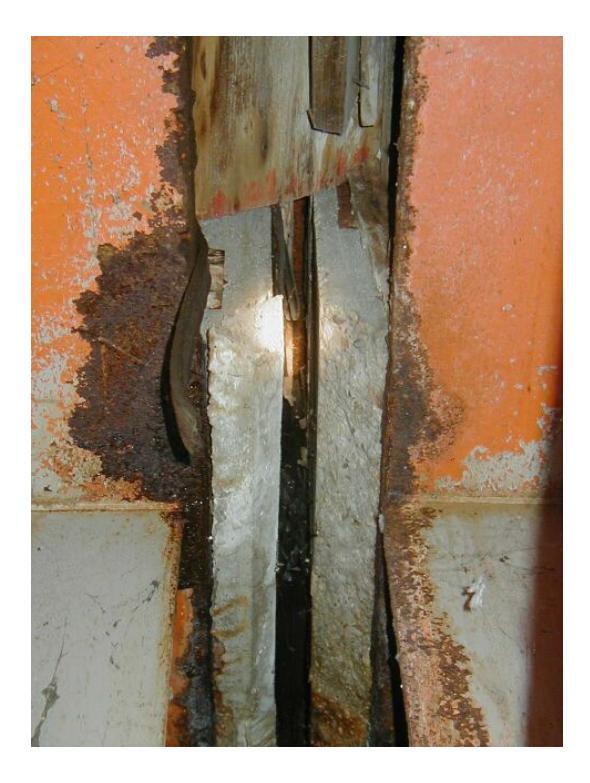
Photo 5: Spalled and sheared off bottom edges of concrete deck slab, corroded top flanges of adjacent girders, and hanging piece of joint filler at failed joint.

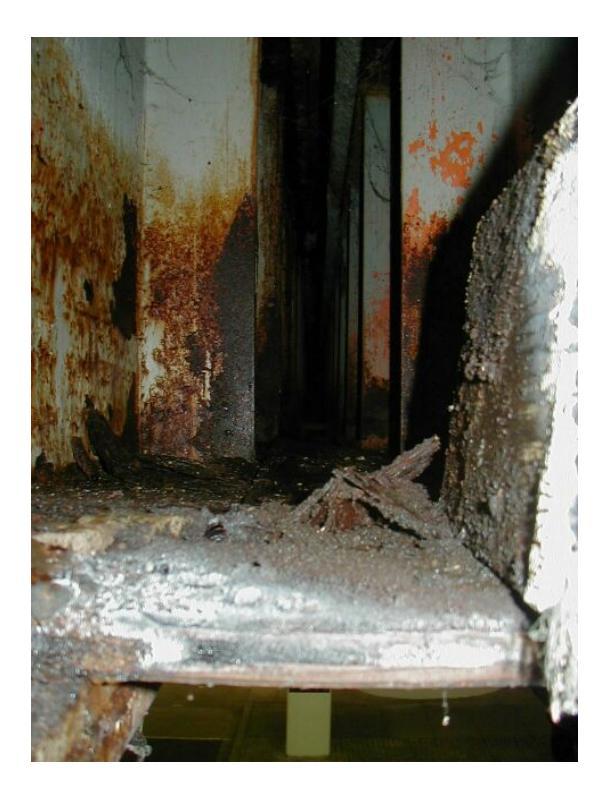
Photo 6: Top surface of damp wood shoring, and corroded flanges, webs, and stiffeners of adjacent girders below failed joint.

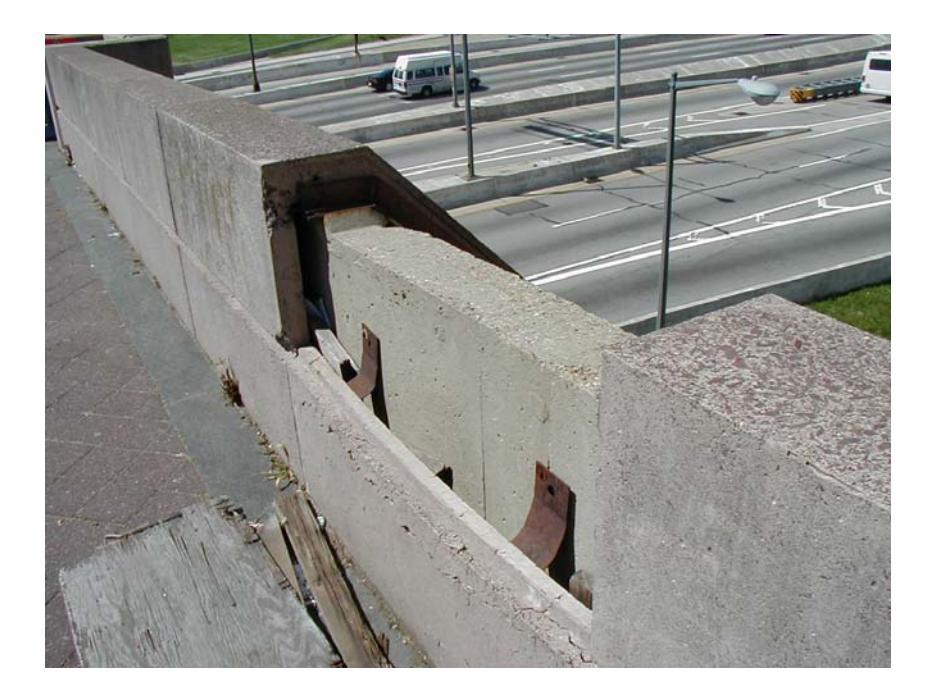
Photo 7: Missing precast concrete panel at parapet wall on Bridge No. 1108, over I-395/Southwest Freeway.

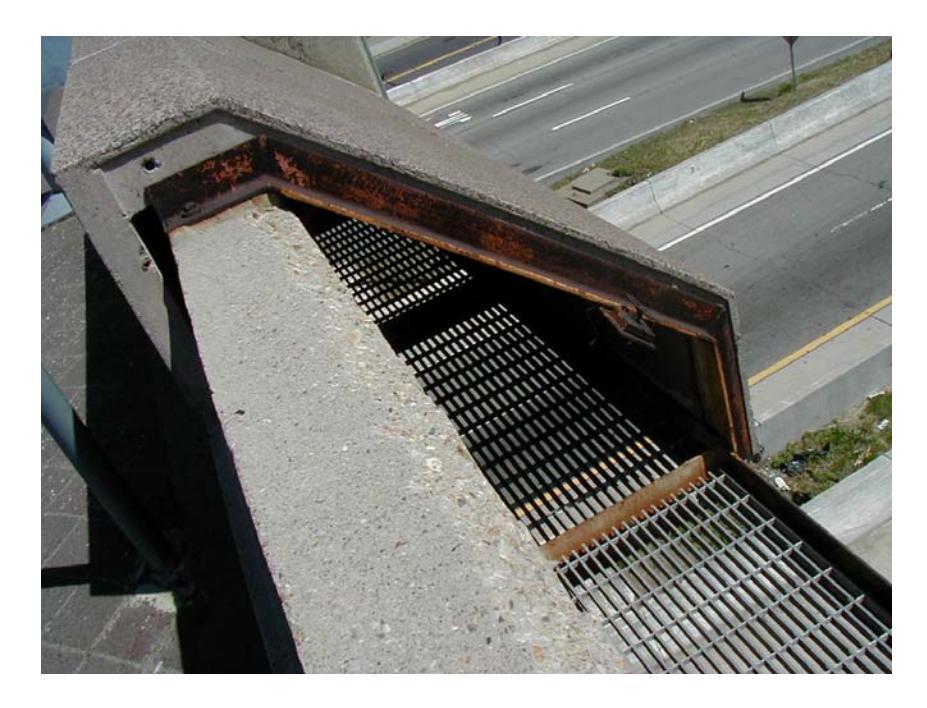
Photo 8: Steel frame used to help support precast panels; shown at location of missing panel on Bridge No. 1108.

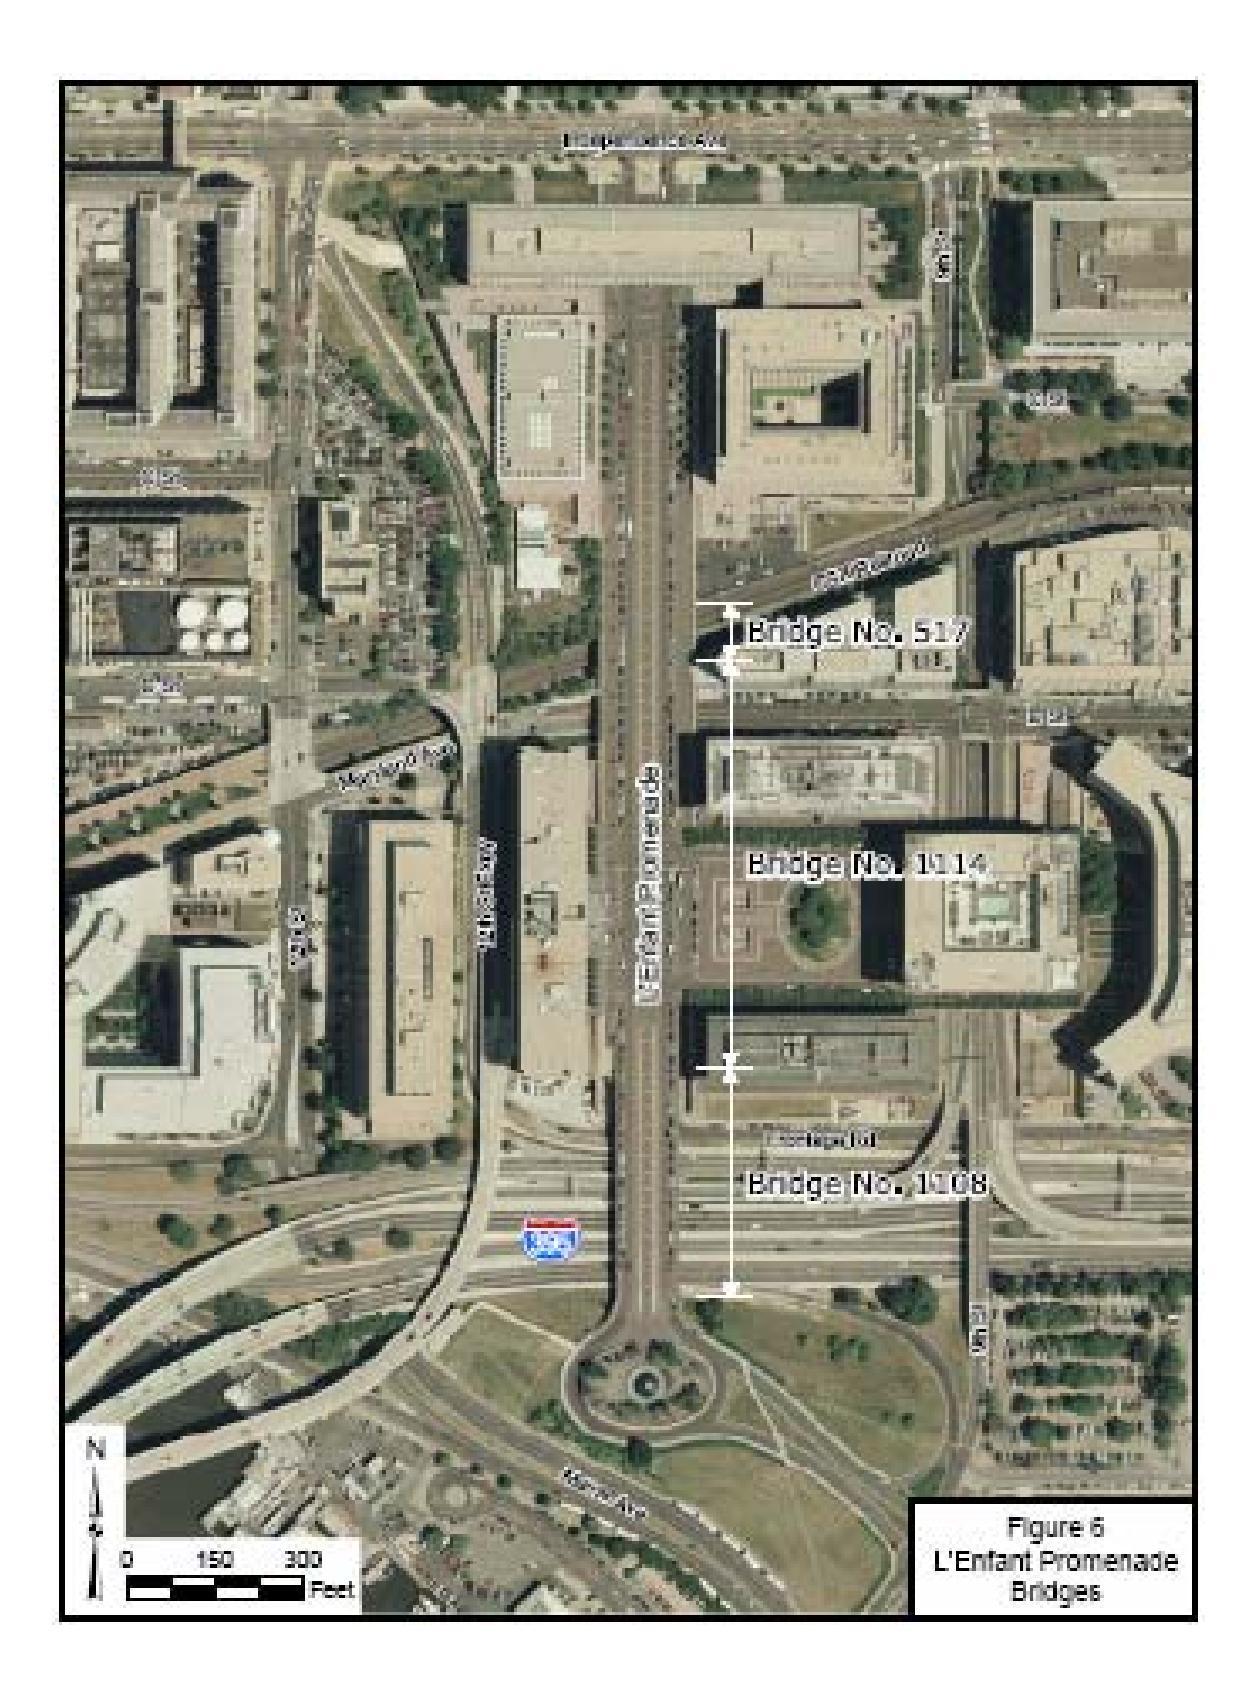
The structure was built in 1966. DDOT performed the most recent bridge inspection on January 29, 2001. The bridge was given a fair rating with minor deterioration.

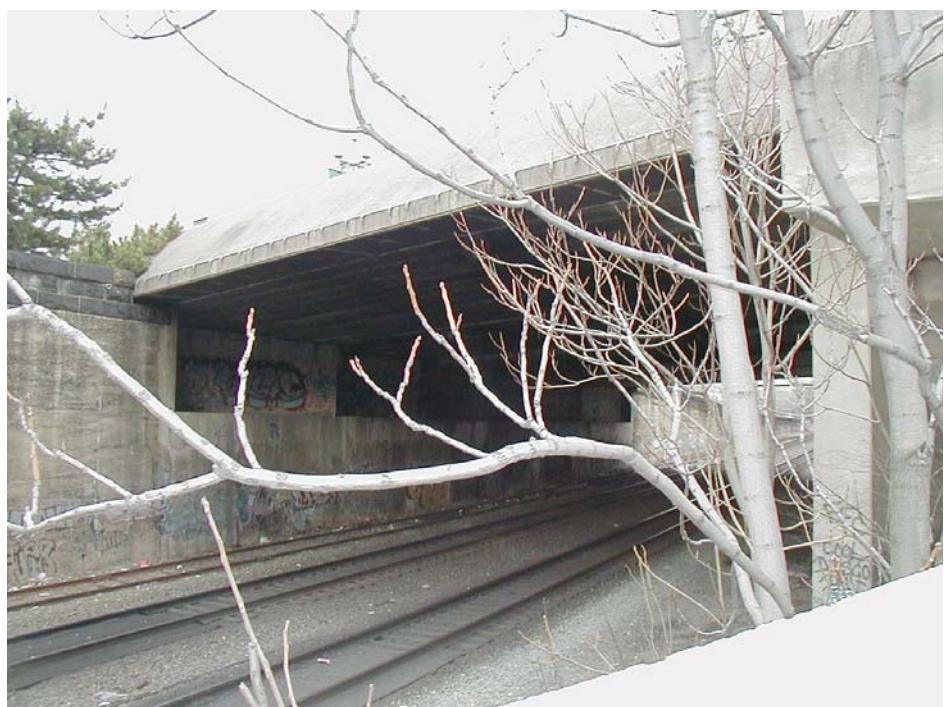
Photograph 1 L'Enfant Promenade Structure over CSX Railroad (Bridge No. 517).

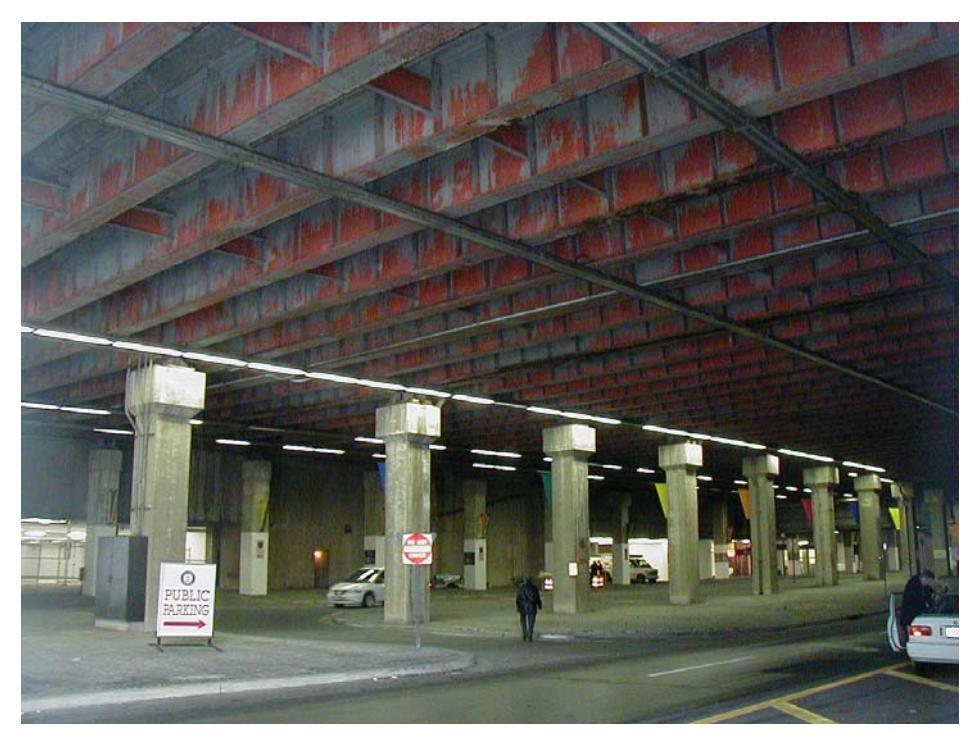
Photograph 3 L'Enfant Promenade Structure over D Street & 10<sup>th</sup> Street (Bridge No. 1114)

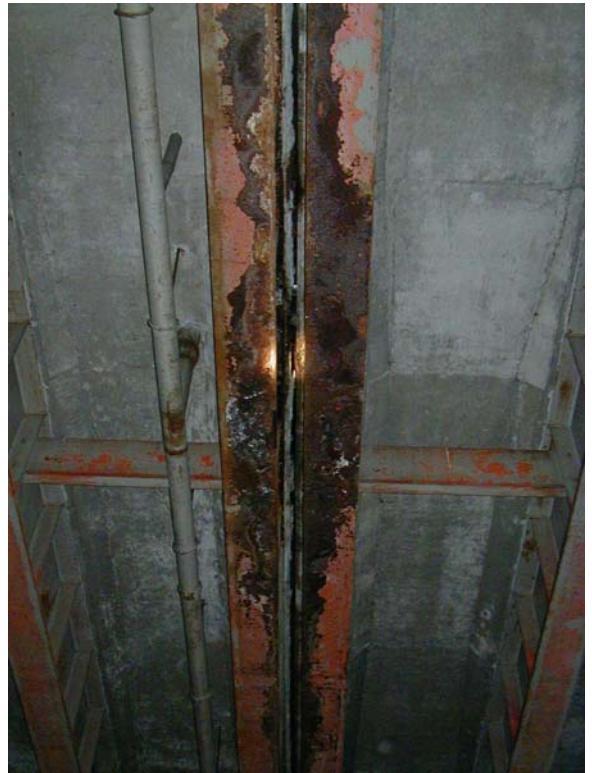
Photograph 4 Bridge No. 1114, Bridge Deck.

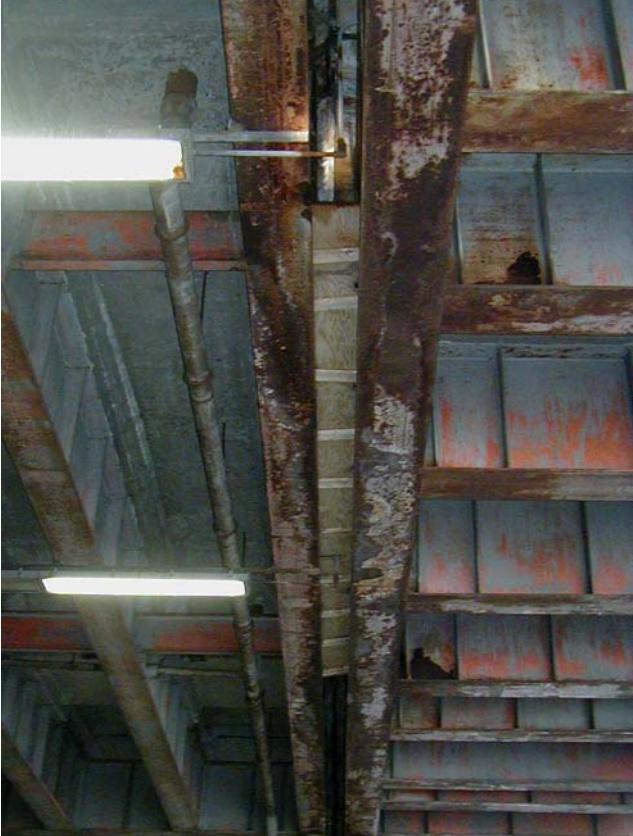
Photograph 5 Bridge No. 1114, Bridge Deck

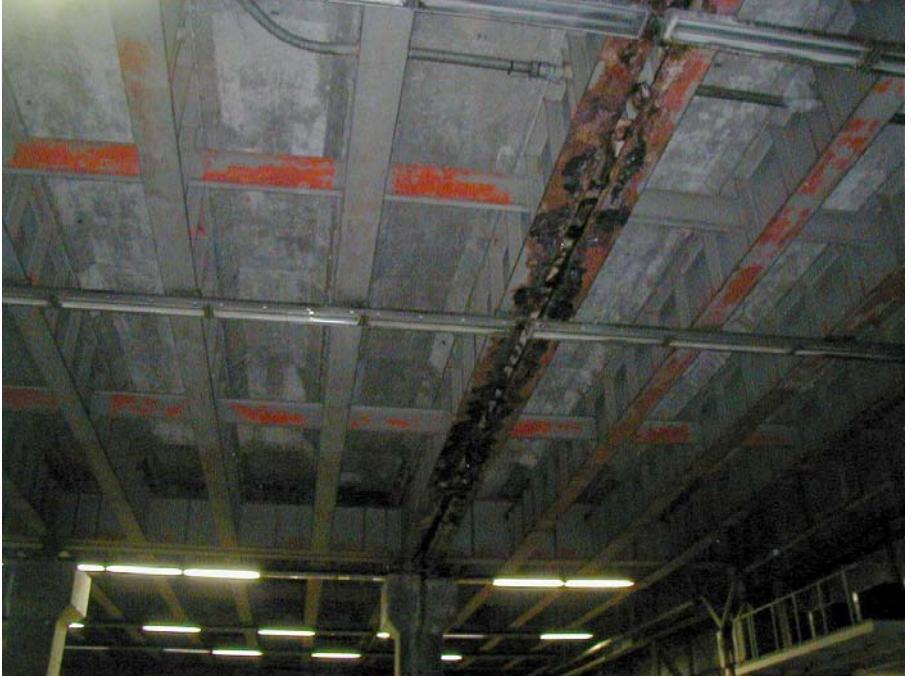
Photograph 7 Bridge No. 1114, showing deterioration of girders and beams.

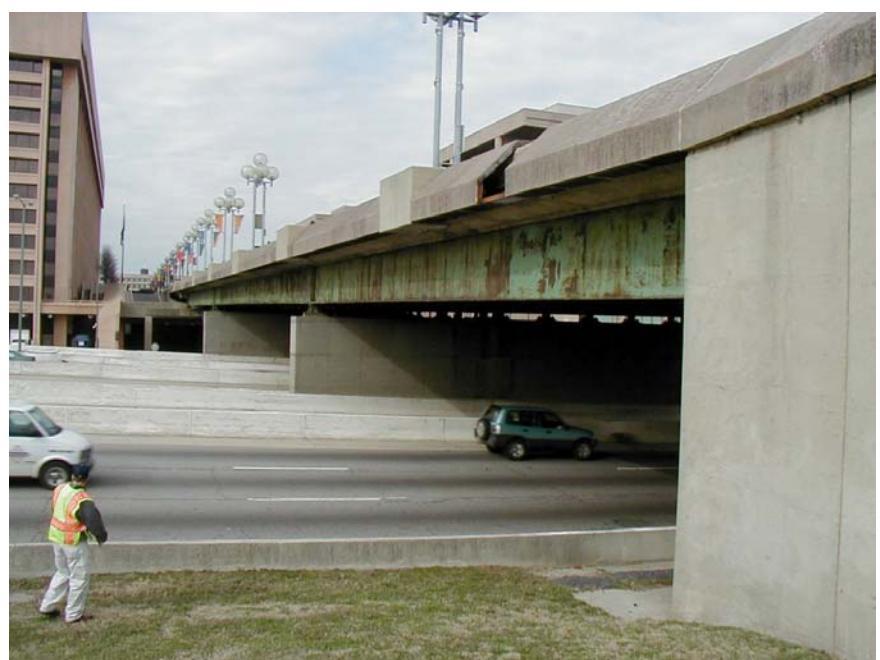
Photograph 8 L'Enfant Promenade Structure over I-395/Frontage Road.

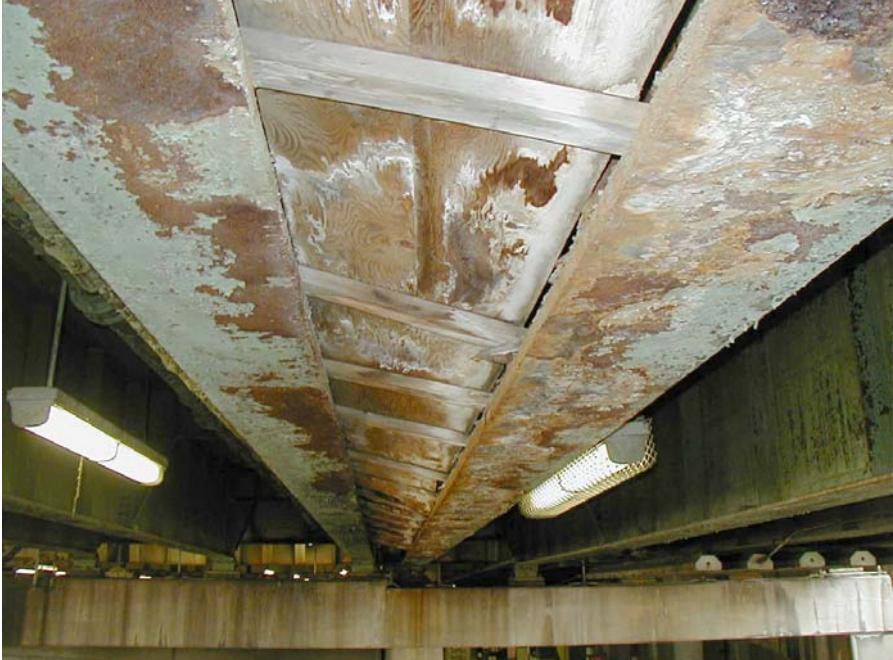
Photograph 9 Bridge No. 1108, Bridge Deck.

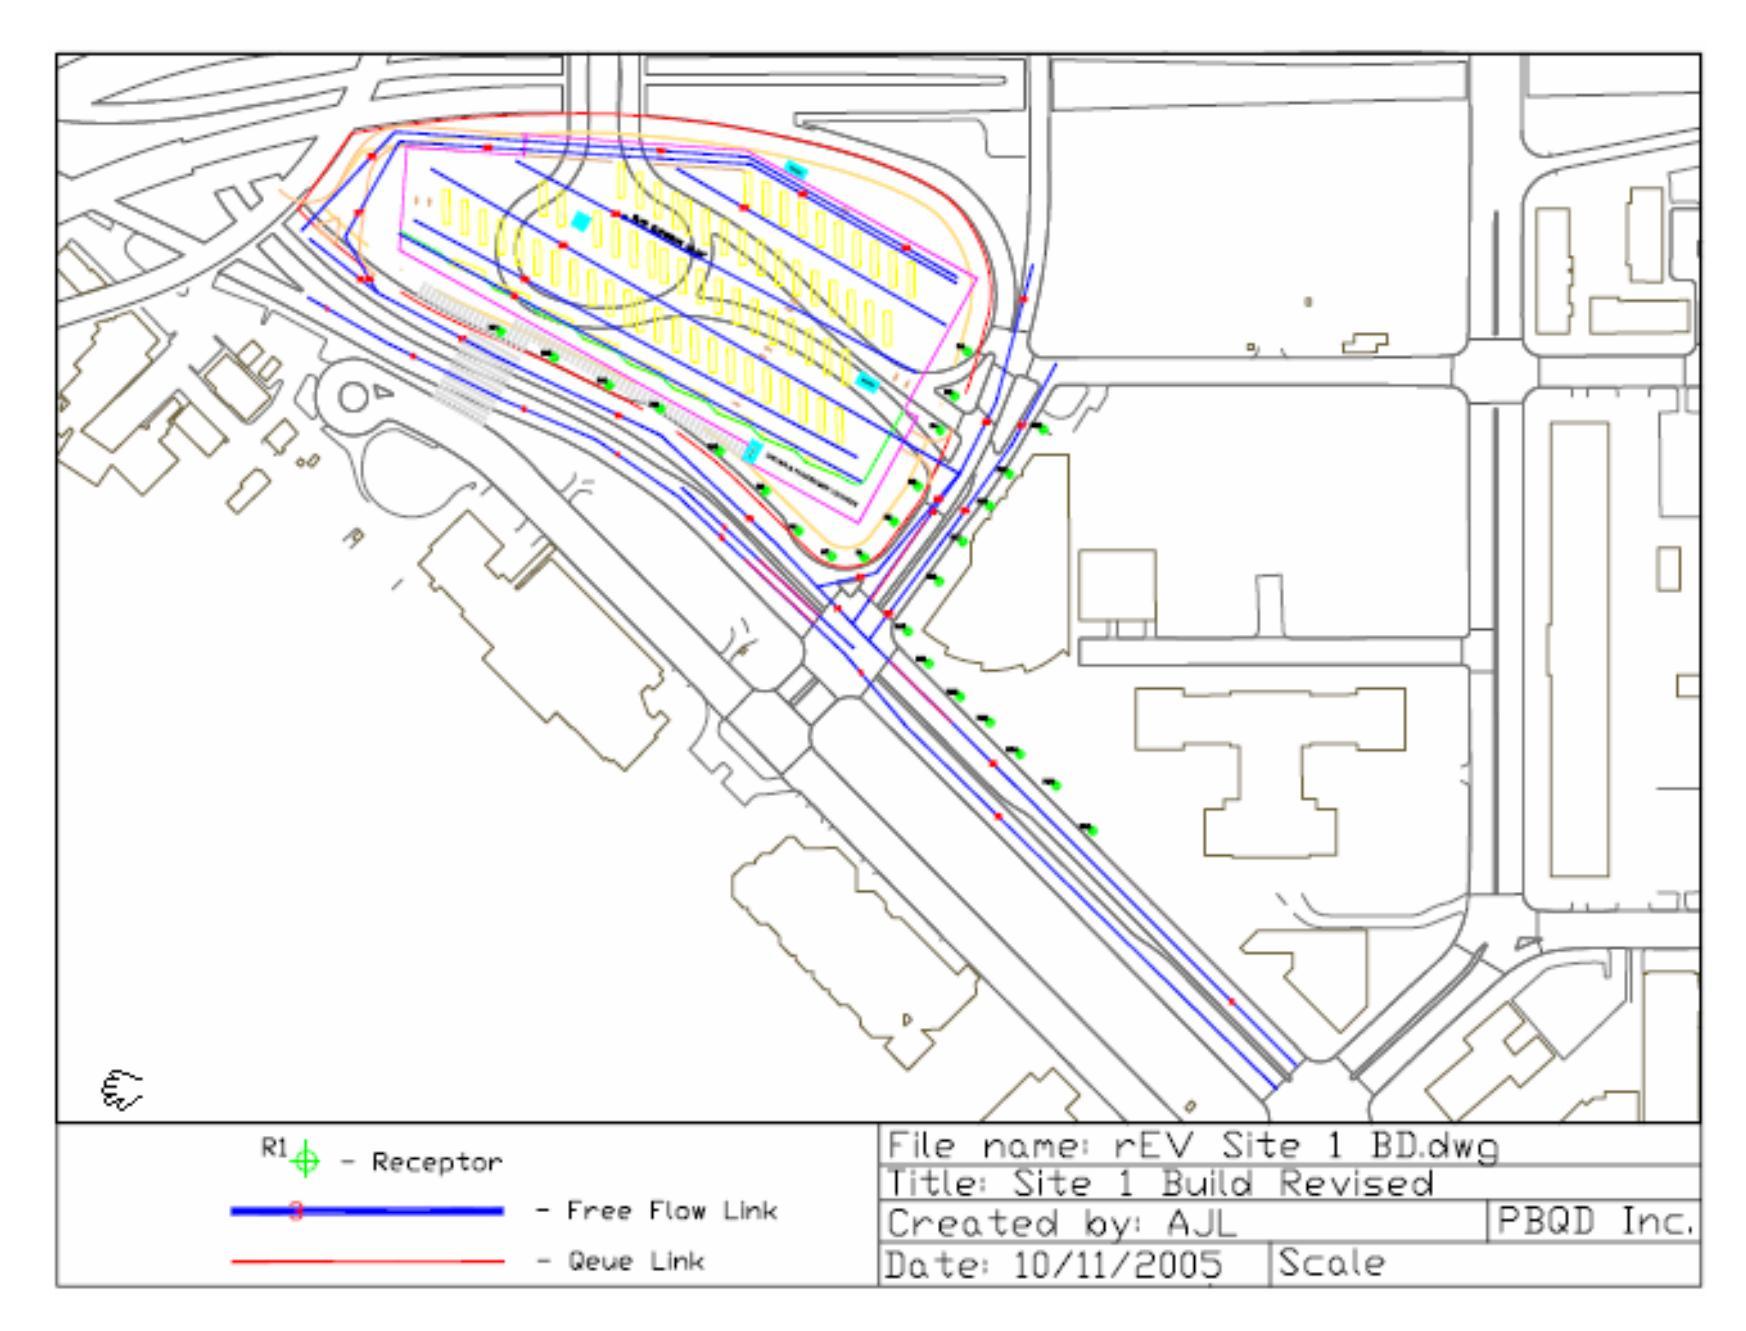
The CO and  $PM_{10}$  levels estimated by the model are the maximum concentrations which could be expected to occur at each air quality receptor site analyzed, given the assumed simultaneous occurrence of a number of worst-case conditions (peak hour traffic conditions, conservative vehicular operating conditions, low wind speeds, low atmospheric temperature, neutral atmospheric conditions, and maximizing wind direction).
