BASE ORDER 8092.1D

Subj: Hazardous Live Minefield

Subj: MAINTENANCE OF HAZARDOUS LIVE MINEFIELD

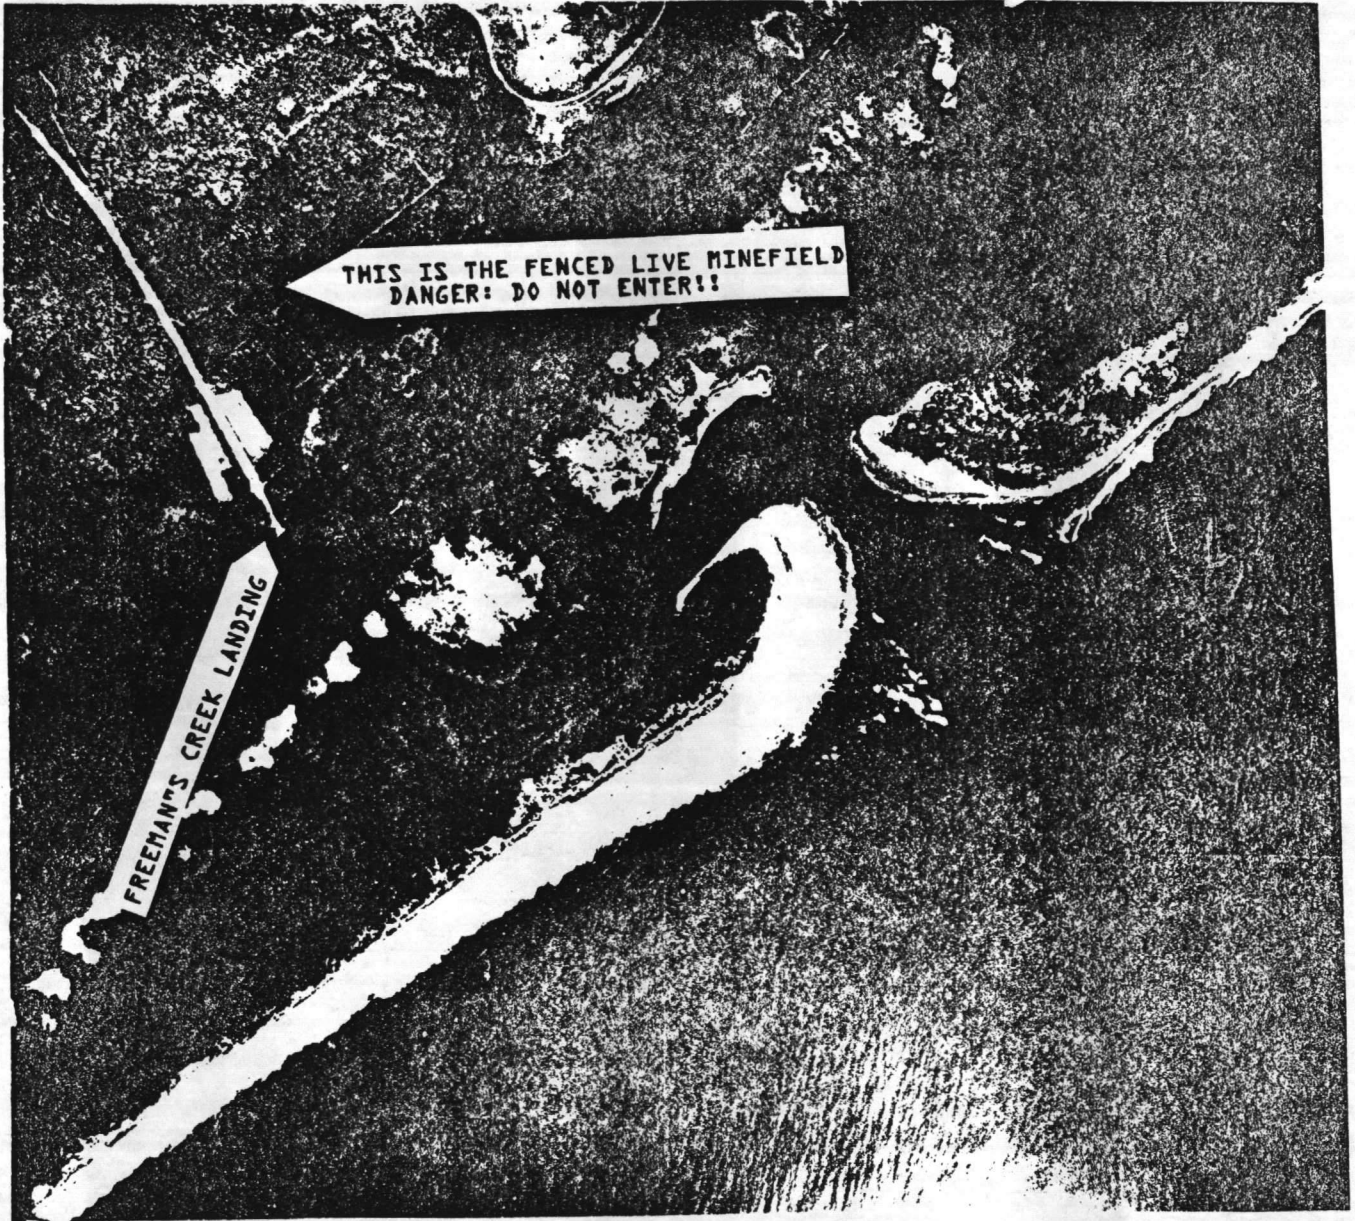
ENCLOSURE (1)

5. Minefield Site. The site is located in the area south of Highway 172 to the Atlantic Intracoastal Waterway and east of Freeman Creek to range G-5. The minefield is in the shape of the letter "L", the short axis pointing southeast. See the enclosure.

PHOTOGRAPH OF LIVE MINEFIELD SITE
