The author(s) shown below used Federal funds provided by the U.S. Department of Justice and prepared the following final report:

Document Title: Forensic Investigation Techniques for Inspecting Electrical Conductors Involved in Fire

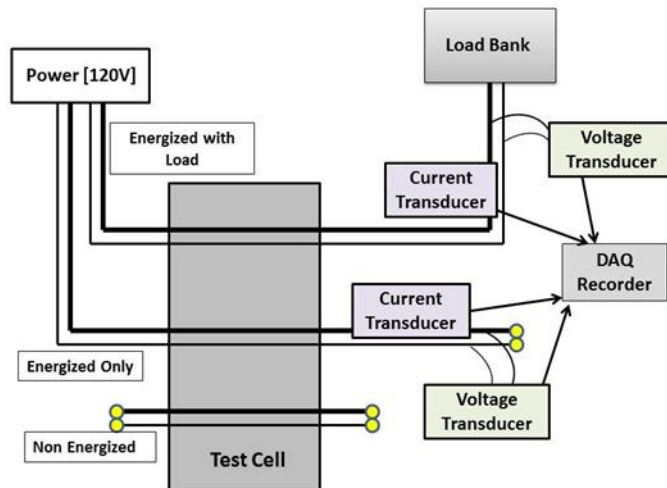
Figure 1: Data Acquisition Setup for Current and Voltage Measurements

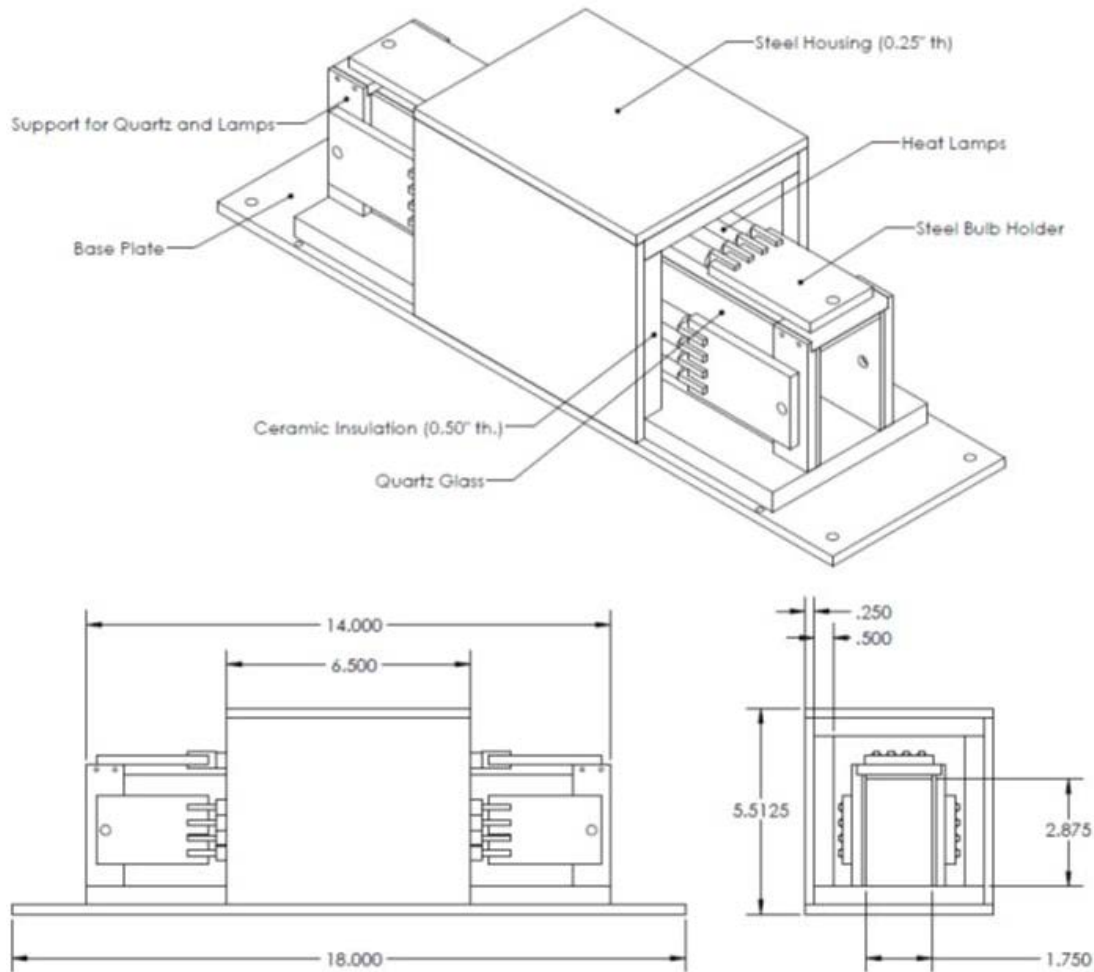
Figure 3: Radiation Testing Tunnel (Units in Inches)

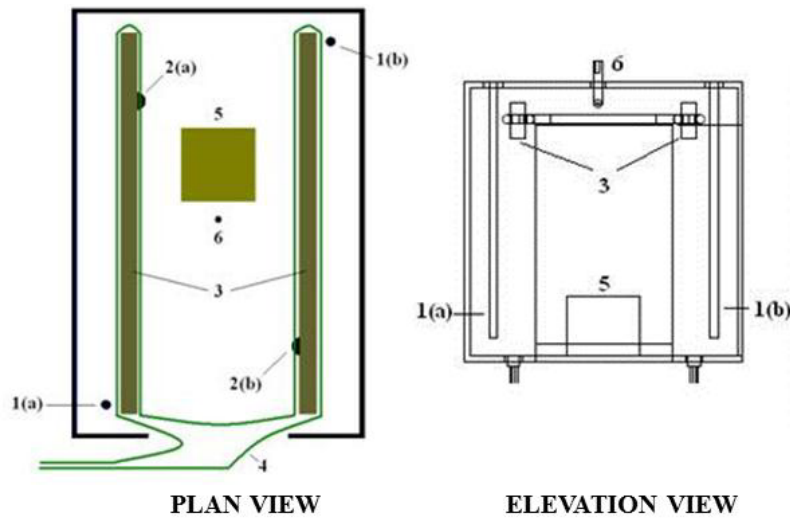
- 1(a) – TC Tree (4 inches from front and left wall)
- 1(b) – TC Tree (4 inches from back and right wall)
- 2(a) – Radiometer (12 inches from front wall, 8 inches from left wall)
- 2(b) – Radiometer (12 inches from back, 8 inches from right wall)
- 3 – 2x4 Wood Beams (6 inches from sides, 3 inches below ceiling)
- 4 – Wire (attached to wood beams via metal staples)
- 5 – Wood Crib ((10X10X9) inches on top of 6-inch diameter dish)

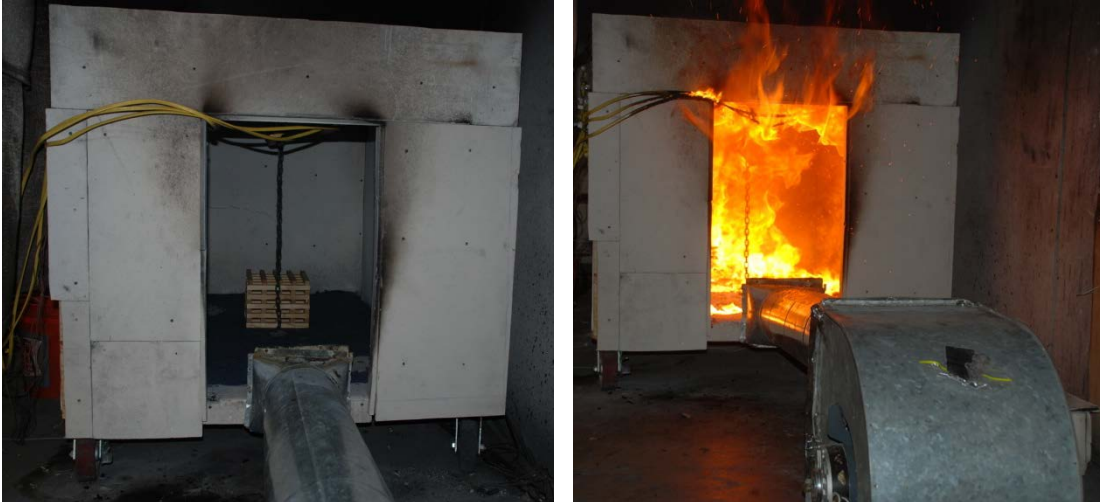
Figure 5: Flashover Compartment

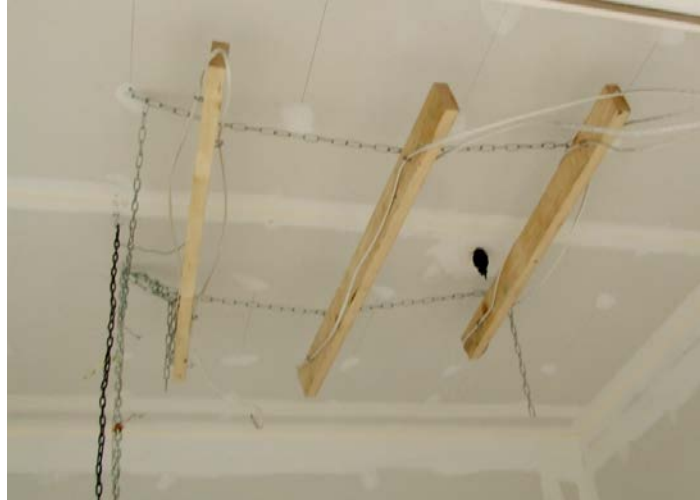
Figure 6: Wire Samples in the Ceiling with Thermocouple Tree

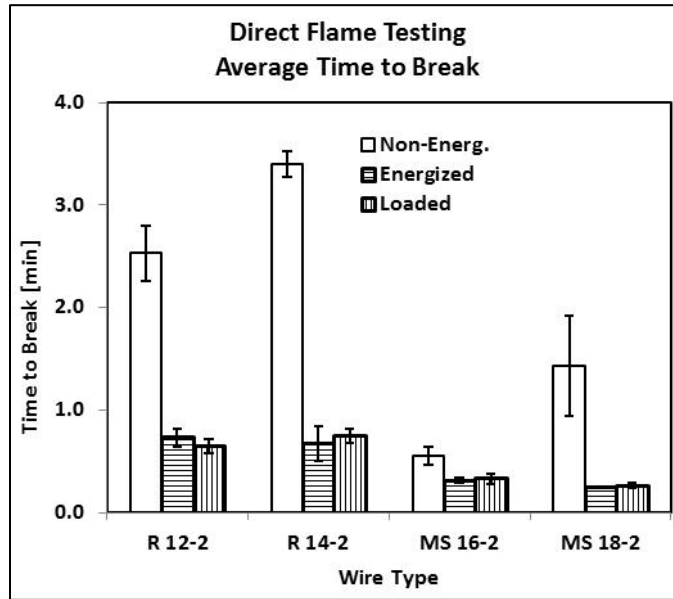
Figure 7: Average Time to Sever or Trip for All Wire Types (DF)

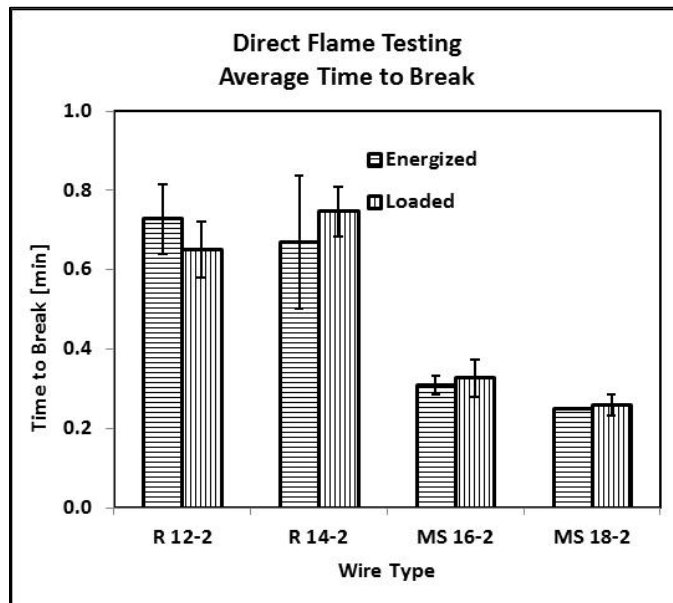
Figure 8: Average Time to Break or Trip for Energized and Loaded-Direct Flame Tests (DF)

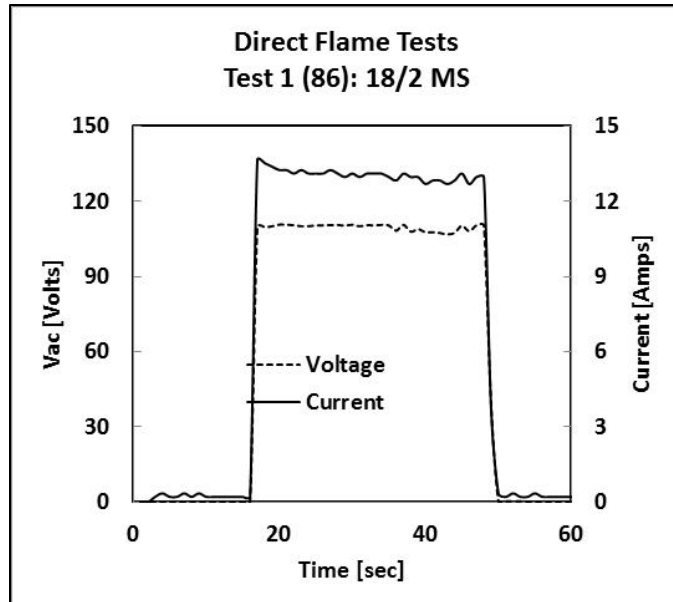
Figure 9: Typical Amperage and Voltage Graph (Loaded Wire DF)

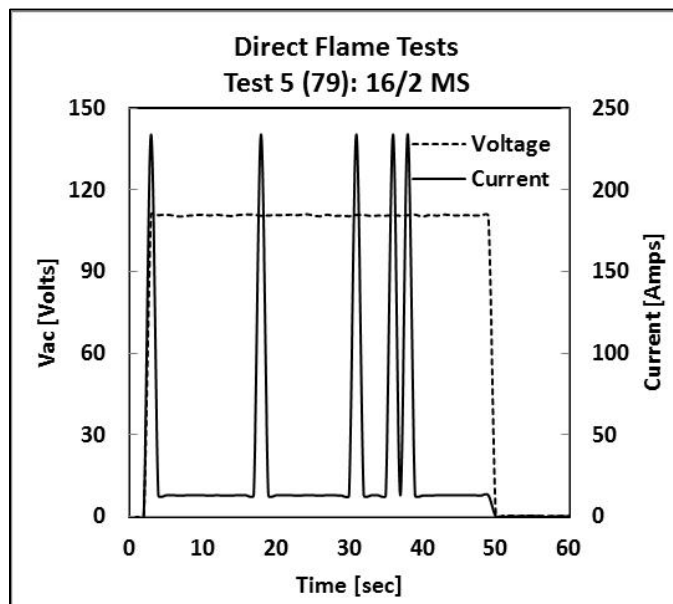
Figure 10: Arcing Through Char (DF)

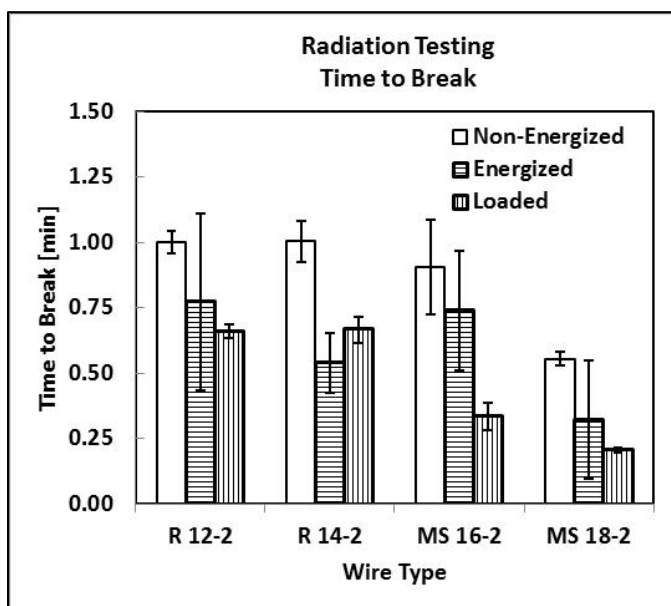
Figure 11: Average Break Time under Radiant Loading (R-All)

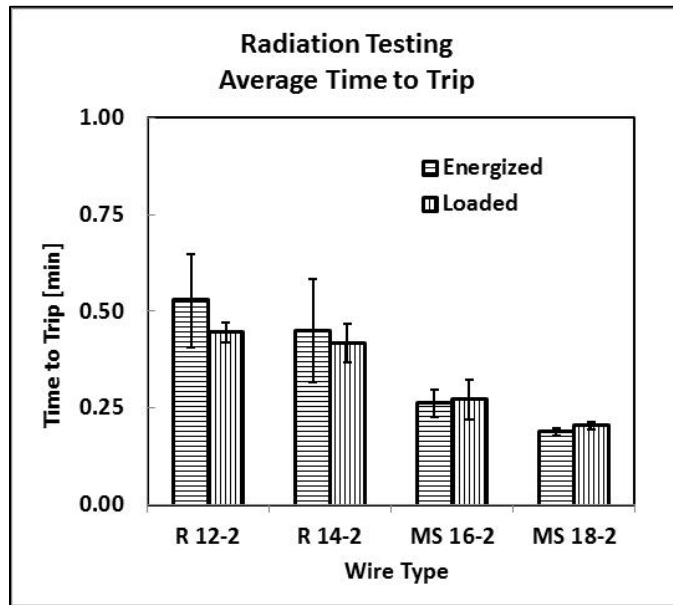
Figure 12: Average Trip Time-Radiation Tunnel Tests (E and L-R)

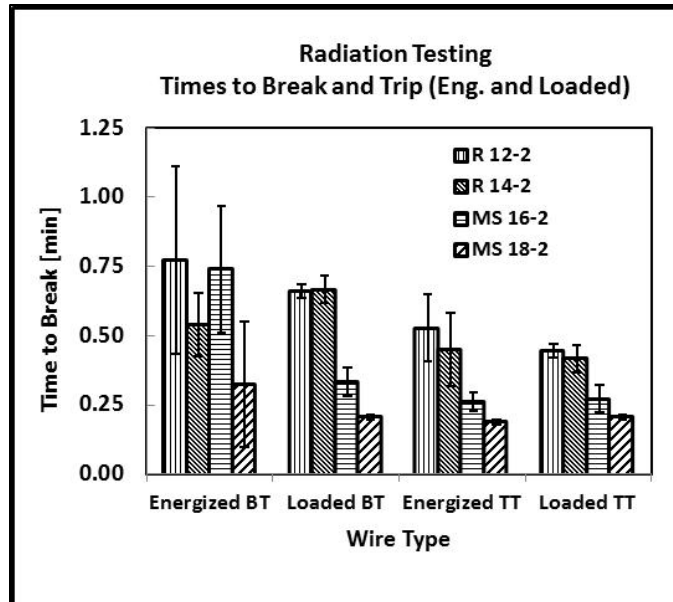
Figure 13: Average Break Time and Trip Time under Radiant Loading (R)

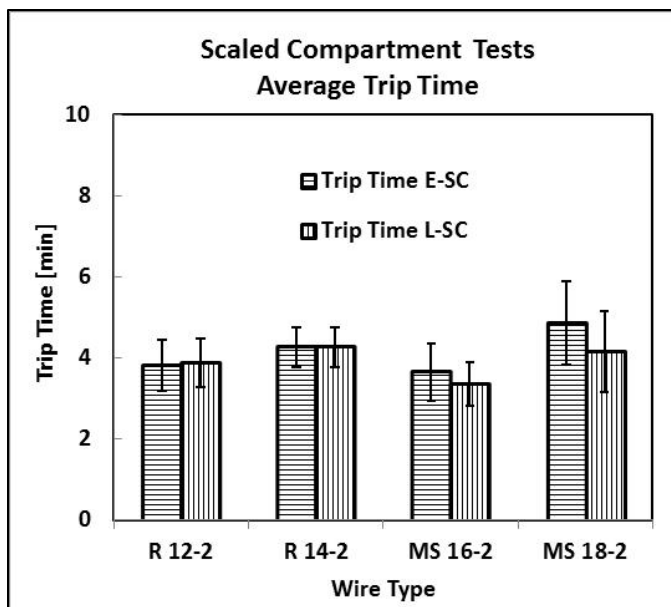
Figure 14: Average Trip Time-Scaled Compartment Tests (SC)

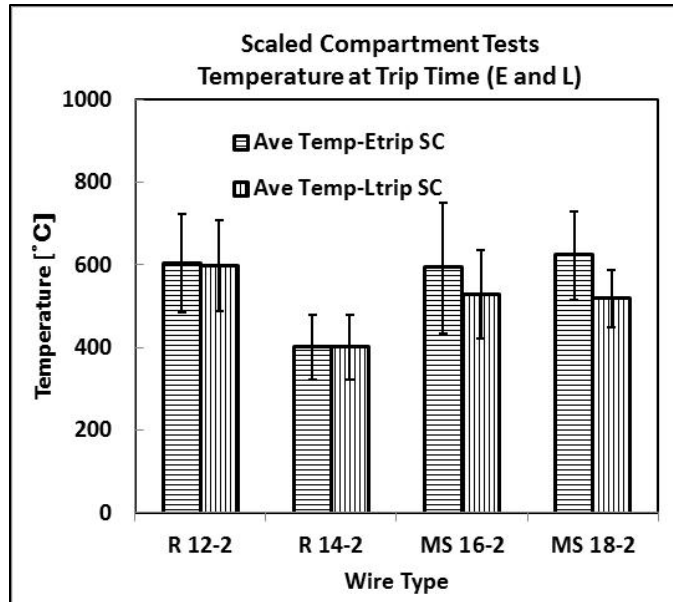
Figure 16: Temperature at Circuit Trip Time-Scaled Compartment Tests (SC)

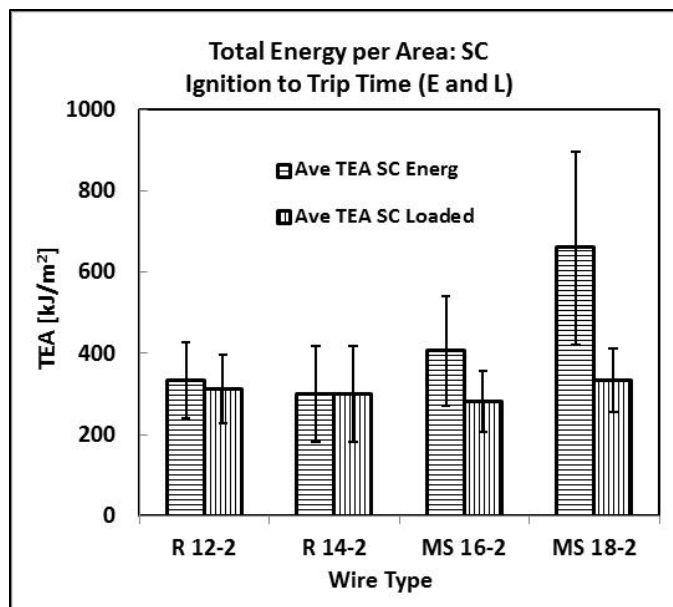
Figure 17: TEA at Trip Time for the Scaled Compartment Tests (SC)

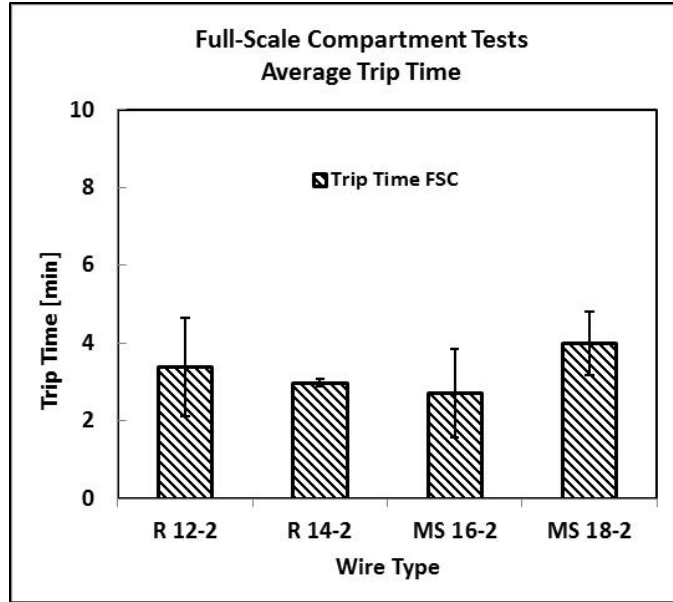
Figure 18: Circuit Trip Time for Full-Scale Compartment Tests (FSC)

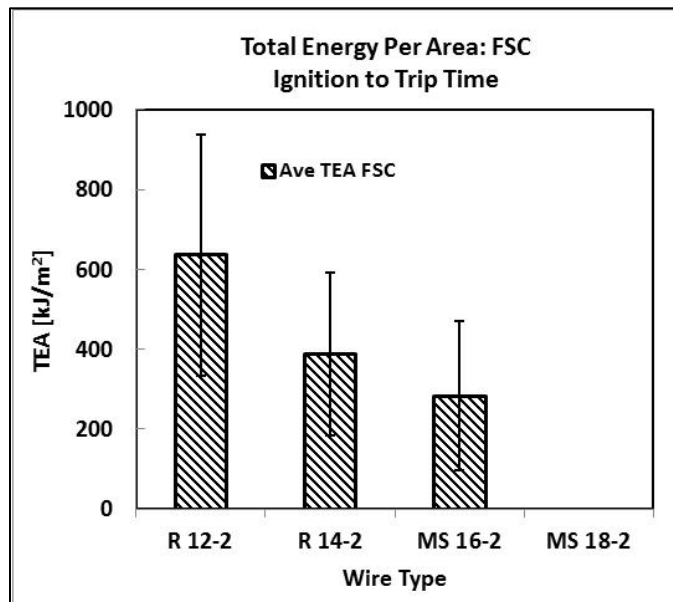
Figure 21: TEA for Full-Scale Compartment Tests (FSC)

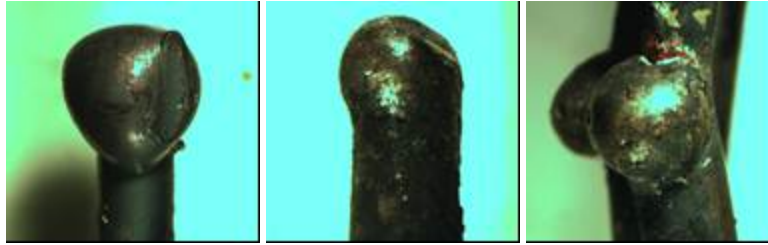
Figure 22: Beads Produced with Direct Flame Exposure (12-gauge: NE, E (center), and L)

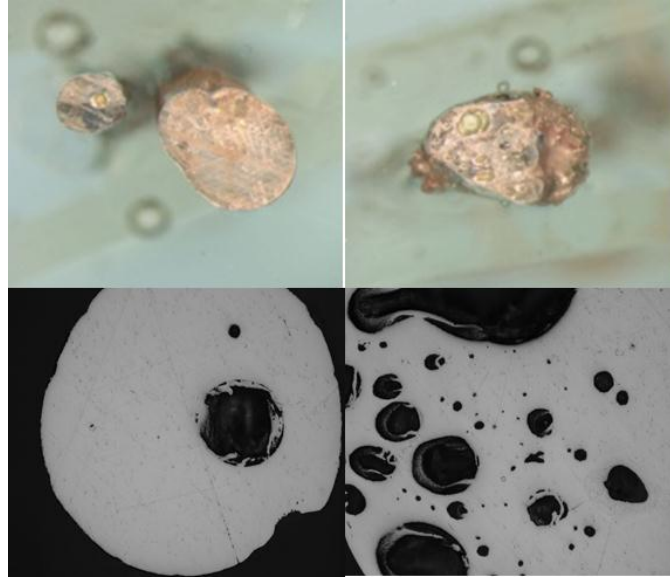
Figure 33: SM and SEM Images of MS Wires under different Electrical Conditions.

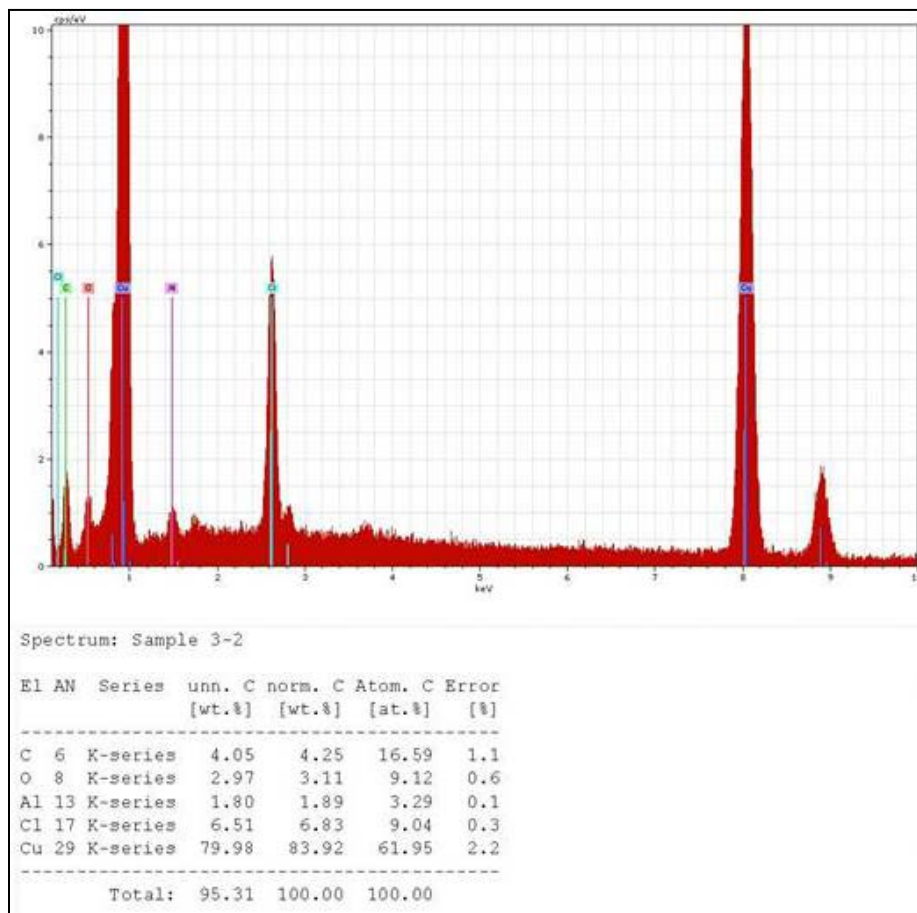
Figure 34: EDS Graph for a Bead Surface formed on an Energized Wire (DF)

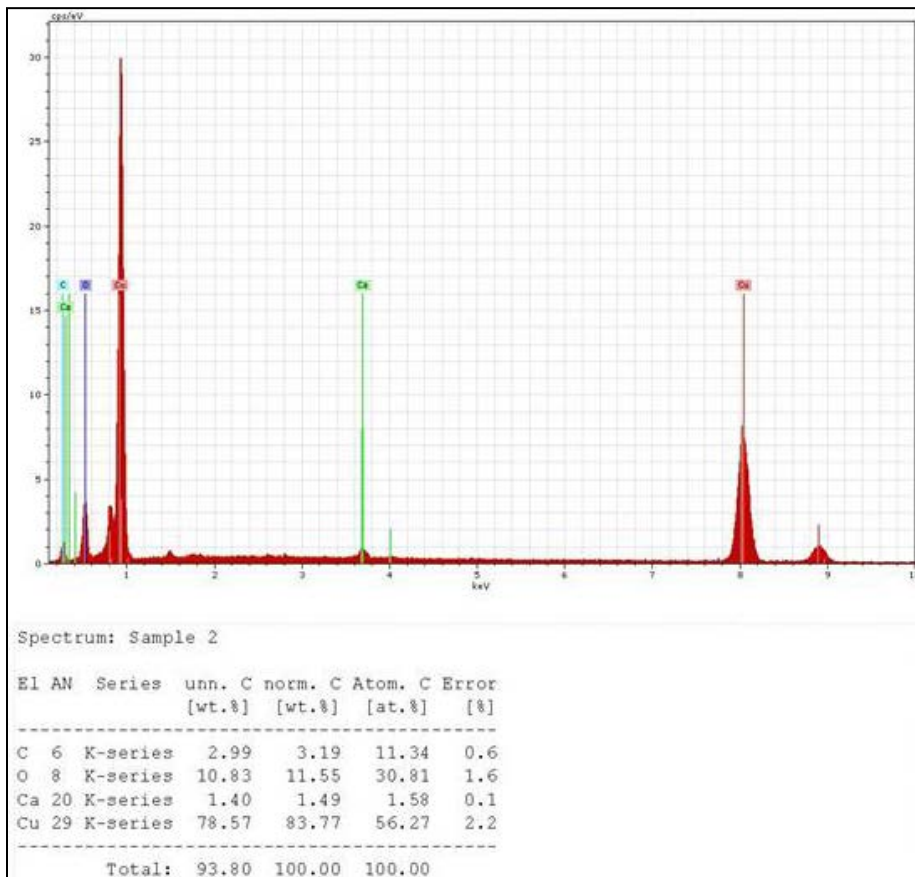
Figure 35: EDS Graph for a Bead Surface formed on a Non-energized Wire (DF)

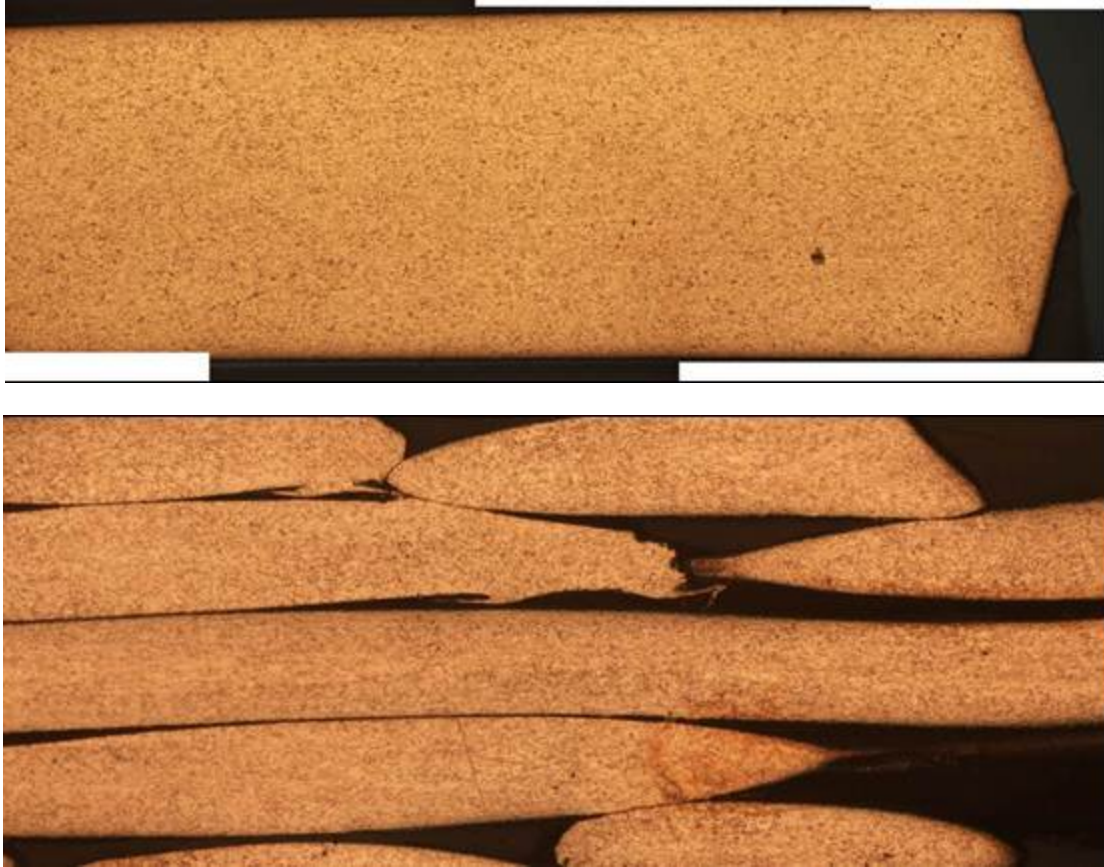
Figure 36: Grain Structures of Wire Control Samples (Unexposed Wires: Solid (Top) and Stranded (Bottom))

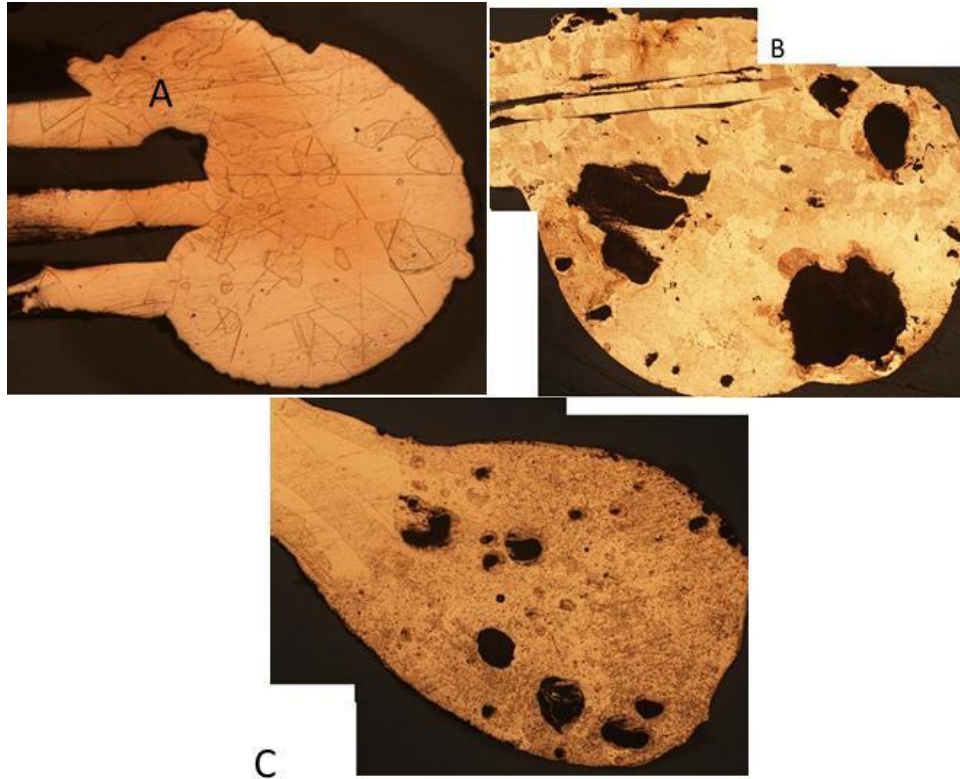
Figure 38: Metallurgical Microscope Images of Beads formed under Scaled Compartment Exposure (All Loaded 18-MS Wires)

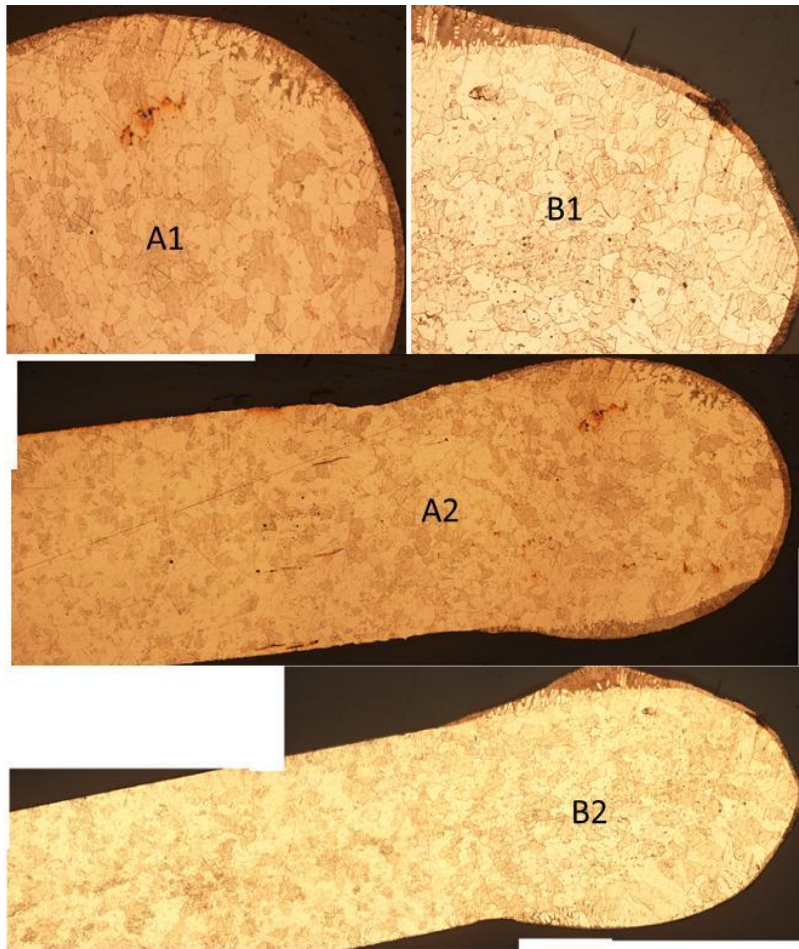
Figure 39: Metallurgical Microscope Images of Beads formed under Direct Flame Exposure (12-R NE (A) and 12-R L (B))

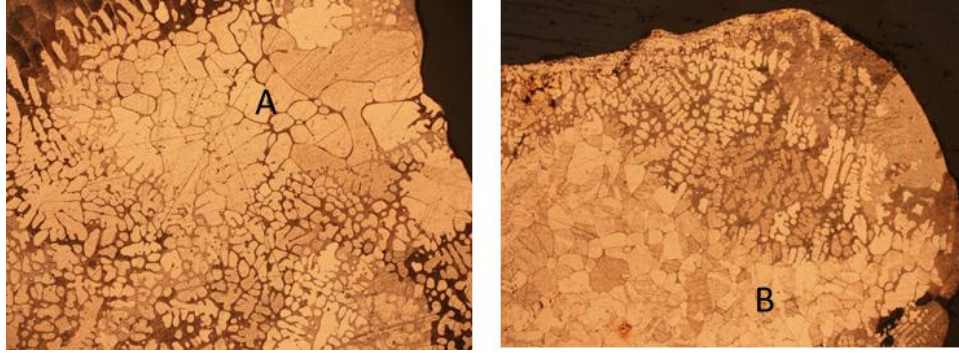
Figure 40: Metallurgical Microscope Images of Beads formed under Scaled Compartment (12-R L (A)) and Radiation (14-R NE (B))

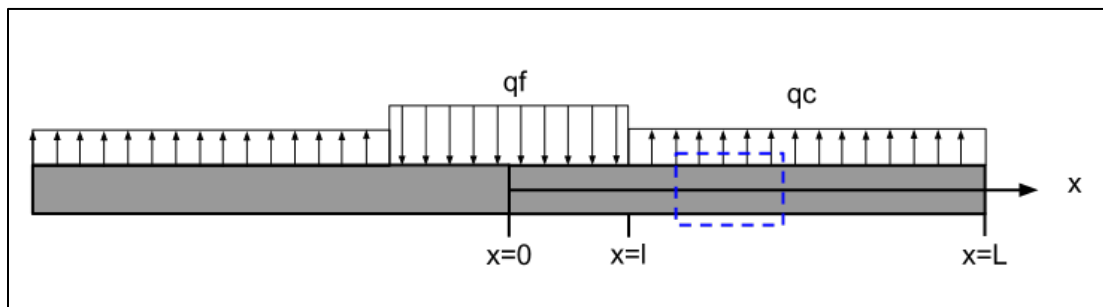
Figure 42: Copper Wire Sample Setup for Heat Transfer Simulation

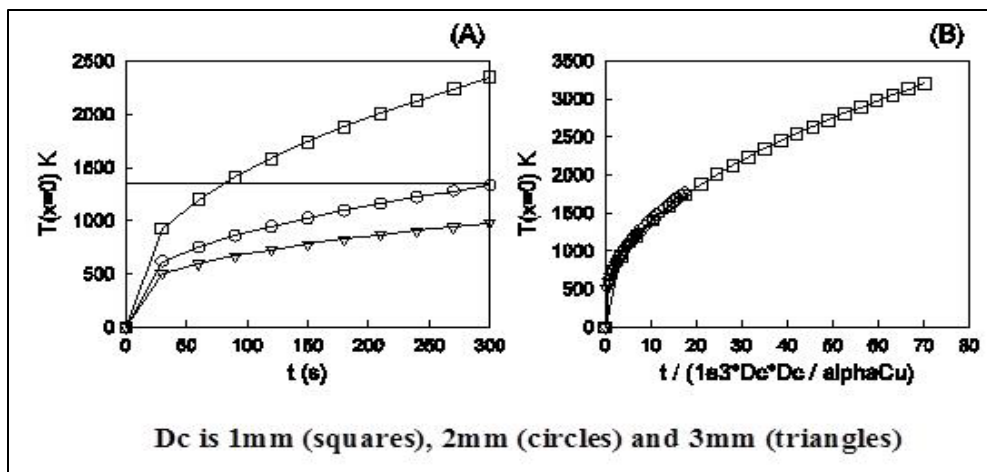
Figure 43: Heat Transfer Simulation Results-Temperature change with Time

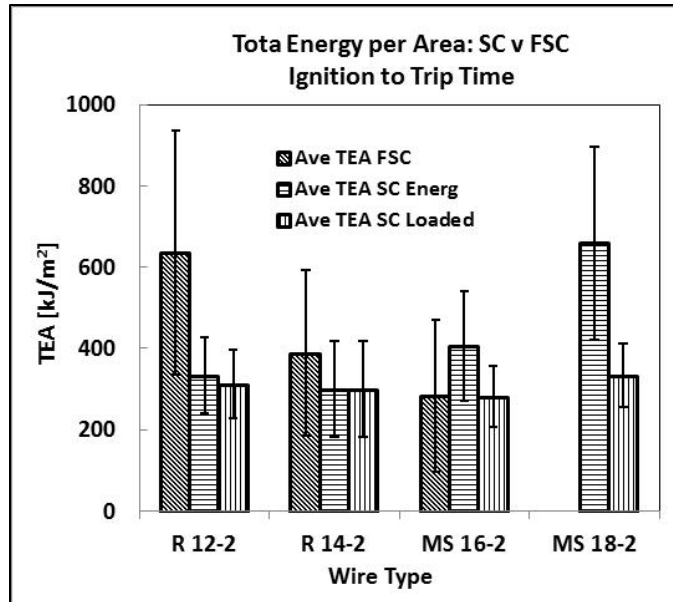
Figure 50: Total Energy per Area Comparison (SC and FSC)

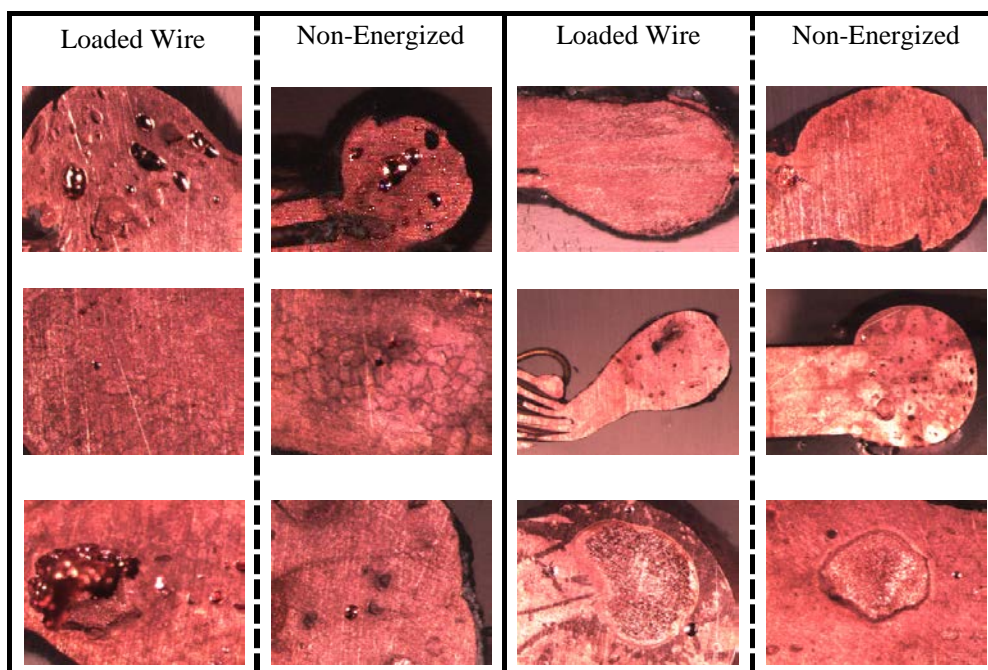
Figure 52: Internal Pattern Comparison of Loaded and Non-energized Beads for various Exposures (SM Images)

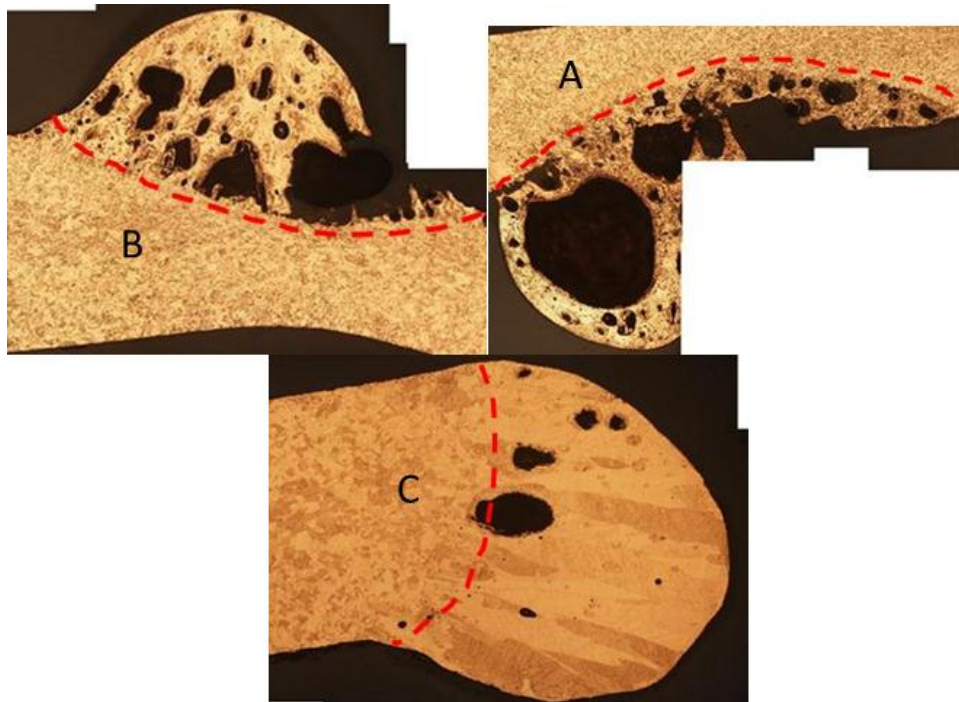
Figure 53: Line of Demarcation (Direct Flame (A and B) and Radiation (C))

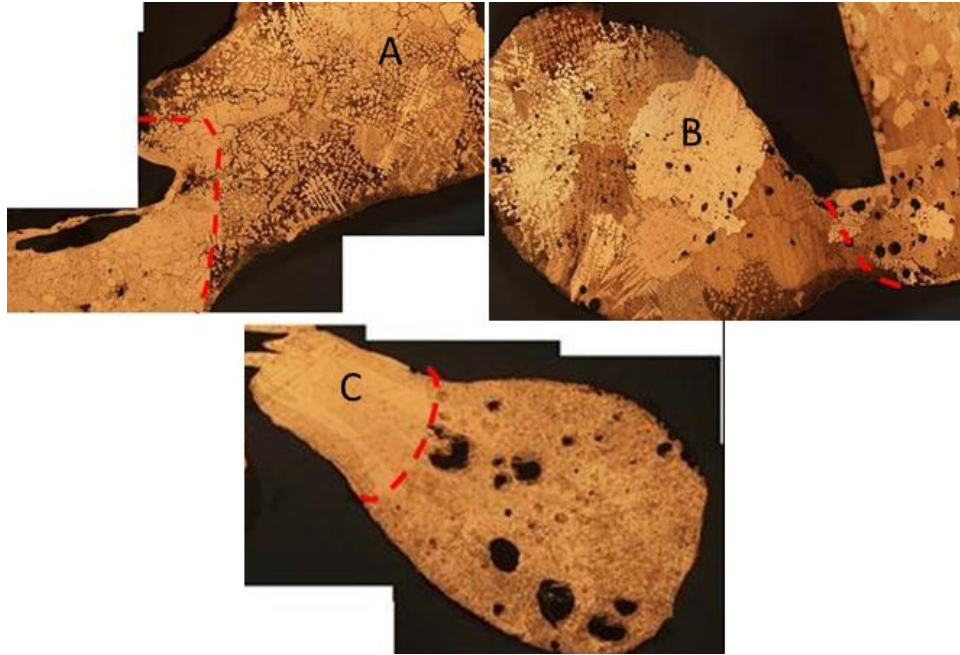
Figure 54: Line of Demarcation (Scaled Compartment-All)
