PHASE I HISTORY/ARCHITECTURE SURVEY AND
ARCHAEOLOGICAL DISTURBANCE STUDY FOR
THE ENVIRONMENTAL IMPACT STATEMENT FOR
ENTRY CONTROL RECONFIGURATION AND
BASE PERIMETER FENCE RELOCATION, AREA A,
WRIGHT-PATTERSON AIR FORCE BASE, OHIO

Fairborn, Greene County, Ohio

MAY 16, 2011

HARDLINES DESIGN COMPANY

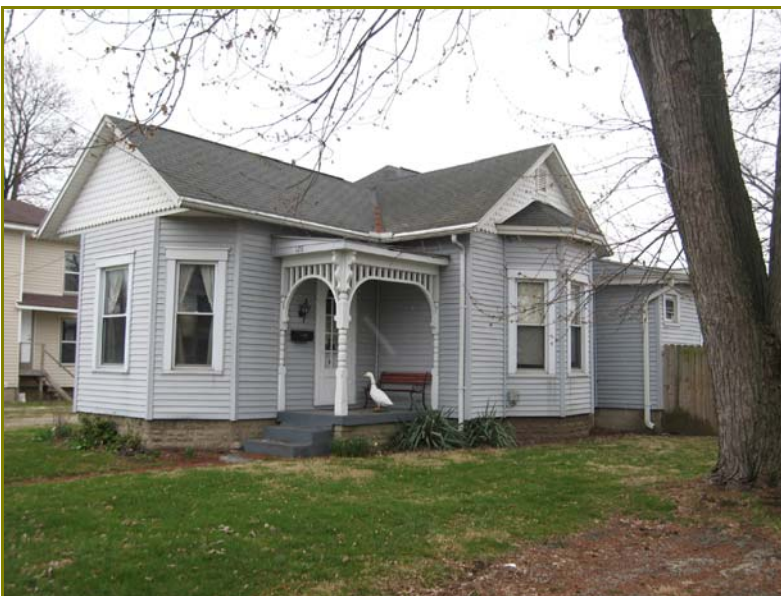
Figure 18. 128 W. Dayton Drive, looking southeast

Queen Anne T-plan house constructed around 1900. This house retains its overall form, scalloped shingles in the gabled end, gingerbread porch details, and wood window surrounds, but it has been altered with vinyl cladding, replacement windows and doors, and a rear addition. This house was moved to this location in the 1920s from the former town of Osborn as a result of the Huffman Dam construction.

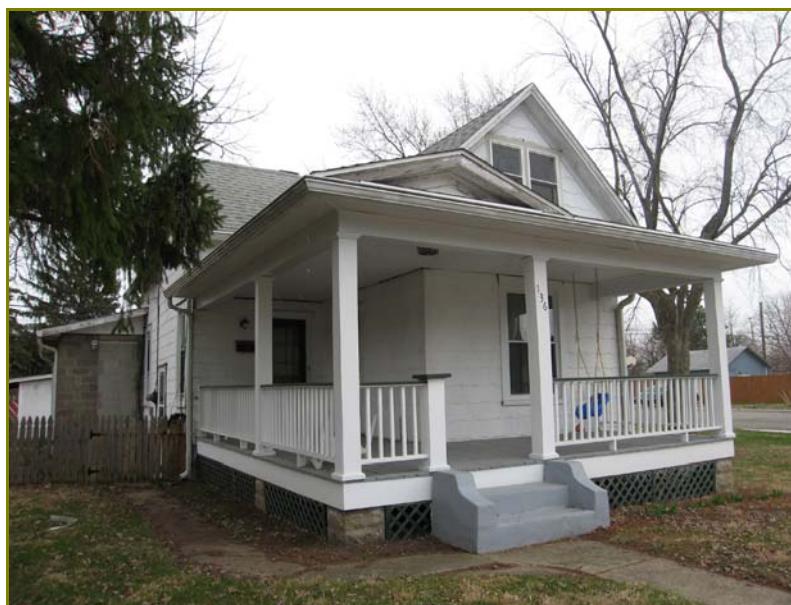
Figure 19. 136 W. Dayton Drive, looking southwest

Queen Anne T-plan house constructed around 1900. This house has been modified by vinyl cladding, replacement windows and doors, modifications made to the porch, and a rear addition. This house was moved to this location in the 1920s from the former town of Osborn as a result of the Huffman Dam construction.

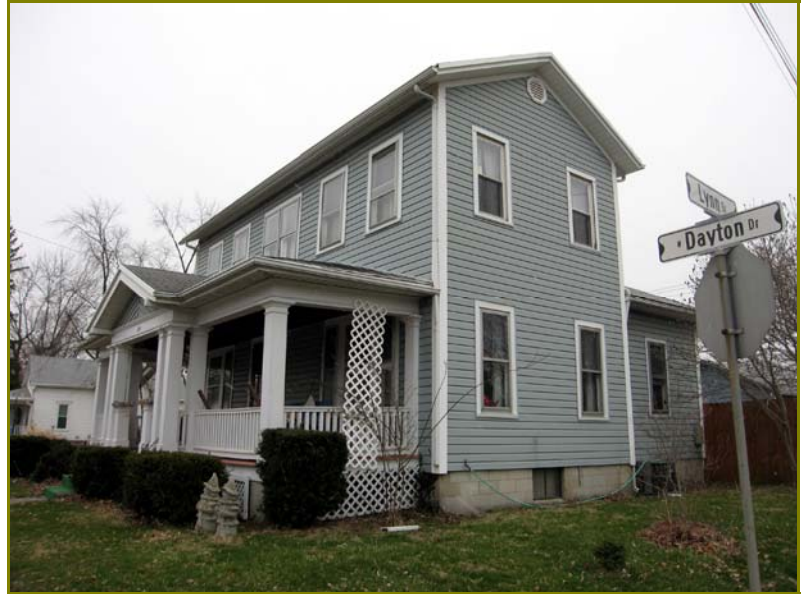
Figure 20. 200 W. Dayton Drive, looking southeast

Wood frame I-house. The building is difficult to date since it has been moved, and all original exterior materials have been replaced. A reasonable date range for this house is between 1860 and 1900. The building has a Colonial Revival style of porch, all new windows and doors, vinyl cladding, and a rear addition. This house was moved to this location in the 1920s from the former town of Osborn as a result of the Huffman Dam construction.

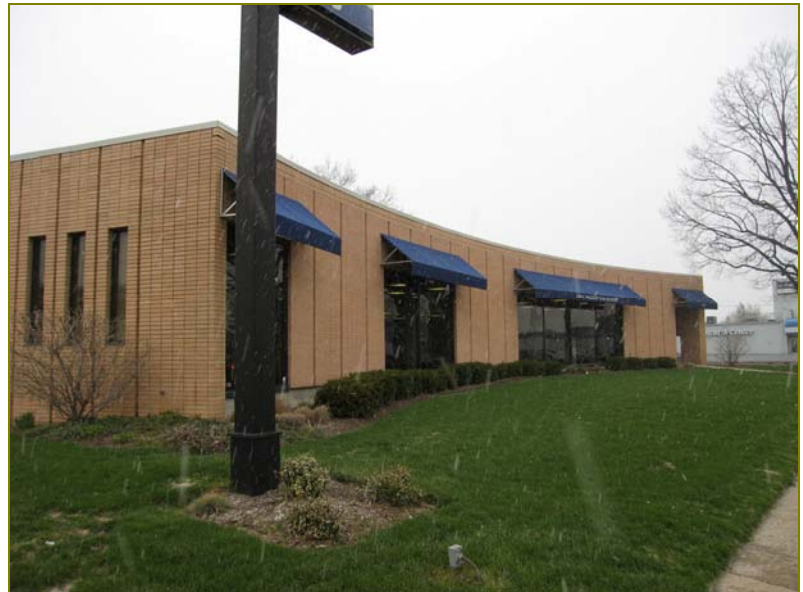
Figure 21. 77 S. Central Avenue, looking northwest

Buff-colored Roman Brick Geometric Expressionist style building constructed in 1965 as the Merchant and Mechanics Federal Savings and Loan. It is a modest example of this style, which was commonly used for savings and loans buildings in the 1960s. The building has been altered by the replacement of all windows and doors and the installation of awnings over the windows and doors.

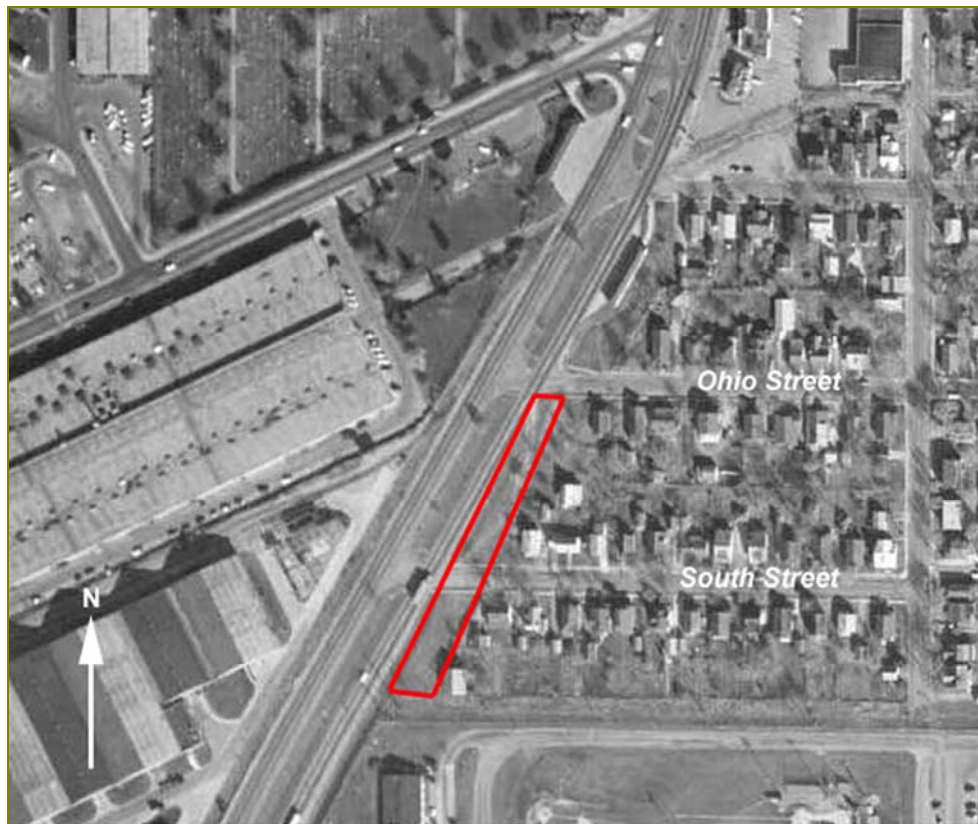
Soil Core #	Disturbed?	Total Depth	Depth of Disturbance	Soil color(s)	Observations
12	No	28 cm	None noted	10YR 3/2 silt loam	1959 aerial shows possible disturbance
13	No	24 cm	None noted	10YR 3/2 silt loam	1959 aerial shows possible disturbance
14	No	26 cm	None noted	10YR 3/2 silt loam	1959 aerial shows possible disturbance
15	No	24 cm	None noted	10YR 3/2 silt loam	1959 aerial shows possible disturbance
16	No	26 cm	None noted	10YR 3/2 silt loam	1959 aerial shows possible disturbance
17	No	28 cm	None noted	10YR 3/2 silt loam	1959 aerial shows possible disturbance
18	No	28 cm	None noted	10YR 3/2 silt loam	1959 aerial shows possible disturbance
19	No	26 cm	None noted	10YR 3/2 silt loam	1959 aerial shows possible disturbance
20	No	28 cm	None noted	10YR 3/2 silt loam	1959 aerial shows possible disturbance
21	No	26 cm	None noted	10YR 3/2 silt loam	1959 aerial shows possible disturbance

Figure 52. Detail of 1959 aerial photograph of Fairborn, Ohio
Red outline shows area probed in 2011, with possible soil disturbance indicated by surface discolorations in photograph
Photograph courtesy ODOT Office of Aerial Engineering
