Office of Legacy Management

**Refinement of Conceptual Model and
Recommendations for Improving Remediation Efficiency
at the Shiprock, New Mexico, Site**

July 2005

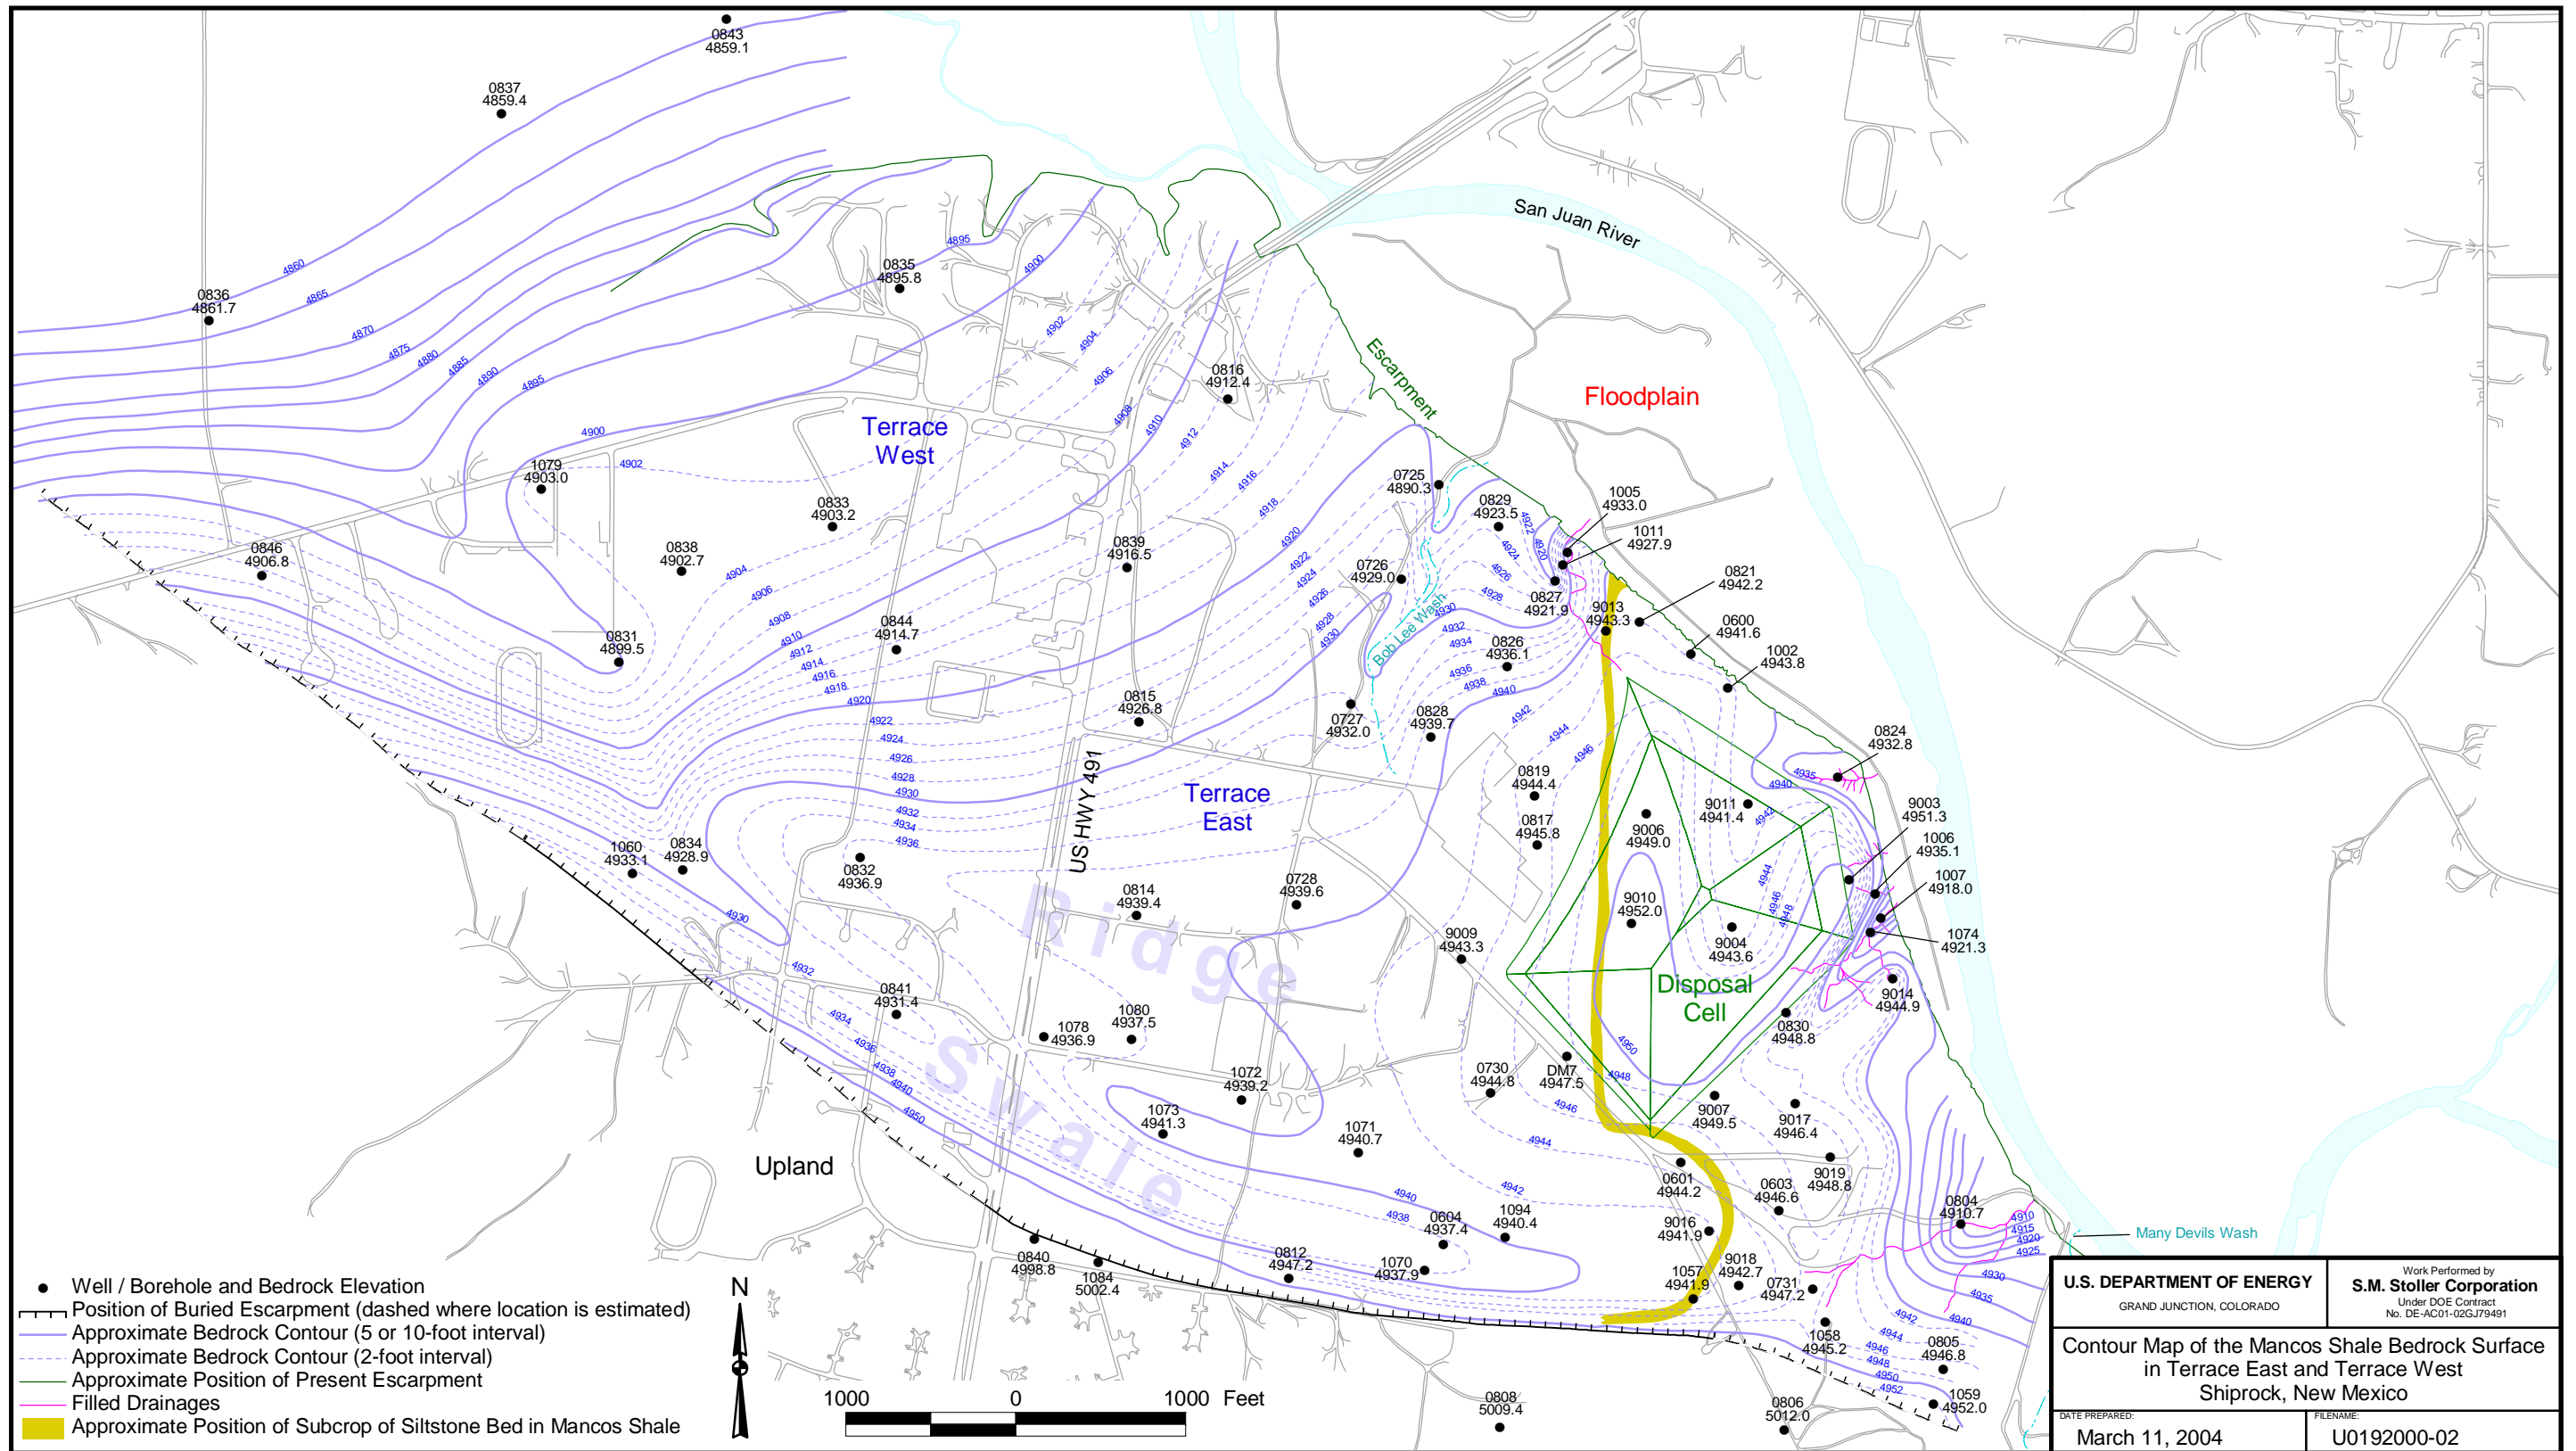
Figure 2-4. Contour Map of the Mancos Shale Bedrock Surface Elevation in Terrace East and Terrace West

South of the disposal cell, nitrate, selenium, and sulfate are the primary contaminants in the terrace ground water system. Ground water in the eastern end of a bedrock swale (Figure 2–4) flows east and southeast toward Many Devils Wash along the top of a thin, east-dipping (about 1 degree or less), resistant, calcareous siltstone bed in the Mancos Shale and in the fractured and weathered shale of the Mancos Shale immediately below. This water discharges into Many Devils Wash, mainly from the confluence of the East Fork downstream to about 150 yards below the knickpoint (Plate 1).

Data presented in the GCAP on the saturated thickness of alluvial material in the terrace indicated an area referred to as a sump (referred to as a swale in this report) where saturated thicknesses exceeded 6 ft in the south end of terrace east. Contaminated ground water in this buried ancestral San Juan River channel (the swale) was estimated at 38 million gal (SOWP Table 4–6). This volume, based on a porosity of 30 percent, represents only a portion of the terrace east area.

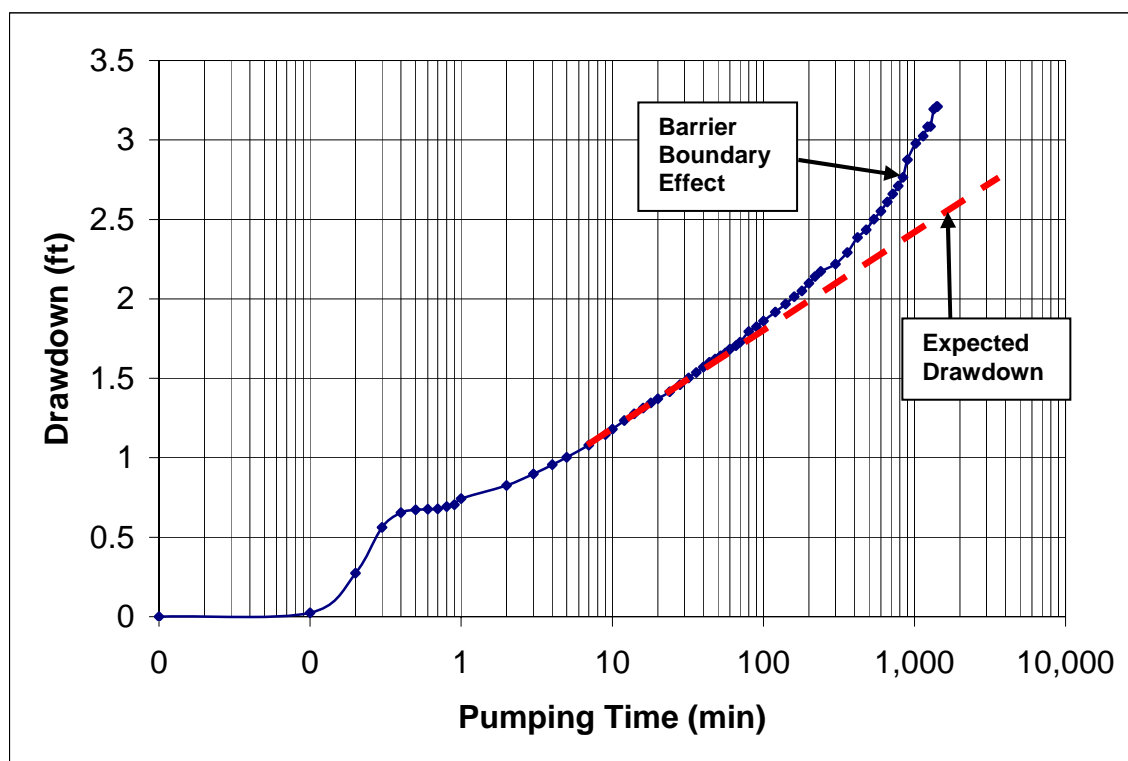
Figure 3–1. Semilogarithmic Plot of Drawdown in Relation to Time at Terrace East Extraction Well 0818

Relatively low extraction rates do not by themselves prove that the lateral extent of the aquifer is limited; however, hydraulic data from an aquifer test conducted at terrace east extraction well 0818 provide evidence that the alluvium, at least at this locale, is laterally discontinuous. Specifically, drawdown data obtained during the test indicated the presence of a barrier boundary about 20 ft from the pumping well. The barrier boundary caused the rate of change in drawdown in the pumping well to vary greatly from the rate that would be expected in an aquifer with no barriers (Figure 3–1). Without additional investigation, the cause of this boundary effect is difficult to determine. Possibly, elevated areas of Mancos Shale bedrock surface or other less permeable materials are acting as impediments to local ground water flow in terrace alluvium near well 0818.

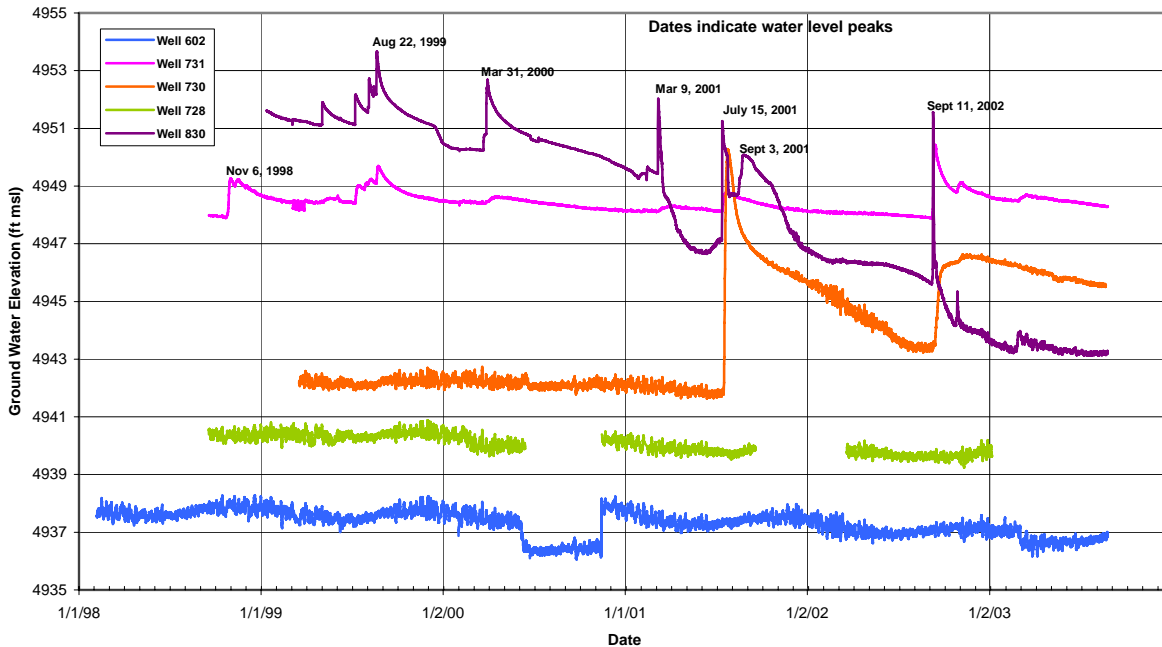
Figure 3–3. Datalogger Information for Specific Terrace Wells

The large increases in ground water levels observed in well 0730 (Figure 3–3) are the result of infiltration of ponded water in the adjacent radon-cover borrow pit. The radon-cover borrow pit is a closed basin that collects rainwater runoff from an area about twice the size of the basin. Local ponding has been observed immediately after several heavy rainfall events in the lowest part of the radon-cover borrow pit just east of well 0730. Tamarisks are growing at scattered locations in the lowest part of the radon-cover borrow pit, indicating the presence of a shallow ground water table. Ground water levels in well 0731 reflect major rain events similar to those in well 0730. The response in well 0731 is attributed to infiltration from ponded water in local surficial depressions in the adjacent NECA gravel pit area. For additional discussion, see Appendix B of this report.

The large increases in water table elevation at well 0730 following large rainfall events suggest that a significant amount of recharge occurs when water ponds in the radon-cover borrow pit. This source of recharge has been ignored in previous remediation planning. If not curtailed, this recharge may extend the length of time required for active ground water remediation. Vegetation in the radon-cover borrow pit may be capable of extracting a substantial amount of ground water that could offset the amount added by infiltration.

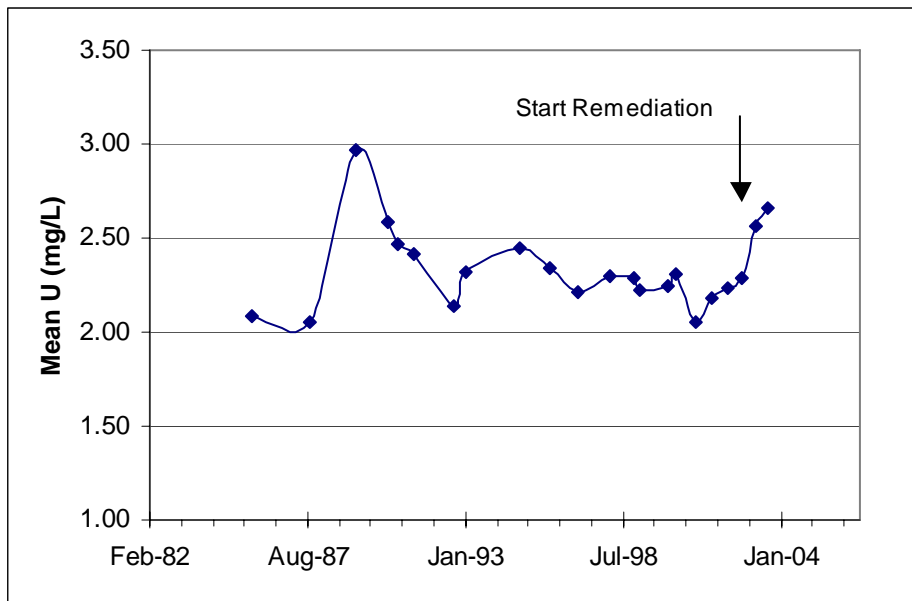
Figure 3-5. Uranium Concentration Metric (mean concentration of samples from wells 0608, 0614, 0615, 0618, 0619, and 0854 in the floodplain).

The metric uranium concentration has not changed substantially over time (Figure 3–5). The mean uranium concentration in the plume is about 2.3 mg/L. Concentration trends for sulfate and nitrate are similar to uranium. Time trends of uranium concentrations in samples from individual wells vary with some trending up and some down. Operation of the remediation system, including the escarpment collection drains as recommended in Section 6.2, should consider the spatial distribution concentration trends.

Reasons for the continued high concentrations of contaminants in ground water in the floodplain are uncertain. The remediation system has been operational for such a short period of time that trends cannot yet be determined. Also, the effect of pumping on the concentrations of contaminants in terrace east ground water is likely to be less than predicted. Alternatively, the flux of contaminated seepage from the terrace is higher than previously thought. However, this explanation is inconsistent with the observation that the highest uranium concentrations are near the river rather than near the escarpment (Figure 2–3). Possibly, the flow rate of floodplain ground water is slower than previously estimated or there are stagnant zones that are not being affected by natural flushing. Also, aquifer sediments and Mancos Shale fractures may contain high concentrations of contaminants that continue to bleed into the ground water.

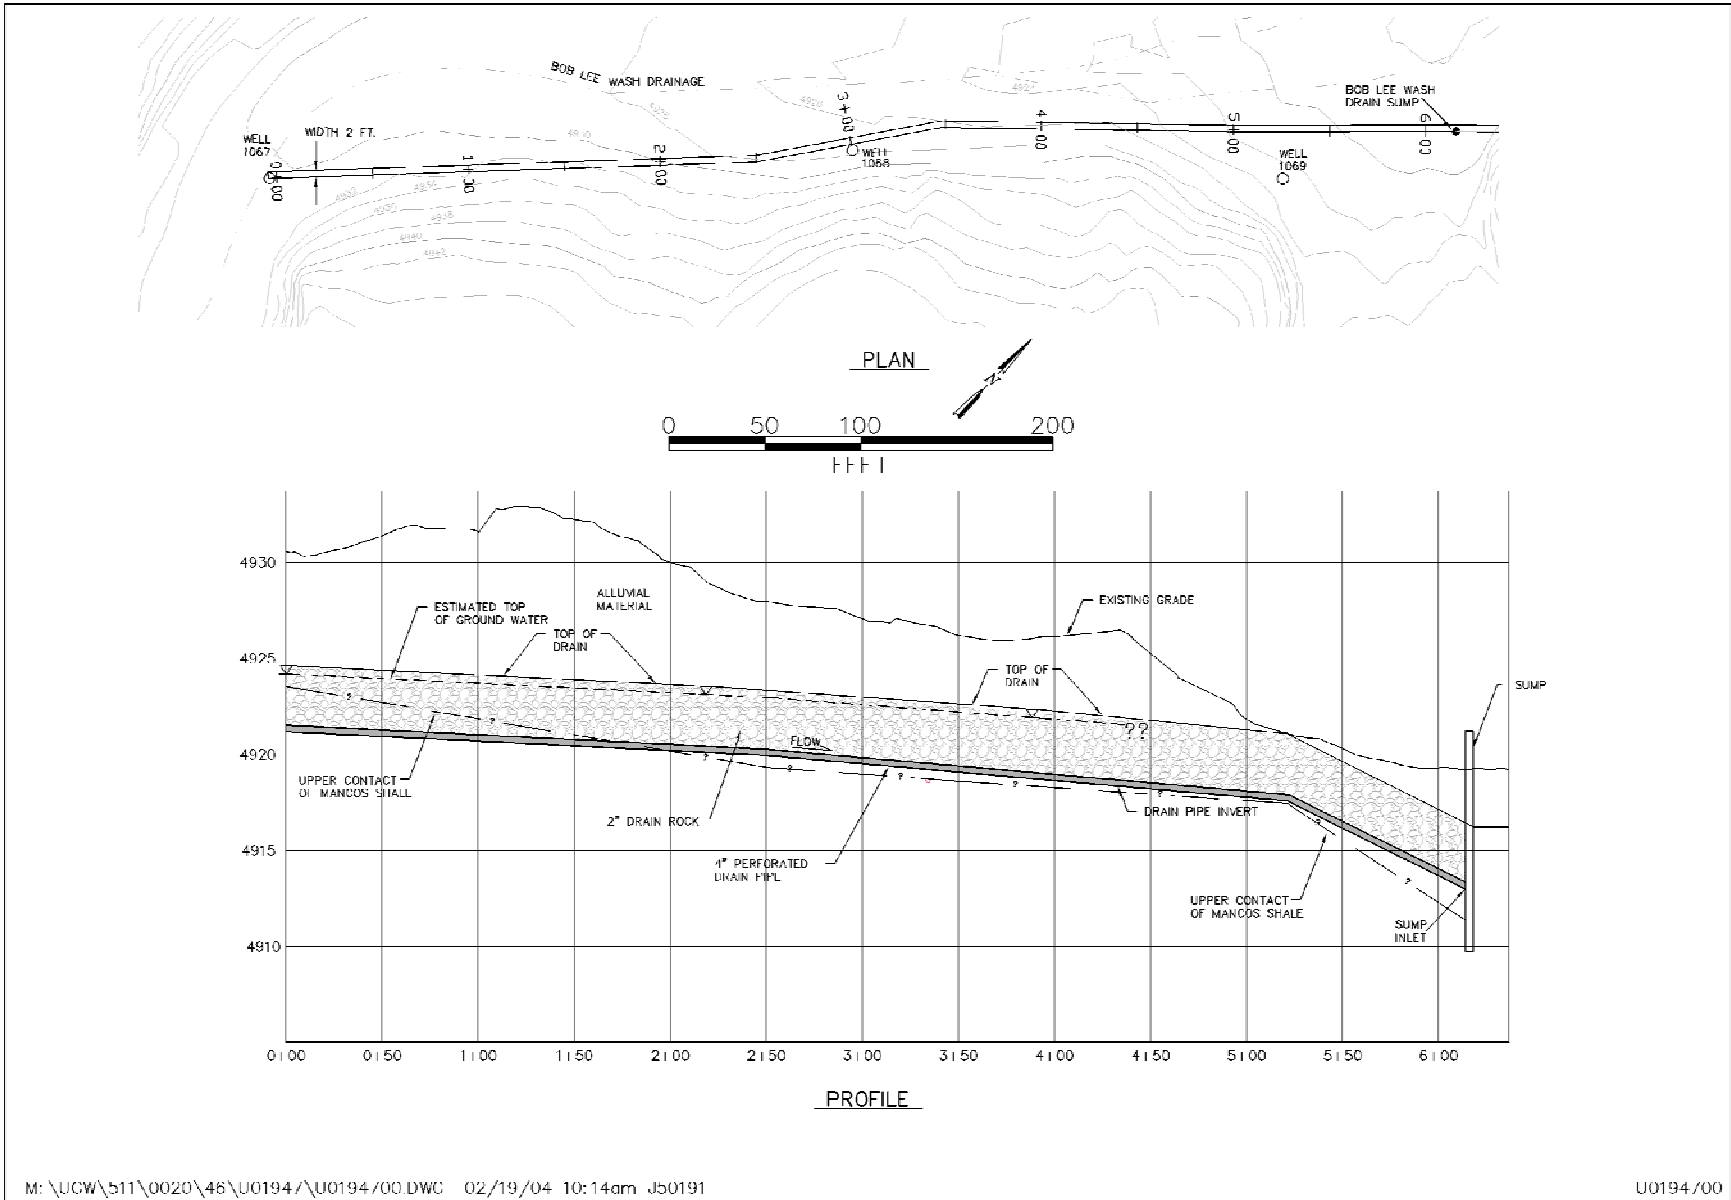
Figure 4-2. As-Built Plan and Profile of the Interceptor Drain in Bob Lee Wash

When the system began operation in mid-March 2003, the discharge rate from the sump was just below 7 gal/min. During the early stages of operation, ponded water was visible on the surface near the sump, suggesting ground water was bypassing the drain because the pump could not accommodate the volume of ground water entering the drain. By early May 2003, the ponded water was no longer present, suggesting that the pump discharge rate was keeping up with the inflow rate (the pumping rate at this time was approximately 5.5 gal/min). As of January 2004, the drain was removing 5.8 gal/min of contaminated ground water.

During the summer months, some bacterial growth was observed clogging the filter. Chemical treatment appeared to remedy this problem, although a number of treatments were necessary to control this growth. Once the daily temperature cooled down in fall 2003, the bacterial growth decreased.

Deeper installation of the drain so that its entire length would be in the bedrock would possibly increase access to a larger volume of available ground water for removal. A larger volume of ground water in conjunction with a higher capacity pump would increase the volume of contaminated ground water removed from this area of the site.

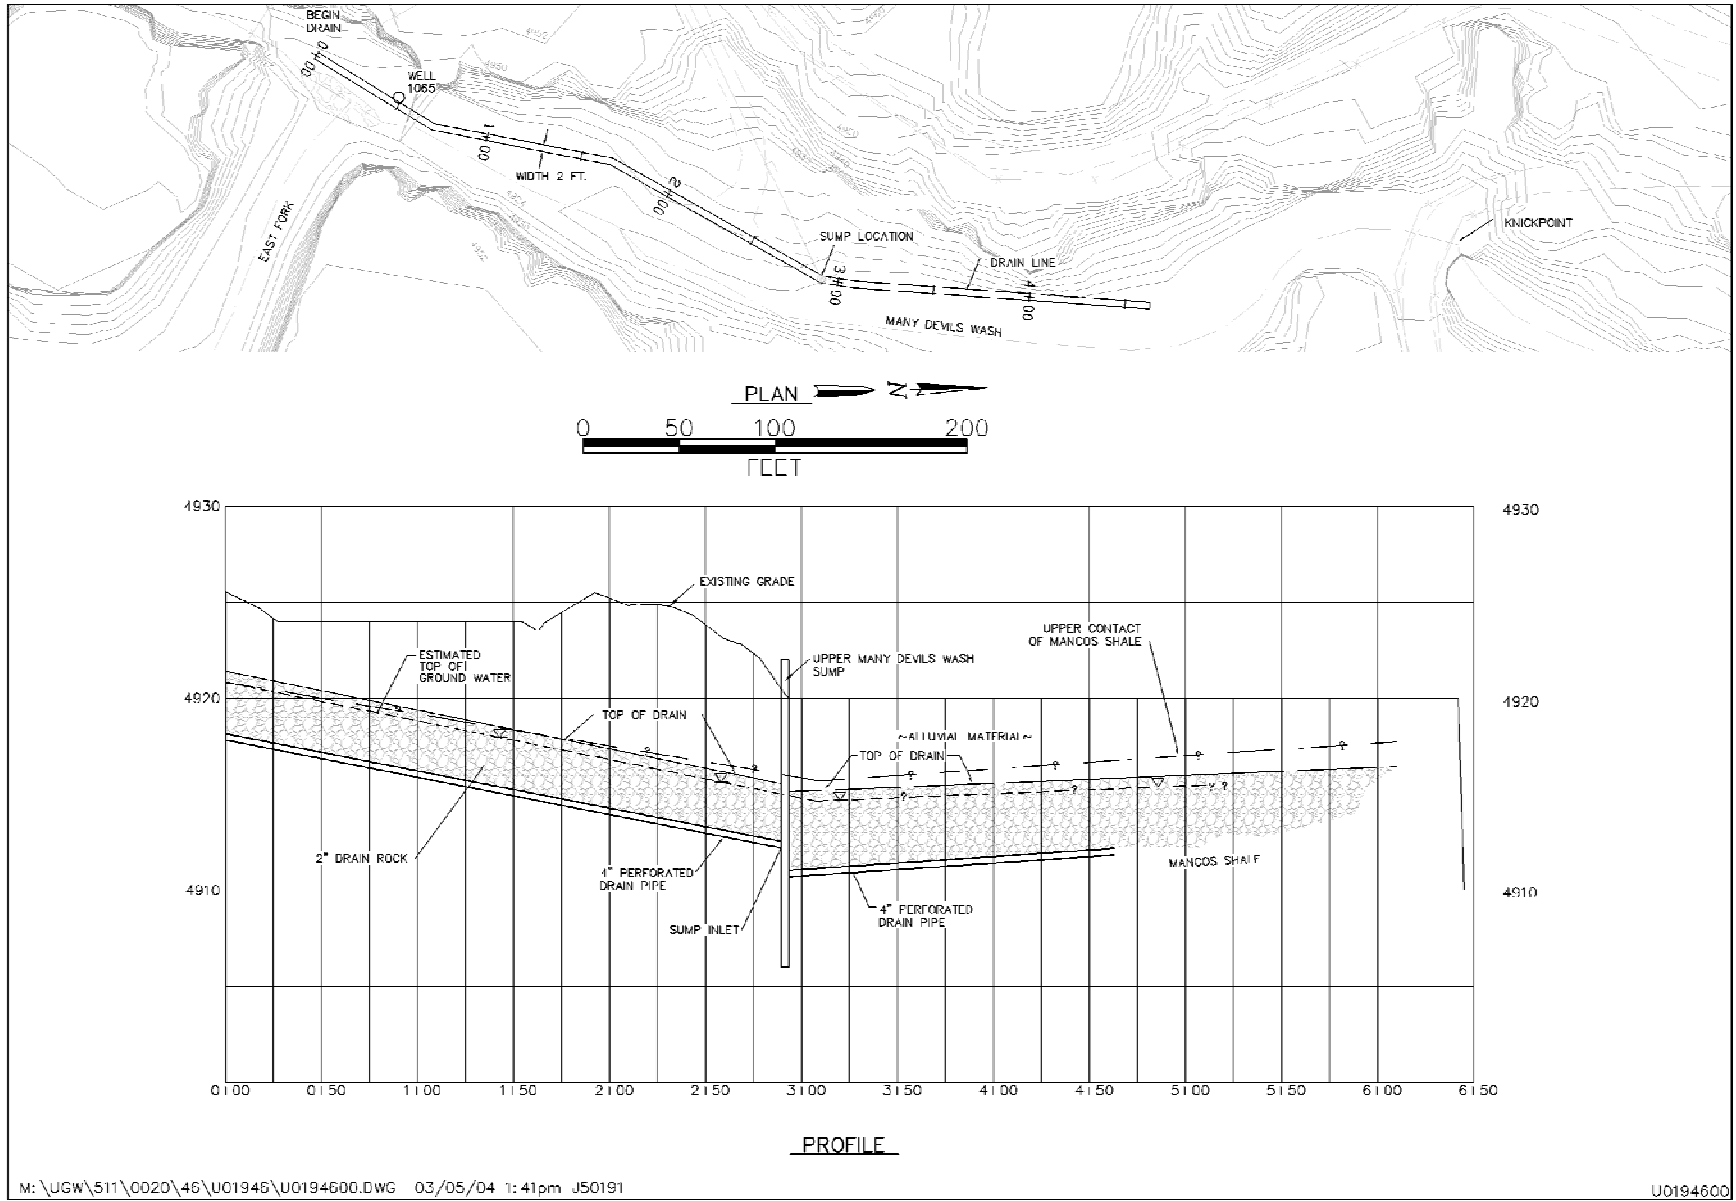
Figure 4-3. As-Built Plan and Profile of the Interceptor Drain in Many Devils Wash

The initial design of the Many Devils Wash drain specified that the drain would extend north as far as the knickpoint in the wash. However, the drain line was extended only to its present location (approximately 150 ft north of the sump), which is approximately halfway between the sump and the knickpoint. Figure 4–3 presents the as-built plan and profile for this drain. The drain was not constructed north to the knickpoint because of conditions identified during trench excavation. As trench excavation advanced north from the sump, the alluvial material and shale bedrock became less saturated. Also, trench excavation became more difficult in the resistant calcareous siltstone bed in the Mancos Shale and in the underlying unweathered shale as the trench progressed northward. Trench excavation ended at a point where the subsurface was nearly dry.

During spring 2003, water began ponding on the surface of the wash from the sump south to the confluence of the East Fork (Plate 1). By June 2003, the water had not been removed by the drain and had not evaporated. The source of this water was believed to be seeps fed by ground water upgradient from the south end of the drain. In an effort to capture this water, a french drain was added in late 2003 to the main drain at its south end near the East Fork confluence. In response to the modification to the drain, the pumping rate doubled (from approximately 0.1 to 0.2 gal/min) and the ponded water dried up for several months. During a site visit in December 2003, ponded water was again observed in the main channel, apparently originating from seeps west of the main drain south of the sump. Also, from October 2003 to early January 2004, the pumping rate increased to approximately 0.4 gal/min. This higher pumping rate could be because of less evaporation during fall and winter, resulting in more available ground water, or could be because additional ground water was reaching the Many Devils Wash area from the west, or a combination of both. The pumping rate increased again in early January 2004 to nearly 0.8 gal/min, which was maintained to early February. This abrupt increase in pumping may be caused in part by a large rain and snowfall event in early January.

An accumulation of silt and mud in the rock covering the french drain may restrict flow of surface water and ground water into the drain at the south end of the interceptor drain. Silt was deposited on top of the rock during several rainfall events that created flows down the wash. Periodic removal of the built-up accumulation of silt would increase the flow to the french drain. In addition, the use of a netting material (as opposed to the geotextile filter fabric) and extending the drain farther south may also increase flow into the drain.
