WONDER MAKERS
ENVIRONMENTAL

June 15, 2009

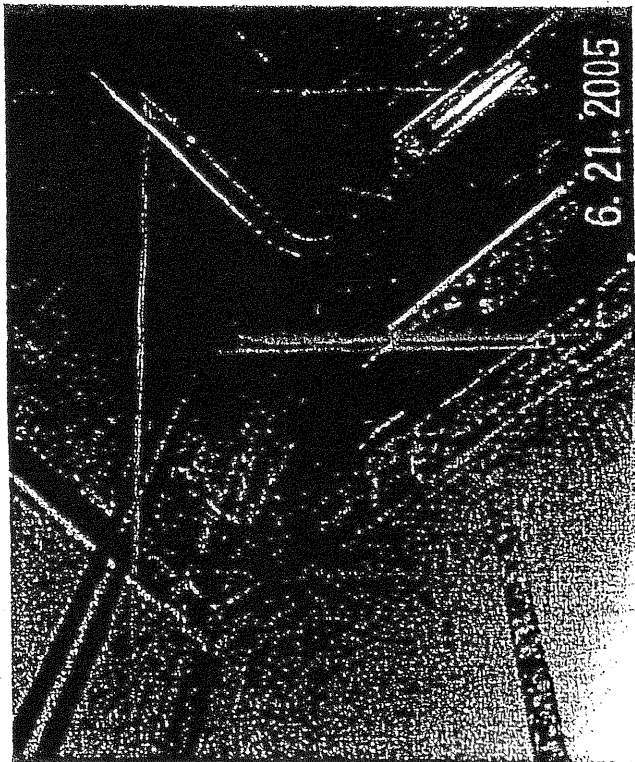
Surface corrosion on elevator shaft GWB liner panel sill-track indicating presence of moisture.

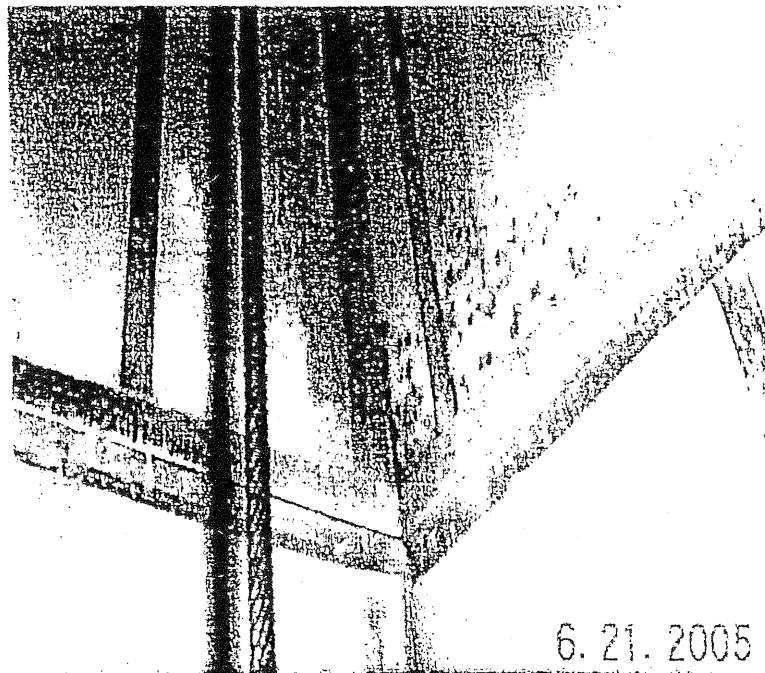
Minor mold on surface of elevator shaft GWB liner, just above the floor line.

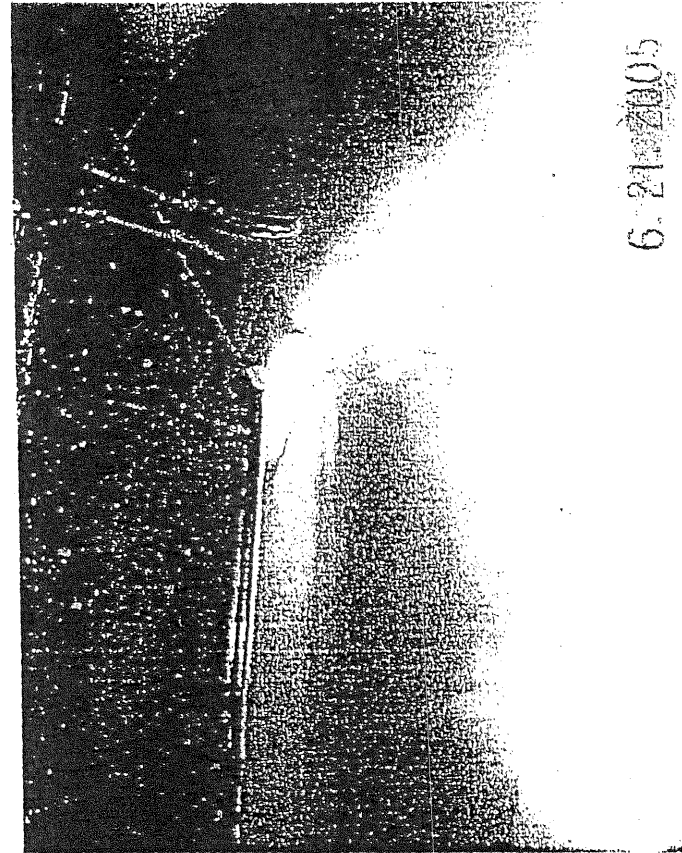
Minor surface mold on elevator shaft liner just above floor line.

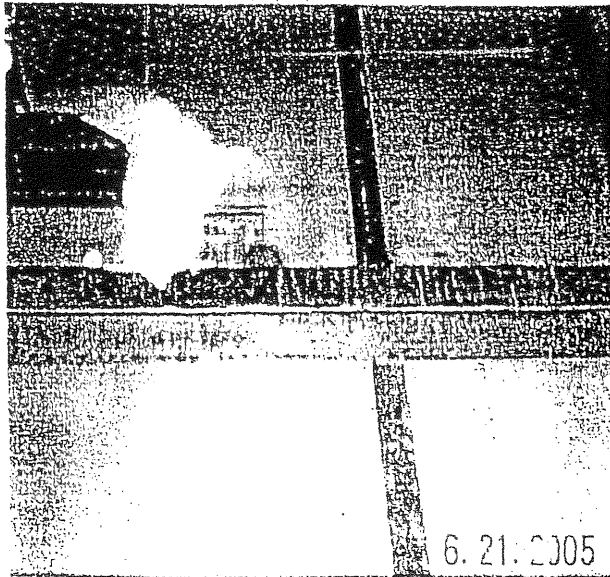
Minor surface mold on elevator gypsum shaft liner panel just above floor line.

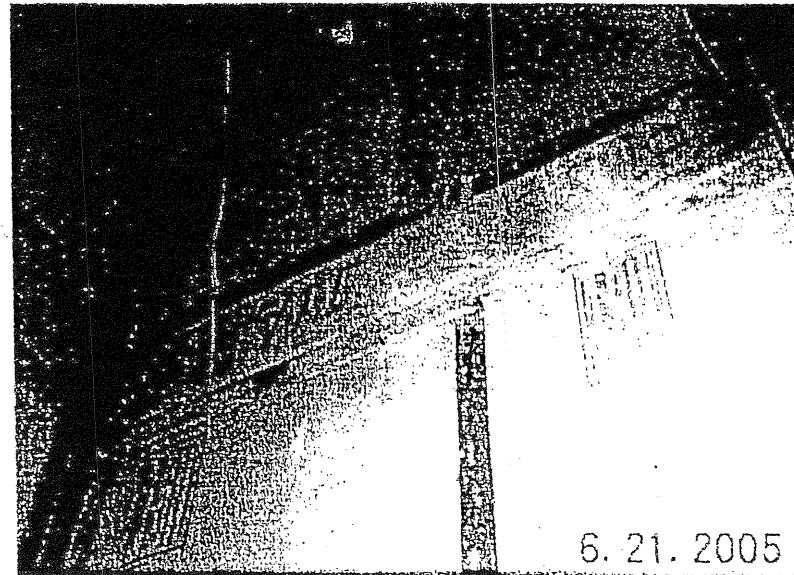
Minor surface mold and water stains on gypsum liner panel below floor slab location.

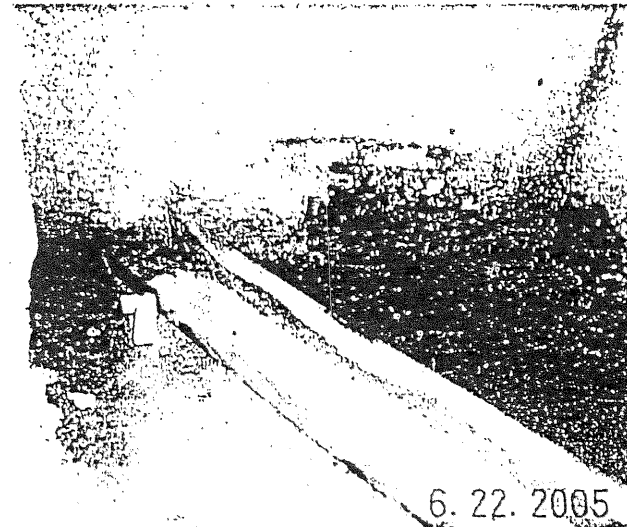
Water stains on elevator gypsum shaft liner panel below location of floor slab.

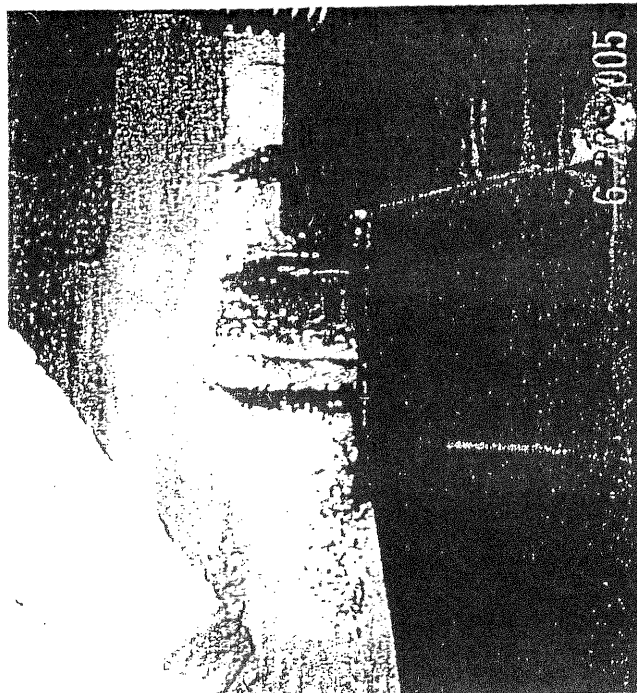
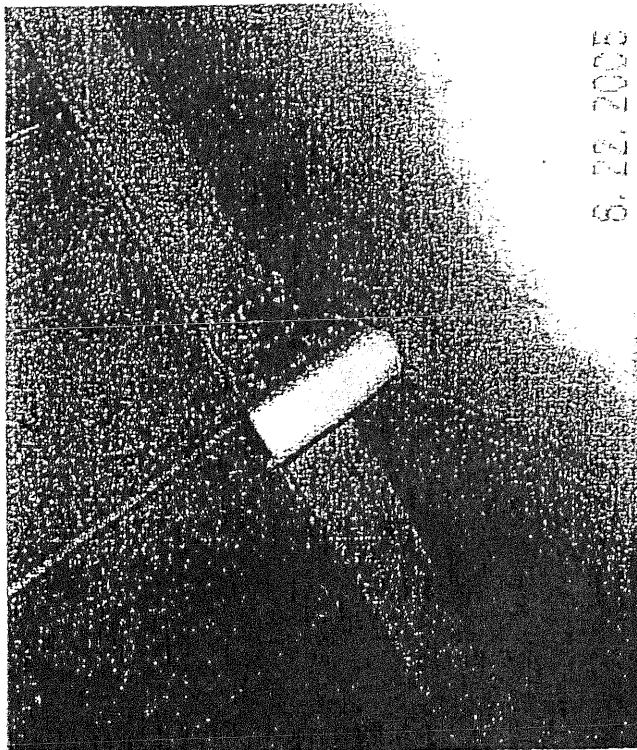
Evidence of past drain leak.

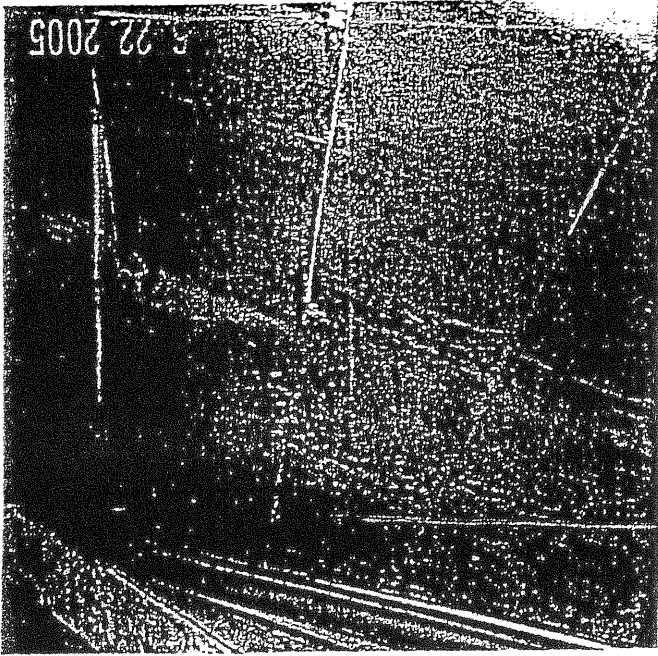
Water stains on inside surface of pre-cast panels below grating at microwave balconies.

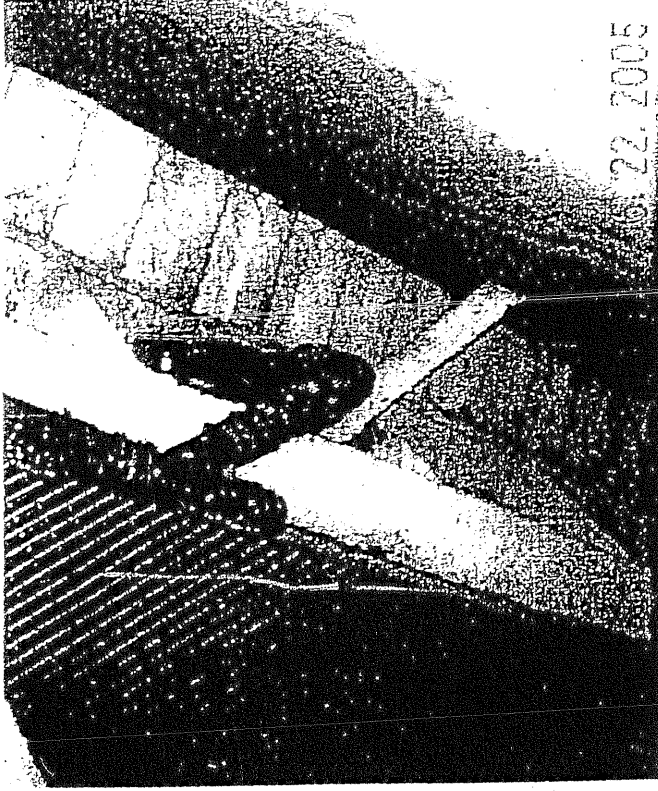
Repaired floor drain from past break and subsequent flooding.

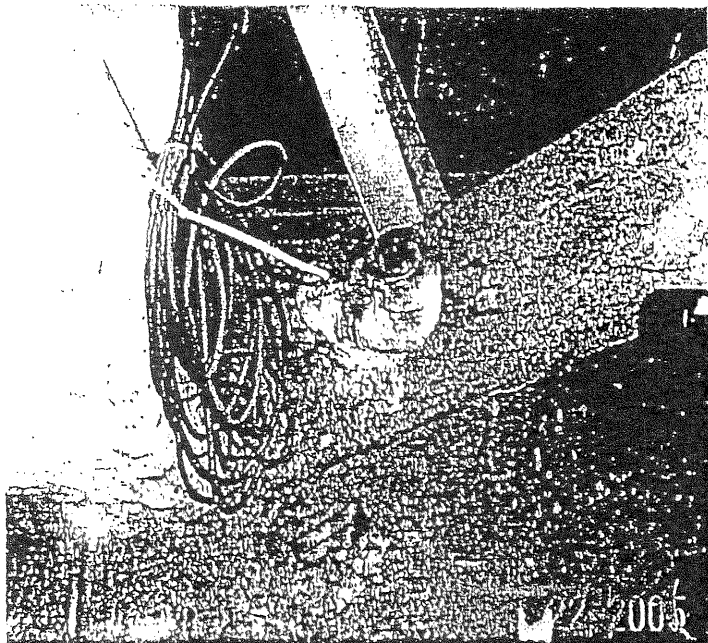
Discarded pipe elbow, indicating repair of a past drainpipe break.

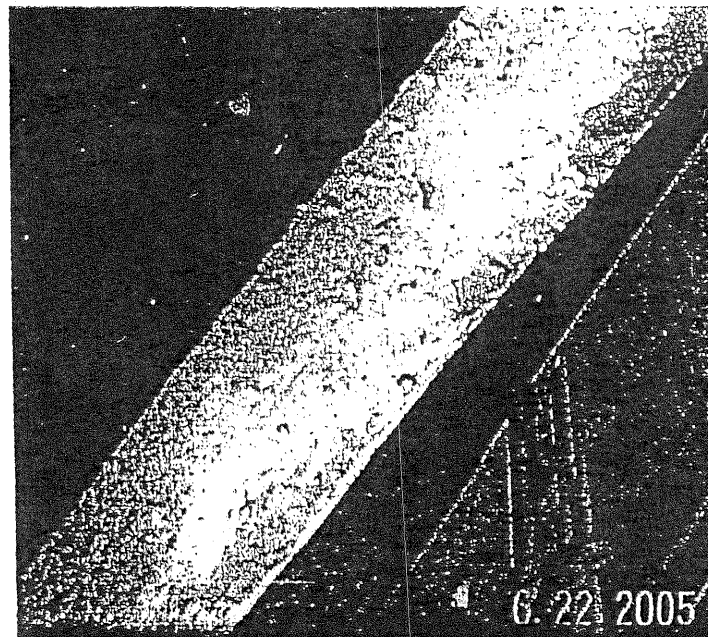
Lightweight fire proofing on structural steel below the microwave balcony. Rainwater from grating above has washed off some of this material, which is blocking the floor drain below.

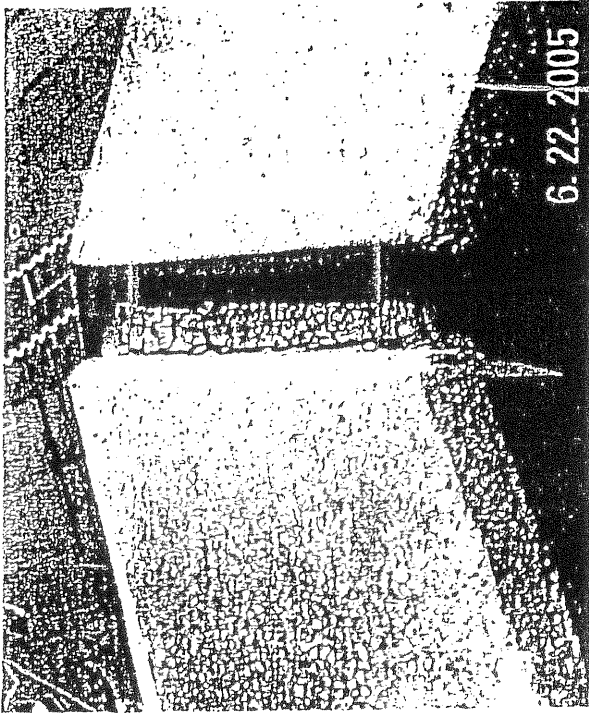
Typical example of failing exterior caulk joints between pre-cast panels.

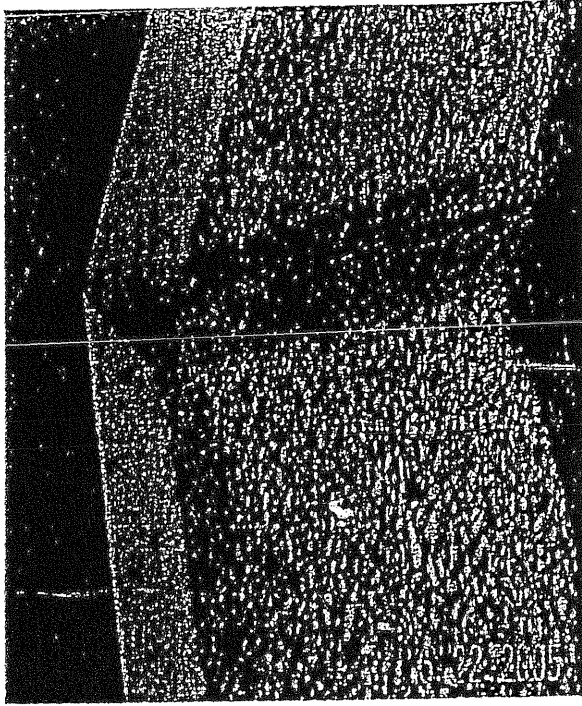
Typical example of failing exterior caulk joints between pre-cast panels.
