**From:** Debra.Rosen@dot.gov  
**Sent:** Wednesday, September 23, 2009 11:07 AM  
**To:** Gorman, Karen  
**Cc:** McMullen, Catherine; Judy.Kaleta@dot.gov  
**Subject:** FW: SUGENT follow-up  
**Attachments:** 1999 Study.pdf; OSCSugentAttach1.pdf; OSCSugentAttach2.pdf; DTW-FAA Tech Rpt.pdf

Karen: Please find below, responses (in red) to the follow-up questions in your e-mail of August 27, 2009, concerning the Sugent investigation, DI-08-0591 and DI-09-1696. Documents referenced in the responses are attached.

Subject: Response to OIG Recommendations for Detroit Metropolitan Wayne County  
Airport (DTW) Air Traffic Control Tower  
Ref: OIG Investigative Report, 08111B33H001, Apr. 3, 2009

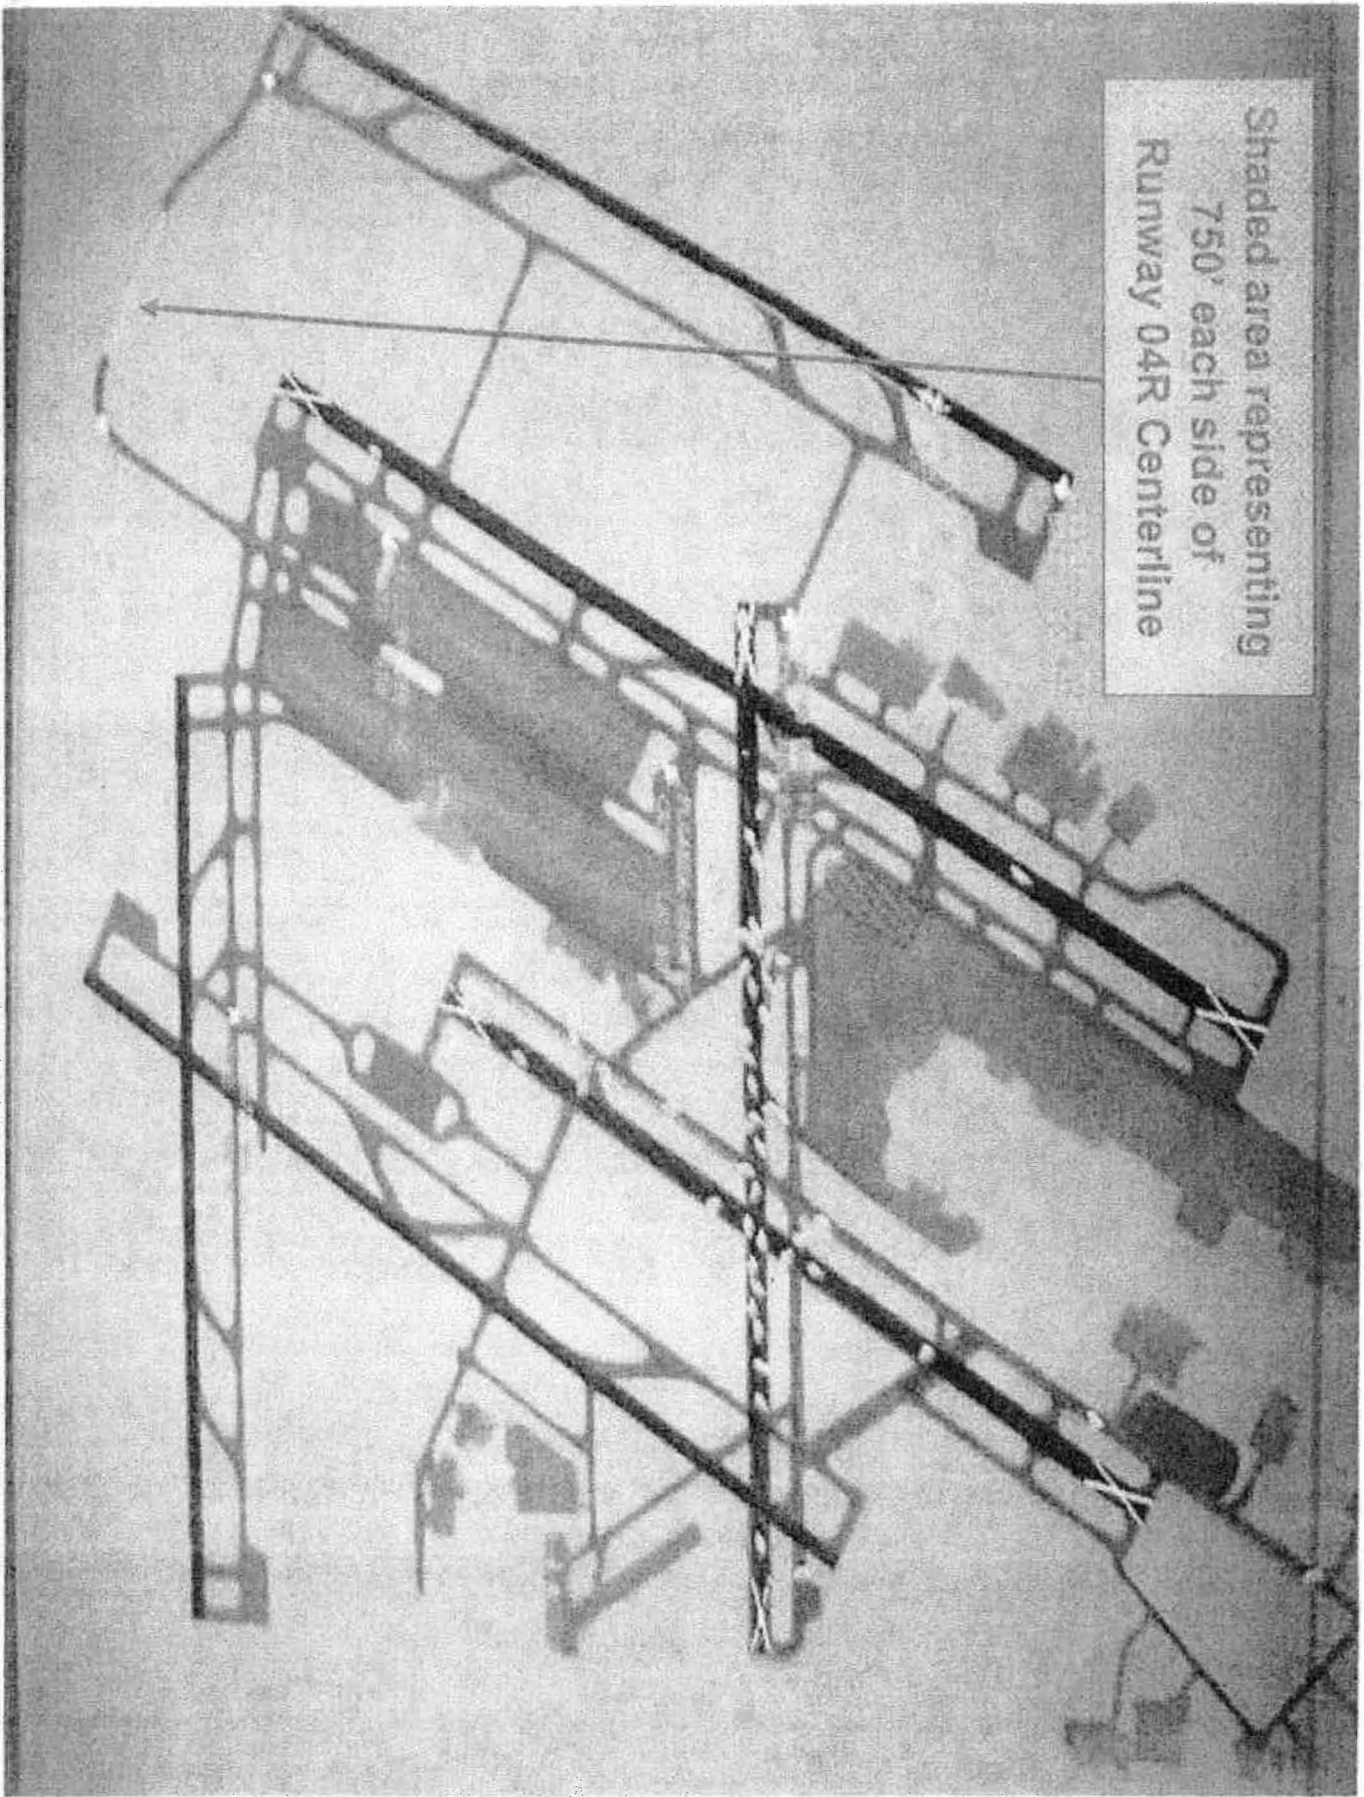
- 4. Explanation of Changes:** This notice modifies the distance requirement for aircraft to remain clear of the Runway 04R ALSF-2 light line during low IFR conditions. It extends the distance from 200' each side of extended center line to 750' each side of center line. It has been determined that the Runway 04R Approach Hold Short markings and signage may be used to ensure protection of these area boundaries on Taxiway Q.

Shaded area representing  
750' each side of  
Runway 04R Centerline

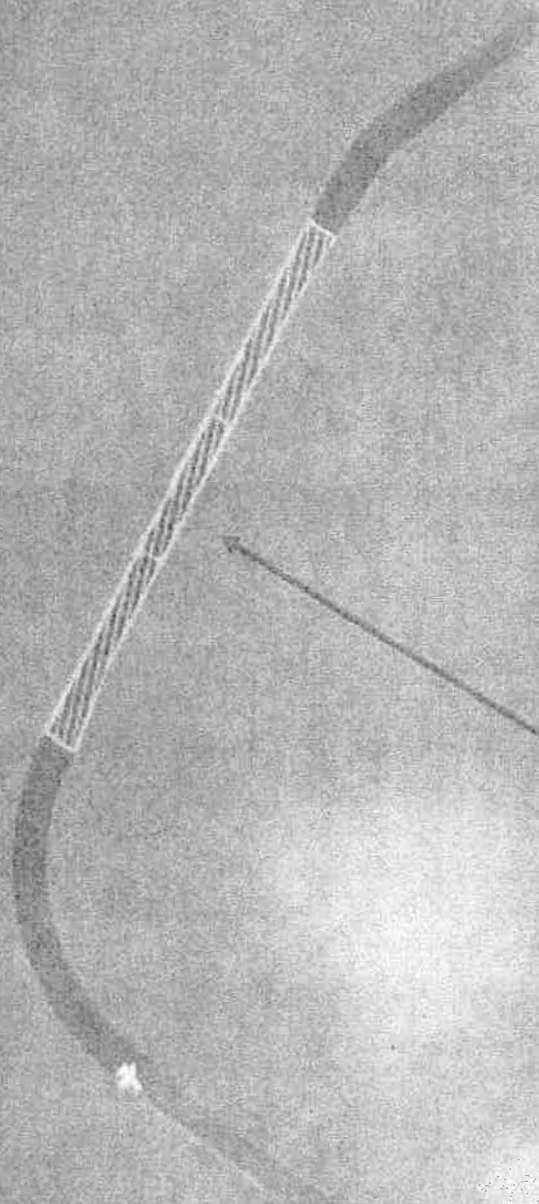
Shaded area representing  
750' each side of  
Runway 04R Centerline

Lines Representing  
200' Each Side of  
Runway 04R Centerline

Lines Representing  
750' Each Side of  
Runway 04R Centerline
